REPORT

ON **GEOTECHNICAL INVESTIGATION**

FOR PROPOSED NEW BUILDING AND REFURBISHMENT OF BUILDINGS W6A AND W6B

AT MACQUARIE UNIVERSITY, NORTH RYDE, NSW

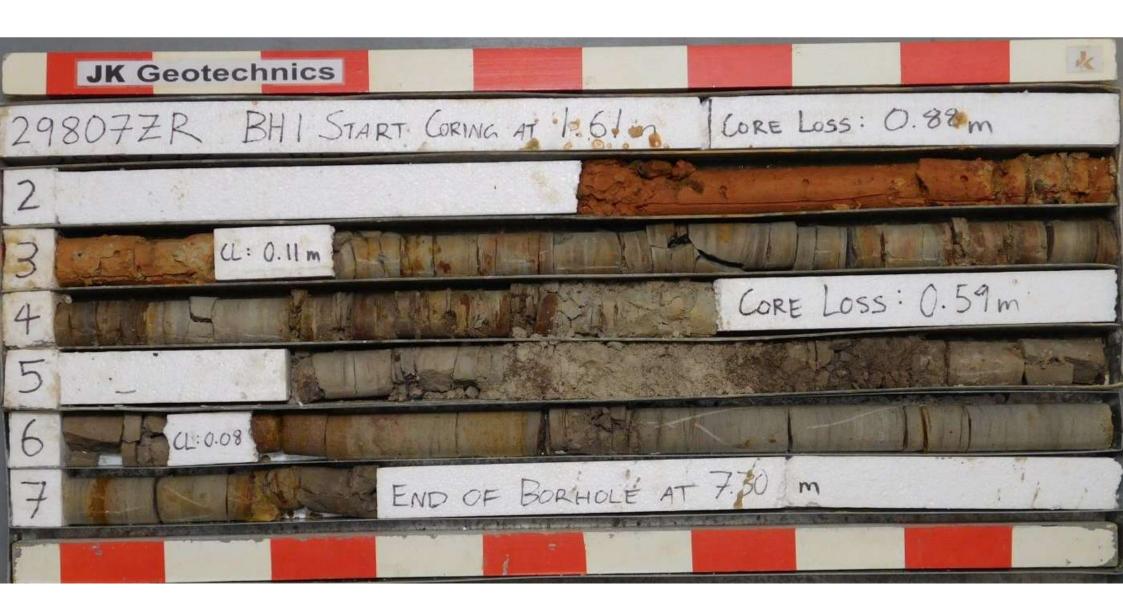
BOREHOLE LOG

-		SANDSTONE: fine grained, light grey, with grey laminae, bedded at 0-5°.	DW	L			(5.36m) J, 75°, Un, R
	=	- - -		with grey familiae, bedded at 0-5.	XW	EL			
	_	6-			DW	L			(6.00m) J, 85°, P, R, CLAY INFILL
	58 -	_		CORE LOSS 0.08m	OW		1 233		_

-	- - - -		SANDSTONE: fine grained, light grey, with grey laminae, bedded at 0-5°.	SW	M			—— (6.52m) XWS, 0°, 70 mm.t
	57 –	7 - -							
	-	- - - -		END OF BOREHOLE AT 7.30 m					50mm DIA. PVC MONITORING WELL INSTALLED 3.0m DEPTH, MACHINE SLOTTED FROM 0.5m TO 3.0m, Zmm SAND FILTER PACK FROM 0.4m TO 7.30m, BENTONITE SEAL FROM 0.1m TO 0.4m, BACK FILLED TO SURFACE

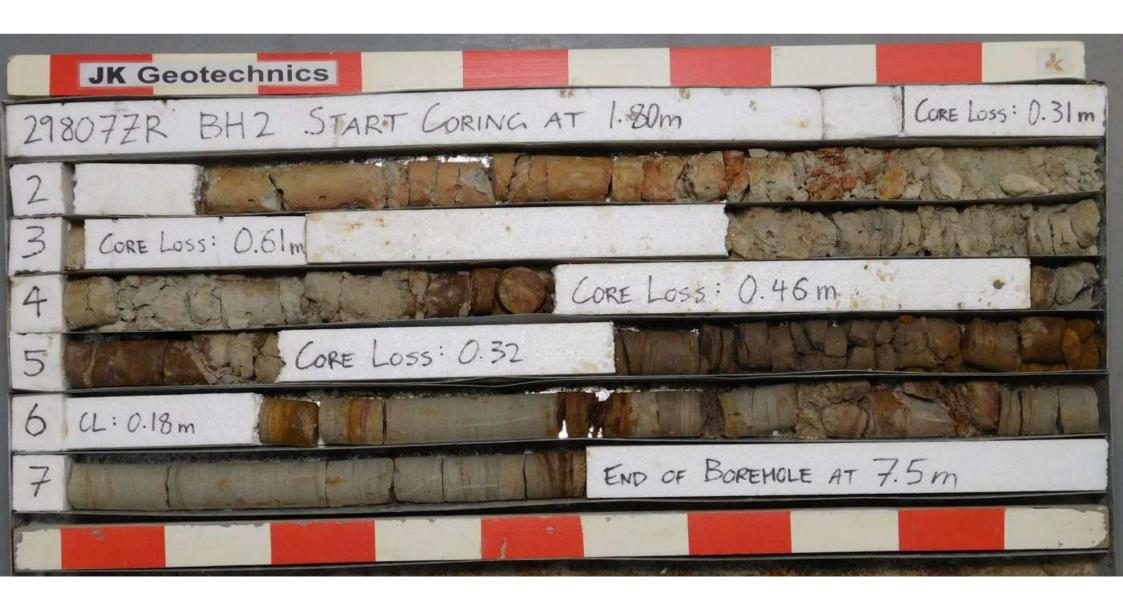
BOREHOLE LOG

- - - 57 –			SANDSTONE: fine grained, light grey with grey laminae, and iron indurated seams and bands, bedded at 0-15°.	DW	M			(6.50m) Be, 15°, P, R (6.61m) XWS, 5°, 20 mm.t (6.72m) CS, 0 - 5°, 30 mm.t (6.75m) J, 90°, P, R (6.84m) J, 70°, P, R, CLAY INFILL

-	-		END OF BOREHOLE AT 7.50 m					50mm DIA. PVC MONITORING WELL INSTALLED 3.0m DEPTH, MACHINE SLOTTED FROM 1.0m TO 3.0m, 2mm SAND FILTER PACK FROM 0.6m TO 7.50m, BENTONITE SEAL FROM 0.15m TO 0.6m, BACK FILLED TO SUFFACE

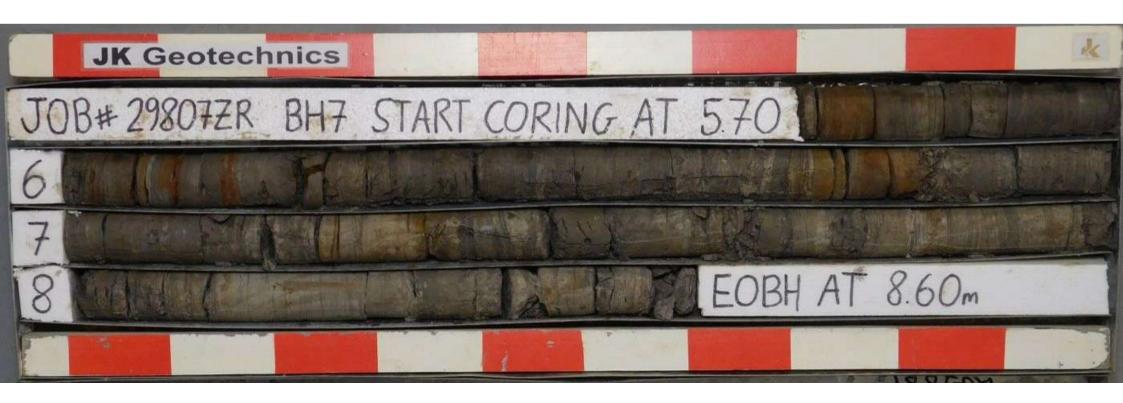
Borehole No. 8

< <drawingfile>> 11/11/2016 09:51</drawingfile>		60	8-		SANDSTONE: fine to medium grained, light grey and grey, thinly bedded at 0-10°, with dark grey laminae.	DW	L - M			- (7.49m) CS, 0 - 5°, 60 mm.t, HP: 210kPa - (7.64m) J, 45°, Un, R - (7.75m) CS, 0 - 10°, 20 mm.t, HP: 270kPa - (8.03m) XWS, 0 - 5°, 110 mm.t - (8.36m) XWS, 0 - 10°, 90 mm.t - (8.50m) CS, 0 - 5°, 10 mm.t - (8.50m) CS, 0 - 5°, 10 mm.t
MASTER 29807ZR NORTH RYDE.GPJ		59 — - - - 58 —	9		END OF BOREHOLE AT 8.60 m					:
JK_LIB_CURRENT - V8.00.GLB Log J&K CORED BOREHOLE -		- - 57 — - -	10—							
		56 -	- - - - -

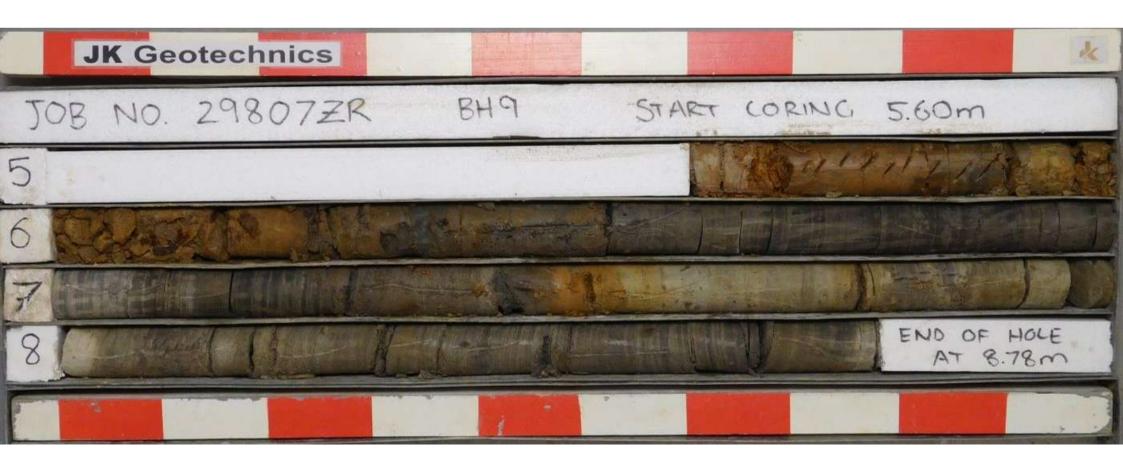
BOREHOLE LOG

Pla	nt ⁻	Туре	e: J	IK308	Bearing: N	/A			Logg	ed/Checked By: A.F./P.R.
Loss\Level		RL (m AHD)	Depth (m)	Graphic Log	CORE DESCRIPTION Rock Type, grain characteristics, colour, structure, minor components.	Weathering	Strength	DINT LOAD FRENGTH INDEX I _s (50)	DEFECT SPACING (mm)	DEFECT DETAILS DESCRIPTION Type, inclination, thickness, planarity, roughness, coating. Specific Genera
	ţ	57 -	6		START CORING AT 5.60m INTERBEDDED SANDSTONE AND SHALE: fine to medium grained, brown grey, bedded at 5-10°.	DW XW DW	L EL VL			- (5.68m) Be, 5°, Un, R, IS - (6.00m) FRACTURED BAND 50mm.t - (6.10m) J, 85°, Un, R, IS - (6.17m) J, 70°, Un, R, IS
					as above, but grey and light grey, with high strengh seams.	XW DW	EL M	•		(6.7711) 3, 70 , GII, P., IS
100% RETURN	į	56 -	7-		SANDSTONE: fine grained, light grey,	XW	EL			- - - - - - (7.52m) Be, 19°, Un, R, IS
	į	55 -	8-		bedded at 5-10°. as above, but bedded at 15°.	SW	Н			(7.77m) Be, 5°, Un, R, IS (7.82m) CS, 5°, 60 mm.t (8.11m) CS, 5°, 55 mm.t (8.20m - 8.46m) XWSx4, 15°, 3 mm.t

ţ	54 -	9-		END OF BOREHOLE AT 8.78 m		M			
	ŧ	53 -	- 10 — - - - -							
	ŧ	52 -	- 11 - - - - -							- - - - - - - -

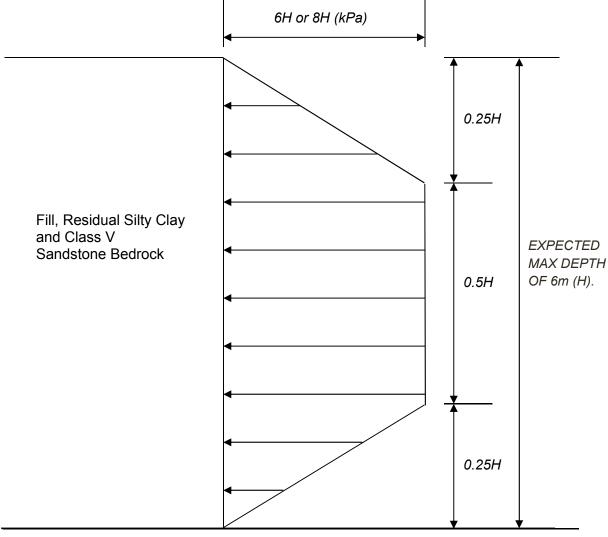
RECOMMENDED DESIGN PRESSURES FOR ANCHORED OR PROPPED RETAINING WALLS – FULL DEPTH RETENTION

- For progressively anchored or propped walls, where minor movements may be tolerated, we recommend the use of a uniform rectangular earth pressure distribution of 6H kPa for the retained profile, where 'H' is the retained height in metres; see Figure 4. If there are any adjacent areas of the site which are highly sensitive to lateral movement, a uniform rectangular earth pressure distribution of 8H kPa for the retained profile should be adopted.
