PRELIMINARY STAGE 1 ENVIRONMENTAL SITE ASSESSMENT

**PROPOSED REFURBISHMENT OF BUILDINGS W6A,
AND W6B AND CONSTRUCTION OF AN ADDITIONAL
NEW BUILDING AT MACQUARIE UNIVERSITY**

**WESTERN ROAD, MACQUARIE UNIVERSITY,
MACQUARIE PARK**

6 JUNE 2017

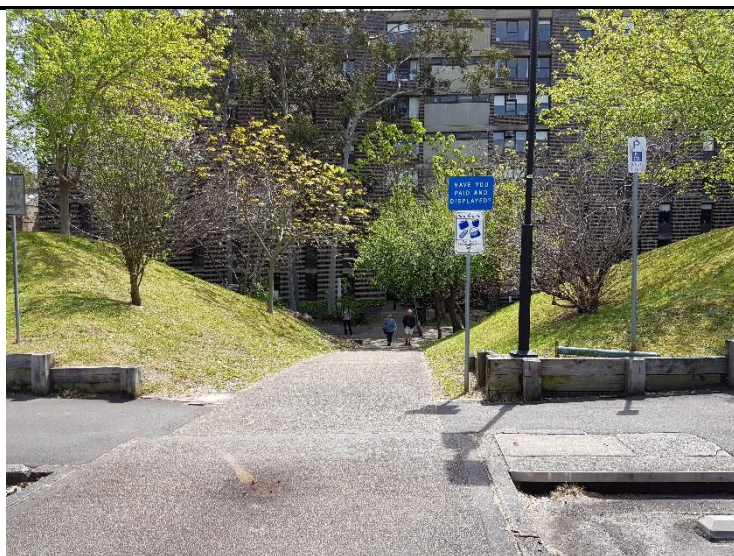
Photograph 1: Shows the south-western boundary of the site, facing north. Note the grassed soil mounds, bisected by concrete paved walkway, with Building W6A in the background, in the southern section of the site, constructed of fill material.

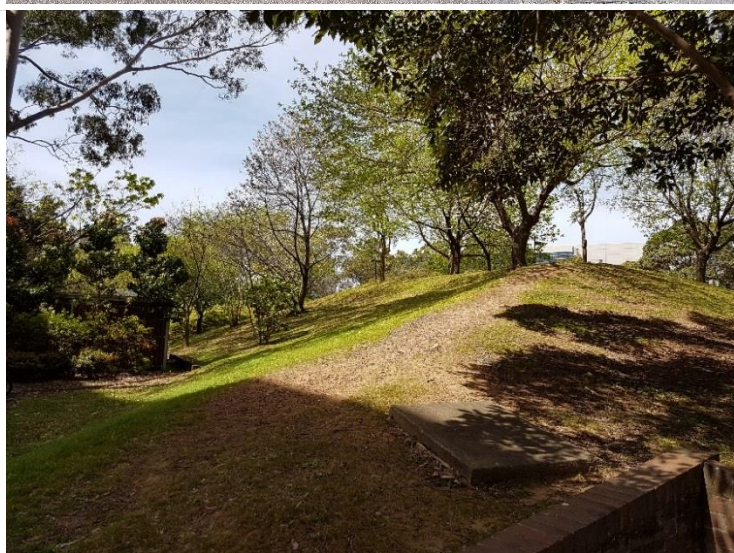
Photograph 2: A closer view of the 'western' soil mound at the site, facing south-east. Note the bike hub to the immediate north of it (central western end of the photograph).

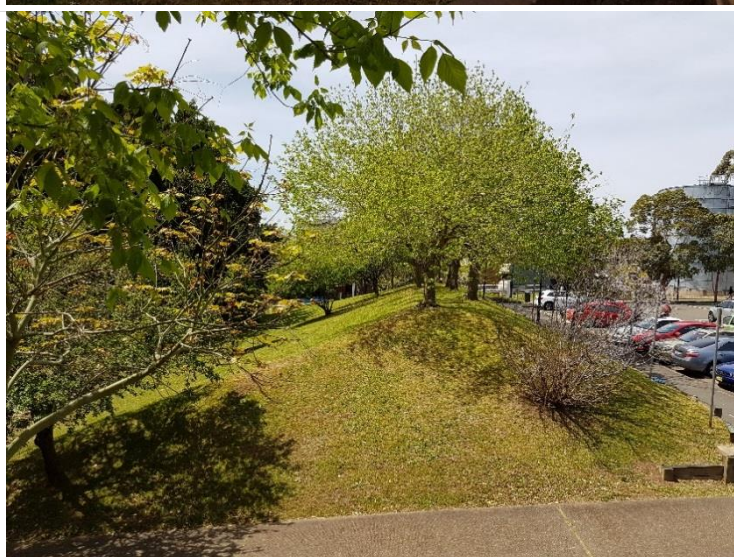
Photograph 3: A closer view of the 'eastern' soil mound at the site, facing east. Note the carpark located to the immediate south of it (right hand section of the photograph).

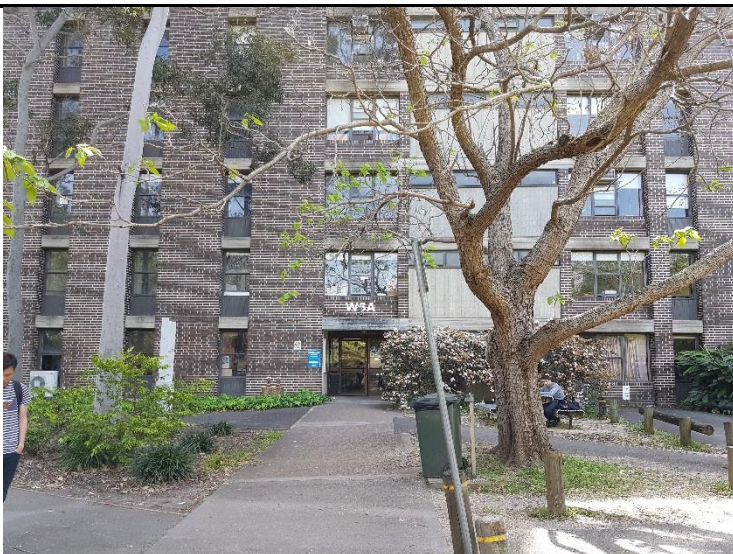
Photograph 4: Shows the back part of Building W6A, in the central section of the site, facing north.

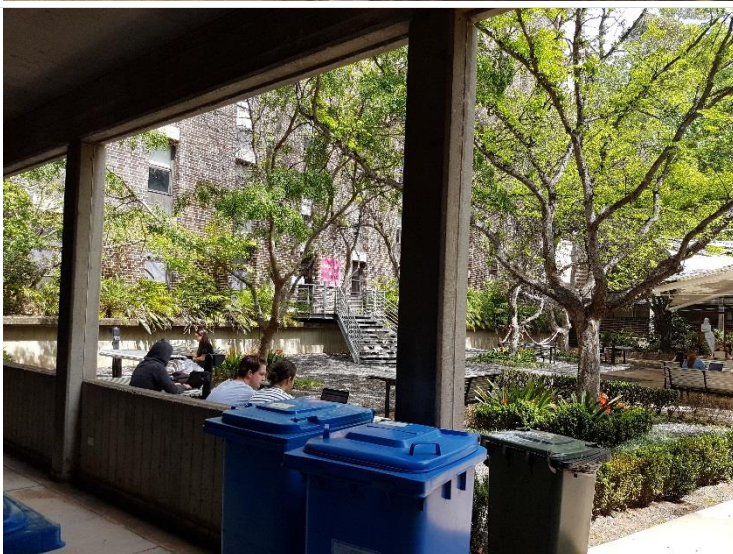
Photograph 6: Shows the gravel surfaced courtyard, in the middle section of the buildings, in the north-eastern section of the site, facing south-west. Note the waste bins for general refuse etc at the site (lower section of the photograph).

Small waste bins were located at the site, for general refuse and waste from the buildings. Some cleaning agents and graffiti removing solutions etc. were noted to be present on site.

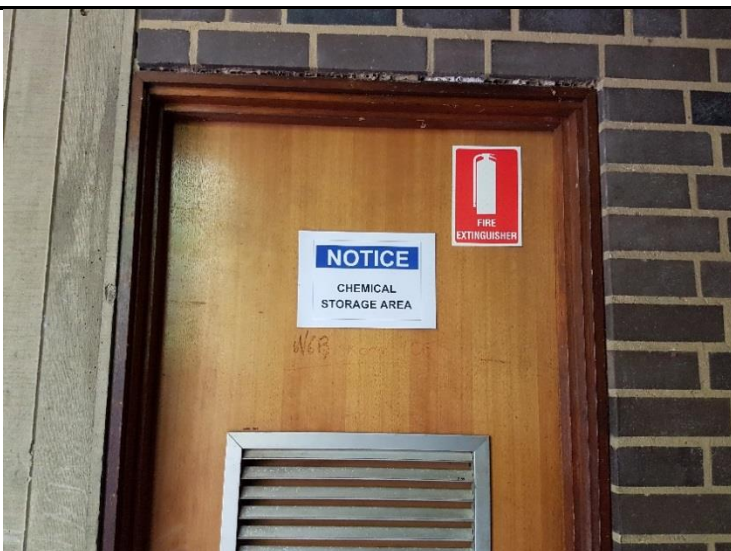
Photograph 7: Shows the Chemical Storage Room, located at the ground floor of Building W6B.

No drums were observed to be stored on site. A closed room, with a notice on the door, stating Chemical Storage Area, was located at the ground floor of Building W6B.

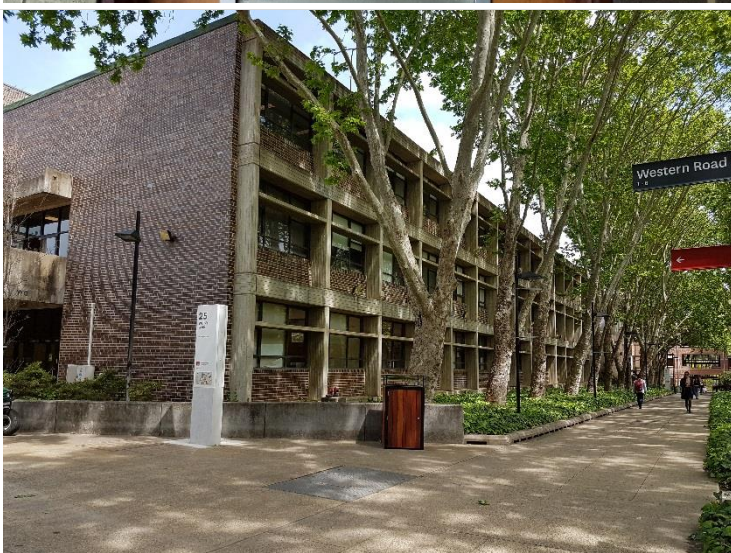
Photograph 8: Shows the northern 'building' of Building W6B, in the northern section of the site, facing south-west. Note the concrete paved, tree lined Wally's Walk to the immediate north of the building (lower right hand section of the photograph).
