Geotechnical Investigation

Lot 10 and Part Lot 11 DP1195449, CNR OF EGRET STREET & CORMORANT ROAD, KOORAGANG ISLAND

Prepared for Sovechles Development Prepared by RCA Australia RCA ref 10556a-201/0 June 2014

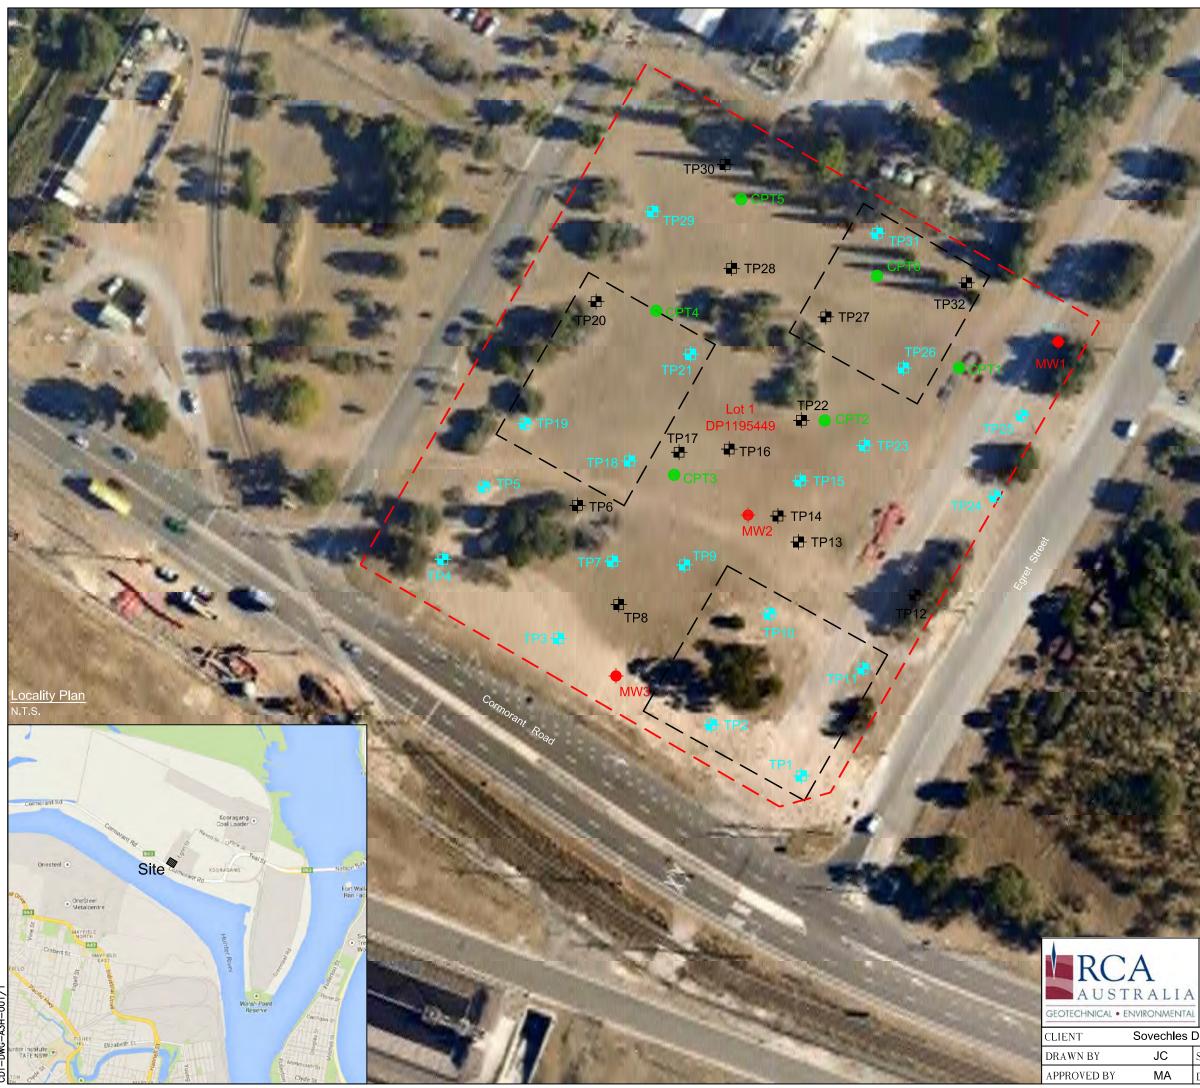
-		-				
echles	Devolopment		RCA Ref	10556	a - 201	/0	
JC	SCALE	1 : 1000 (A3)	DRAWING	No	1	REV	0
MA	DATE	5/6/2014	OFFICE	NEW	'CAS	TLE

SITE AND TEST PIT LOCATION PLAN LOT 1 DP1195449 CORMORANT ROAD KOORAGANG ISLAND
