Preliminary Site Investigation:  
Part of Lot 10 DP 1170710,  
Concrete Batching Plant (SSD 8544) at  
Glebe Island, Rozelle, NSW

P1706122JR01V02  
February 2018

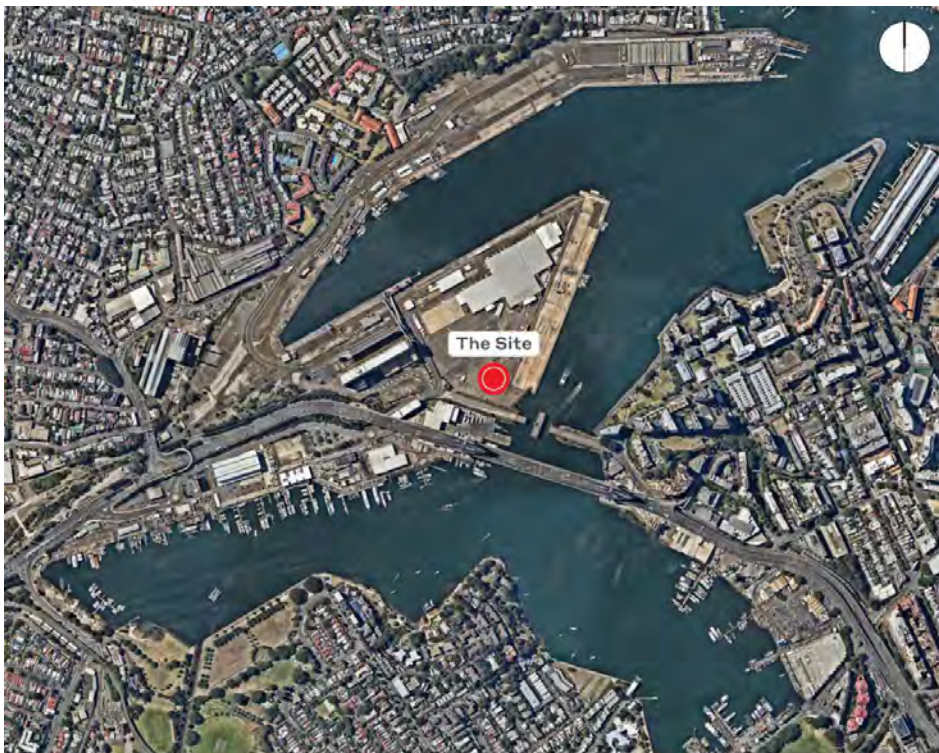
**Figure 1- The Site**

Hanson propose to develop a new intermodal aggregate storage facility and concrete plant to be located adjacent to Glebe Island Berth one (GLB1 - legally described as Lot 10 in DP 1170710) (the Site), as shown in **Figure 1**. The plant will be designed with a capacity to produce up to 1 million cubic metres of concrete per annum and will supply aggregate to other Hanson sites in the vicinity. The proposed plant will serve two purposes:

The Site, Glebe Island

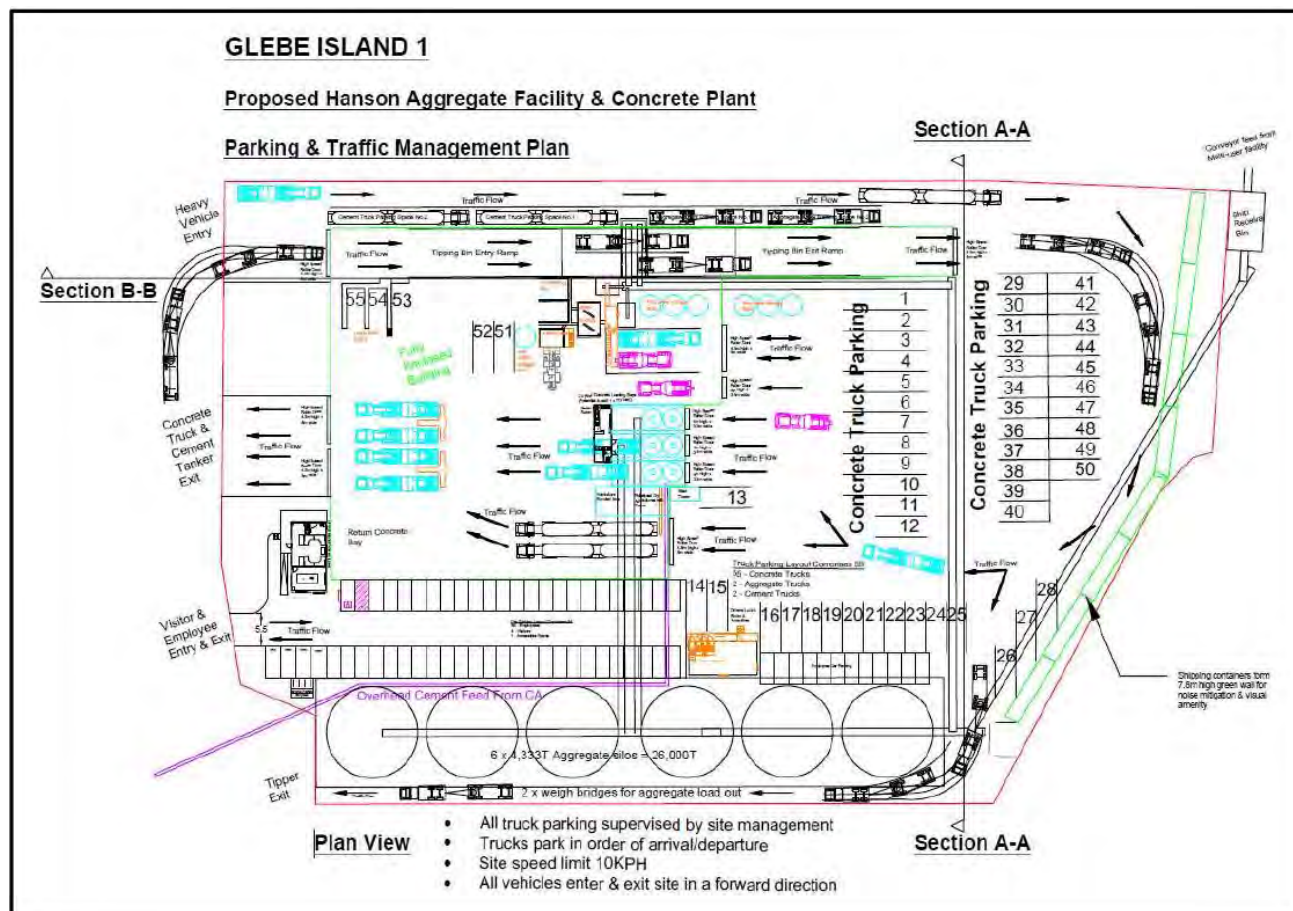
Figure 2- Site layout

The plant is proposed to adopt a low profile design sympathetic to its surrounding environs. The majority of the batching activities will be undertaken in an enclosed area in order to limit the noise and air quality impacts of the proposed plant. The highest structures will be the cement silos which will be up to 35m tall, half the height of the adjoining heritage listed Glebe Island Silos.

| • Physical elements of the plant will include: | • Weigh hoppers; |
| • Cement silos; | • Slump stand; |
| • Aggregate silos; | • Conveyors, |
| • Sand silos; | • Truck parking; |
| • Water tanks; | • Car parking; |

- Weigh bridges;
- Water tanks;
- Building enclosure; and
- Ancillary offices and staff areas.

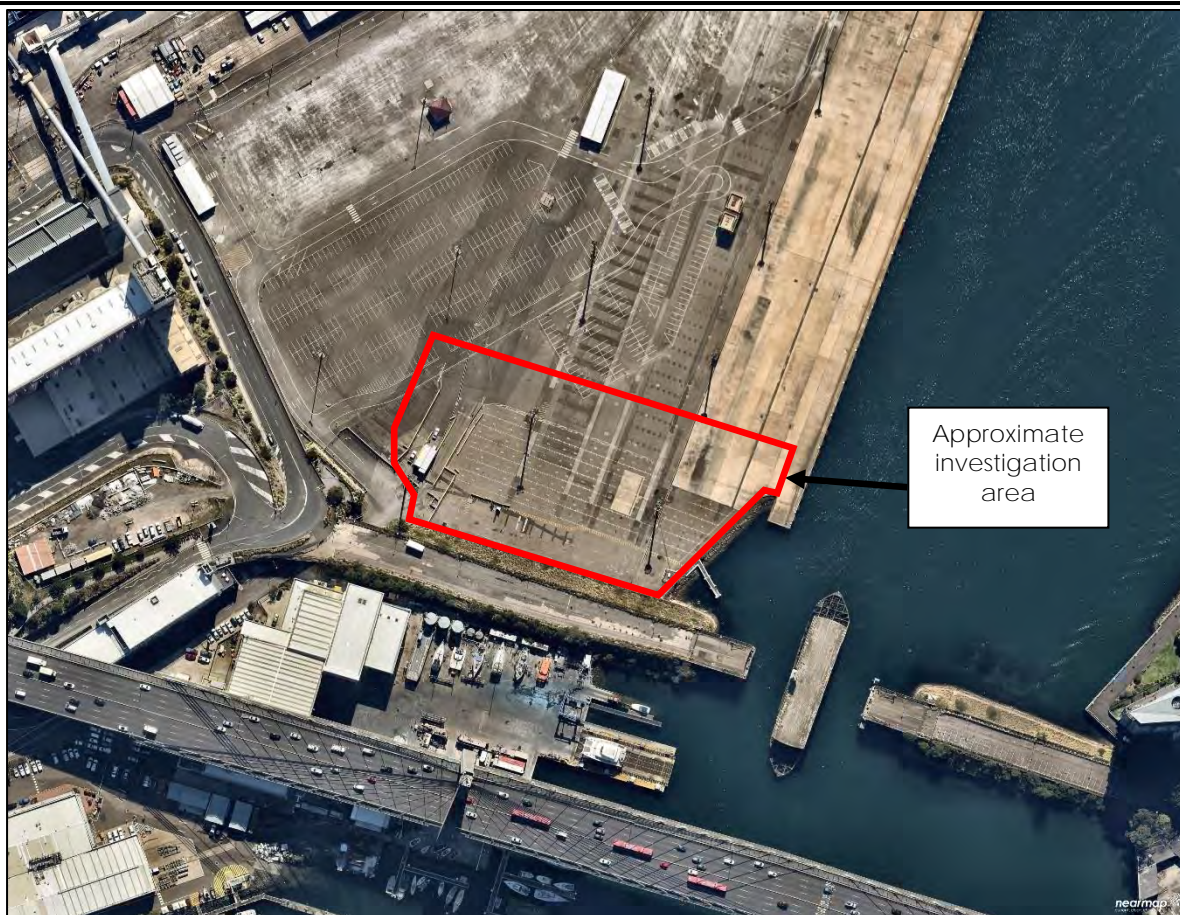
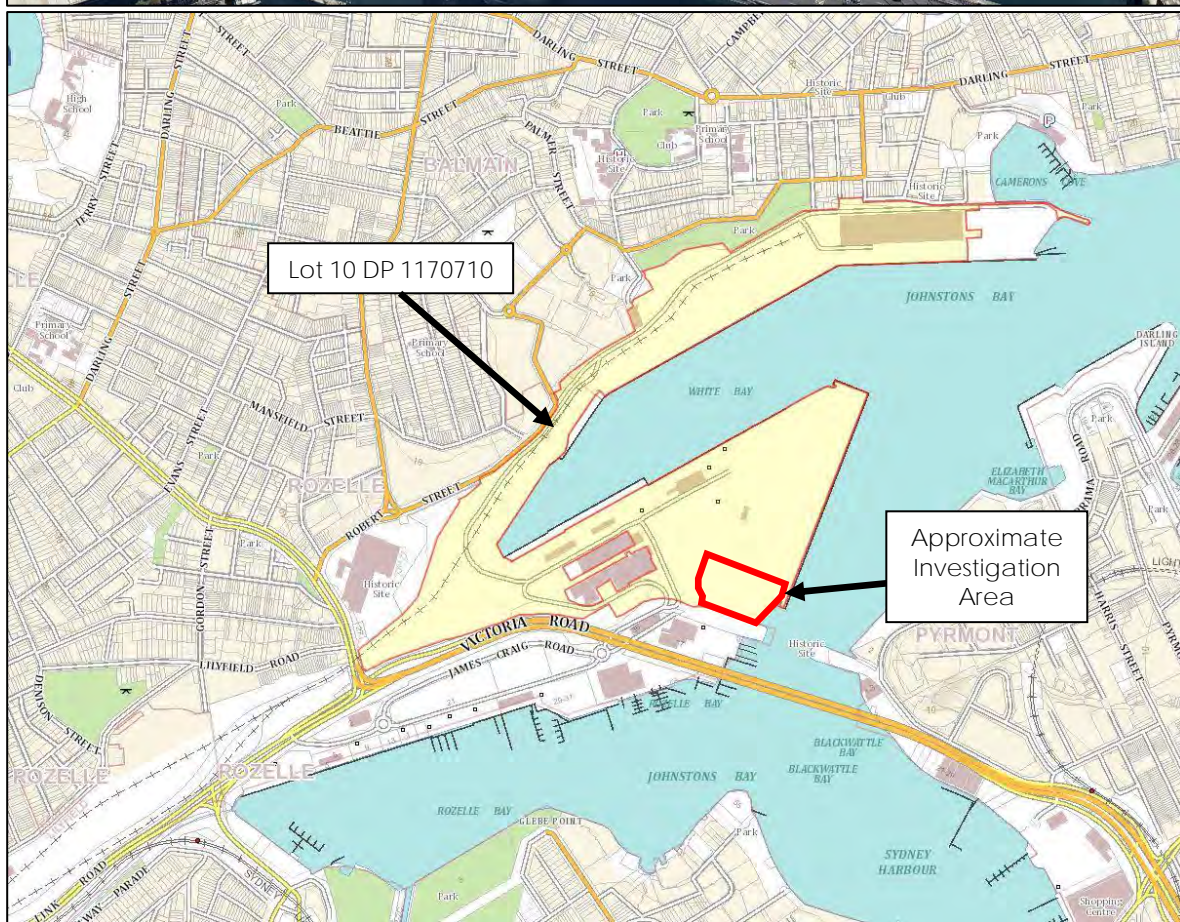
Site information is summarised in Table 1, and site location and general surrounds shown in Figure 1, Attachment A.

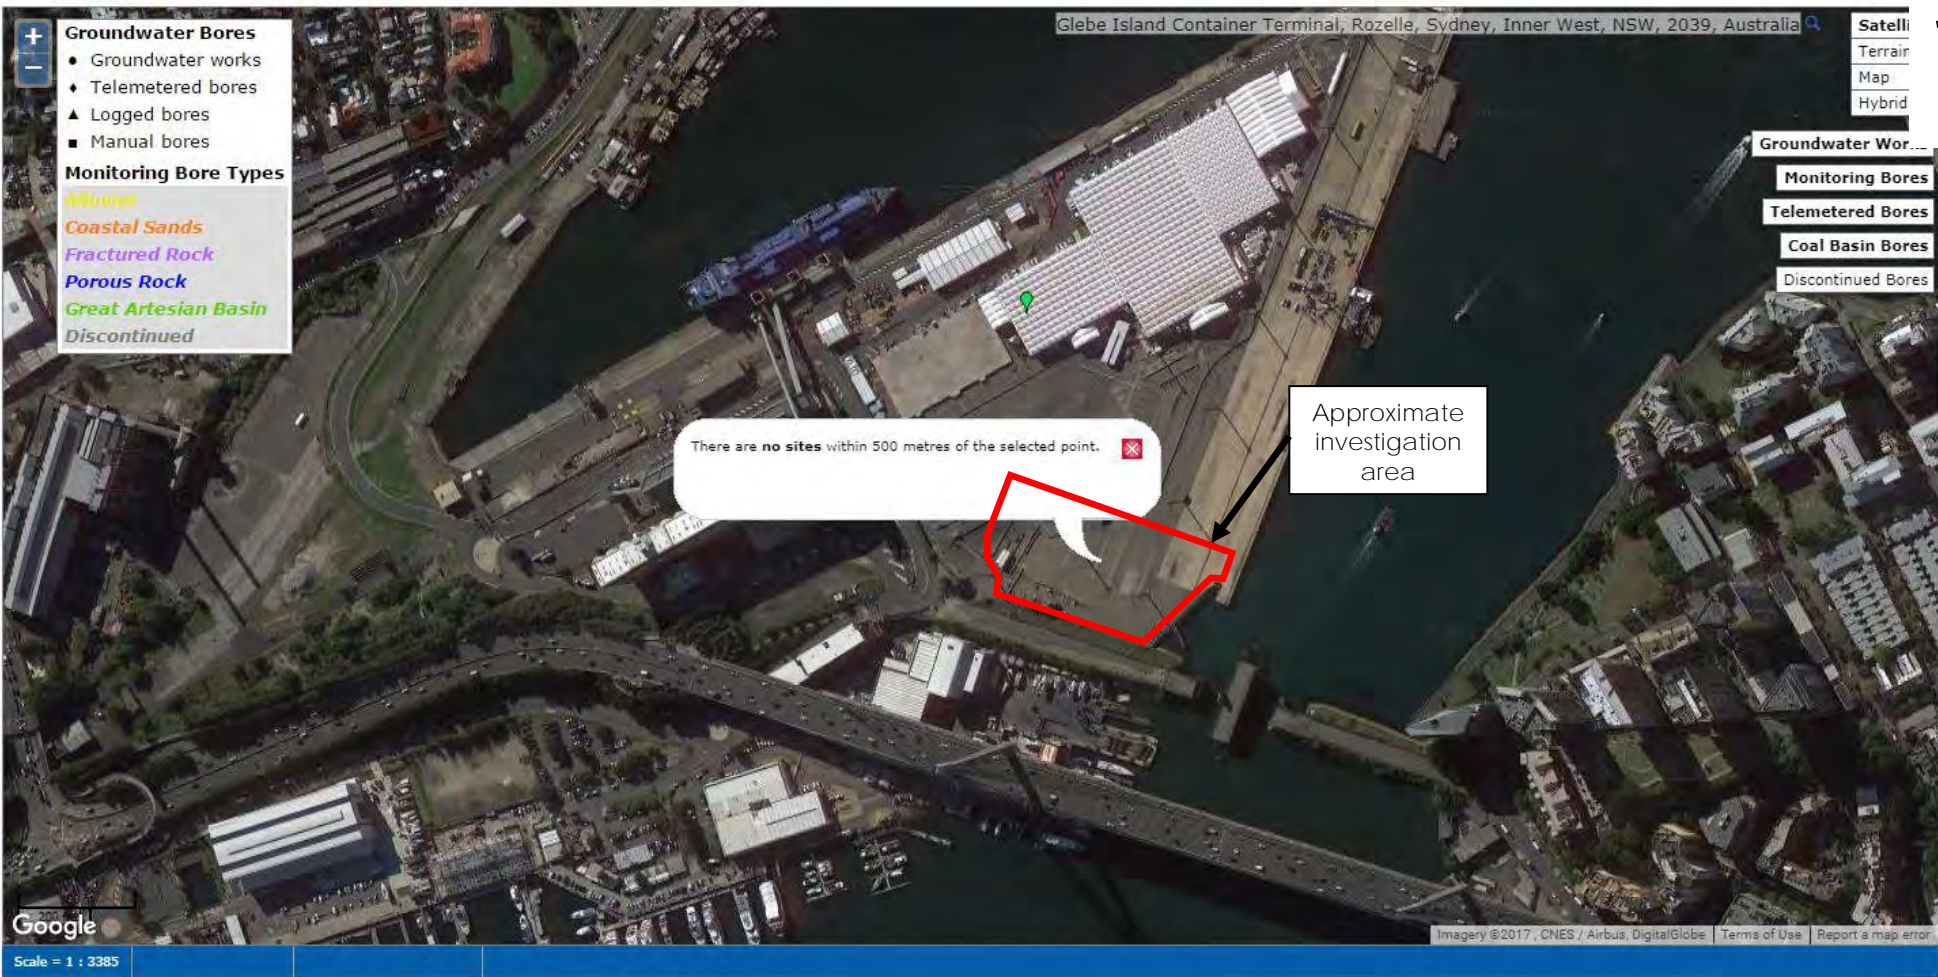
Review of NSW Department of Primary Industries Water's database indicated no groundwater bores are located within 500 m of the investigation area (refer to Figure 2, Attachment A).

Given proximity to Johnson Bay and underlying fill, groundwater levels are likely to be within 1 to 2 m of the existing ground surface. Further investigations would be required to fully characterise site groundwater conditions.
