Remediation Action Plan

Proposed University Facility Redevelopment
Building J03, Electrical Engineering, Darlington

Project 85658.02
March 2018

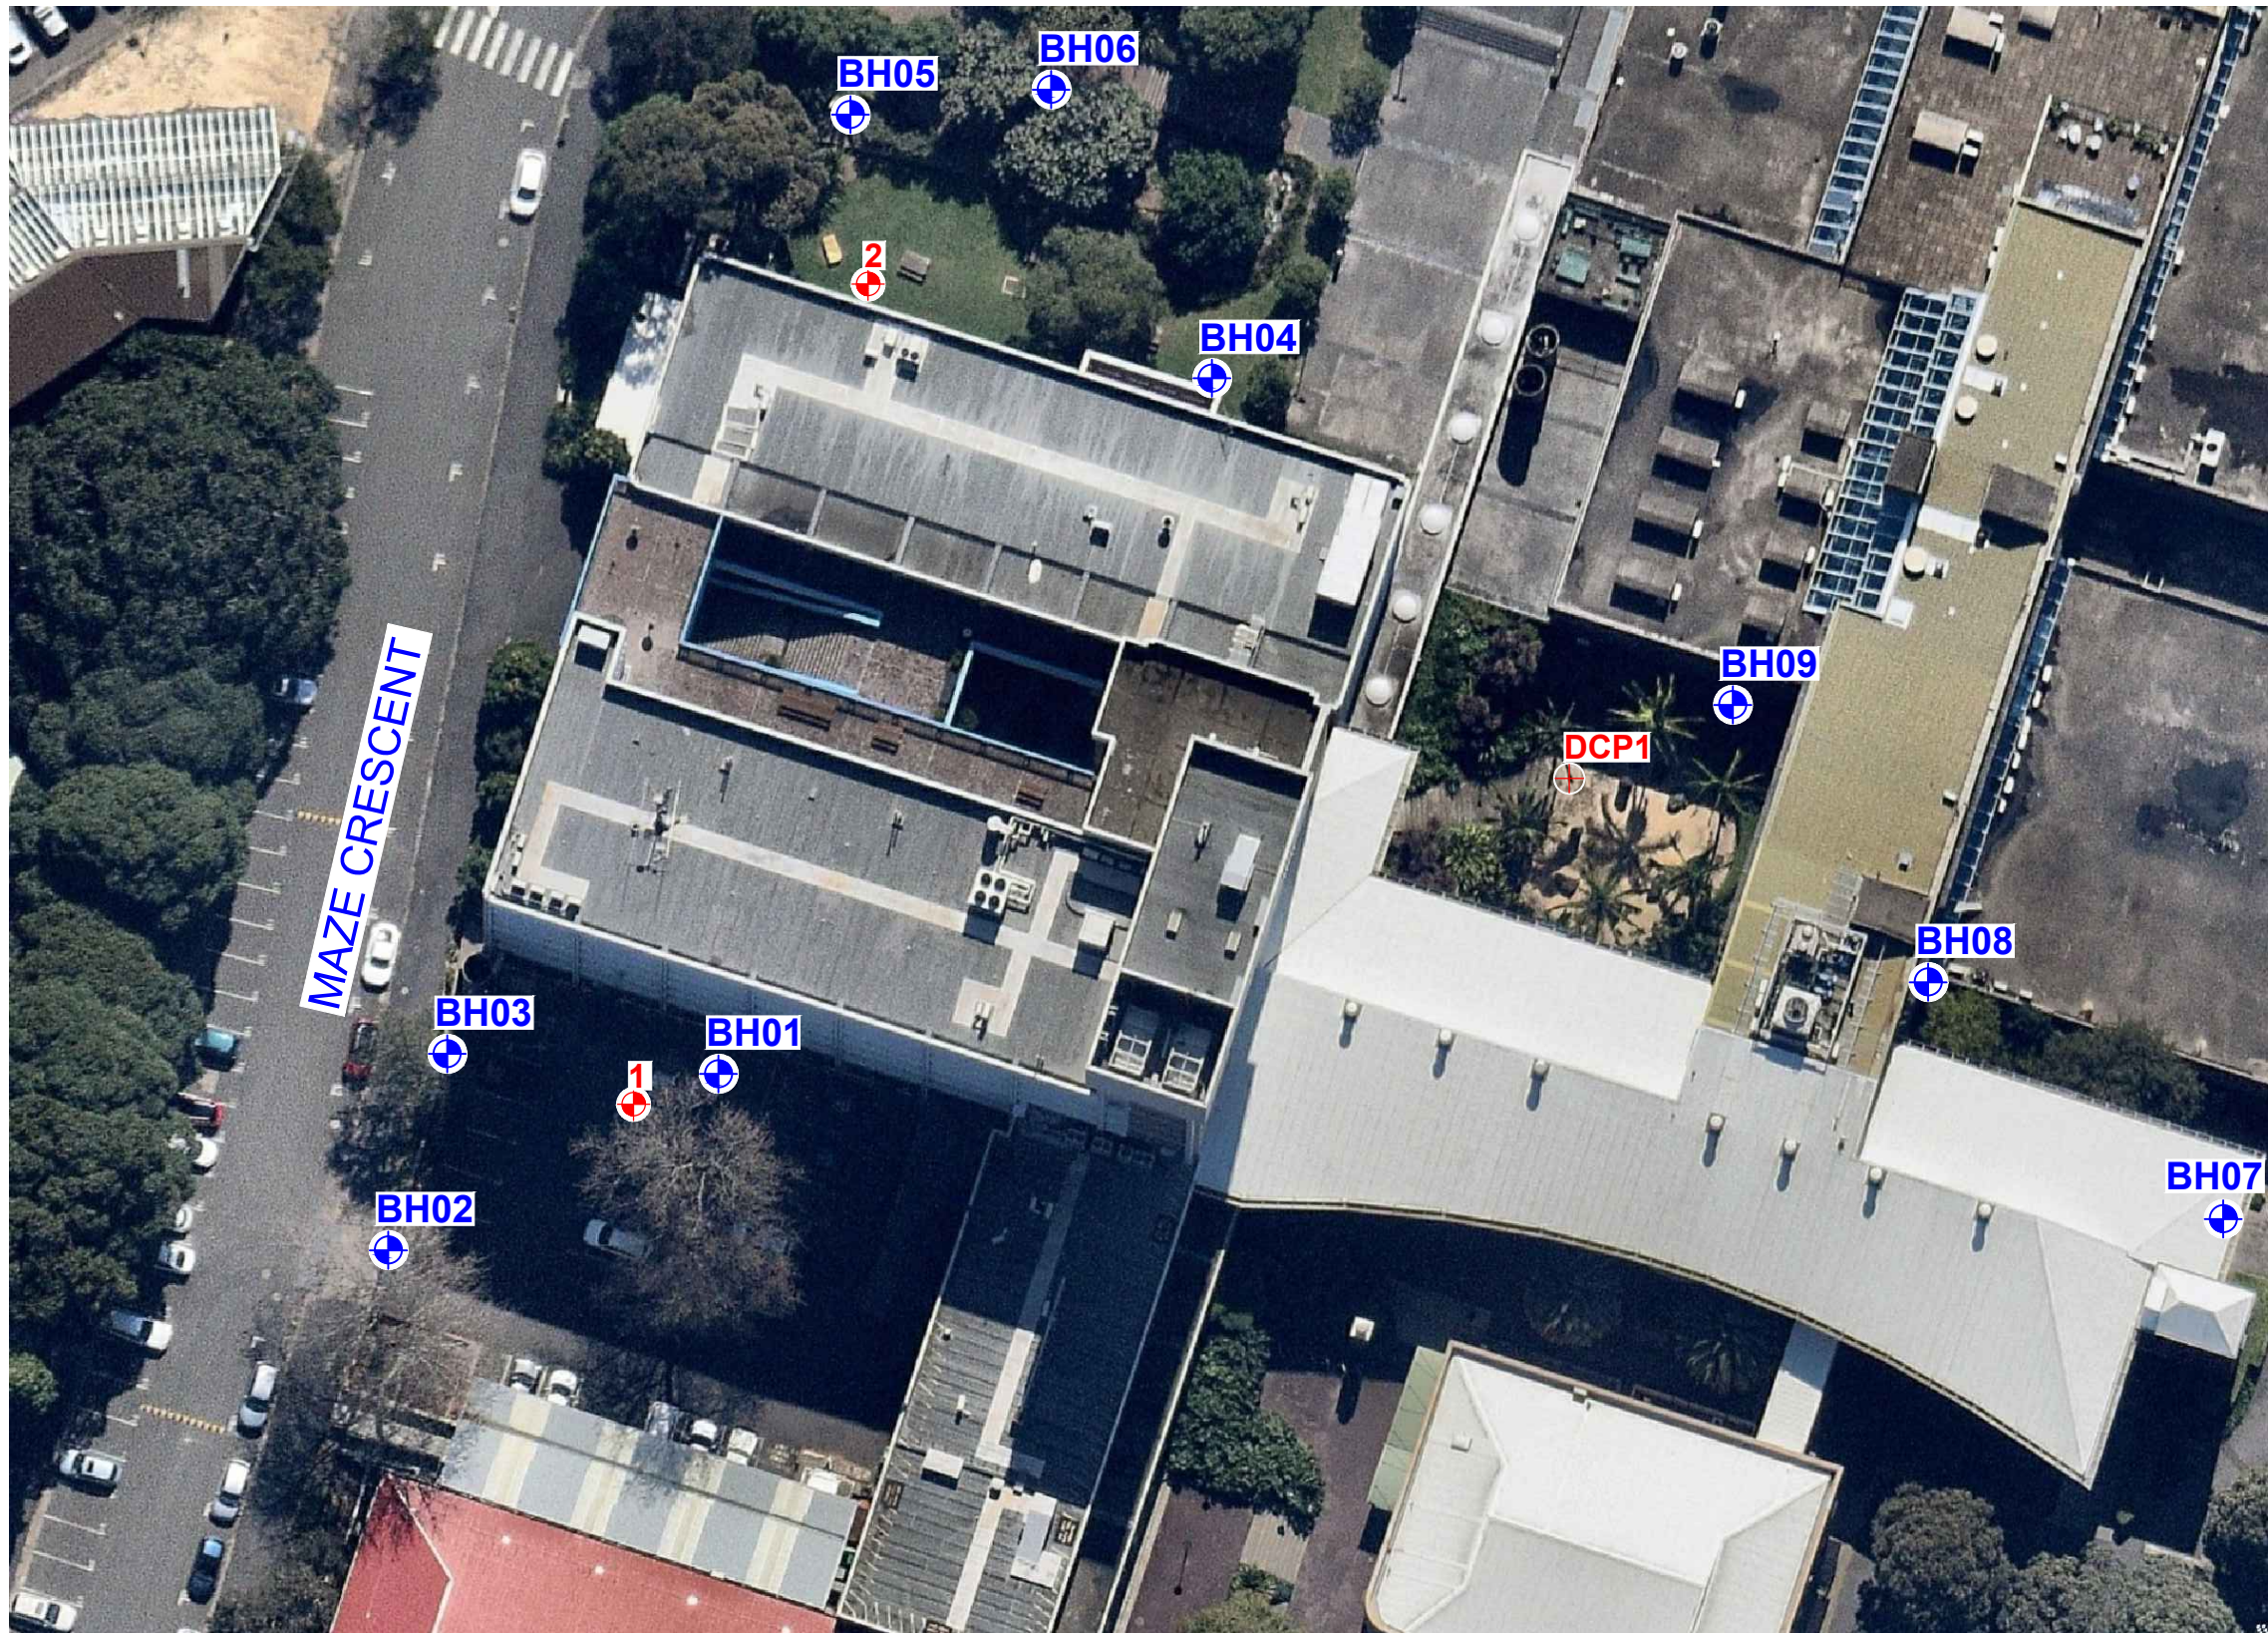
- ◆ Test bore location (DP 2016)
- + Dynamic cone penetrometer test location (DP 2016)
- ◆ Current borehole location

The site comprises an irregular shaped area, the general layout of which is provided on Drawing 1, Appendix B. Currently the site is occupied by a large building containing University facilities. Around the building there is a garden/grassed area to the north and a car park to the south. The eastern end of the site comprises paved external areas and a second university building. Access to the site is off Maze Crescent to the west. The site slopes gently downwards to the east, generally following the existing topography, and ground surface levels vary between about RL 24 m and RL 16 m AHD.

The locations of the DP boreholes are shown on Drawing 1 in Appendix B. A summary table of analytical results is provided in Table F1 in Appendix C.
