Report on
Preliminary Site Investigation with Limited Sampling

Proposed Picton High School Redevelopment
480 Argyle Street, Picton, NSW

Project 34252.02
April 2017

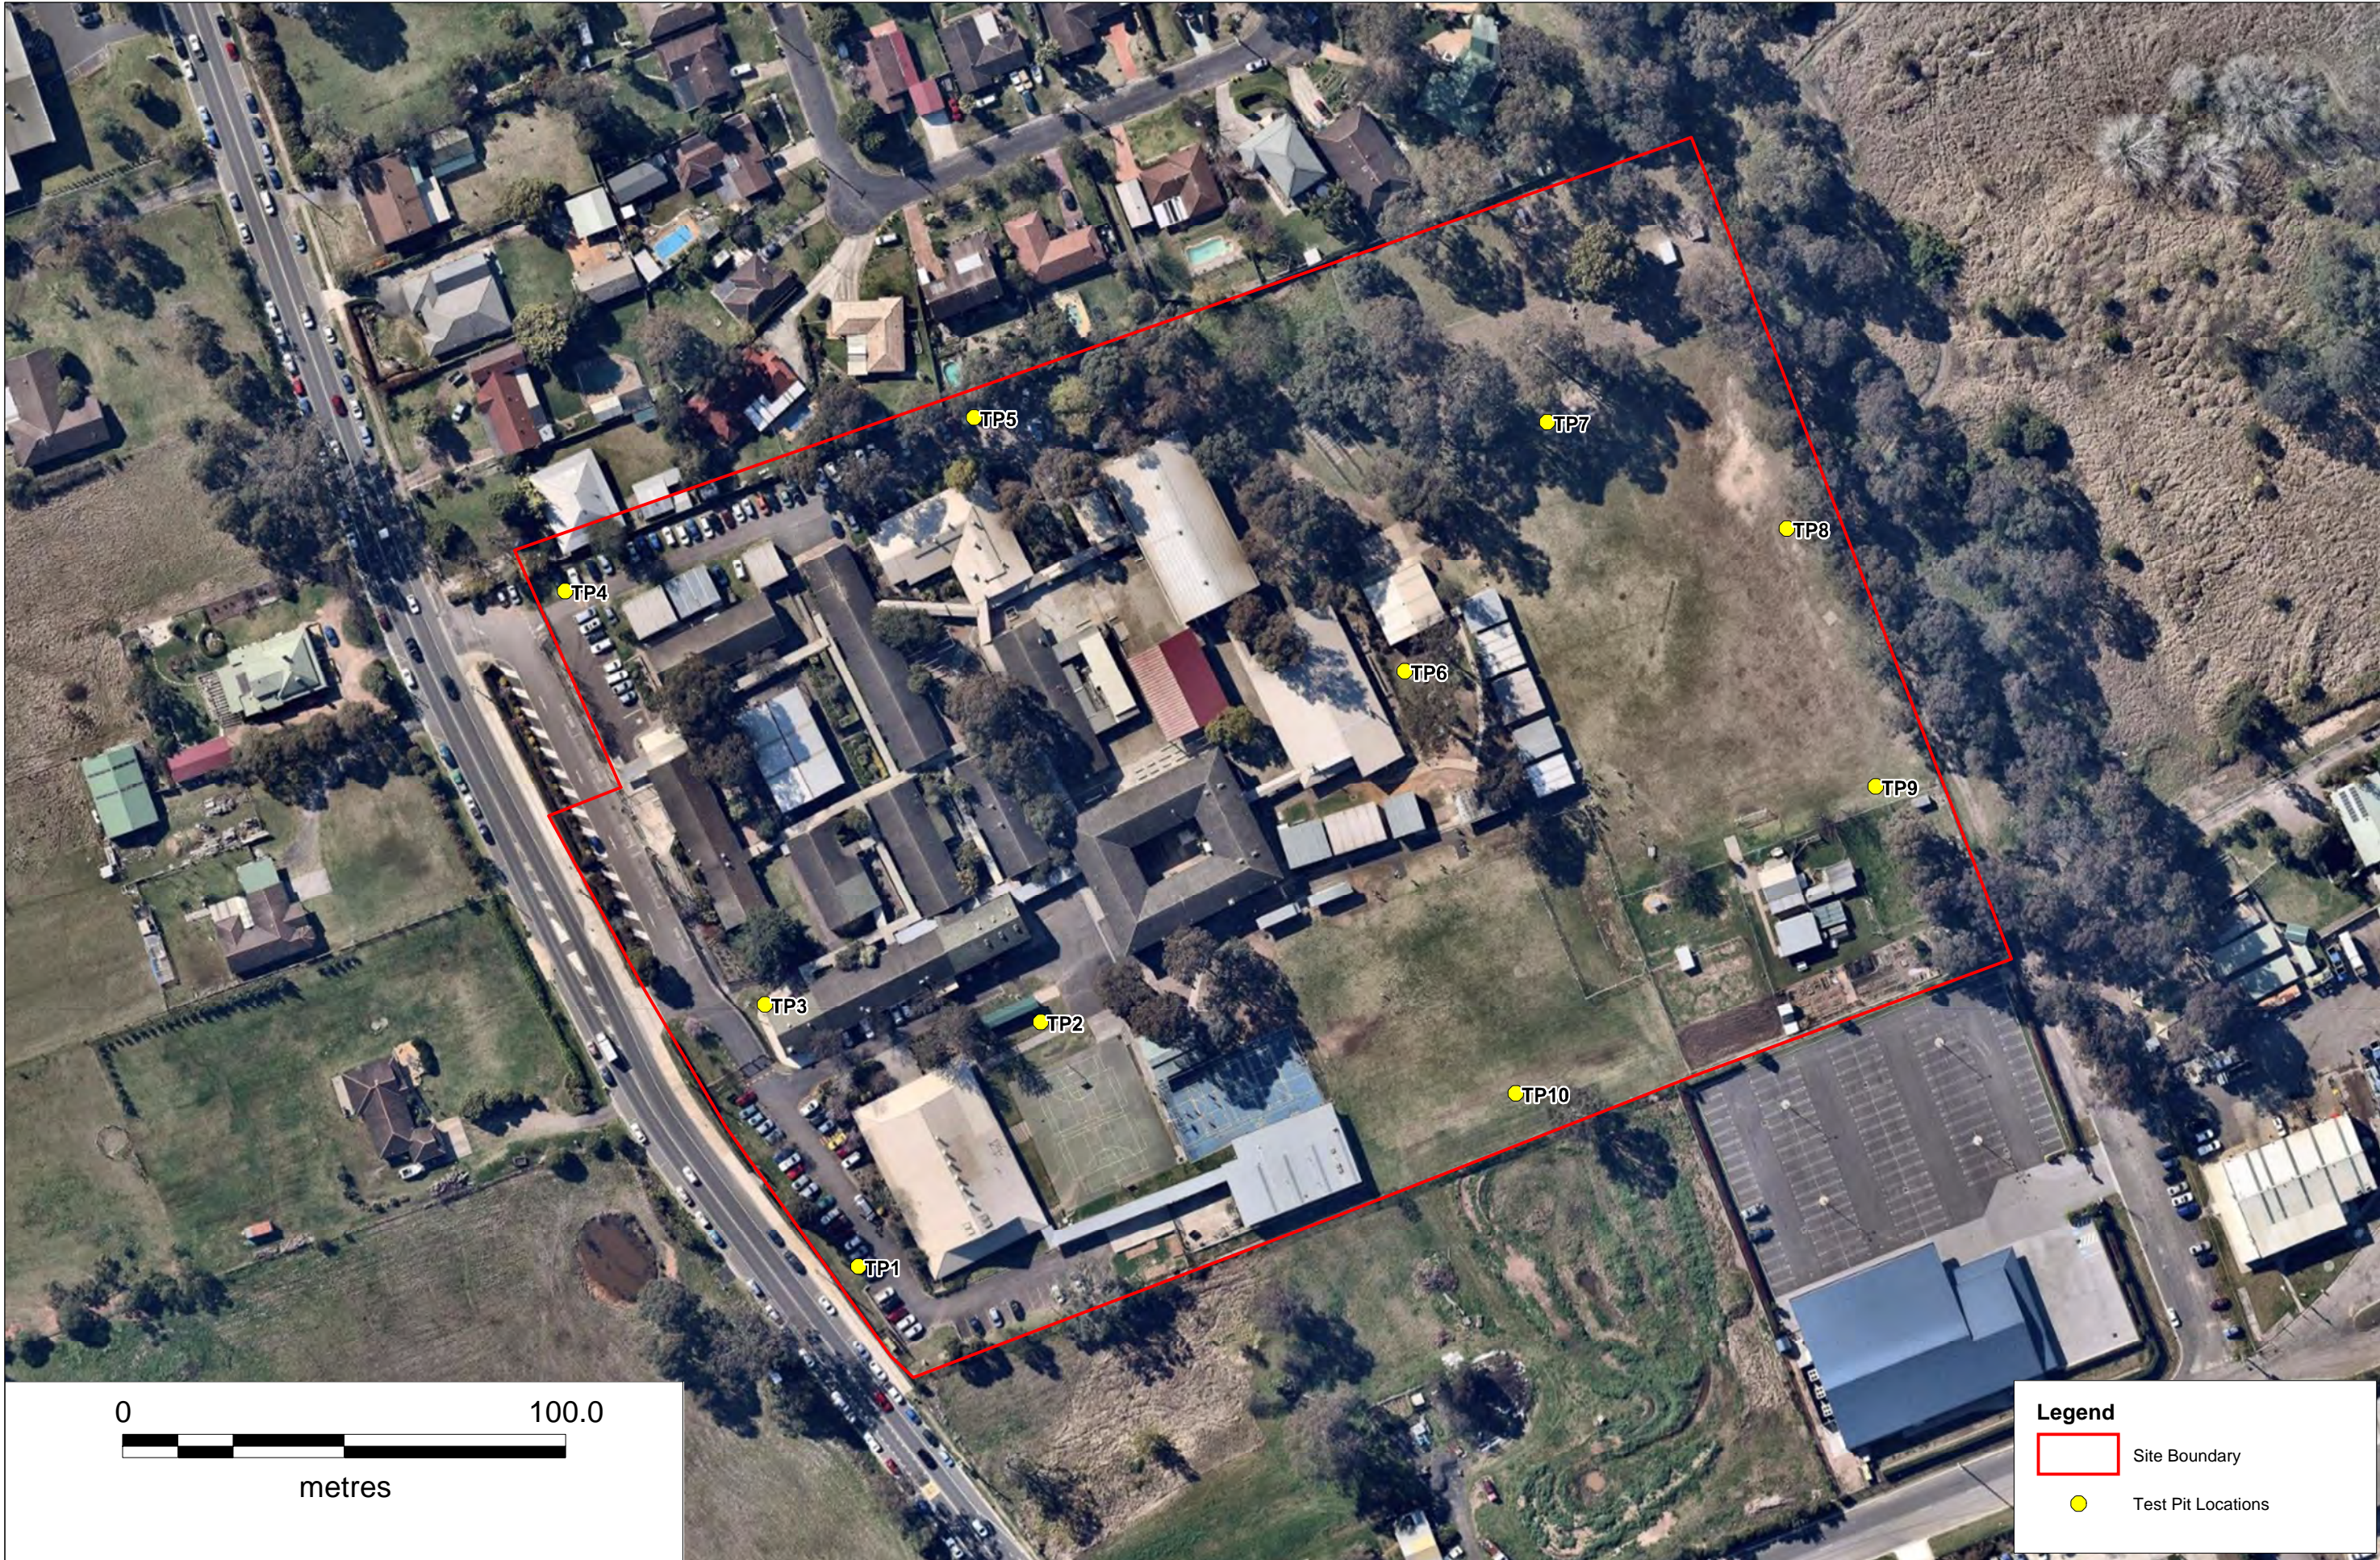
TITLE: **Test Pit Locations**
Proposed Picton High School Development
480 Argyle Street, Picton, NSW

Soil samples were generally collected from within the test pits at depths of 0.0 m - 0.2 m, 0.4 m - 0.5 m and every 0.5 m interval to the end of investigation. The soil samples were collected targeting fill layers and any change in the soil profile within test pits. The geological profile observed within each test pit was logged. The test pit logs are provided in Appendix F. All soil samples were screened using a PID for the presence of VOC in soil. Based on the results of PID screening, selected samples (one sample from each test pit location) were submitted to laboratory for analysis of COPC. One suspected PACM fragment found on the ground surface near the northern site boundary during the site walkover was also collected and submitted to the laboratory for analysis. The test pit locations are shown on Drawing 3, Appendix A.

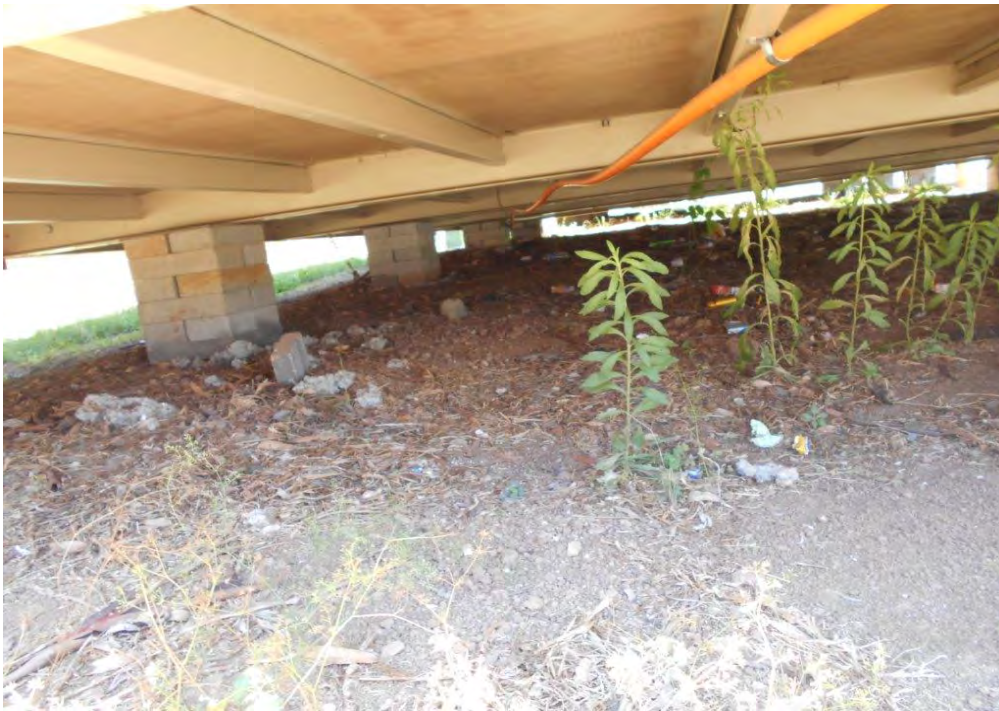
- Rubbish and anthropogenic material including fragments of brick, concrete, plastic and timber were observed in gravelly clayey surface fill in the crawl space underneath multiple demountable buildings (Photograph 3);

Photograph 3 - Rubbish and anthropogenic material underneath demountable buildings.

Anthropogenic materials including brick fragments, concrete, plastic and timber were observed underneath multiple demountable buildings. A fragment of buried terracotta pipe was also observed adjacent to one of the demountable building. However, a detailed inspection of the area was not possible due to access limitations. DP therefore recommends a detailed inspection is completed after removal of the buildings and following provision of an asbestos clearance certificate by a qualified occupational hygienist. Targeted sampling and analysis may be required if fill containing anthropogenic material is observed.

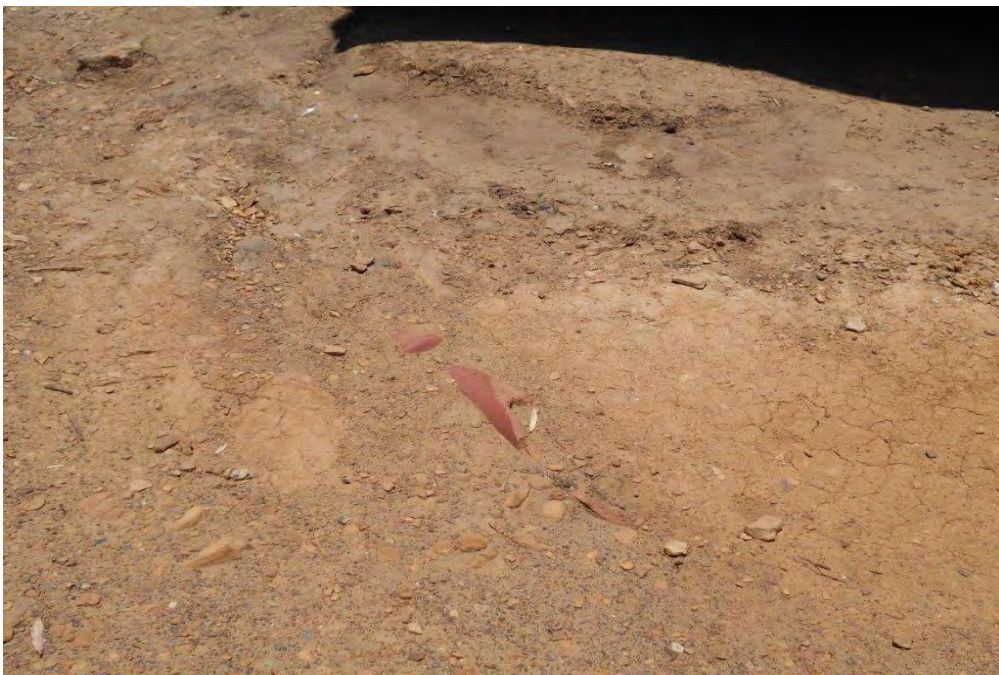
- Part of a broken terracotta pipe was found protruding out from fill soil immediately adjacent to one of the demountable building located east of the science laboratory. The surrounding area comprised gravelly clays; with the exception of the pipe. No suspected PACM was observed in the fill soil at this location (Photograph 4);

Photograph 4 - Terracotta pipe and surrounding fill.

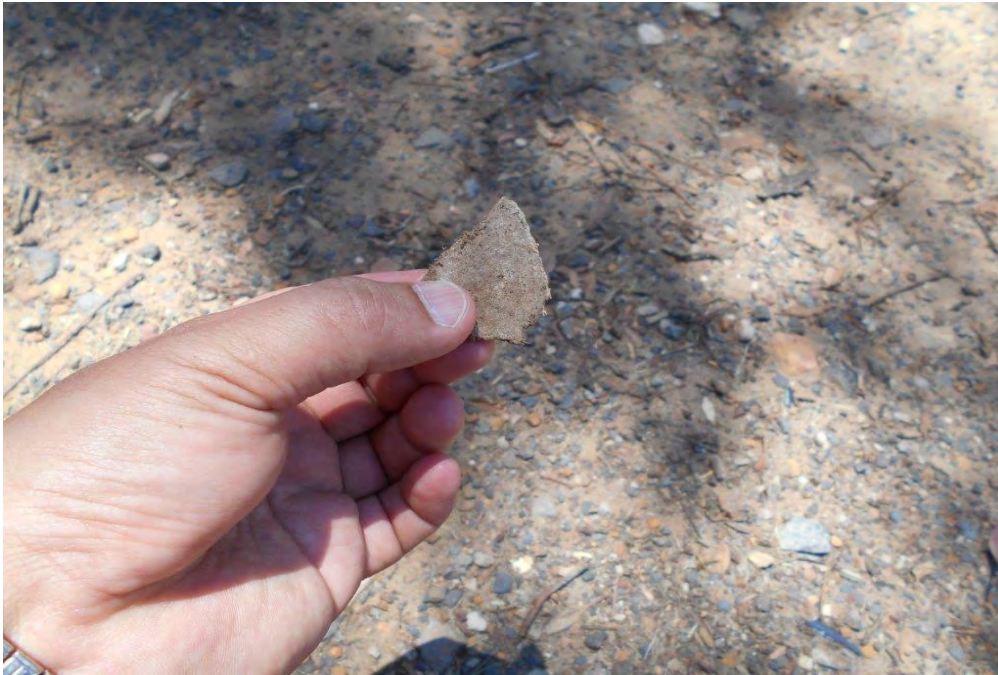
- A fragment of PACM (confirmed by laboratory to contain asbestos; refer to Appendix G) was observed on the ground surface in a loose gravelly road base fill near the northern site boundary (Photograph 5);

A fragment of ACM was observed near the northern site boundary, on the ground surface. The fragment was submitted for laboratory analysis and was confirmed to contain chrysotile and amosite asbestos. The ACM observed could have been sourced from one of the following:

- Import of fill to the site for site surface levelling;
- Demolition of site structures previously undertaken at the site; or
- Weathering and general wear and tear of the structures over time.

Photograph 5 - Fragment of PACM found on the ground surface near northern site boundary

- A bonded ACM fragment was observed near the northern site boundary, which should be managed as per The NSW Department of Education, *Asbestos Management Plan for NSW Government Schools*. Given the presence of ACM in structures at the site, DP recommends that the northern site boundary area and the balance of the site (including identified PAEC locations) are subject to a detailed site inspection after demolition of existing structures is completed. The inspection should be completed with reference to NSW EPA endorsed guidelines: Western Australia Department of Health (DoH) *Guidelines for the Assessment, Remediation and Management of Asbestos-Contaminated Sites in Western Australia*, May 2009;

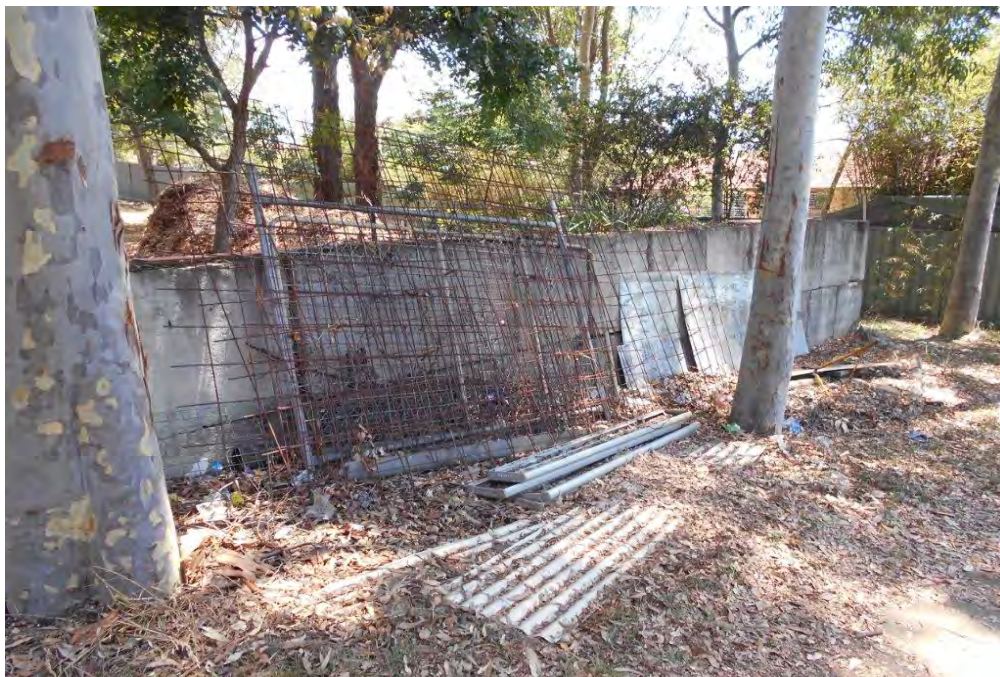
- Loose anthropogenic material including metal posts, rio-bar frame, corrugated tin sheeting, timber and fragments of concrete were stockpiled on the site towards the northern site boundary, behind a retaining wall (Photograph 6);

Photograph 6 - Anthropogenic material found behind the retaining wall in the northern portion of site.

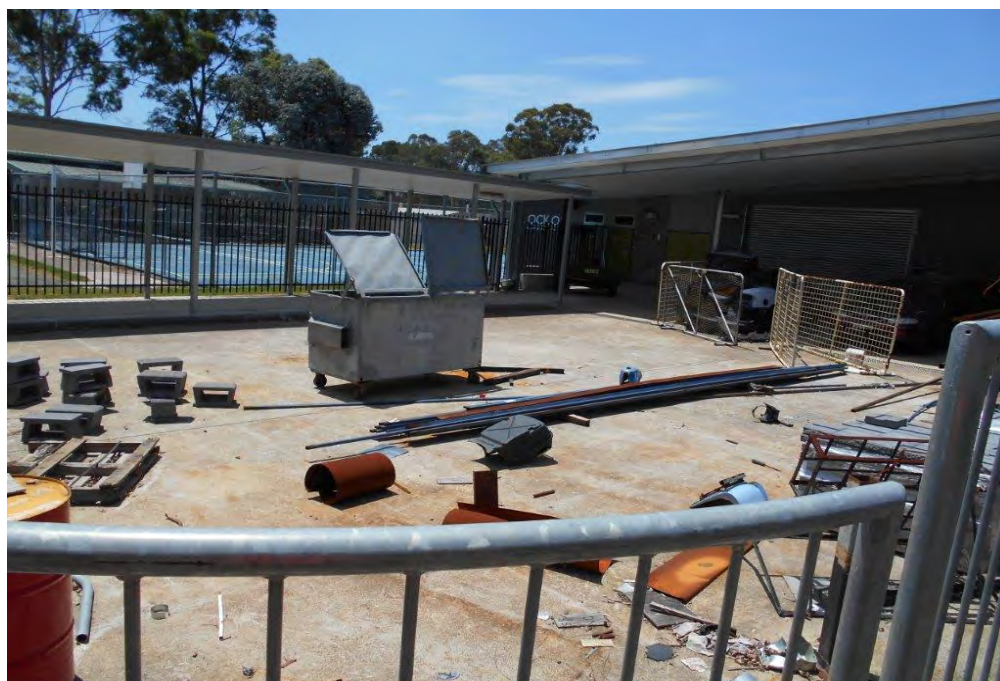
- Construction and associated materials including drums, metal posts and wooden pallets were noted within the maintenance shed area located near the southern site boundary (Photograph 8);

Photograph 8 - Construction materials within the maintenance shed.

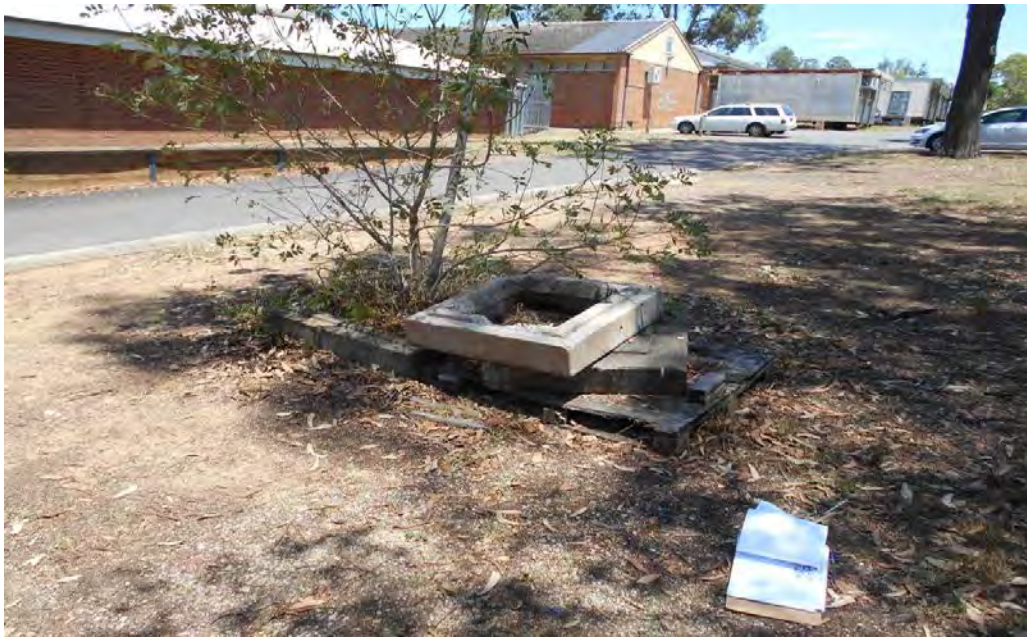
- A small stack of concrete slabs/wooden pallets was observed on the road verge near the northern site boundary (Photograph 9);
- Road-base type fill (bituminous fill) was observed in various locations at the site including immediately to the north of basketball court (Photograph 10) and in isolated locations within the site;

Photograph 9 - Stack of concrete slabs / wooden pallets.

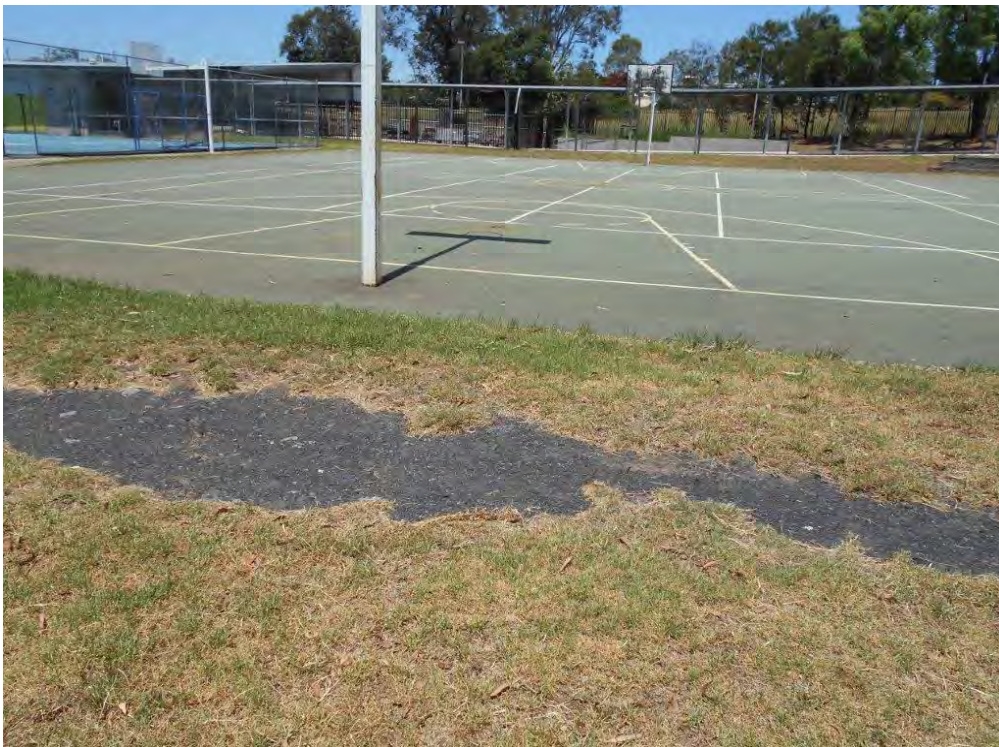
Photograph 10 - Patch of bitumenour fill north of basketball court. Photograph facing south.

Localised fill material was identified in parts of the site. However, based on visual observations, the fill appear to largely comprise either reworked natural materials or inert materials (i.e. road-base). Notwithstanding DP recommends that an UXF is prepared prior to demolition and construction works at the site, should visual or olfactory indicators of possibly contamination (including ACM) be observed during construction works.

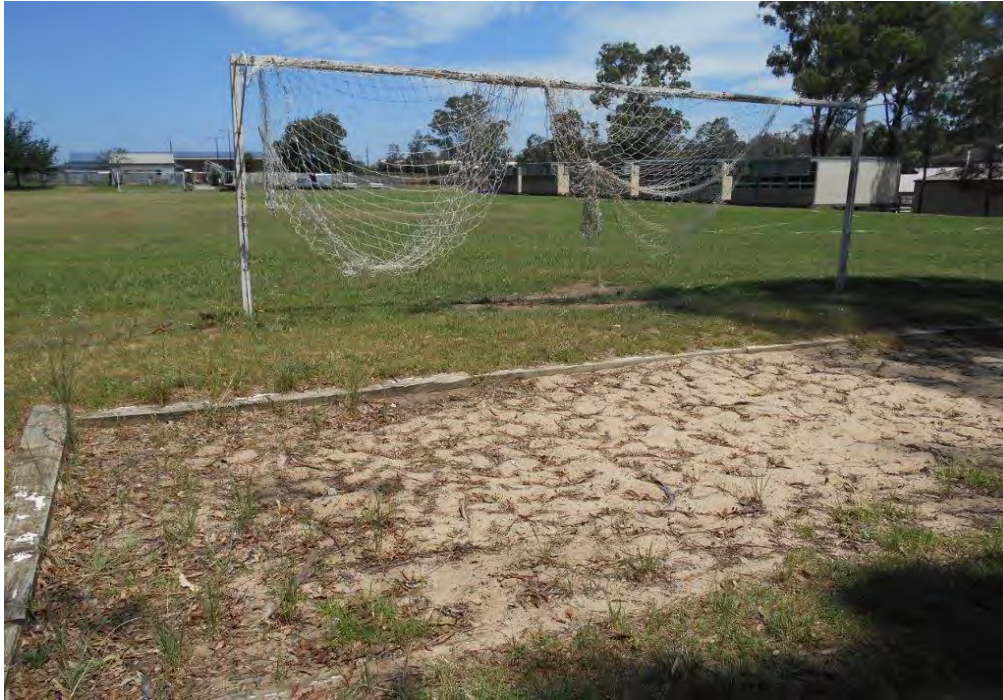
- Sandy fill was observed behind the goal posts within the playing field in the northeast portion of the site (Photograph 11);
- A former brick and concrete structure was observed in the north east corner of the site; loose construction and demolition-type fill was observed on the surface of the structure (Photograph 12); and

Photograph 11 - Sandy fill within playing field at the northeast portion of the site.

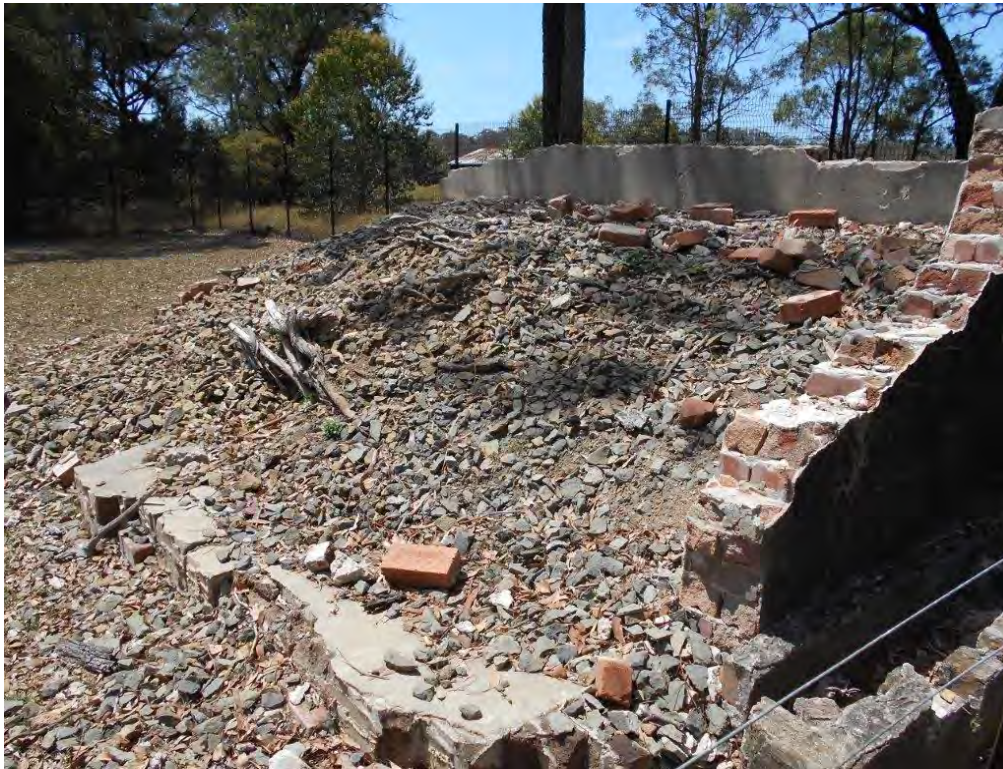
Photograph 12 - Former brick and concrete structure at northeast corner of site.

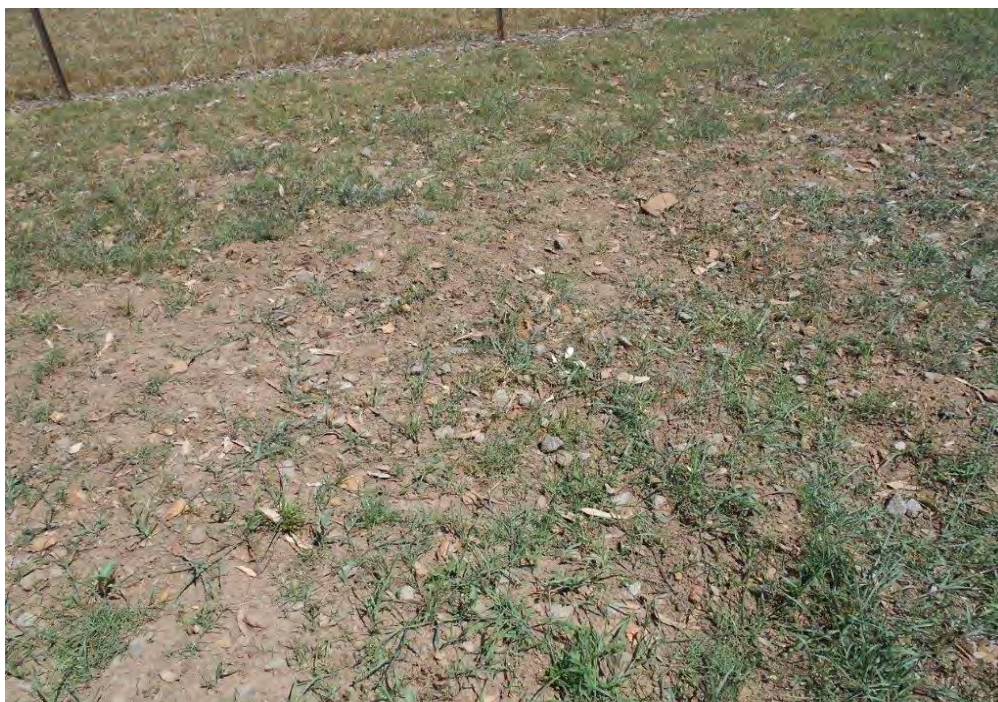
- Gravelly clay fill was noted in the southern portion of the playfield, within the stock pen located at the southeast portion of the site and in a cattle grazing area in the northeast corner of the site (Photograph 13).

Photograph 13 - Gravelly clay fill within cattle grazing area at the northeast corner of the site.
