# Picton High School

## Proposed Roadworks Road Safety Audit

TPPP Reference: 18169

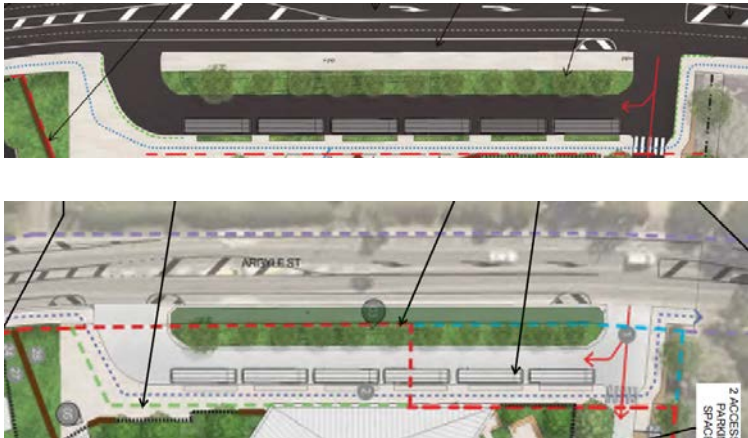
Item No.	Descriptions of Findings	Photo	Likelihood	Severity	Risk Rating
1.	<p>All pedestrians walking along Argyle Street will need to divert into the site due to the 1200mm fence barriers and the removal of the footpath between the access/egress. Pedestrians may not be sure if they are trespassing into private land owned by the school. Consequently, pedestrians may walk into the road outside the fence which has potential for collisions with vehicles.</p> <p>N.B. The plans are not consistent – the Traffic &amp; Security Design shows the footpath between the entrance / exit retained whilst the Site Context Plan shows this footpath replaced with a wider verge and no footpath but shows no fence.</p>

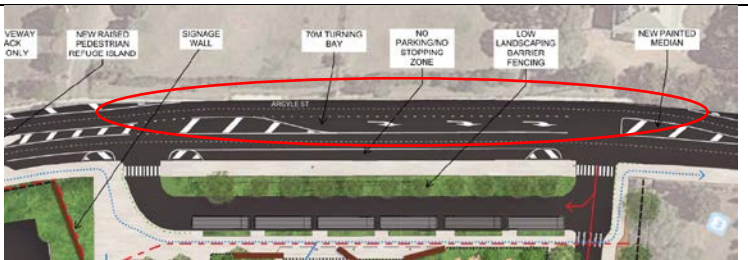
2	<p>Provision of a 70m right turn bay for the Argyle Street to School Bus Interchange right turn movement and a new wide painted median in Argyle Street results in the removal of a number of 2 minute on-street parking spaces on the west side of Argyle Street.</p> <p>These car spaces are currently used by parents to drop off and pick up students.</p> <p>Insufficient parking supply may result in motorists' parking/ stopping in unsafe locations.</p>

Occasional	Moderate	Medium

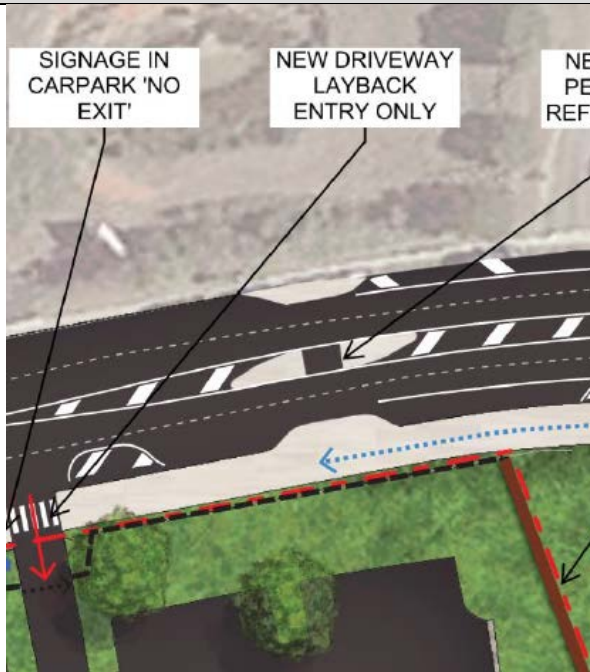
Item No.	Descriptions of Findings	Photo	Likelihood	Severity	Risk Rating
3	<p>Observations have shown that motorists often give priority to pedestrians at the existing pedestrian refuge across Argyle Street which may result in some students becoming conditioned to receiving priority. This may not always be the case resulting in pedestrian conflicts</p> <p>Consideration should be given to other pedestrian crossing treatments where pedestrians have priority over motorist.</p>

Highly Probable	Moderate	High

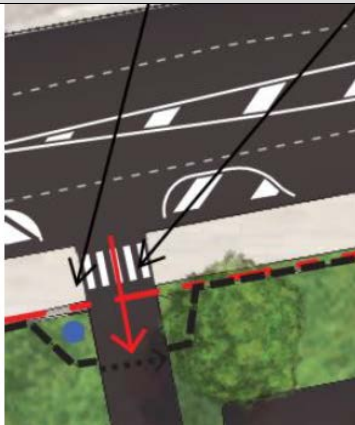
Item No.	Descriptions of Findings	Photo	Likelihood	Severity	Risk Rating
5	<p>A dedicated right turn bay is not provided for the right turn movement from Argyle Street into the new access into the staff car park.</p> <p>Lack of a right turn bay may result in rear end incidents.</p>

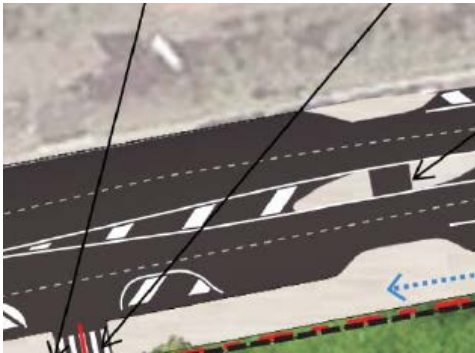
Occasional	Minor	Low
6	<p>No pedestrian footpath facilities are provided on the west side of Argyle Street south of the proposed pedestrian refuge facility which is where students are likely to walk to reach parked cars</p> <p>The lack of a surfaced footpath can result in pedestrians tripping over.</p>

Occasional	Minor	Low

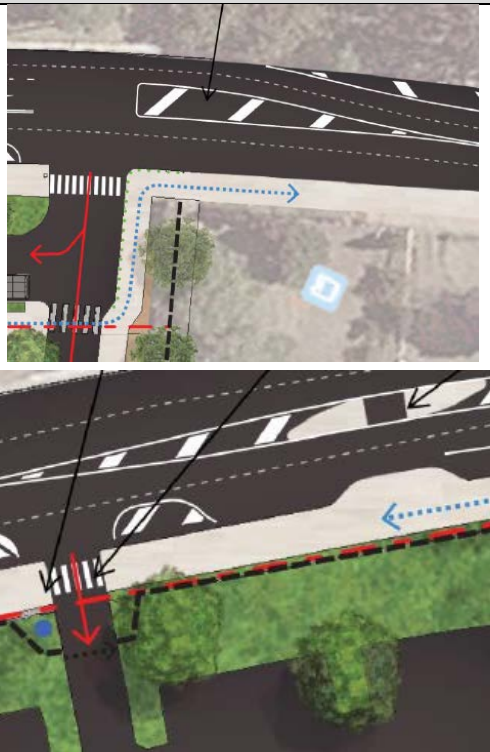
Item No.	Descriptions of Findings	Photo	Likelihood	Severity	Risk Rating
7.	Left turn auxiliary lanes are not provided on approach to the School bus interchange or staff car park. Lack of left turn auxiliary lanes may result in motorists decelerating within the Argyle Street southbound carriageway which may result in rear end incidents.

Occasional	Minor	Low
8.	The proposed bus interchange has capacity for six buses.  Buses do not appear to have sufficient taper in/ taper out length to enable bus drivers to enter and exit independent of other buses.

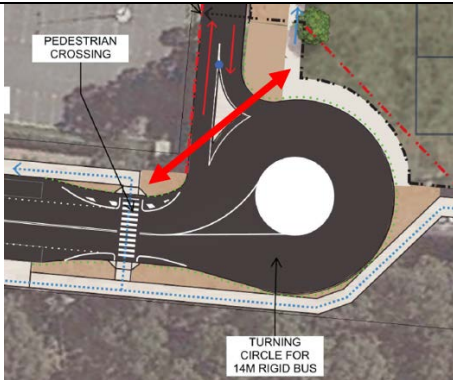
Occasional	Minor	Low
10.	Pedestrians will undertake the shortest and most direct path between the school and bus pick/ drop off zone.  Pedestrians are likely to cross the new school access even though no pedestrian facilities are proposed which is likely to result in pedestrian collisions.

Occasional	Minor	Low
11.	Wonga Road is a public road. The RMS warrant for a pedestrian crossing is unlikely to be satisfied.

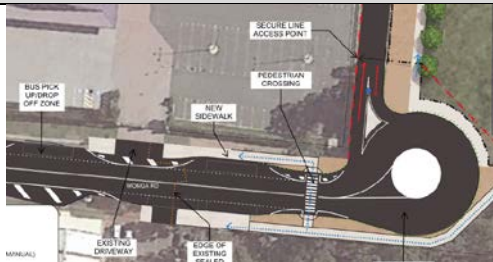
Item No.	Descriptions of Findings	Photo	Likelihood	Severity	Risk Rating
12.	The Wonga Road scheme comprises pick up/ drop off facilities for buses only. Consideration for a pick-up/ drop off area for parents should be considered.

Note only.		
13.	Retaining access to the existing Animal facility should be considered.

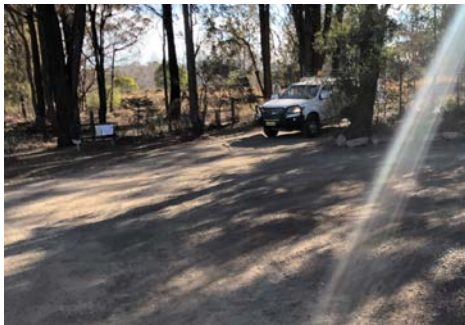
Note only.

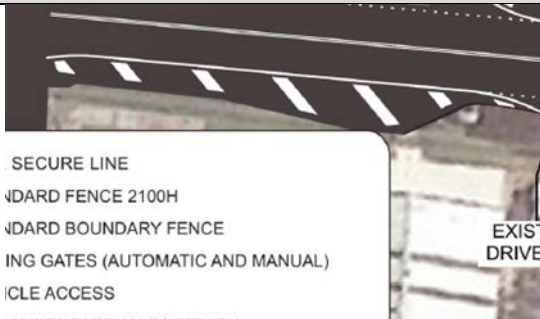
Item No.	Descriptions of Findings	Photo	Likelihood	Severity	Risk Rating
14.	As parking will be in demand, parking on the east side of Wonga Road should be retained.
