Report on
Preliminary Geotechnical Investigation

Proposed Picton High School Redevelopment
Argyle Street, Picton, NSW

Project 34252.02
April 2018

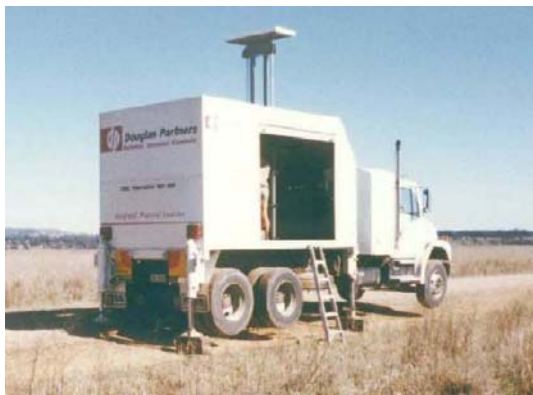
Figure 2: Purpose built CPT rig

The cone is thrust into the ground at a steady rate of about 20 mm/sec, usually using the hydraulic rams of a purpose built CPT rig, or a drilling rig. The testing is carried out in accordance with the Australian Standard AS1289 Test 6.5.1.

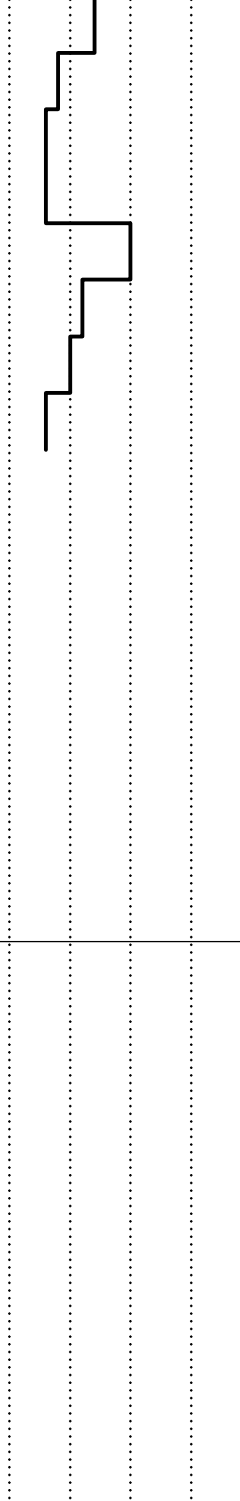
0.2	FILLING - brown silty clay, MC<PL		D	0.2				
1	0.9	CLAY - very stiff, brown and grey silty clay, MC~PL

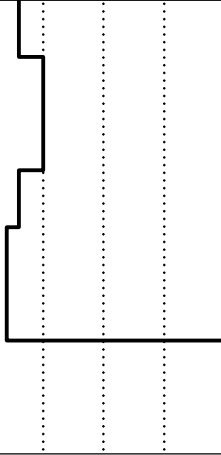
0.2	FILLING - brown silty clay with some gravel, MC<PL			0.2							
	0.5	CLAY - red brown silty clay, MC~PL
