Bushfire Assessment

**Picton High School
Redevelopment**

480 Argyle Street, Picton

16 May 2018

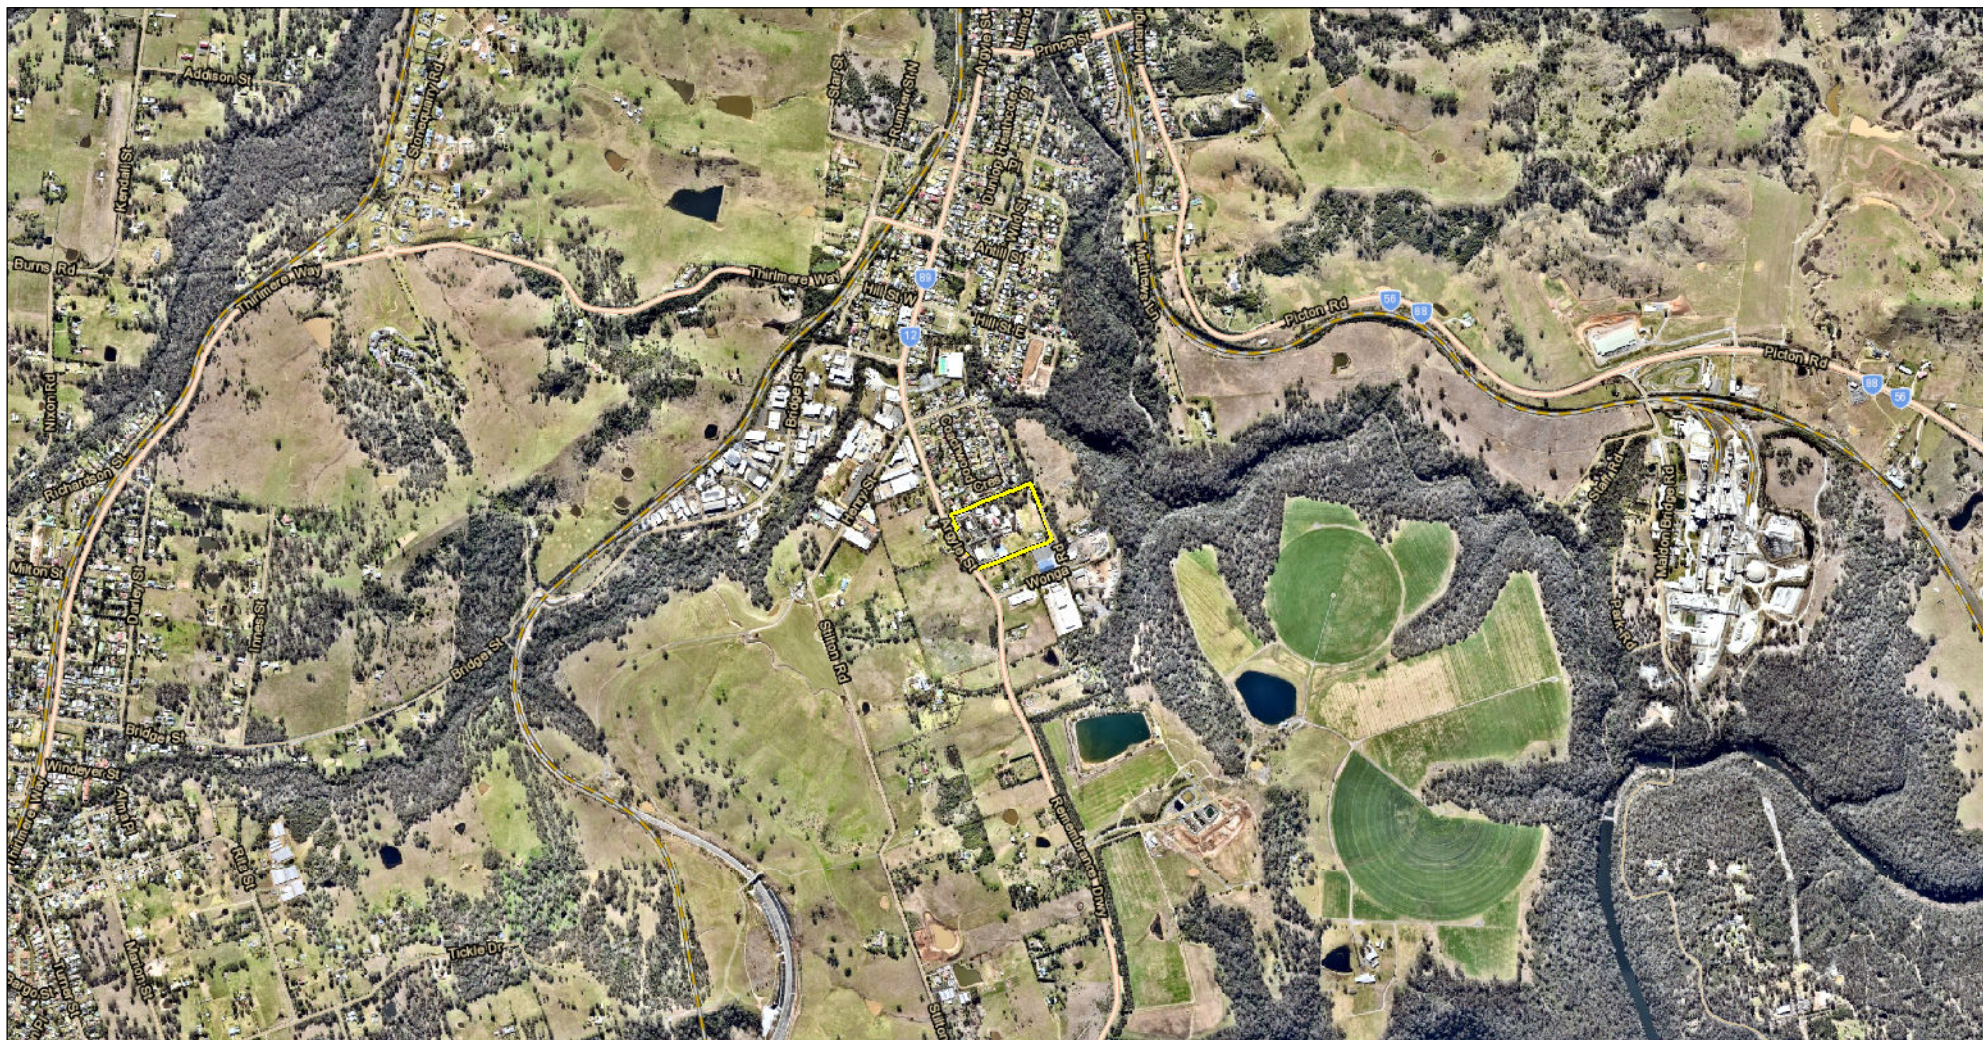
Figure 1: The Location of the Subject Land

The school site is situated at the southern edge of the township of Picton as shown in Figure 1. Predominantly surrounded by cleared and managed lands, the 'bushfire prone vegetation' closest to the school site consists of forest on the steep slopes of Stonequarry Creek over 140 m to the east of the school boundary.

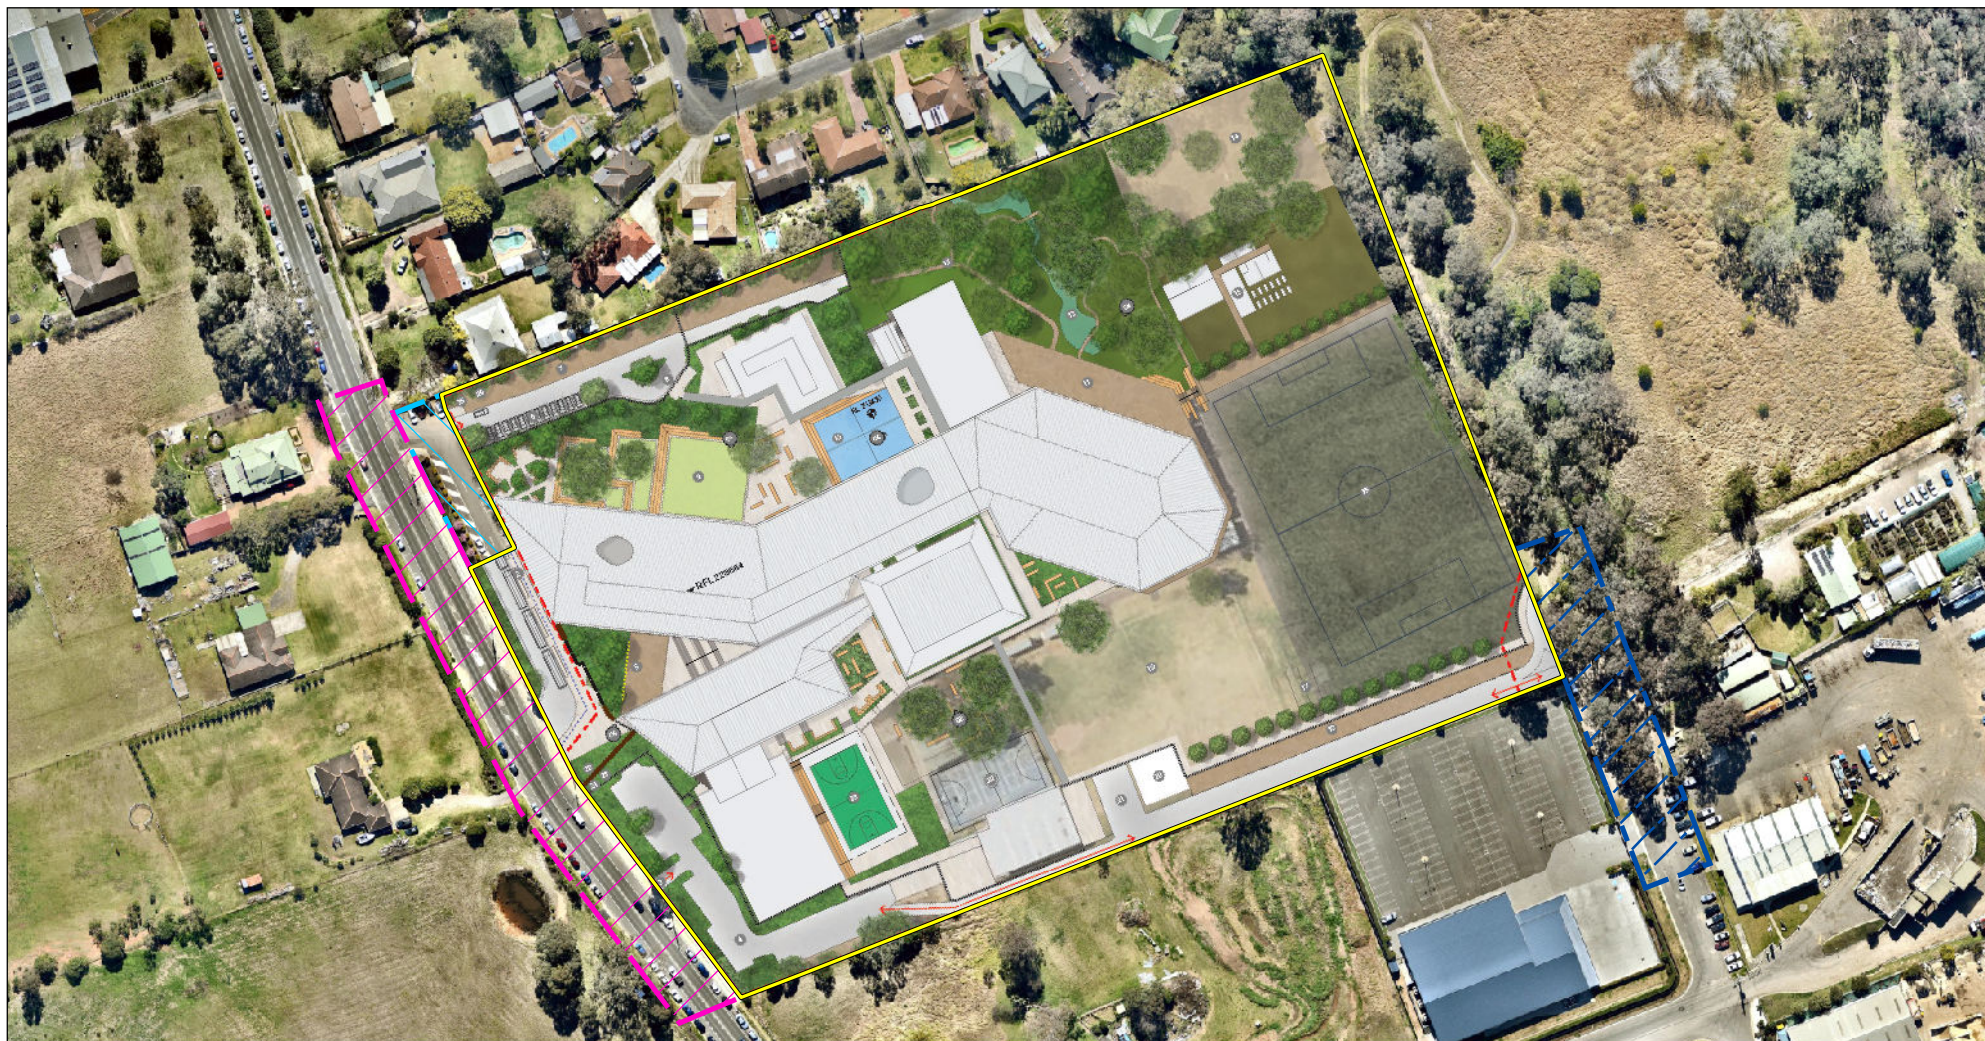
Figure 2: Proposal

The proposal consists of the replacement of most of the school buildings with a contemporary, purpose-built design to allow for the capacity of 1,500 students with core facilities for 2,000 students and future expansion zones for an additional 500 students. Seven buildings will be retained and integrated into the new works as shown on the development site plan included as Figure 2.

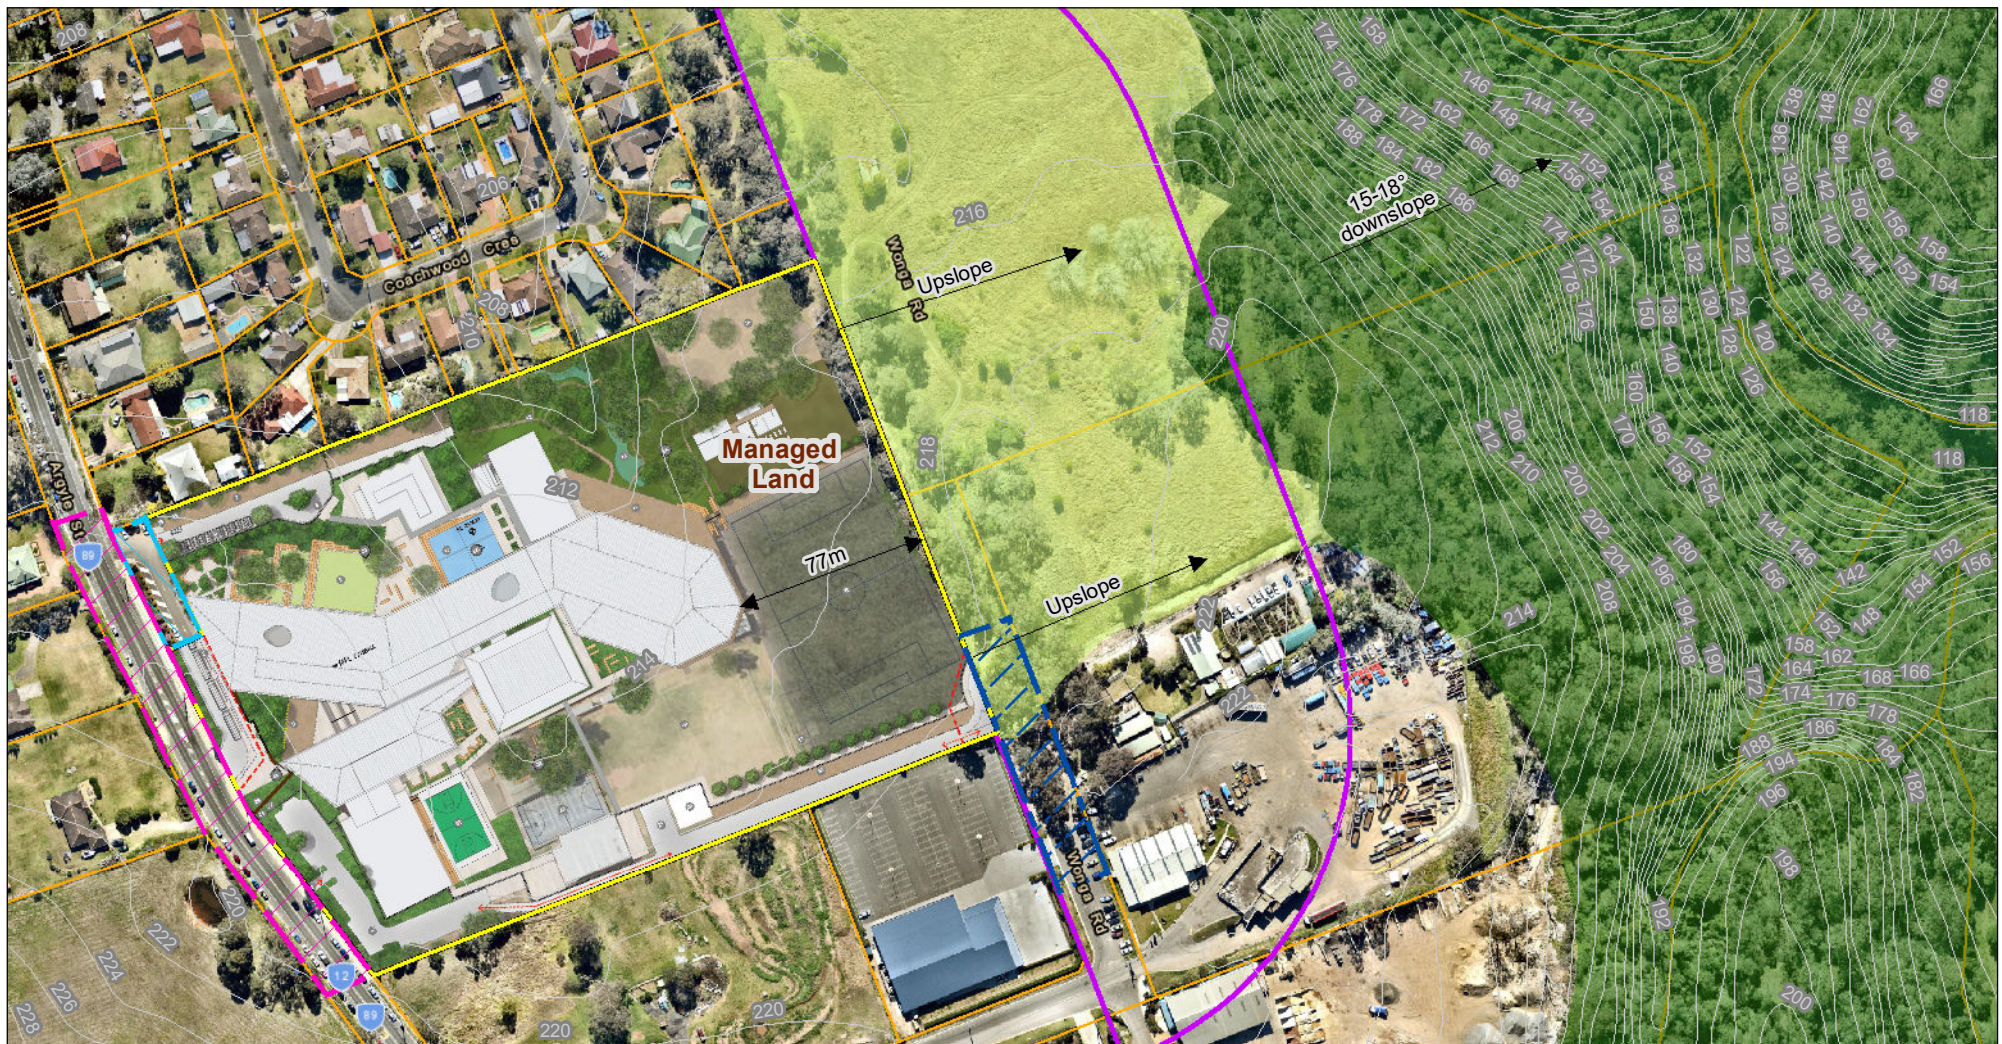
Figure 4: Bushfire Hazard Analysis

The vegetation within 140 m of the school site has been assessed in accordance with the methodology specified within PBP. The 140 m assessment area and predominant vegetation is mapped on Figure 4, which shows that the bushfire hazard lies to the east of the school site only. The remaining sides of the school (north, west and south) consist of cleared and developed lands for a considerable distance. The school grounds are managed and consist of buildings, playing fields and scattered trees in the north-eastern corner with a cleared and mown understorey.

The 'effective slope' influencing fire behaviour has been assessed in accordance with the methodology specified within PBP. This is conducted by measuring the slope that would most influence fire behaviour where the hazard occurs within 100 m of the development proposal. The slope was determined using a 2 m contour layer as shown on Figure 4.

Using the vegetation and slope data discussed in Section 2 and mapped on Figure 4, APZs suitable for the development of a school have been calculated. The available APZ is indicated on Figure 4 and listed in Table 2 below. The APZ will consist of the managed school grounds and will exceed the minimum requirements. Additional APZ establishment is not required.

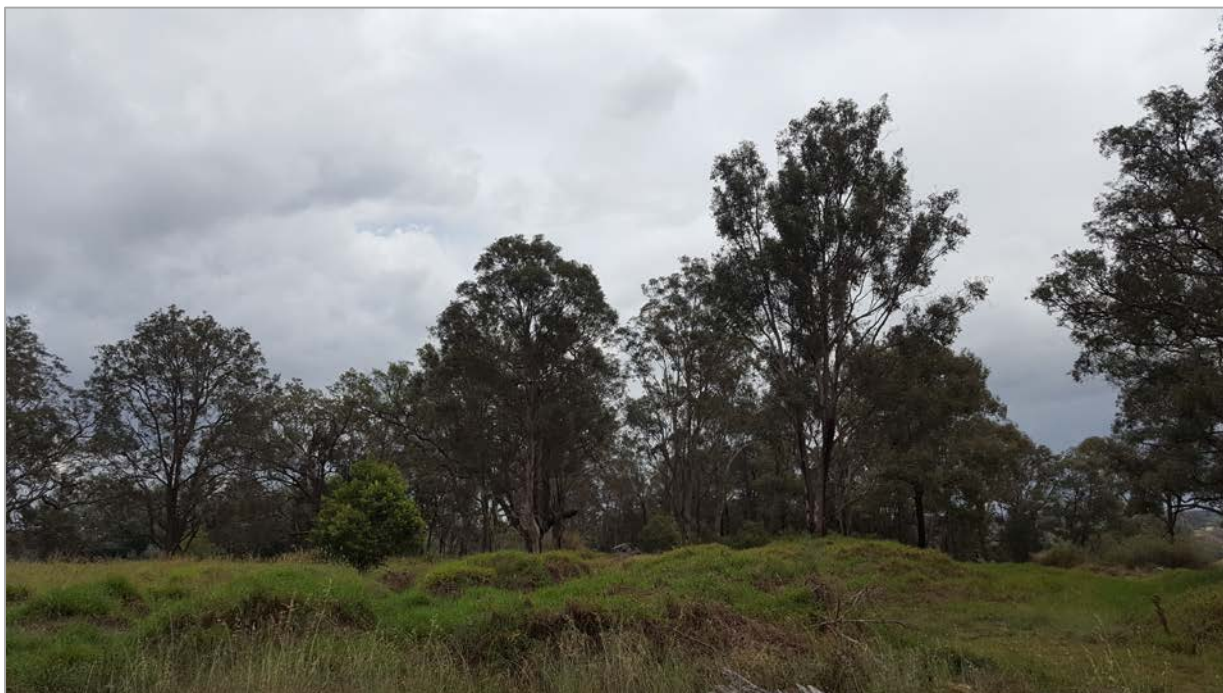
Photograph 1: Forest outside of the 140 m assessment area to the east of the school site

Western Sandstone Gully Forest is located on the steep slopes leading down to Stonequarry Creek. Classified as 'forest', the vegetation is beyond the 140 m assessment area and is therefore not the predominant vegetation. However, the presence of vast tracts of forest within the steeply incised gullies to the east is the primary influencing factor underpinning the bushfire risk at the school, and therefore the forest has been considered in determining the appropriate bushfire protection measures.

The forest is located greater than 100 m from the school boundary therefore does not technically fall into the assessment area. The forest is located on the steeply incised gully walls of Stonequarry Creek, on a gradient exceeding the PBP slope class of 'Downslope >15-18 degrees'.

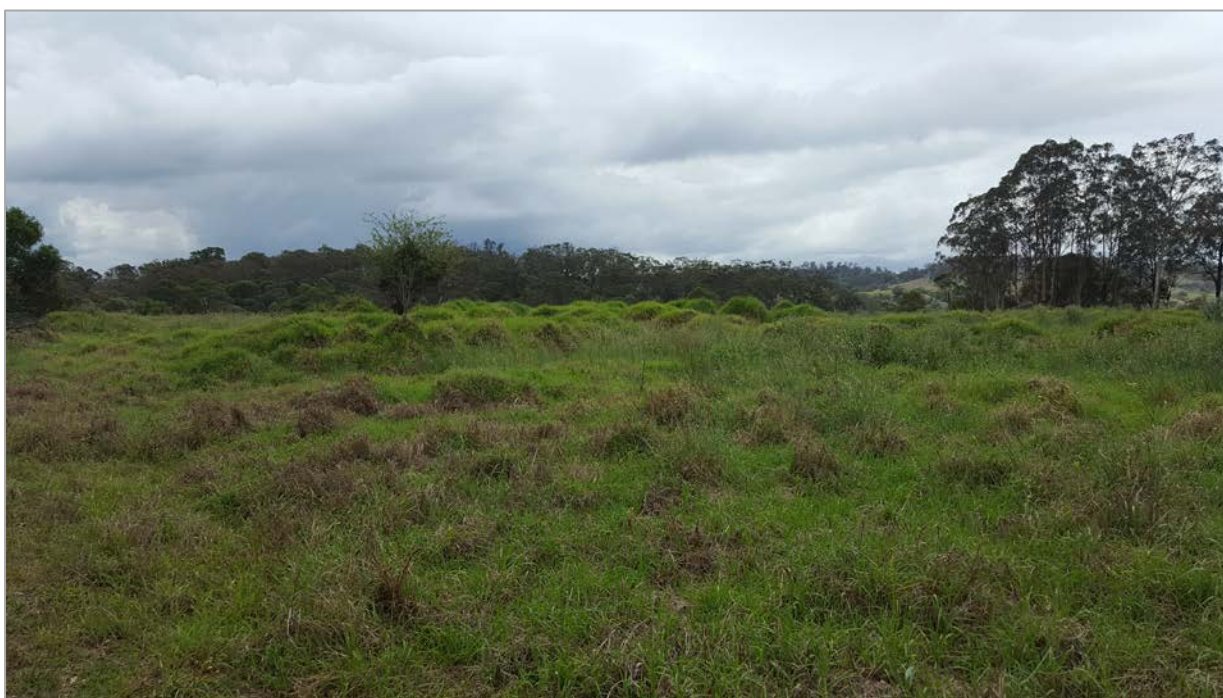
Photograph 2: Grassland over old tip to the east between forest and school site

Between the forest and the school boundary is an unmaintained cleared area that has been colonised by predominantly Kikuyu grass. Regeneration of native shrubs and trees has been minimal due to the past use of the area as a tip, which has since been covered in fill creating an uneven, hummocky surface covered in Kikuyu grass. Even though not predominantly

consisting of native grasses, it is classified as 'grassland' due to the unmaintained nature of the land by grazing or other means.

Between the school boundary and the steep downslopes is land that is relatively flat or gently sloping uphill. Therefore, the grassland is located on a gradient within the PBP slope class of 'upslope/flat'.

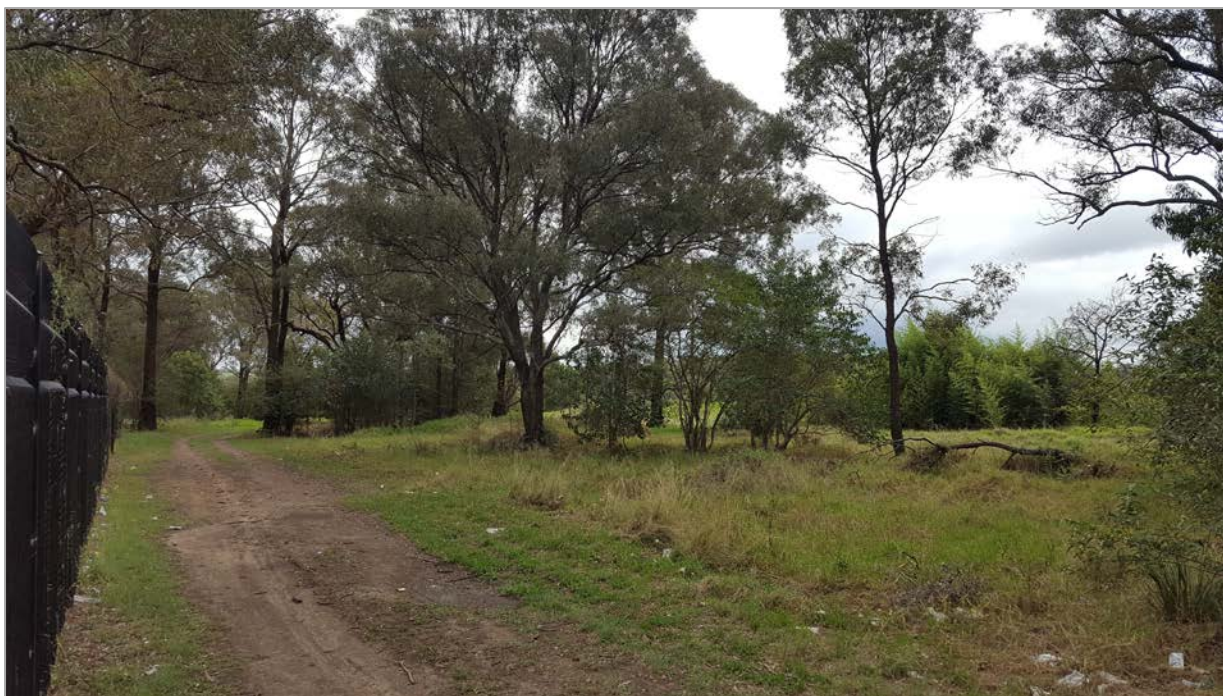
Photograph 3: Low hazard corridor to the east between school site and grassland

Along the eastern boundary within the adjacent properties is a narrow corridor of forest that is classified as 'low hazard'. The corridor is highly disturbed with an open understorey colonised by Kikuyu Grass and other exotics such as Bamboo. It also contains the unsealed extension on Wonga Road and access trails within its limits.

Like that of the grassland, the low hazard is also on land within the PBP slope class of 'upslope/flat'.

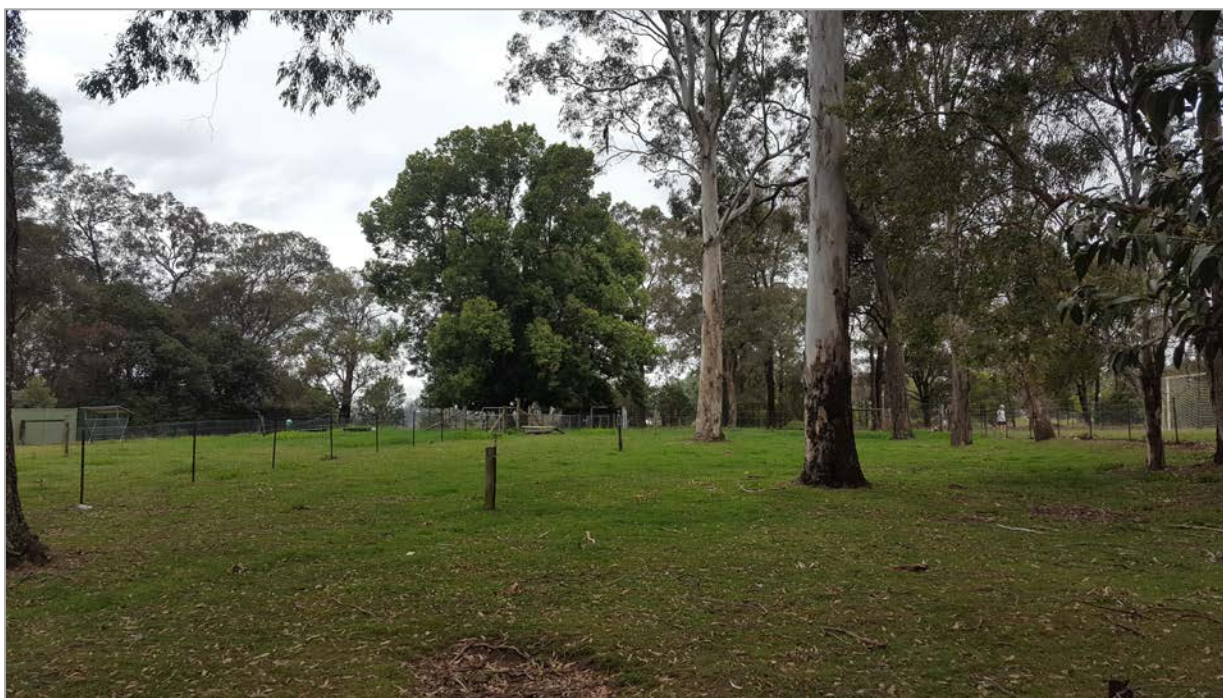
Photograph 4: Managed north-eastern corner of the school site

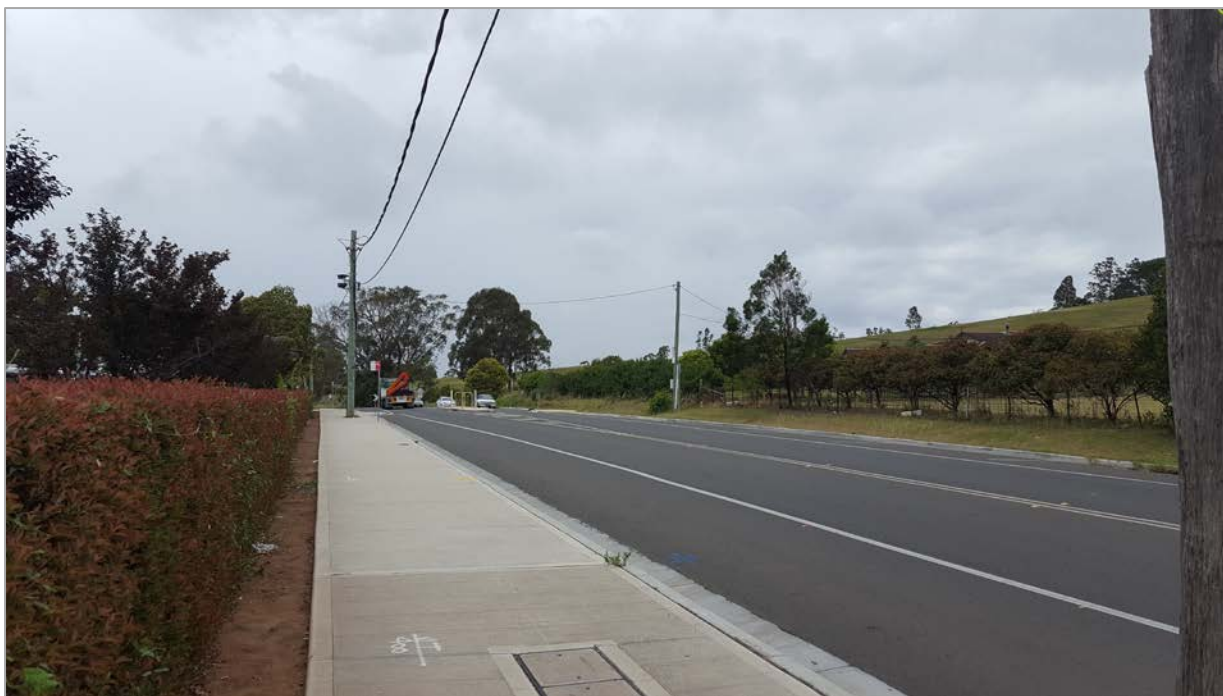
Photograph 5: Argyle Street providing primary access point on western boundary

Argyle Street and Wonga Road provides the public road access to the school site. Both roads and connecting roads comply with the PBP Acceptable Solutions for the design and construction of public roads.

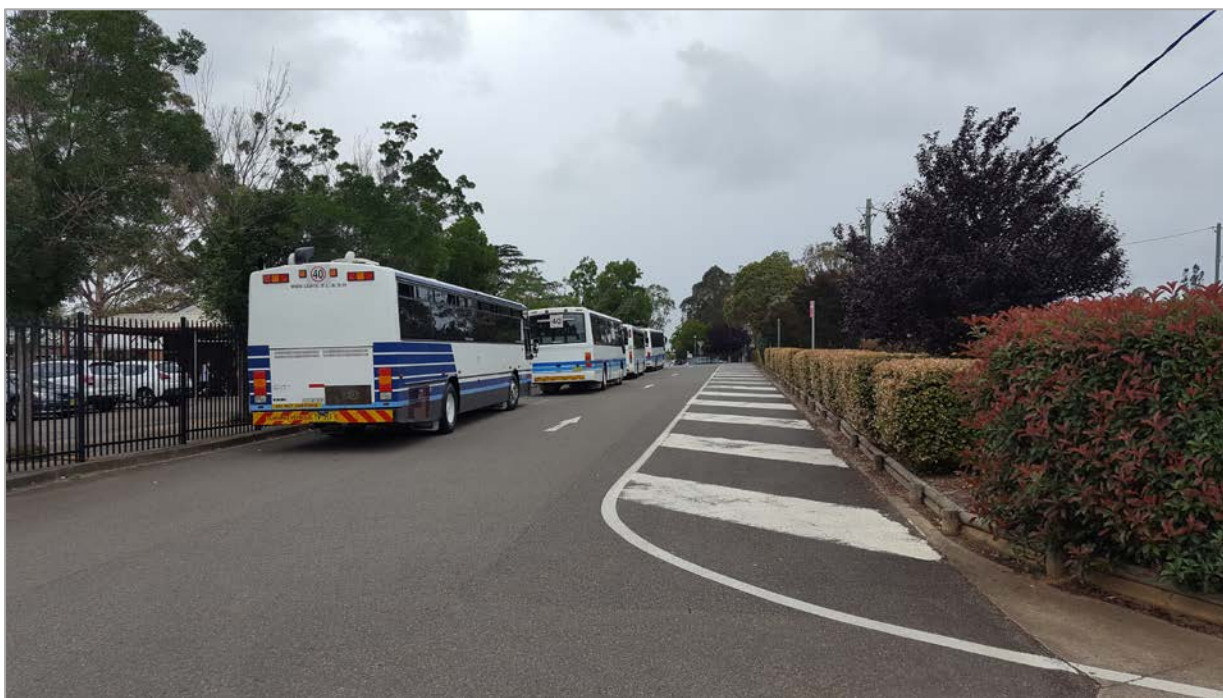
Photograph 6: Through access drive off Argyle Street on western boundary

The primary access to the school will remain unchanged and consists of the drive-through access road off Argyle Street forming the western boundary of the school site. The access is designed to cater for bus movements and therefore suitable for fire and emergency authorities. Secondary and perimeter access is provided by Wonga Road forming the eastern boundary and providing additional separation from the identified hazards to the east. The existing access achieves the aim and objectives of PBP. Additional access provisions for bushfire protection are not required.

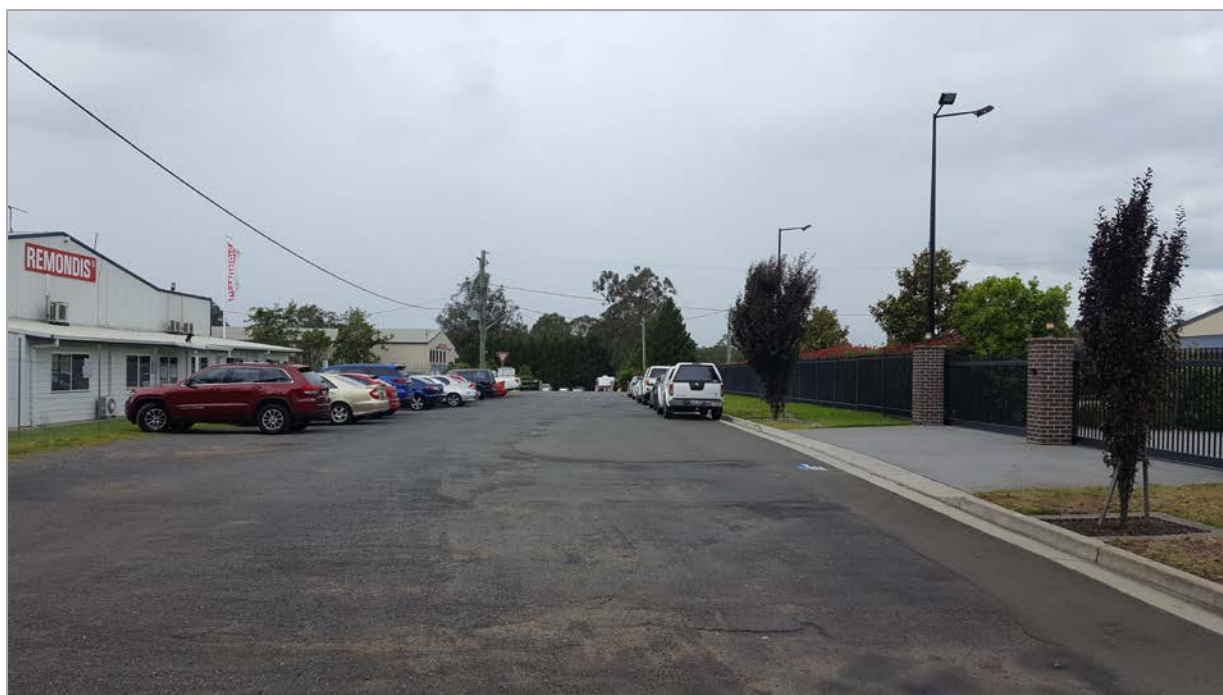
Photograph 7: Wonga Road providing secondary access point on eastern boundary

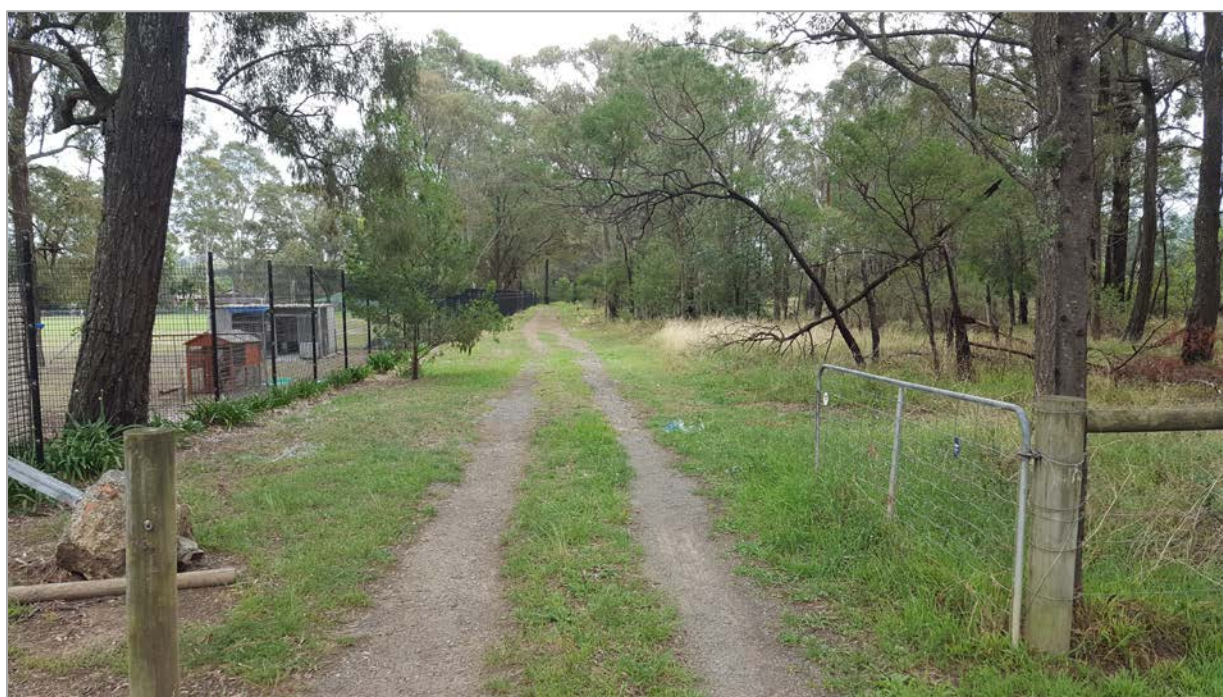
Photograph 8: Unsealed extension of Wonga Road providing perimeter access to east
