Analysis of Design Options: Concert Hall, Creative Learning Centre

1 Options and Design Alternatives

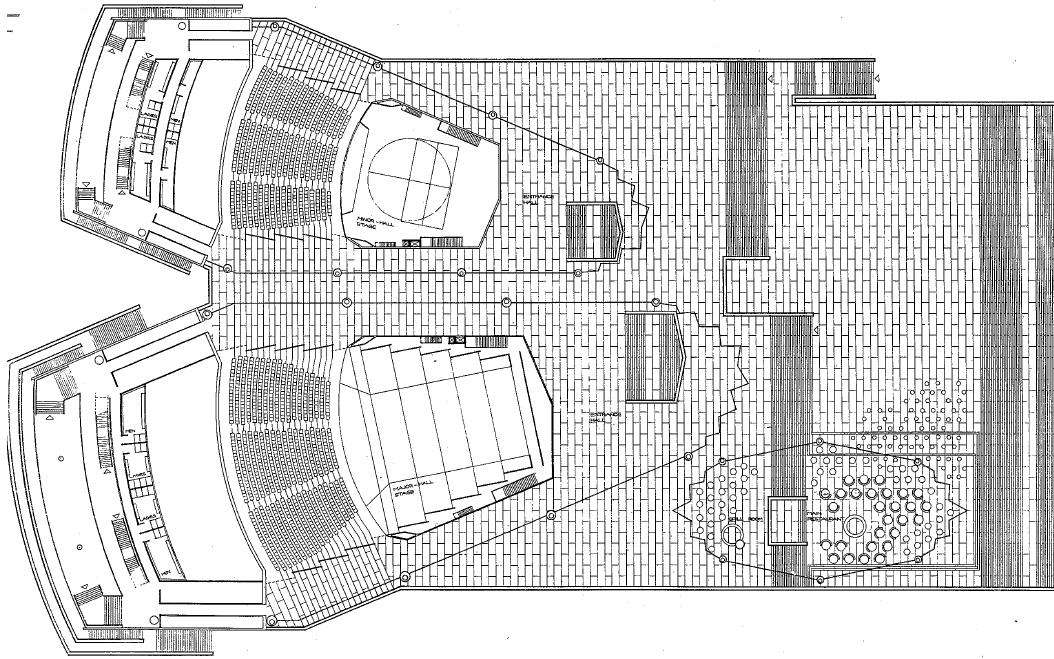
The concept of a passageway in the location identified in the proposal is considered appropriate on the basis that Jørn Utzon's original design for the building envisaged passageways on Level 3 in both the Eastern and Western foyers of the Minor (now JST) and Major (Concert Hall) Halls. This is evidenced by Utzon's drawings in the Red Book (1958) in Figure 2 and also in the photograph in Figure 3, which show these passageways were included in the podium at its completion in 1963.

Figure 2: Extract from The “Red Book” – Sydney National Opera House – Jørn Utzon March 1958

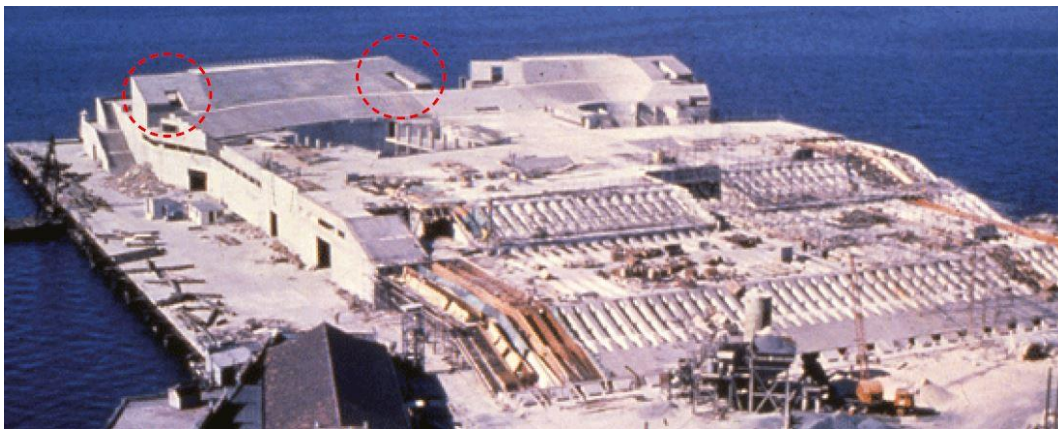
Figure 3: Photograph of completed podium, 1963, showing construction of passageways

It is important to note that while the tunnels identified in Figure 3 were constructed, they were closed over due to design program changes after Utzon’s departure in 1966.

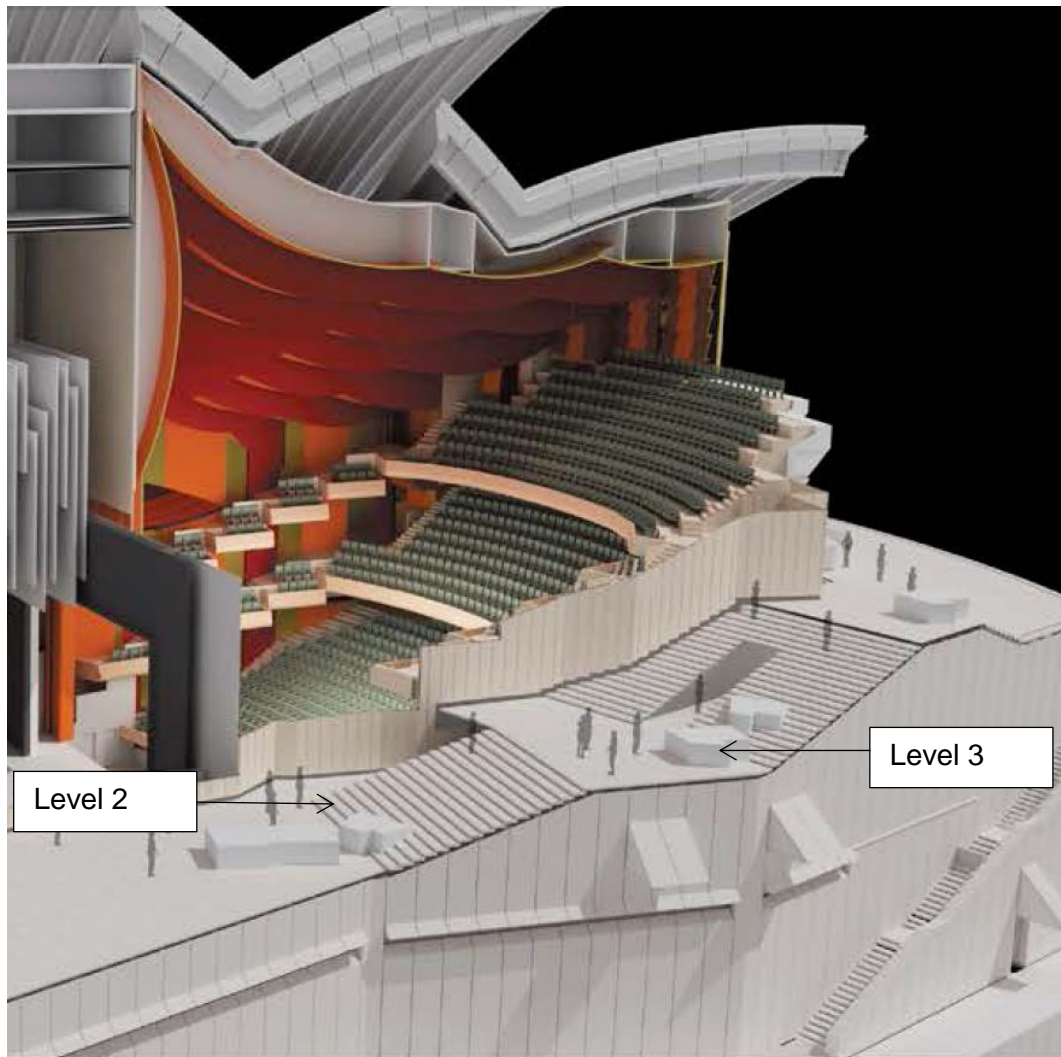
proposal. The *Gold Book* proposal has a narrower auditorium, allowing a wider passage and stair in the side foyers than is possible now.

Figure 4: Concept Design of Joan Sutherland Theatre 'Gold Book' illustrating the passageways at both levels 2 and 3

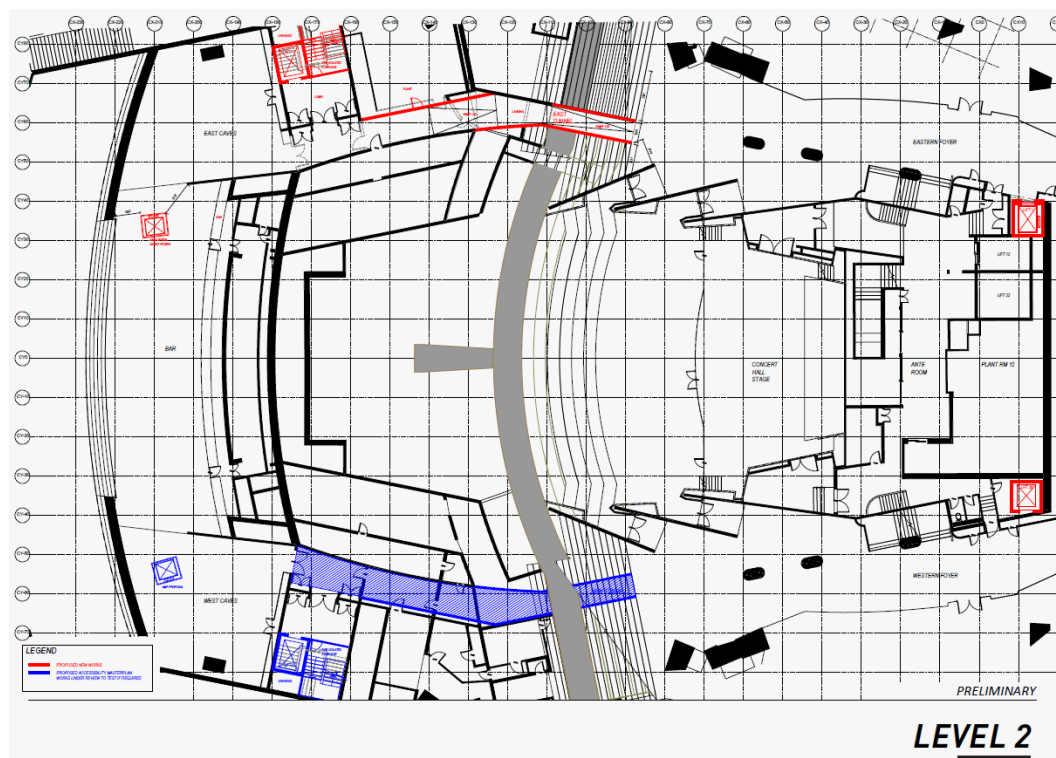
ARM Architecture's initial concept design work tested this symmetrical approach and evaluated whether all proposed lifts were required or if a 'half' approach restricted to either the west side or east side had merit.

Figure 5: AMP Concept of two passageways from Southern to Northern Foyer at Level 2

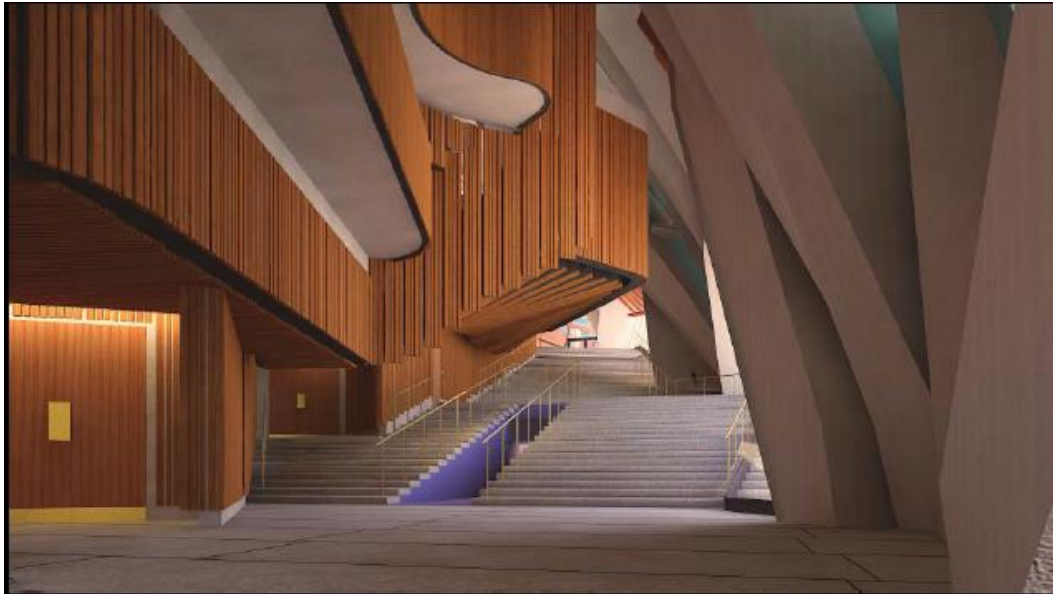
The concept design (Figure 6) located the passageway centrally in the stairs, with the alignment of the entry point parallel to the brush box wall of the auditorium.

Figure 6: Option showing passage located centrally in stairs, but parallel to brush box

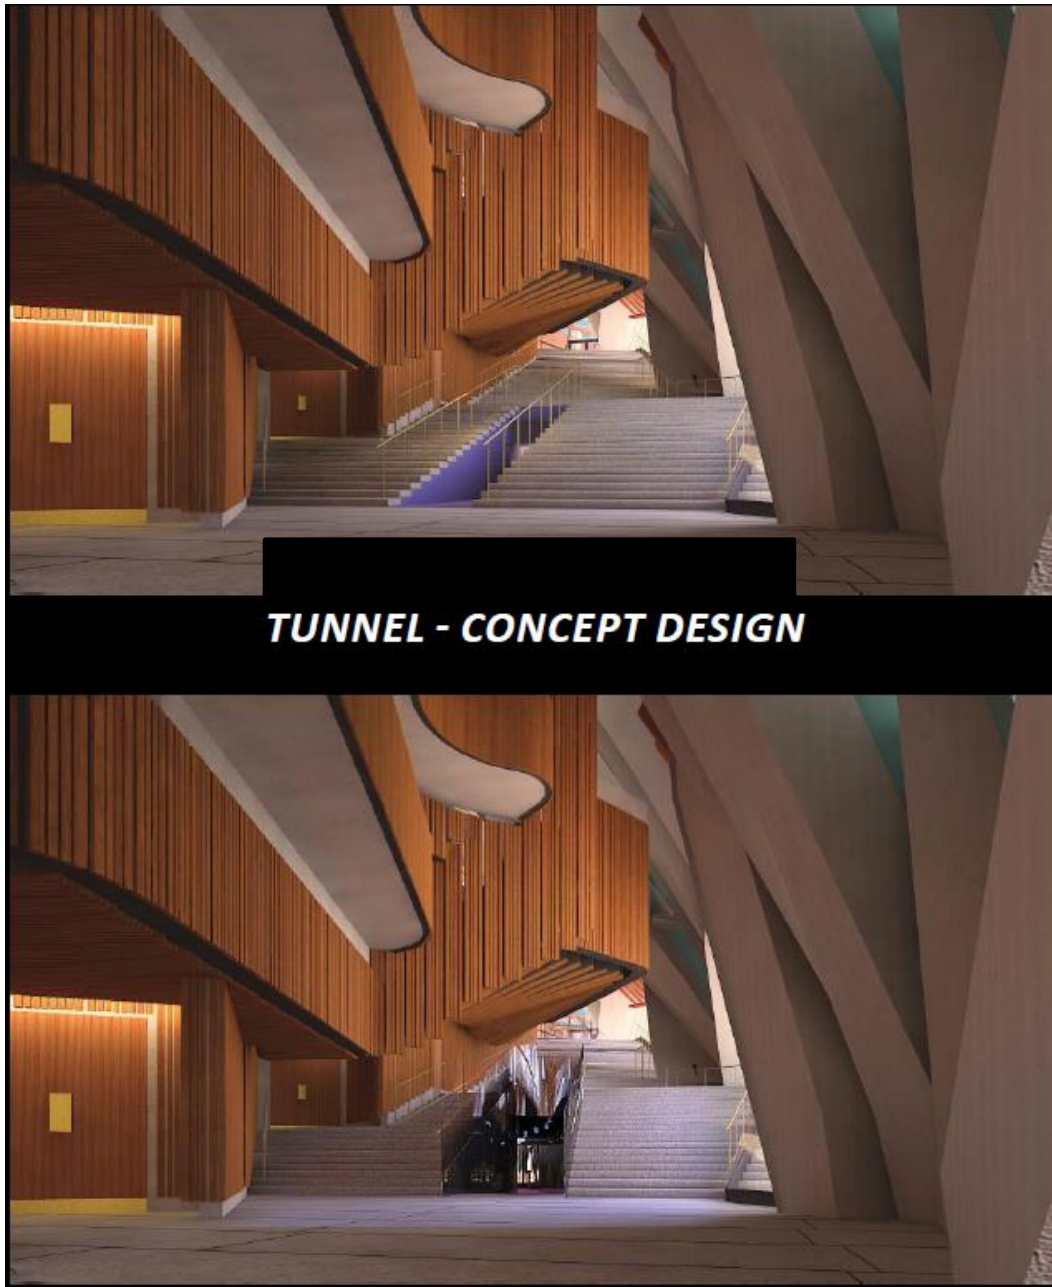
The Eastern passageway was further refined and developed in the first phase of schematic design. The entry was moved further to the east, opening up the view to it from further back in the Southern Foyer as well as being widened to provide a more generous passage width. A revised concept for materiality of the passage surfaces and balustrades was developed. The following Figure 7 demonstrates the change from concept to early schematic design.

Figure 7: Initial Concept and Schematic Designs for the Passageway

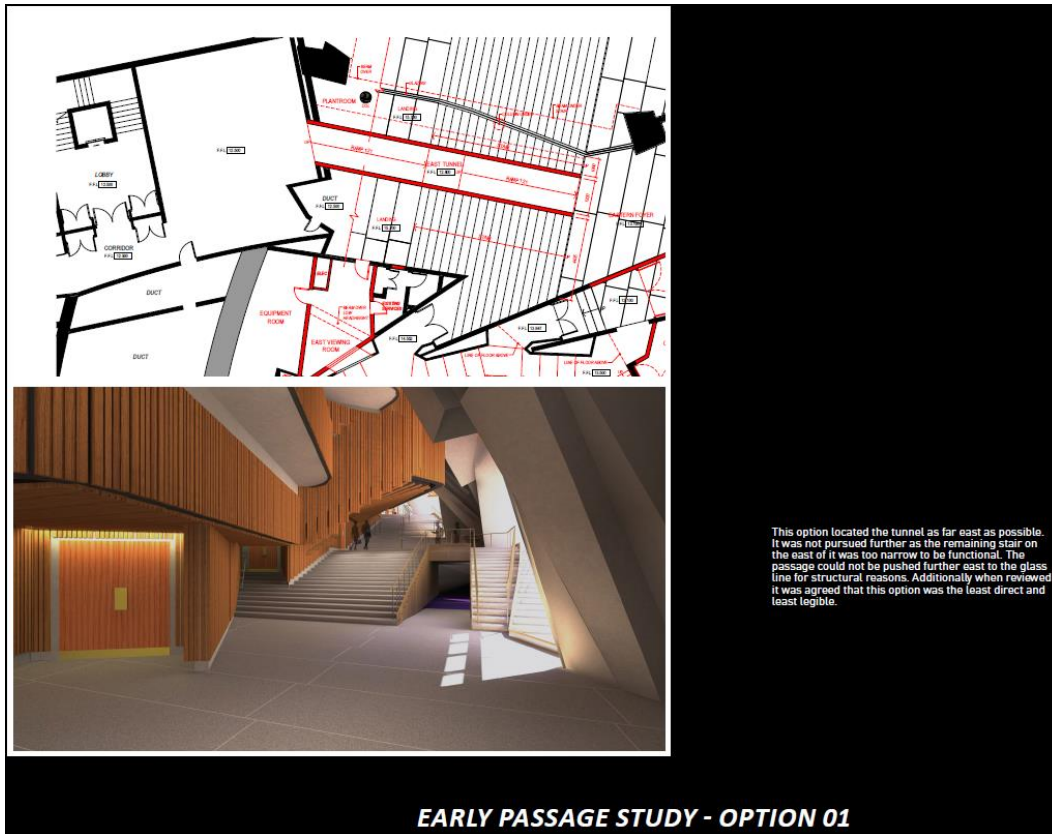
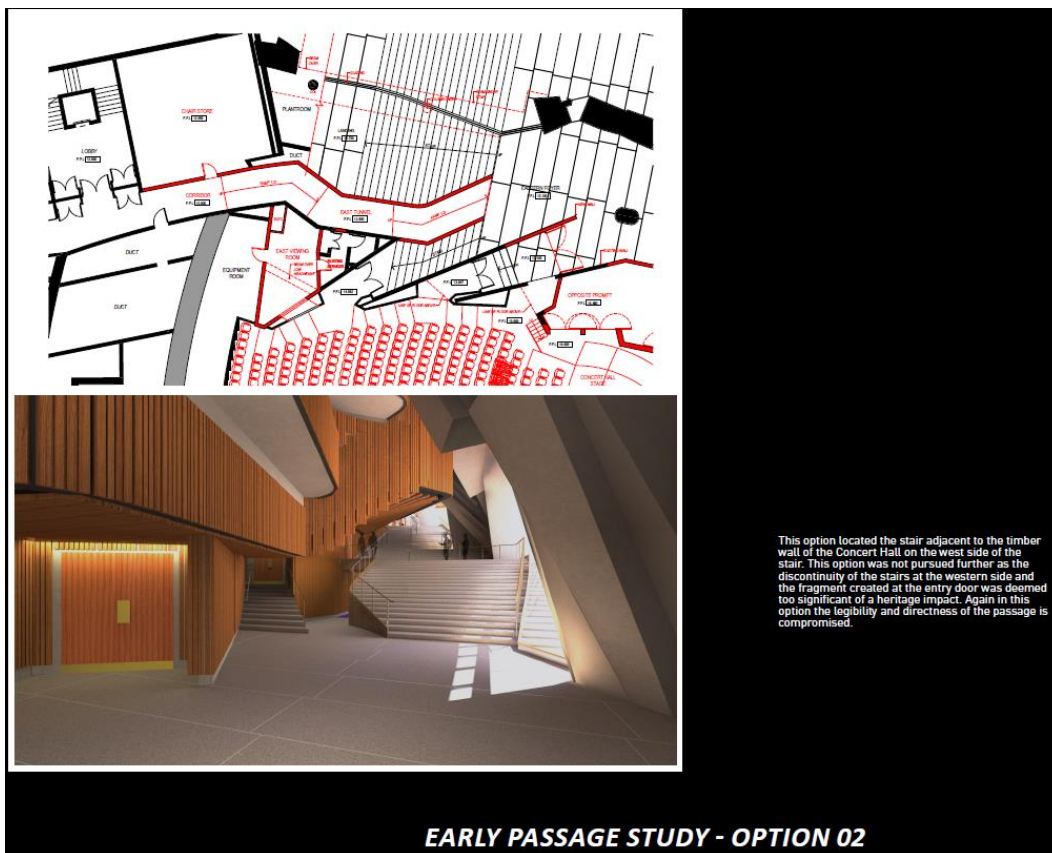
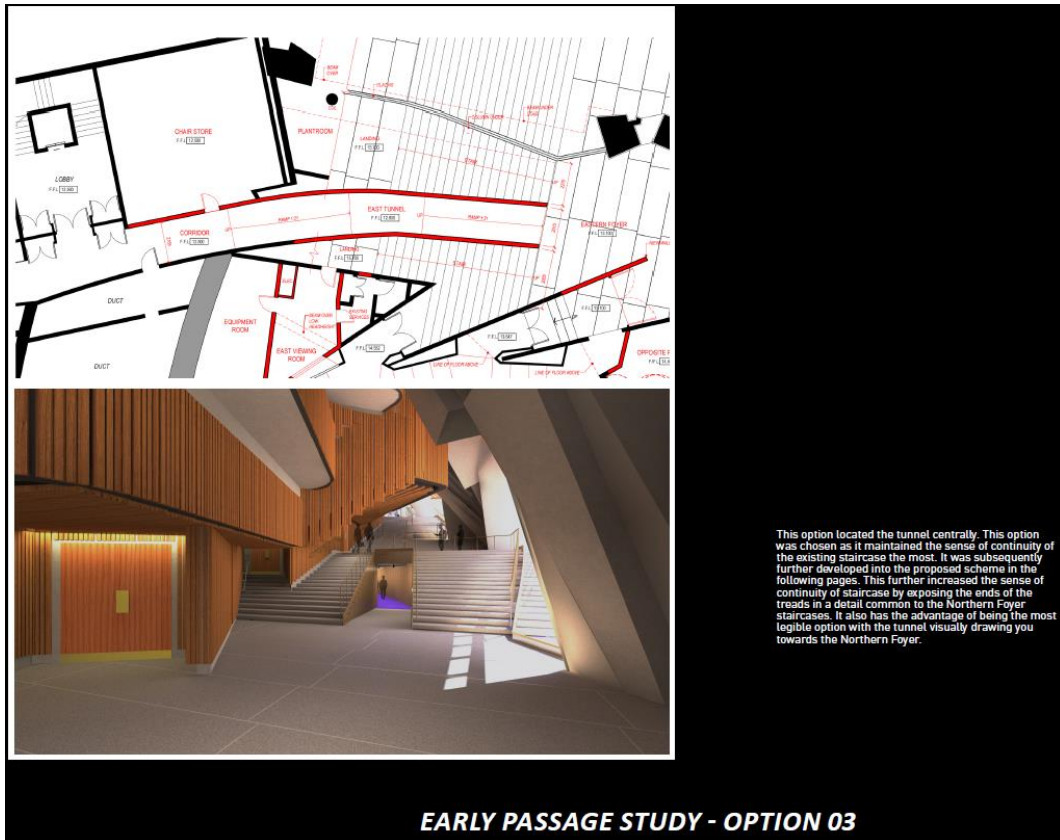
The following diagrams show the options considered for the location of the passage and then the final proposition. All options were reviewed with the EAP, CC Heritage Consultant - Design 5 Architects. The consensus reached was that the centrally located passage was the best option to proceed with to satisfy both heritage and DDA amenity requirements.

Figure 8: Early Passage Study – Option 01

Figure 9: Early Passage Study – Option 02

Figure 10: Early Passage Study – Option 03

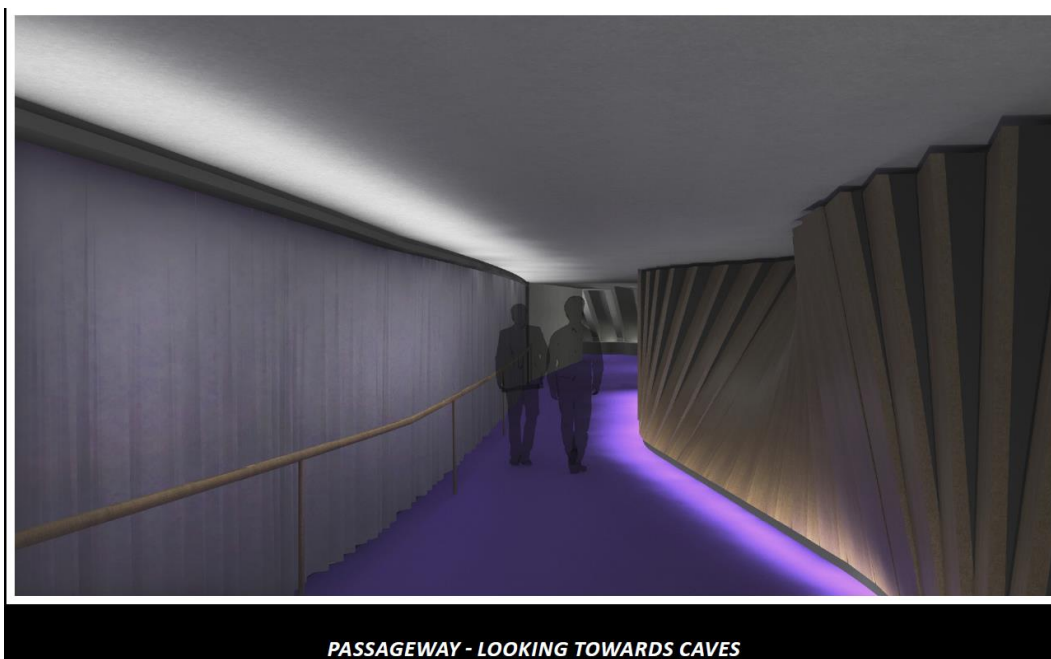
Figure 12: Final Passageway Entry – Level 2

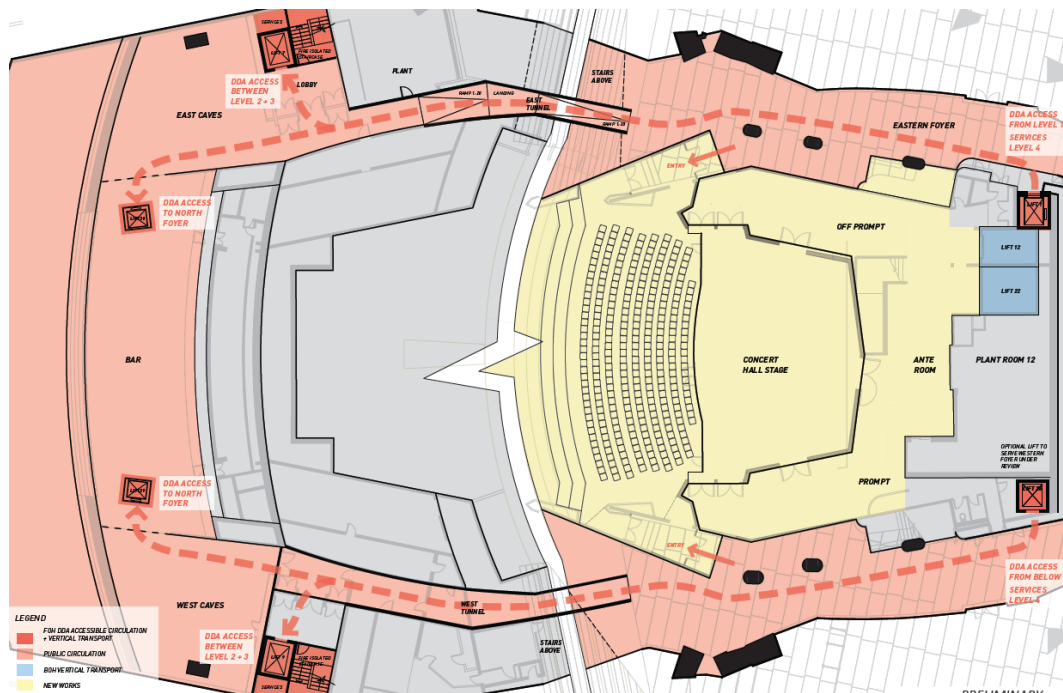
The AMP recommended updating three lifts and installing three new lifts around the Concert Hall to provide improved access for performers, patrons and staff. These included new lifts 26, 29 and 30 plus an extension of Lift 1 to travel from Ground Floor to Level 4 and Lift 26 linking the Western Foyers to the Concert Hall Southern Foyer and arriving at Level 4. Existing Lifts 7 and 9 were proposed to become front of house lifts connecting Level 2 and Level 3. Conceptual, schematic and detailed design analysis was undertaken in consultation with key stakeholders and the EAP to determine the buildability and practicality of implementing the lift upgrade works identified in the AMP.

Figure 15: Lifts Proposed in Accessibility Master Plan

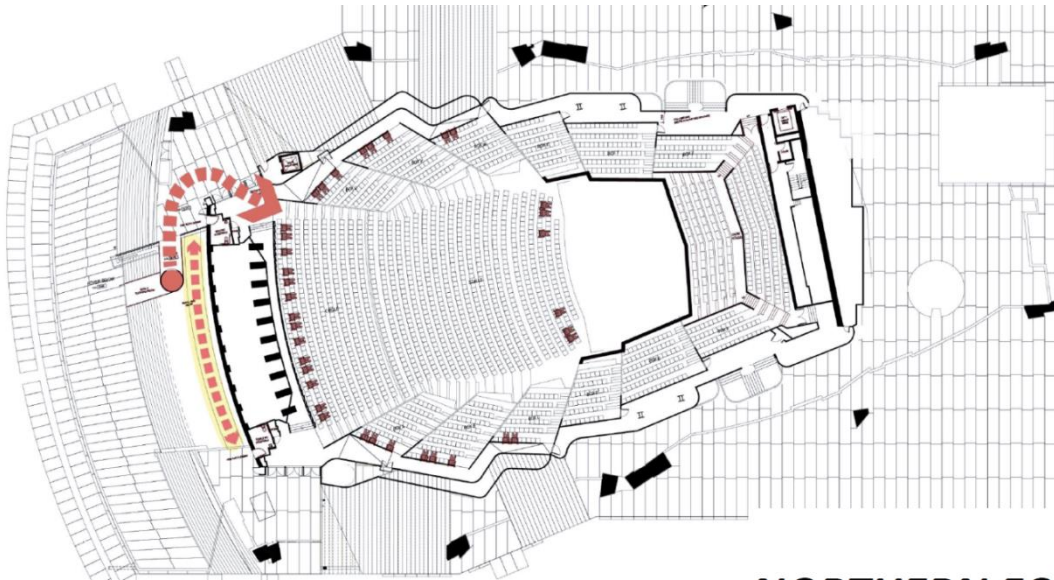
- Option 1: a single lift located at the eastern end of the broad stairs in the Northern Foyer, along with an optional connecting “bridge”, necessary to provide an accessible travel path to the accessible seating via Level 4 on both sides of the auditorium. Shown in the following Figure 16.

Figure 16: CH Northern Foyer Lift Option 1 (including optional “bridge”)

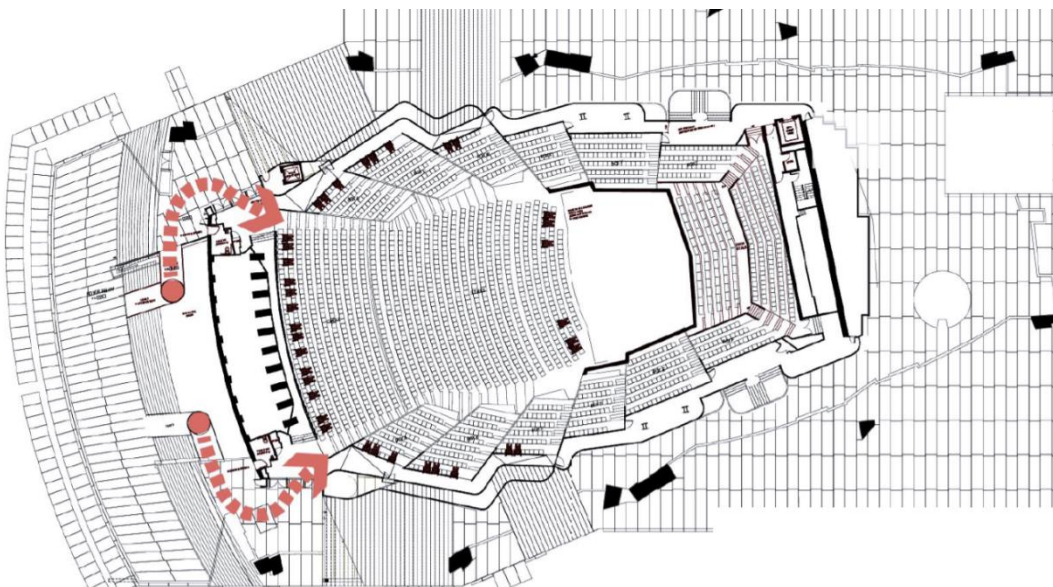
- Option 2: construction of two new lift shafts (lift shafts 29 & 30) within the Northern Foyers towards the edges of the central broad stairs (see following Figure 17)

Figure 17: CH Northern Foyer Lifts Option 2

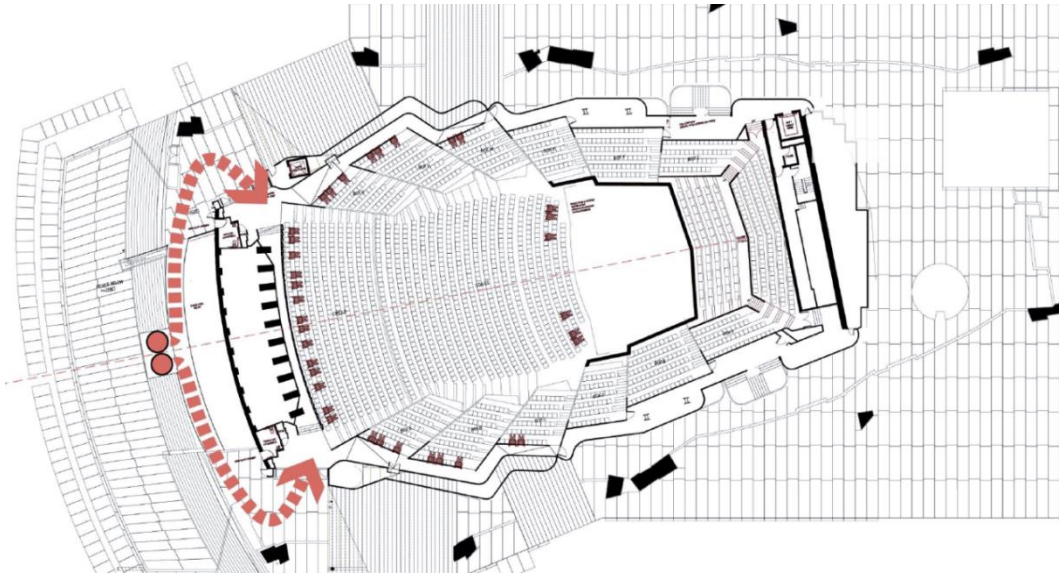
- Option 3: construction of two new lift shafts (lift shafts 29 & 30) within the Northern Foyers at the centre of the central broad stairs and connecting “bridges” to Level 4 (see following Figure 18)

Figure 18: CH Northern Foyer Lifts Option 3

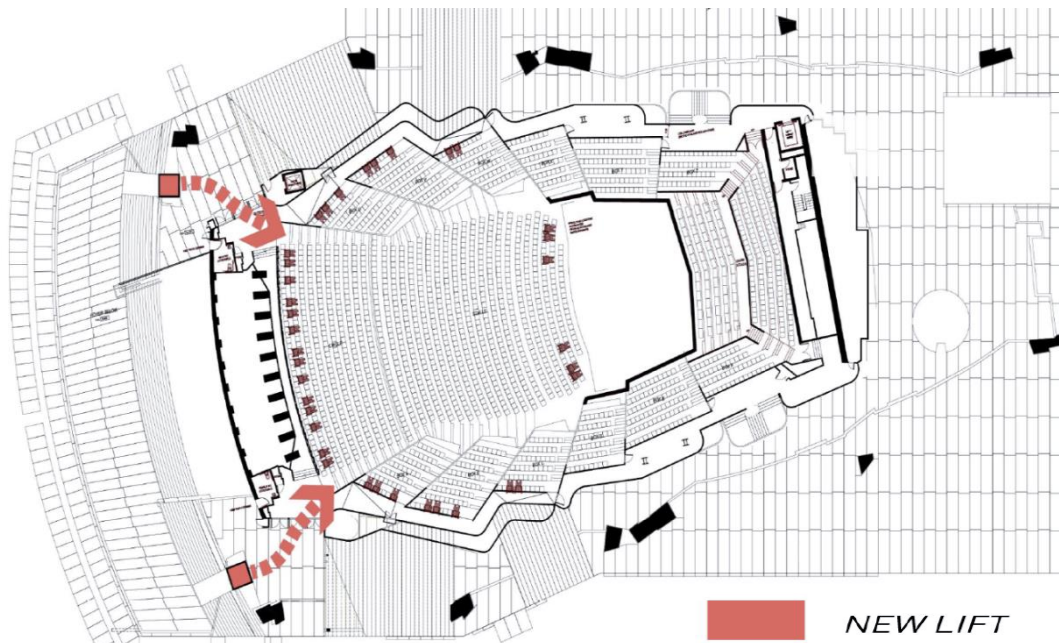
- Option 4: construction of two new lift shafts (lift shafts 29 & 30) within the Northern Foyers towards the outer edges of the Northern Foyer (see following diagram)

Figure 19: CH Northern Foyer Lifts Option 4

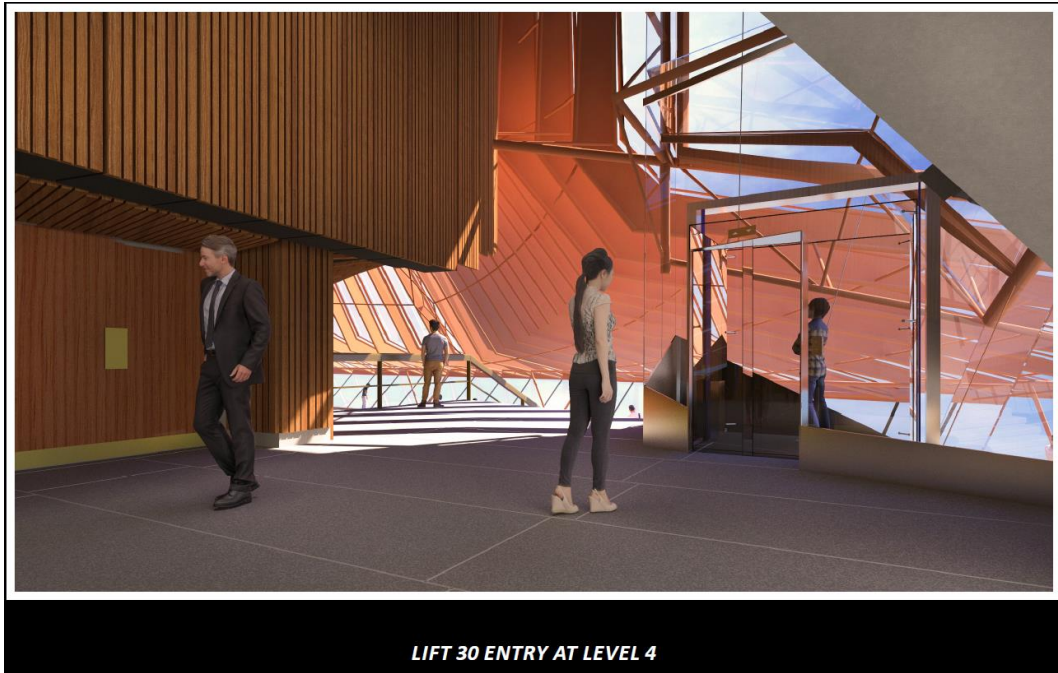
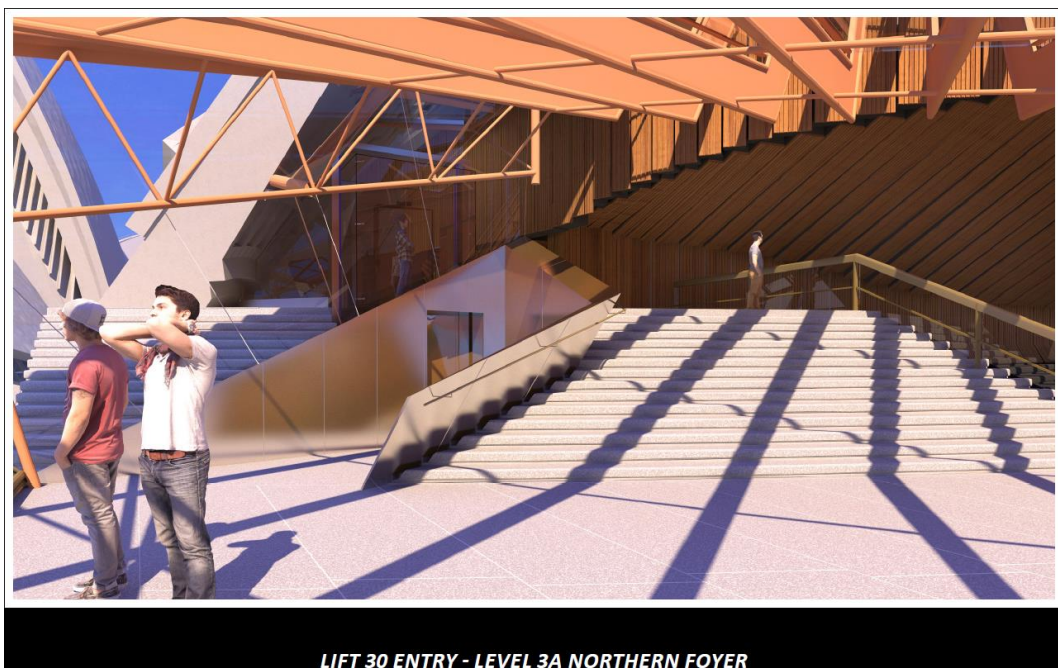
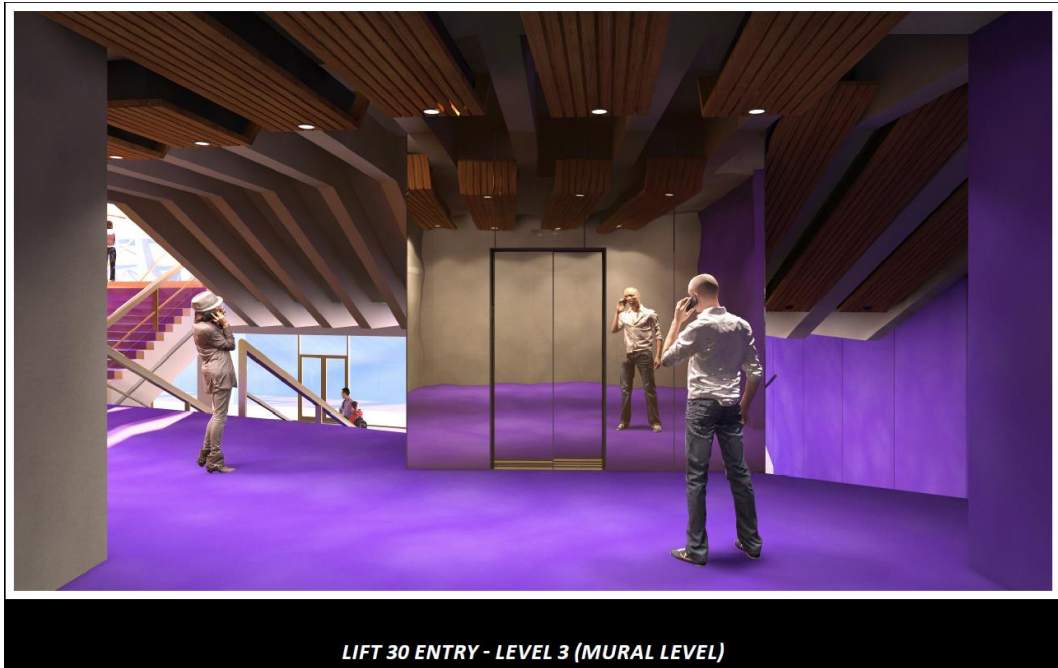
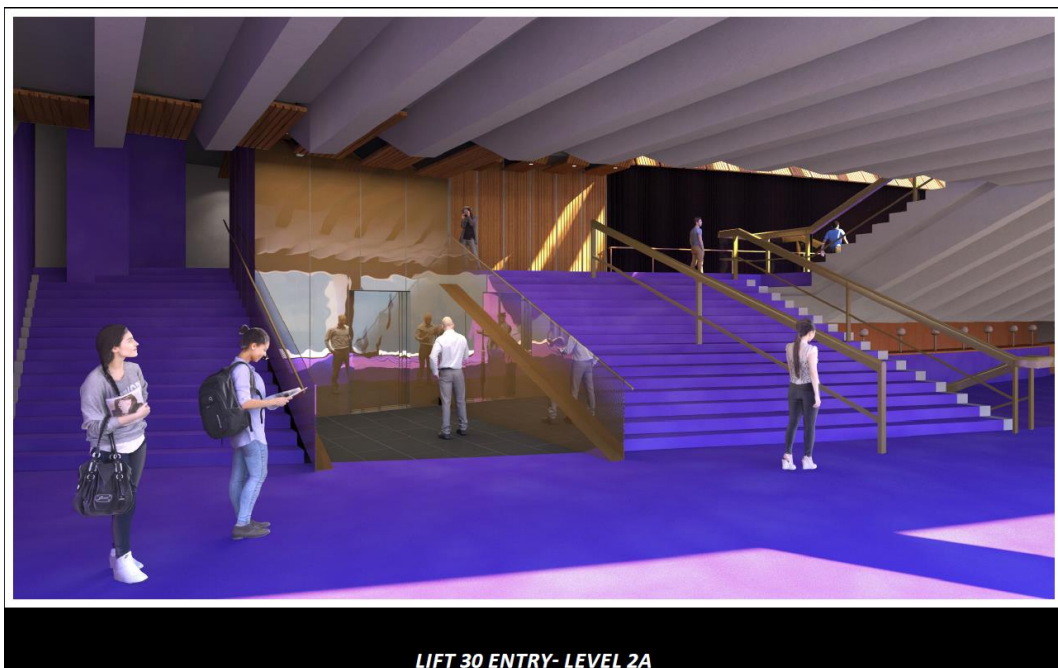
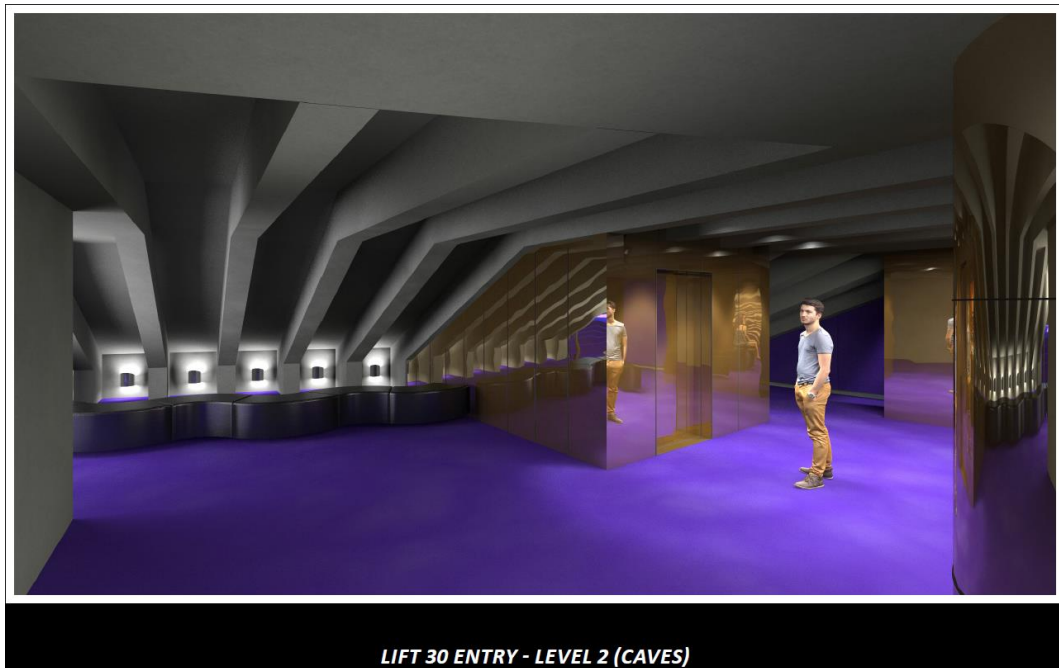
Careful consideration was given to the integration of the lift shaft with the profile of the existing off-form concrete stair beams. The polished cladding was designed to reflect the existing concrete beams and ceiling profile creating an illusion that the cut beams have been maintained. This was done in consideration of the heritage importance the profiled concrete beams, as noted in the SOH Conservation Management Plan.

The following series of renders reflect the design of the lifts at the schematic design stage.

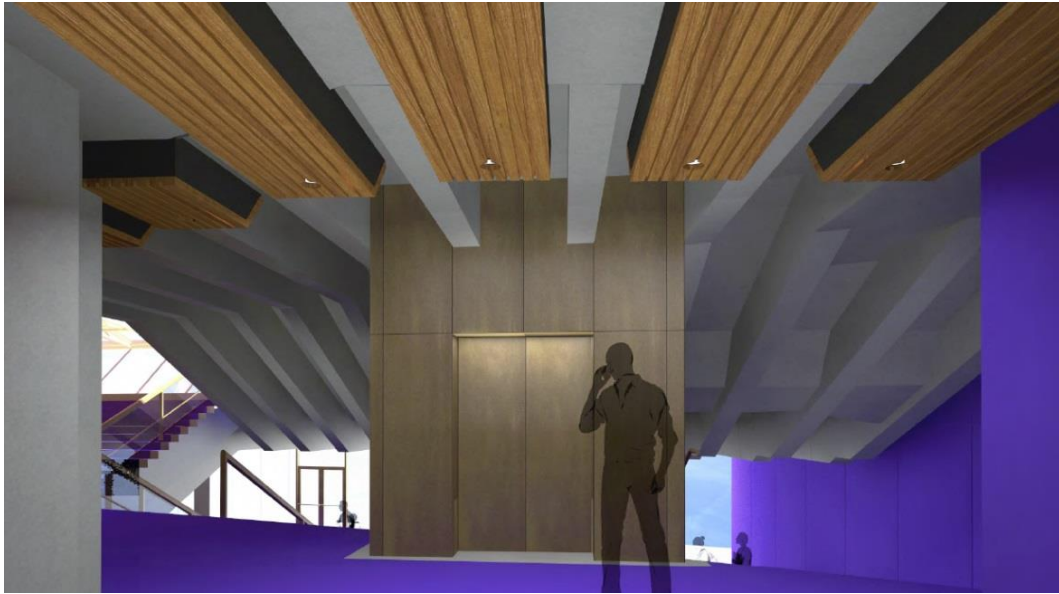
Figure 26: Lift 30 Level 3A

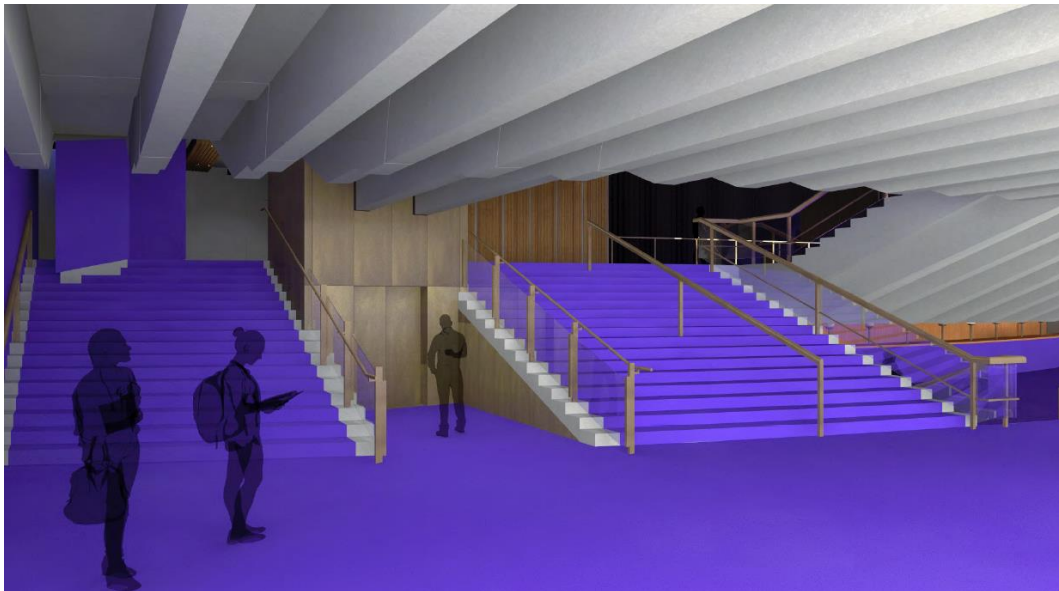
Figure 27: Lift 30 Level 3

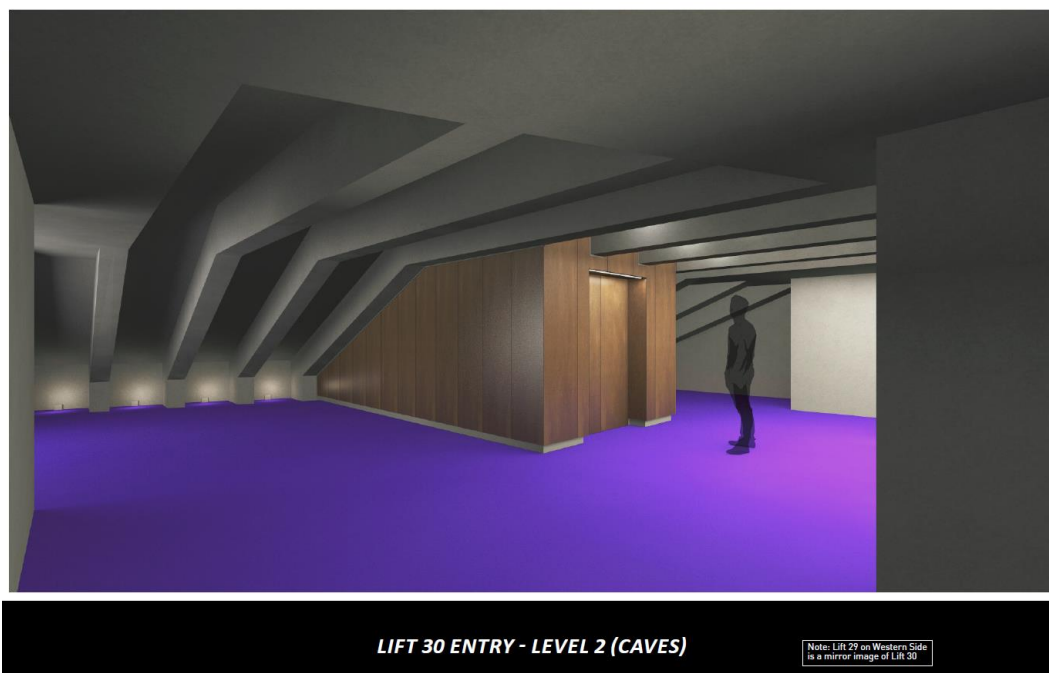
Figure 28: Lift 30 Level 2A

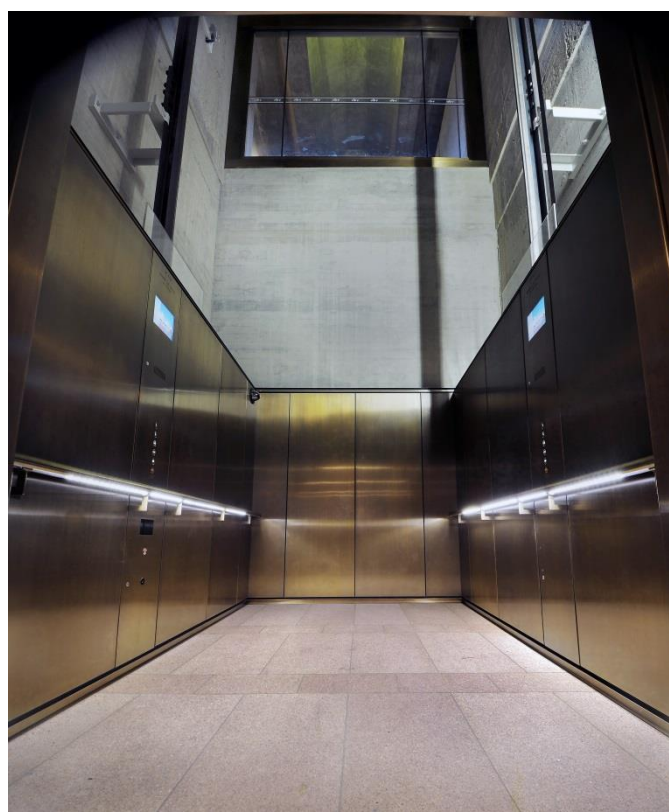
The use of bronze cladding is similar to that used in Lift 17 which was installed as part of the Western Foyers upgrade in 2009. The interior of Lift 17 is shown in the following photograph.

Figure 30: Lift 17 Interior, Western Foyers (existing)

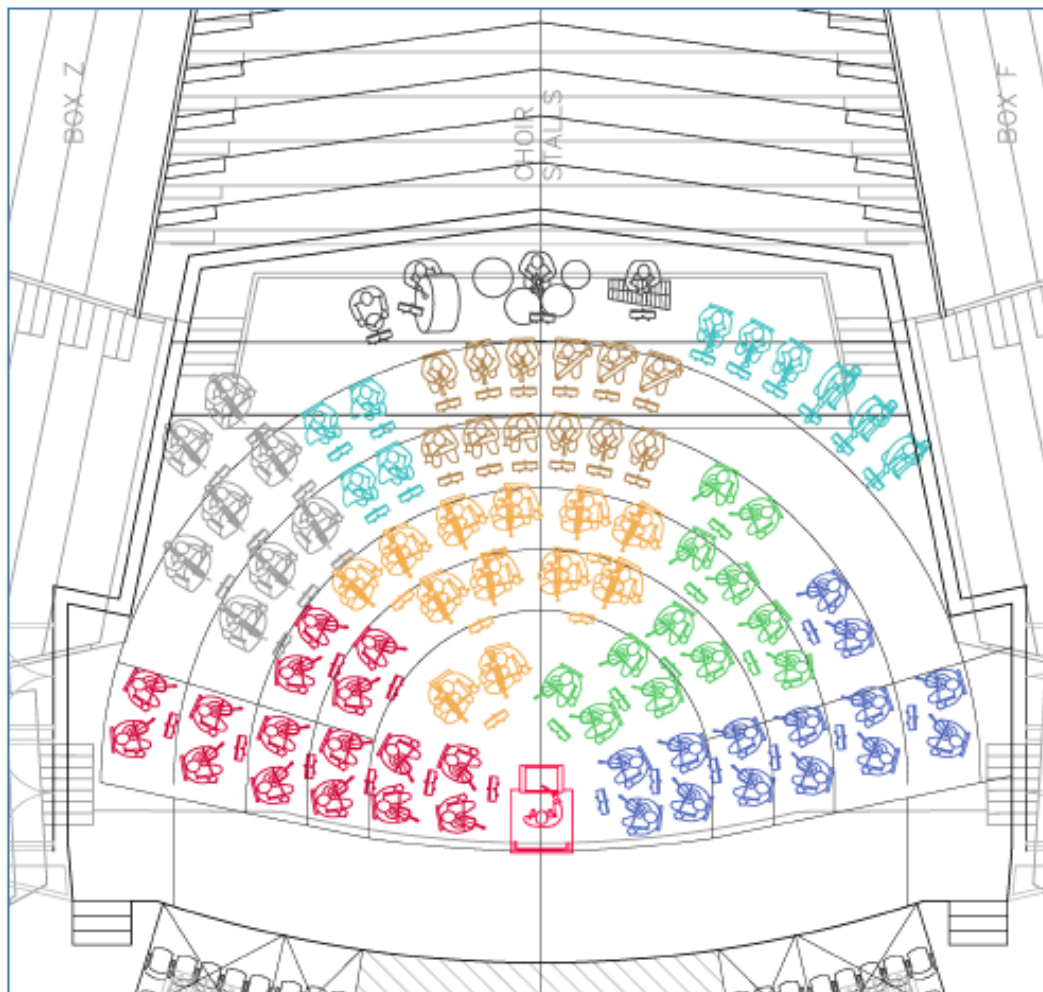
The modifications to the podium as proposed in the concept design are shown in the following Figure 31.

Figure 31: Concept Design Podium Layout

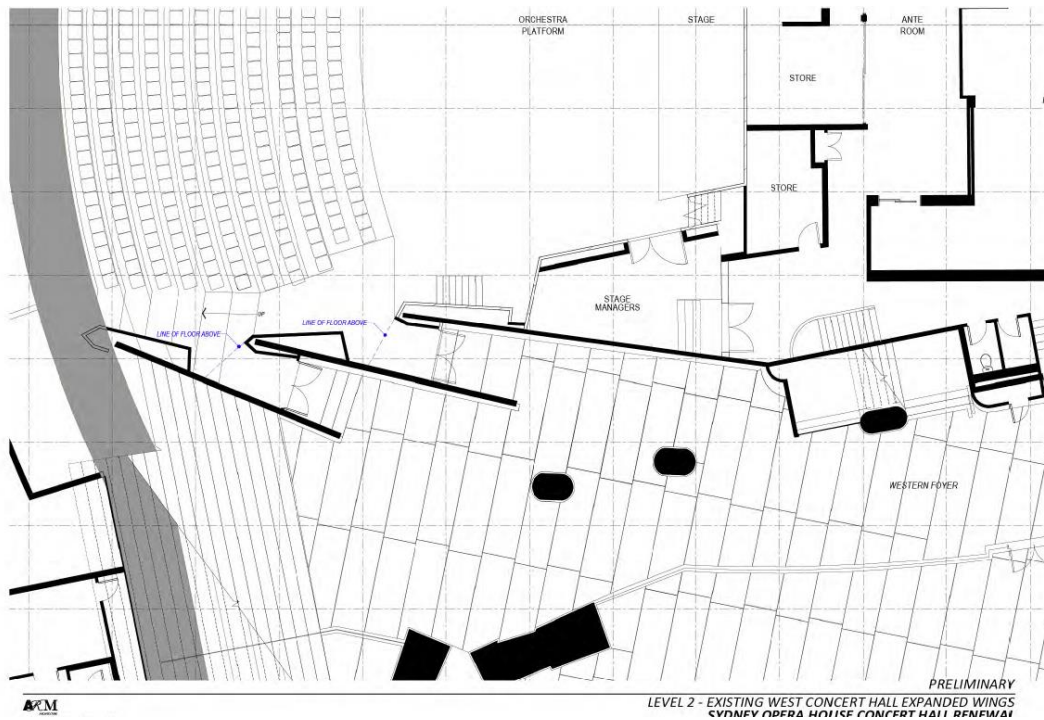
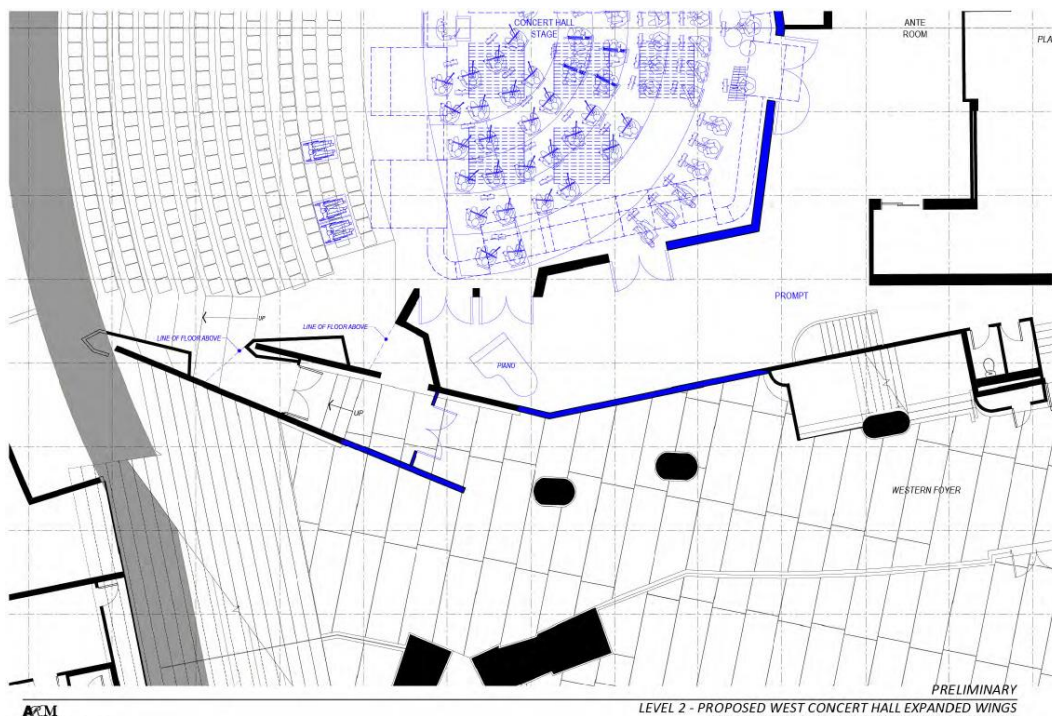
In addition to the changes to the podium, the concept design also proposed changes to the podium surrounds and backstage – raising the anteroom floor to be at the same elevation as the lowered stage, and rearranging the wings to provide better access to the podium.

Figure 32: Existing Stage Wings (Western Side only shown)

Figure 33: Proposed Stage Wings (Western Side only shown)

The above figures show the proposed change to the stage wings to provide better access to the podium. These changes impact the eastern and western foyers of the Concert Hall. The following set of images show how these changes will appear in the foyers.
