Analysis of Design Options: Concert Hall, Creative Learning Centre

1 Options and Design Alternatives

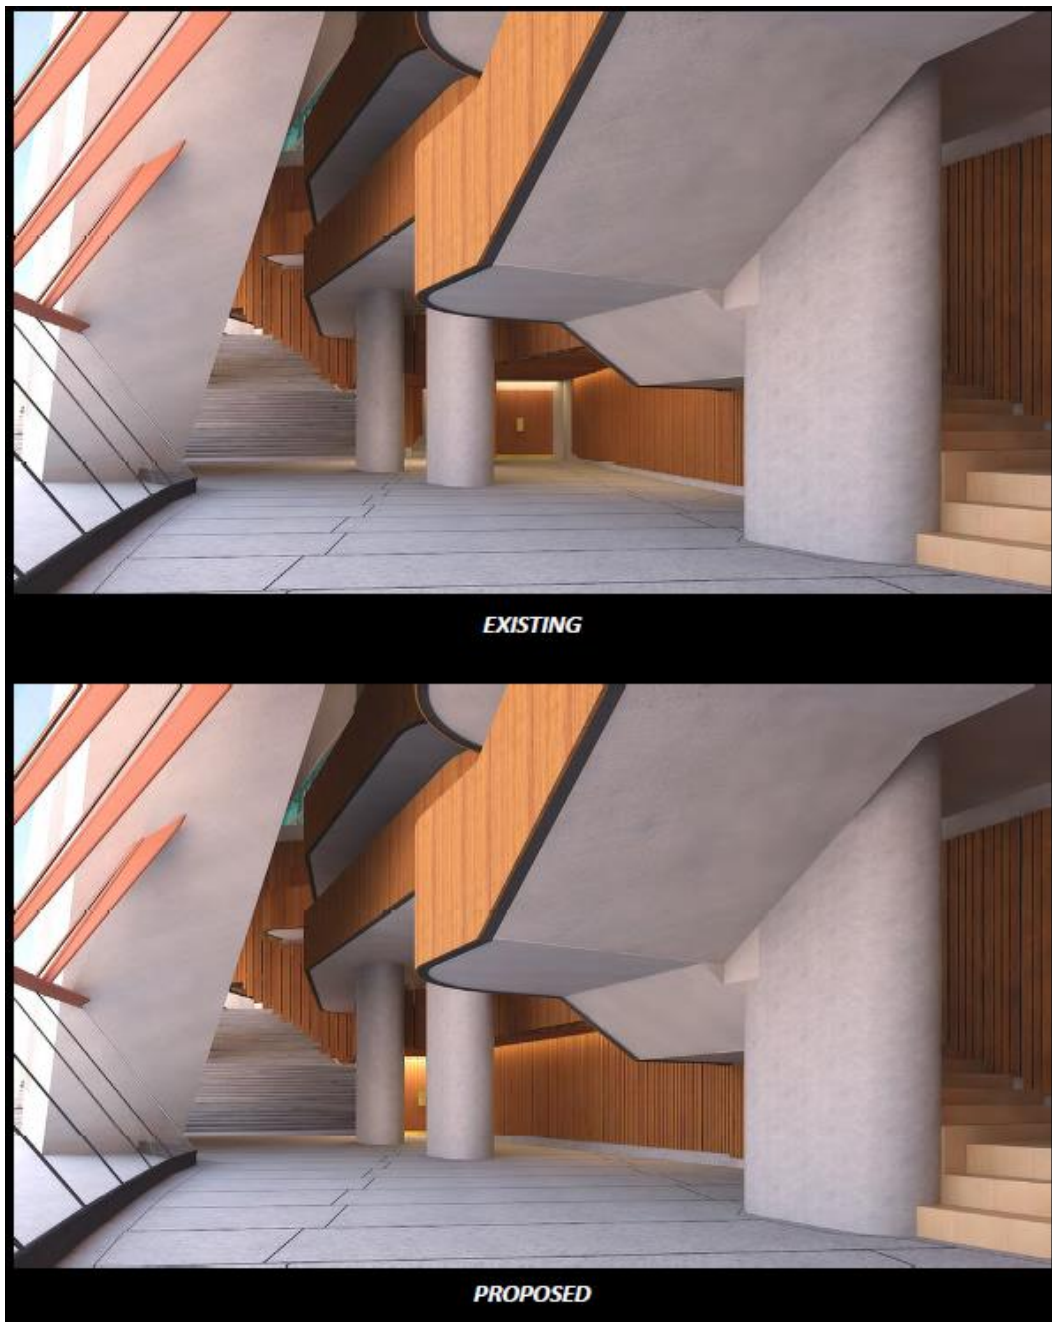
Figure 33: Proposed Stage Wings (Western Side only shown)

The above figures show the proposed change to the stage wings to provide better access to the podium. These changes impact the eastern and western foyers of the Concert Hall. The following set of images show how these changes will appear in the foyers.

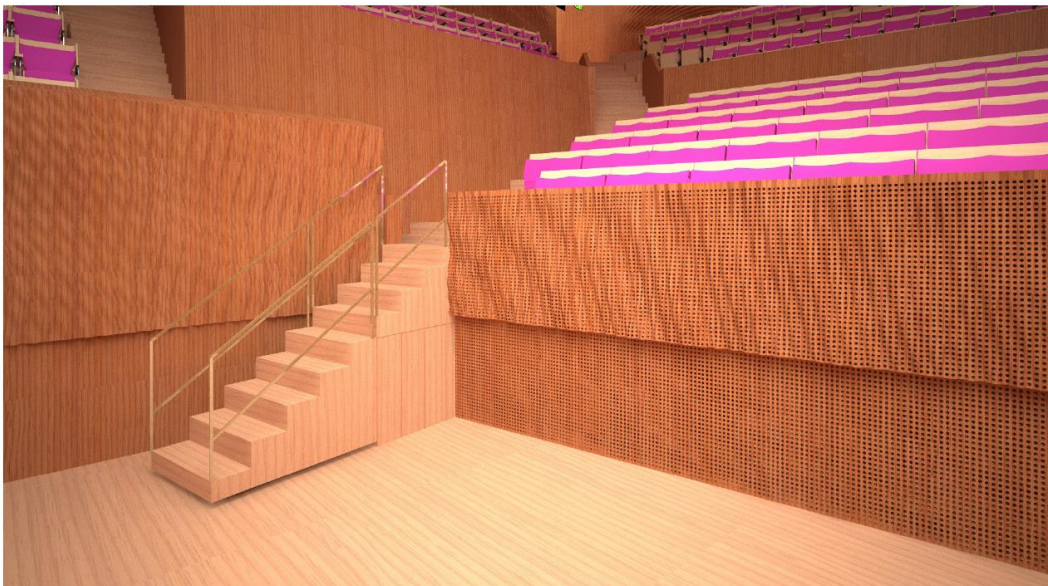
Figure 37: Concert Hall Schematic Design – Stage Surrounds showing Acoustically Diffusive Finish and Perforations in Rear Wall

The schematic design included the provision of retractable and removal stairs to access the choir stalls from the stage. This design provided for the stairs to be deployed with the stage risers in either the up or down positions. The schematic design also included acoustically diffusive surfaces on the walls surrounding the stage, including perforations on the rear stage wall below the choir. The diffusive surface is an essential component in the acoustic solution and has been interpreted by the architects as the pattern of the soundwave created by a musical note. These features are shown in Figure 37 and Figure 38 with further detail provided in Section 1.4.2.6 below

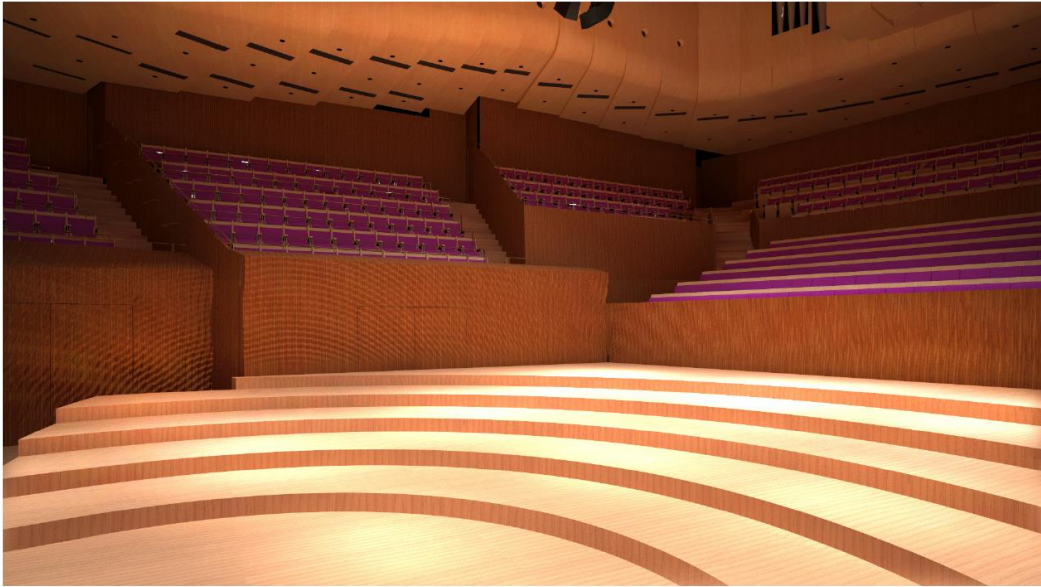
The design development phase has removed the perforations from the rear wall of the stage surround. This is shown in Figure 39.

Figure 39: Concert Hall Design Development – Stage Surrounds with Stage Risers in Place

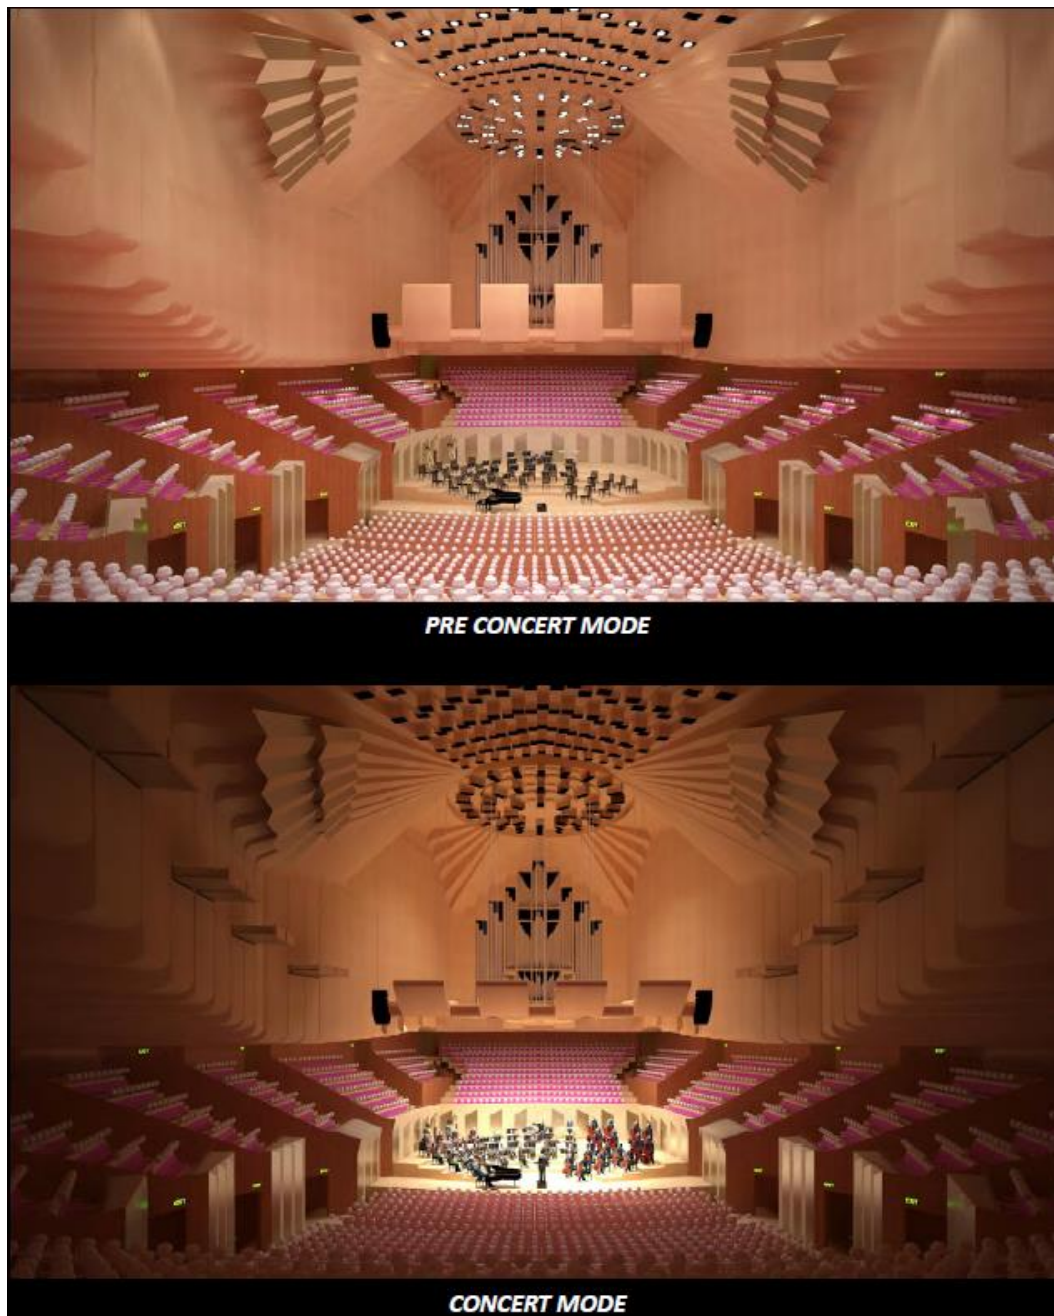
The above configuration is shown in Figure 40.

Figure 40: Concert Hall Concept Design – Acoustic Reflectors shown in Pre-Concert and Concert Modes

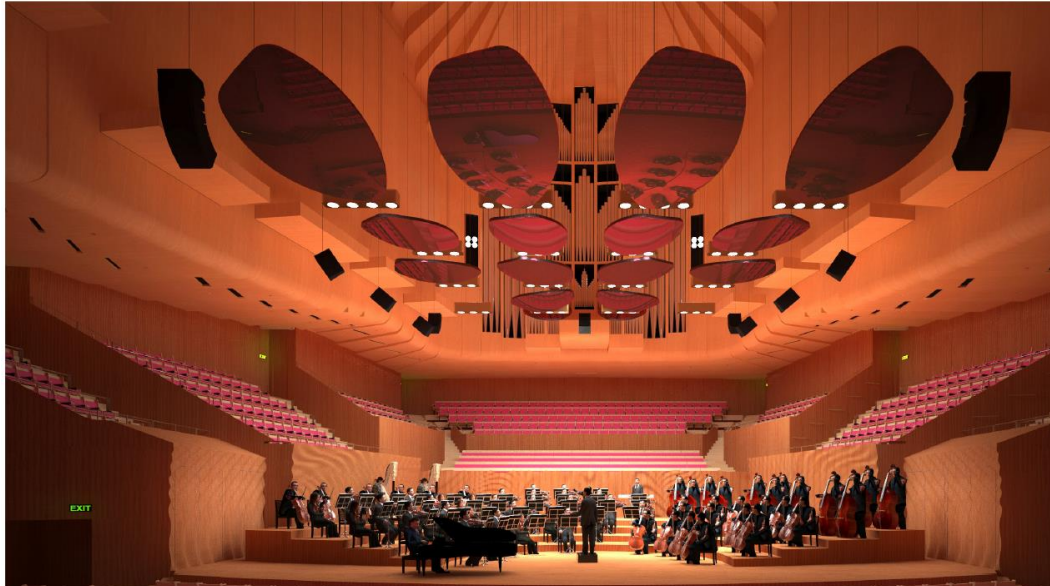
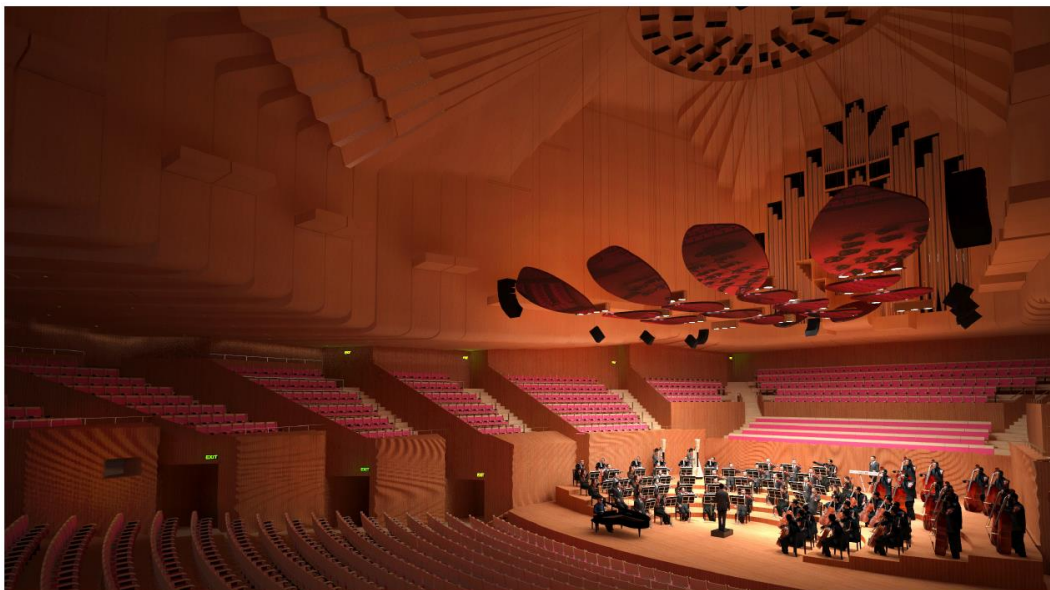
The proposed reflector configuration is shown in the renders in Figure 41 and Figure 42.

Figure 41: Concert Hall Schematic Design – Acoustic Reflector Array (view from stalls)

Figure 42: Concert Hall Schematic Design – Acoustic Reflector Array (view from Box A)

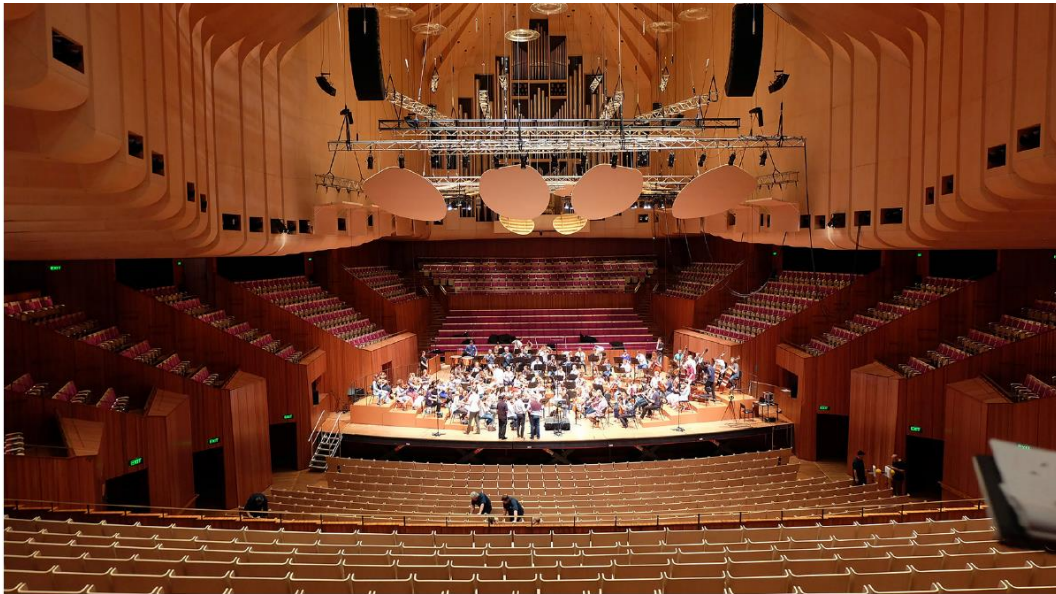
wall drawer reflectors also being curved. A photo of the prototype testing on 9 November 2016 is shown in Figure 43.

Figure 43: Concert Hall Reflector Prototype Testing - 9 November 2016

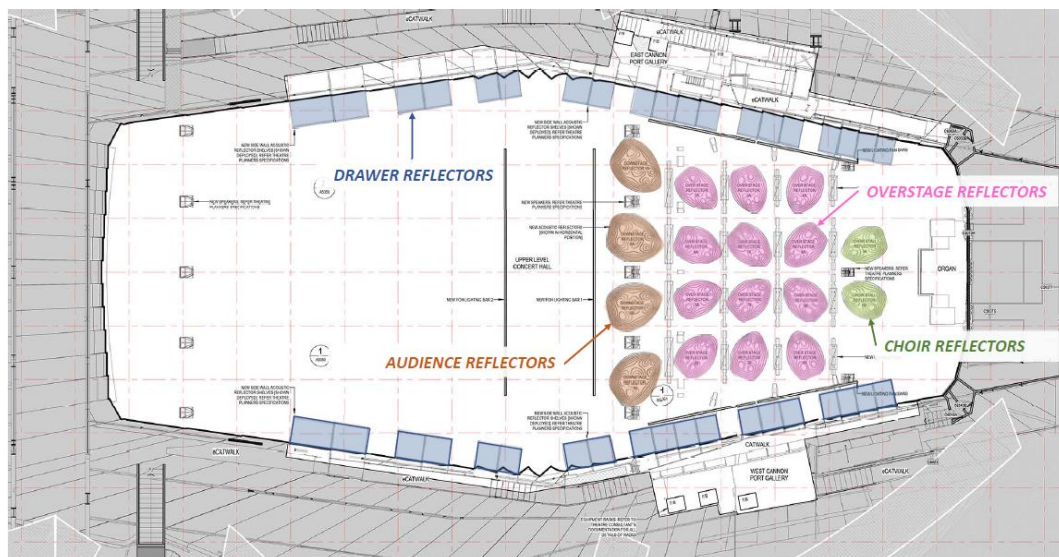
The plan view of the proposed overstage, audience, choir and retractable “drawer” reflectors is shown in Figure 44. Architectural renders of the Concert Hall in acoustic performance mode are shown in Figure 45 and Figure 46.

Figure 44: Concert Hall Design Development - Plan of Reflectors

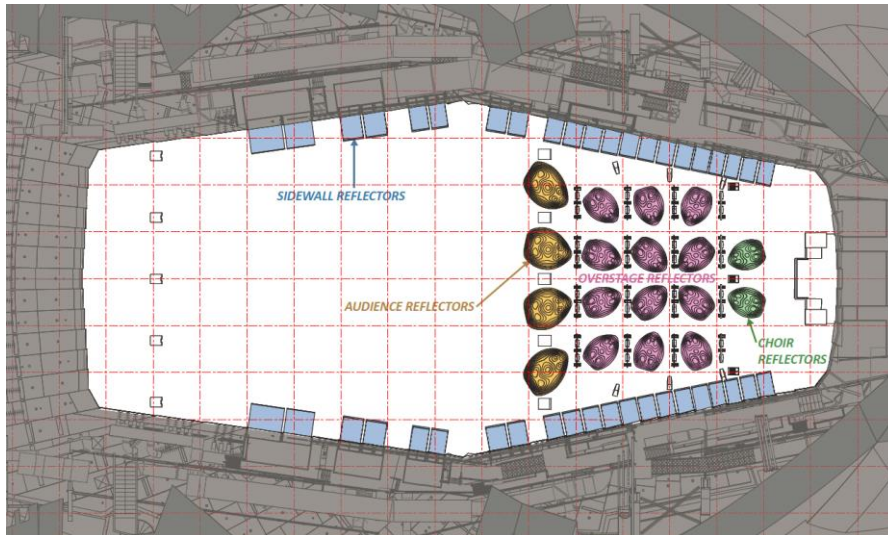
Theatreplan were engaged to replace Schuler Shook as Theatre Design Consultants. Theatreplan revised the design of the side wall reflectors, located over the audience area, to be a hinged design that folds back into the side walls of the Concert Hall.

This final arrangement of overstage and side wall reflectors is shown in Figure 47. The array of overstage reflectors has not been changed, however the configuration of sidewall reflectors has been modified to improve sound reinforcement to the platform for the orchestra.

Figure 47: Diagrammatic Plan of New Acoustic Elements

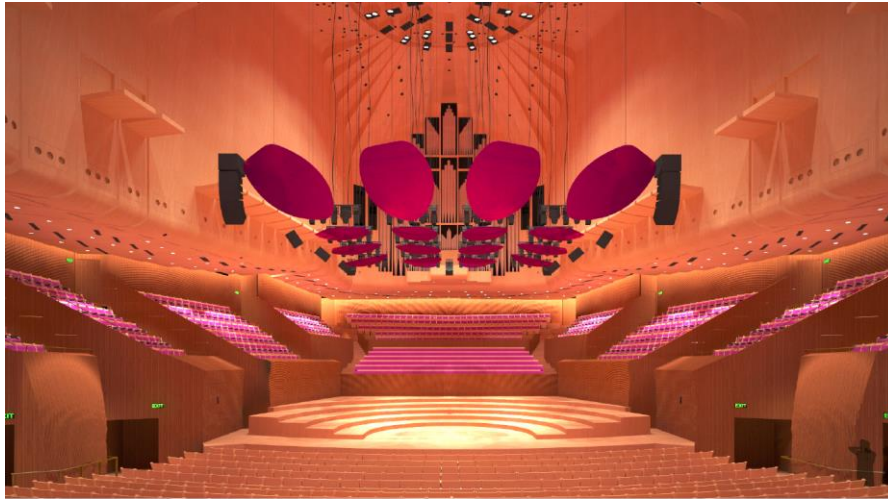
Figure 49 : View from Upper Circle – New Acoustic Elements – Performance Lighting

The configuration of the sidewall reflectors and overstage reflectors are shown in the following renders – Figure 48 to Figure 53.

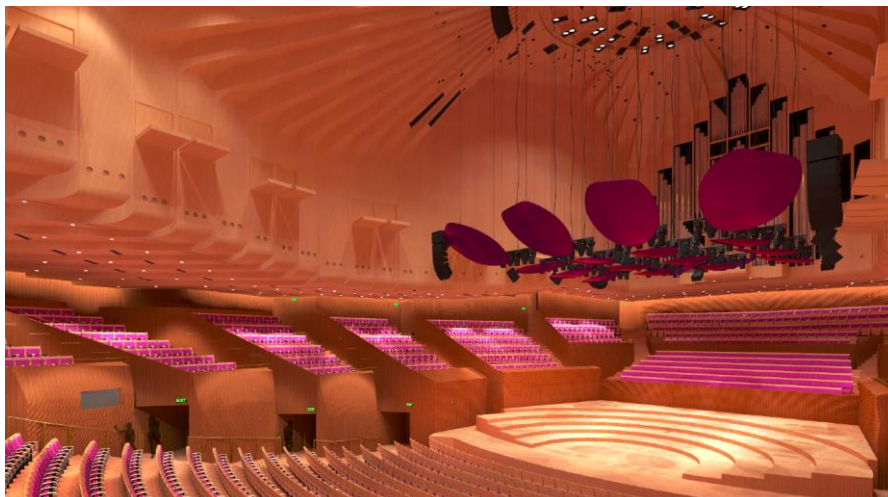
Figure 51: View from Rear of Stalls - New Acoustic Elements – Performance Lighting

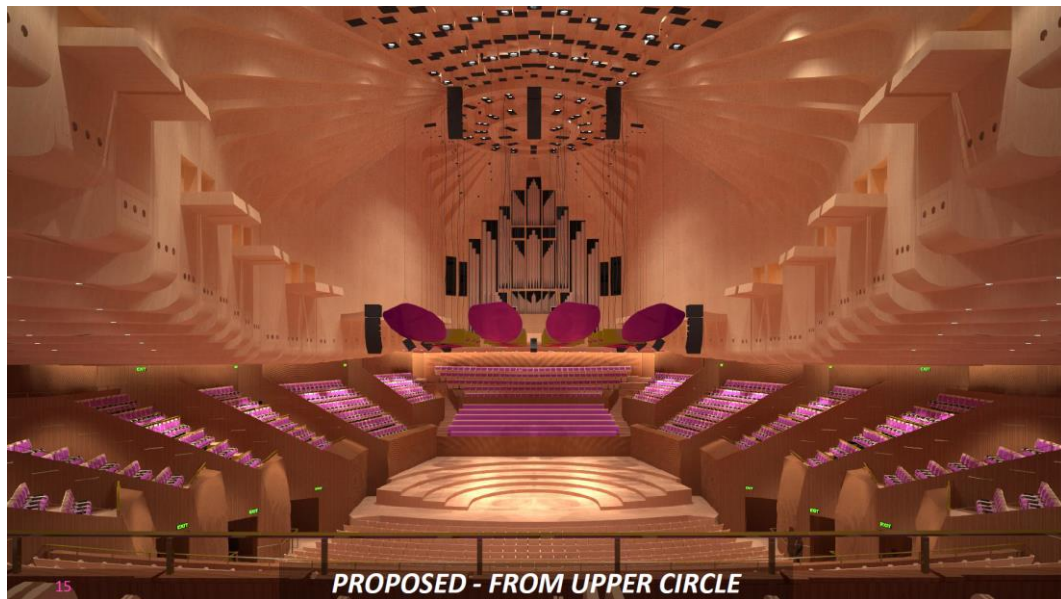
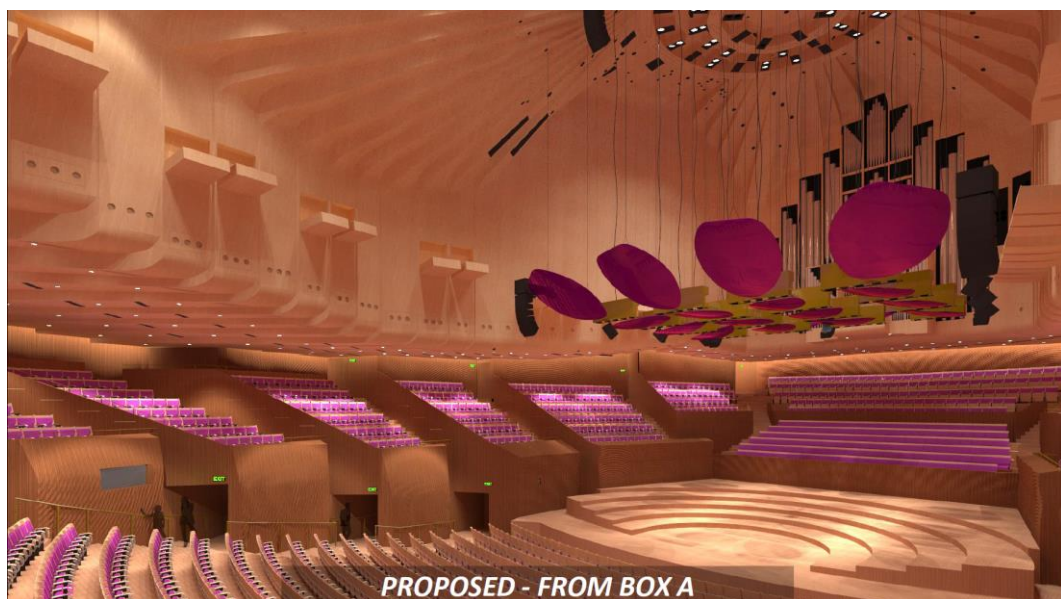
At this stage, Theatreplan were engaged to replace Schuler-Shook as theatre design consultants. Theatreplan reviewed the Schuler-Shook design and proposed a design that did not require the FOH lighting bars. This design included both front lighting and down lighting within the overstage pods, along with 2 movable lights in each pod that can be used

for amplified music and other theatrical style performances. This design is shown in Figure 54 and Figure 55.

Figure 54: ARM/Theatreplan design for lighting pods

Figure 55: ARM/Theatreplan design for lighting pods

The EAP's advice was that the Panel supported the removal of the FOH lighting bars, but they were concerned that the larger clad pods created a visual ceiling and therefore the pods were too intrusive. The EAP recommended that lighting bars to the same length as the pods should be considered and that these would maintain clear vision between the acoustic reflectors and that although the light fittings would be more visible, there would be lines of sight between the fittings.

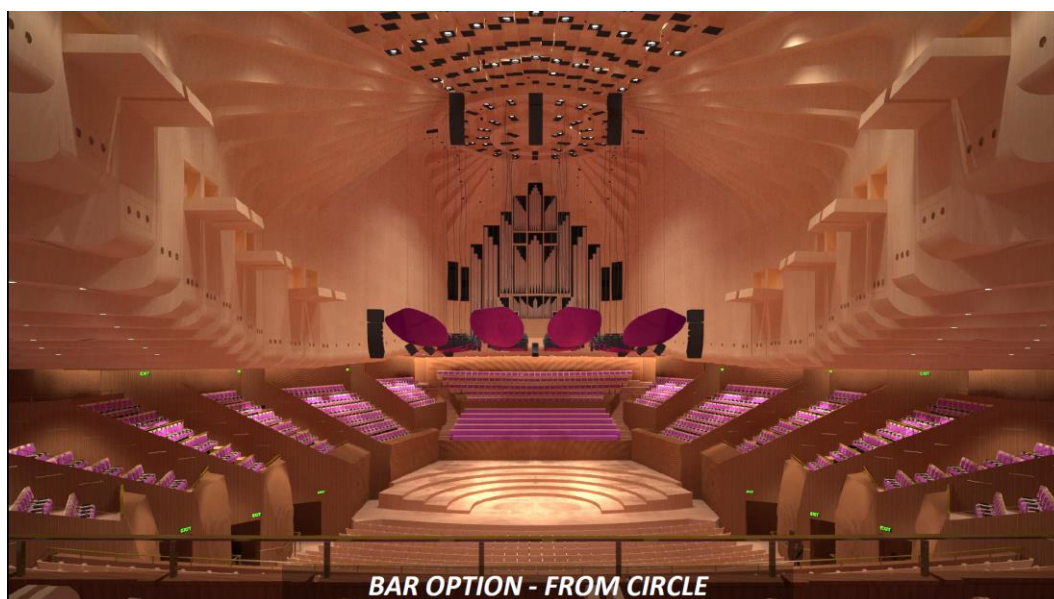
This design was further developed and is shown in Figure 56 and Figure 57.

Figure 56: ARM/Theatreplan design for lighting bars

Figure 57: ARM/Theatreplan design for lighting bars

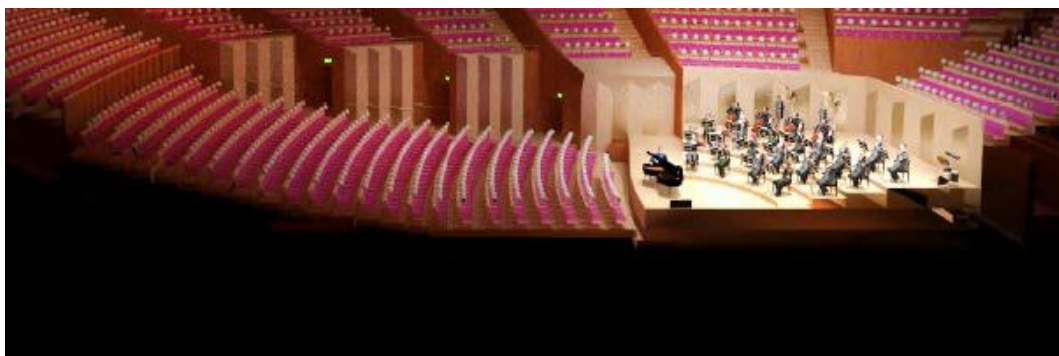
Figure 58: Concert Hall – Required Treatments to Box Fronts and Stage Surrounds

The proposed treatments to the box fronts and stage surround as developed during the concept design phase are shown in Figure 58, Figure 59 and Figure 60.

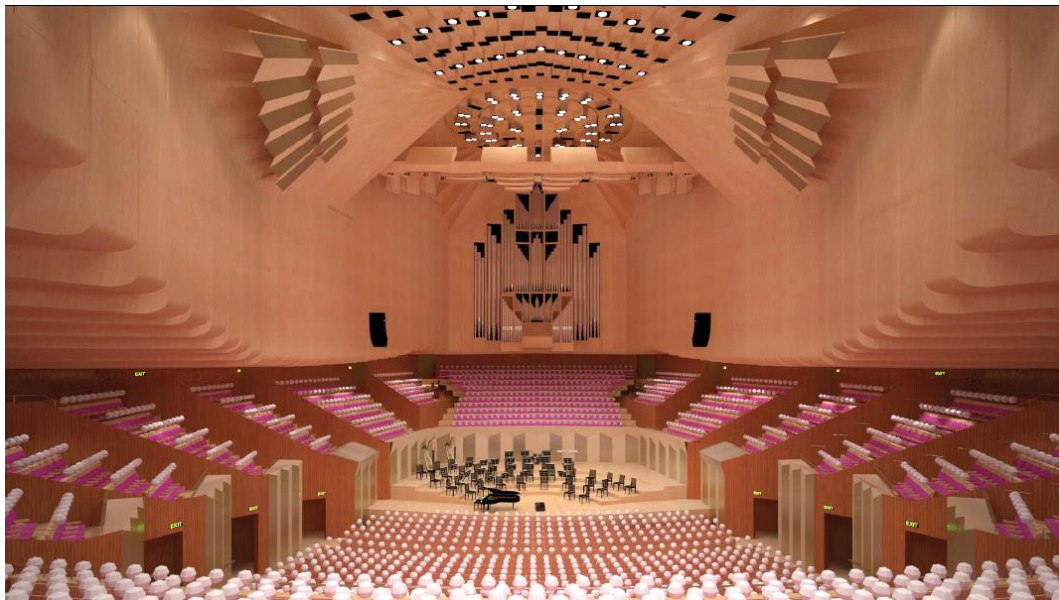
Figure 59: Concert Hall Concept Design– Proposed Treatments to Box Fronts and Stage Surrounds

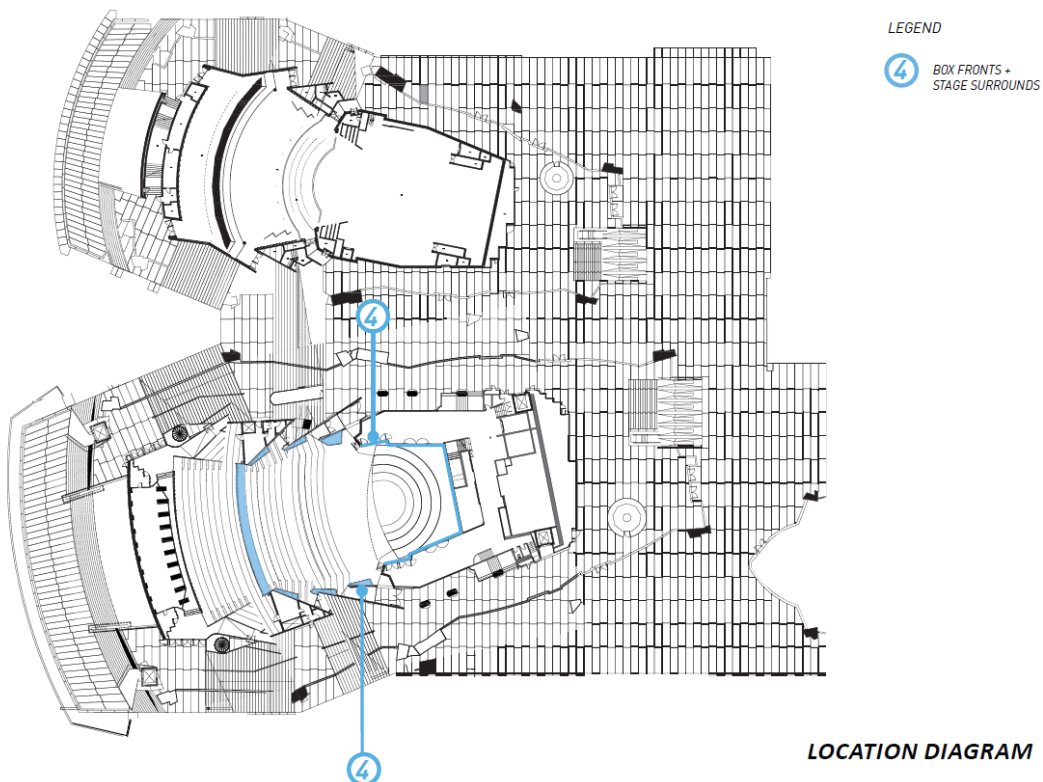
The walls to be treated in this manner are shown in the plan view in Figure 61.

Figure 61: Concert Hall Schematic Design – Plan showing Diffusive Surface Treatments

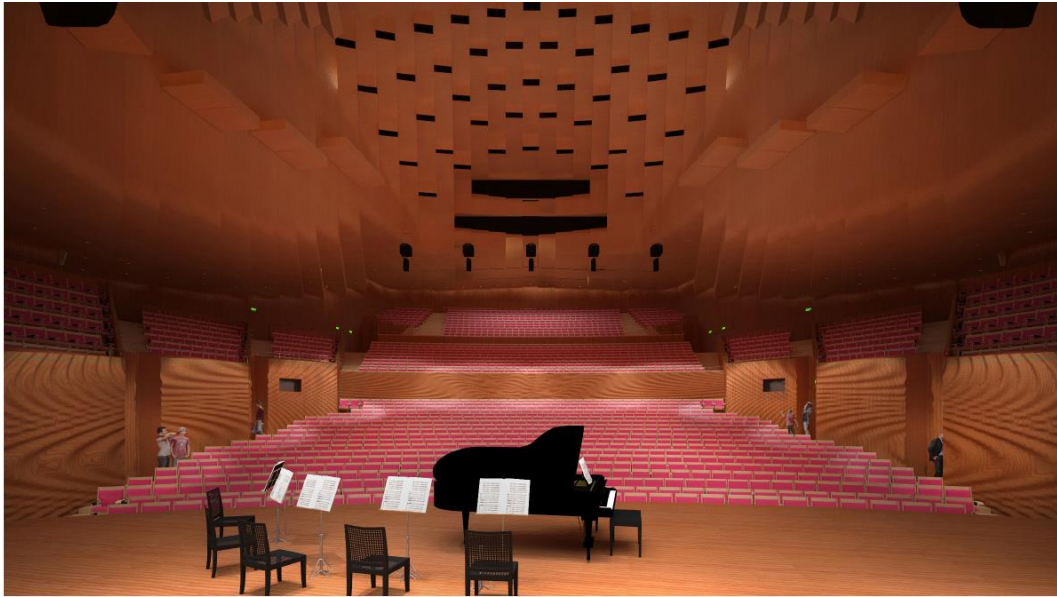
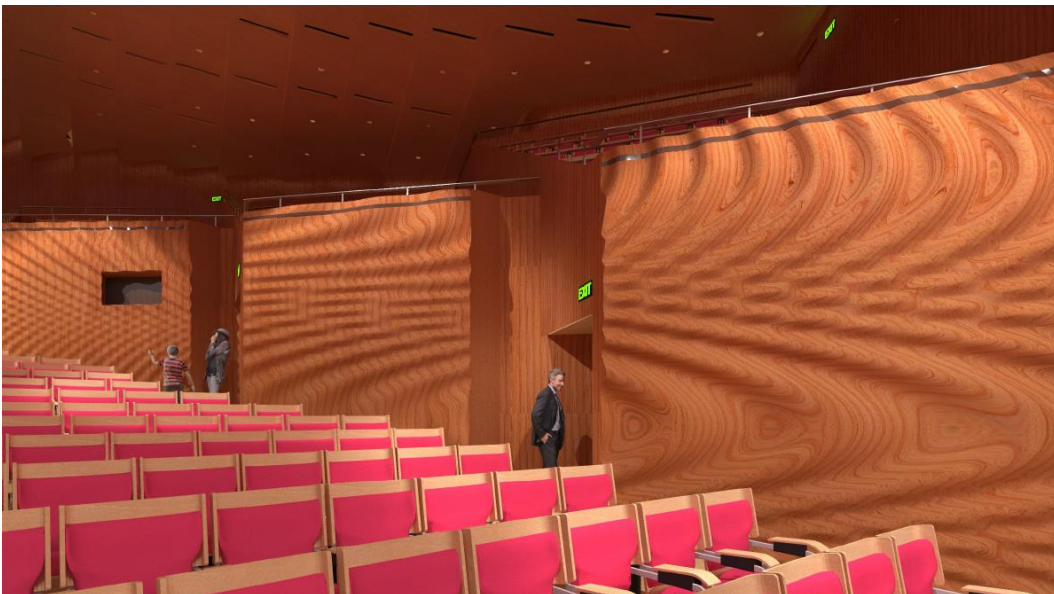
Renders of the schematic design diffusive surfaces are shown in Figure 62 and Figure 63.

Figure 62: Concert Hall Schematic Design – Proposed Box Fronts and Rear Wall of Stalls (from stage)

Figure 63: Concert Hall Schematic Design – Proposed Box Fronts (from Row E)

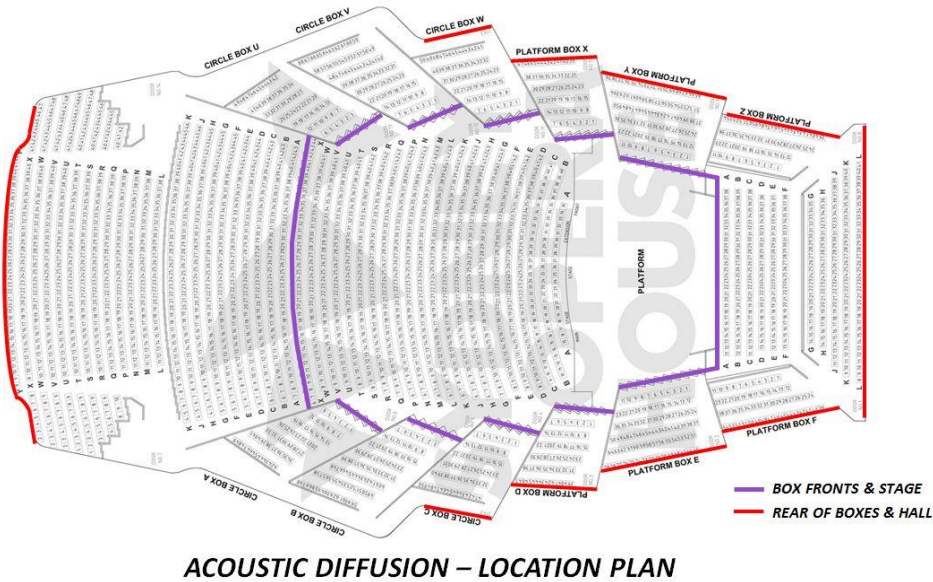
- The extent of the diffusive surfaces is indicated in Figure 64: Concert Hall Design Development – Final location of Diffusive Surfaces below. Both elements are supported by the EAP.
- The box fronts around the stalls have been tilted backwards slightly, and this allows for the large ceiling acoustic reflectors to be omitted.

Figure 64: Concert Hall Design Development – Final location of Diffusive Surfaces

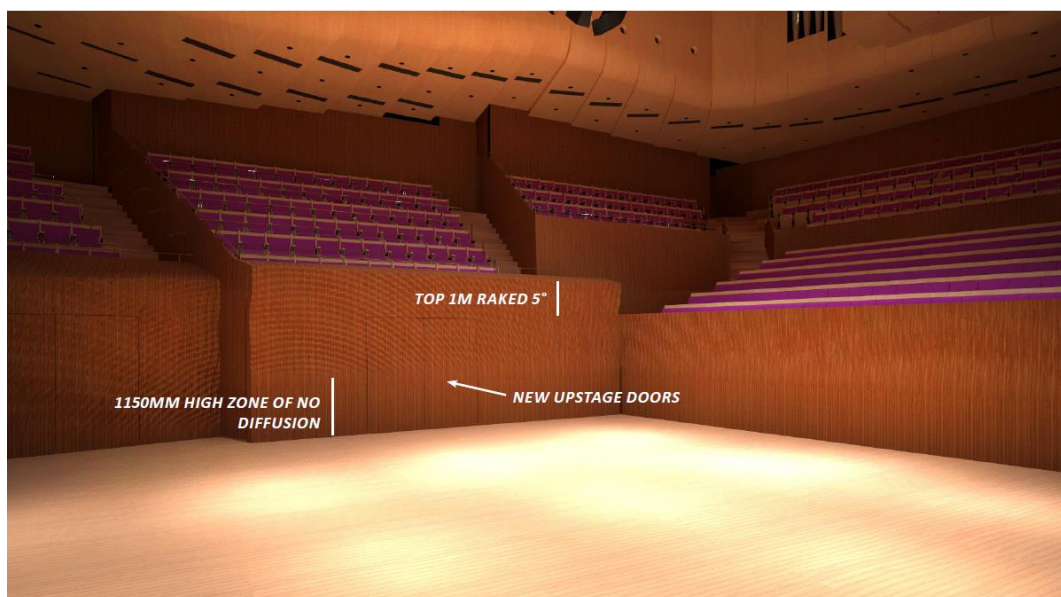
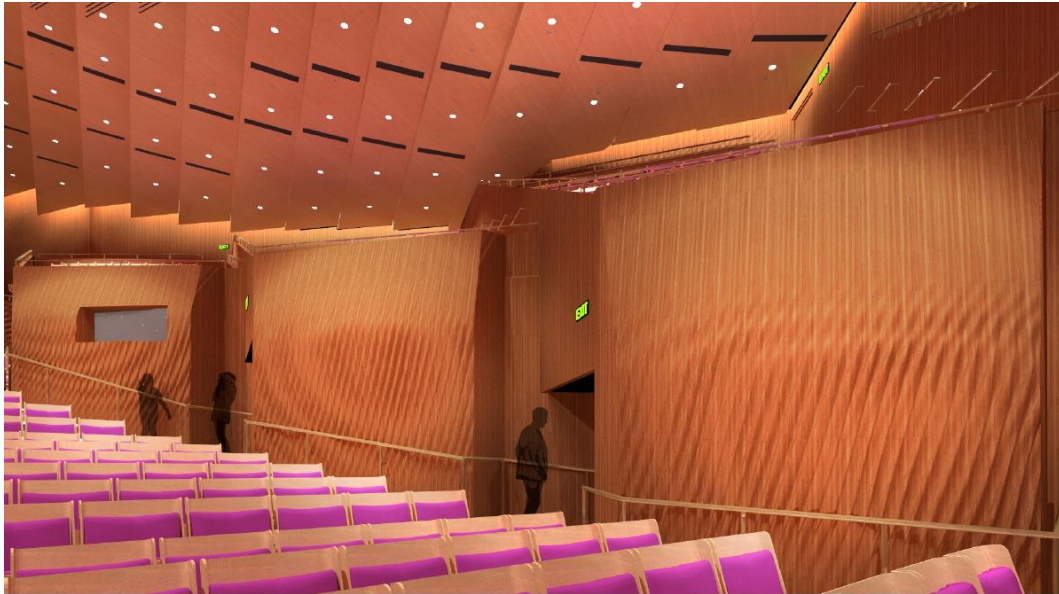
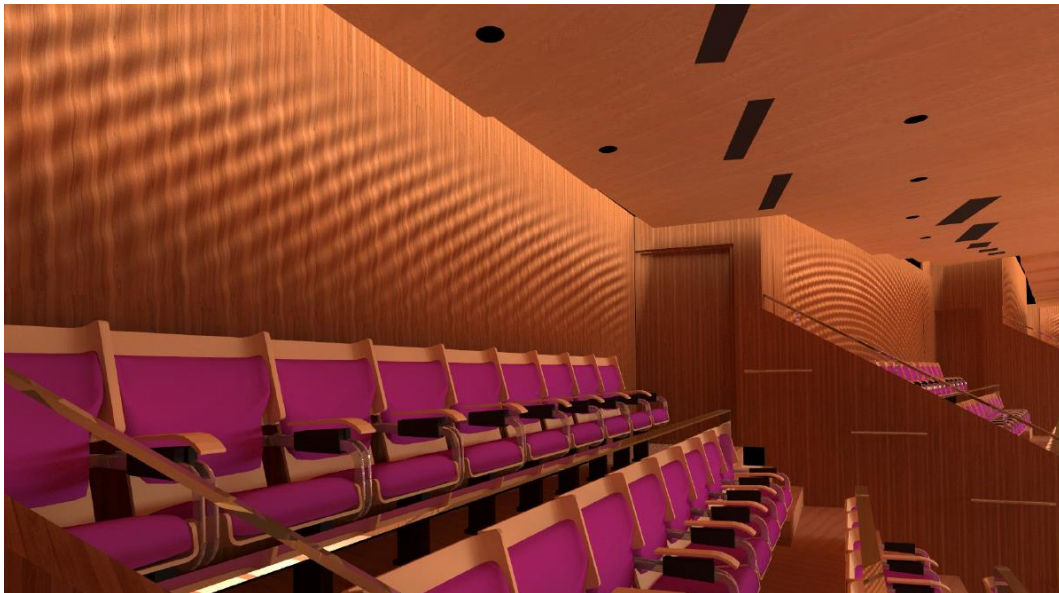
Architectural renders of the proposed diffusive surfaces are shown in Figure 65, Figure 66 and Figure 67.

Figure 65: Concert Hall Design Development – Stage Surrounds (stage risers down)

Figure 66: Concert Hall Design Development – Box Fronts Diffusive Surfaces (from Row E)

Figure 67: Concert Hall Design Development – Box Rear Wall Diffusive Surface

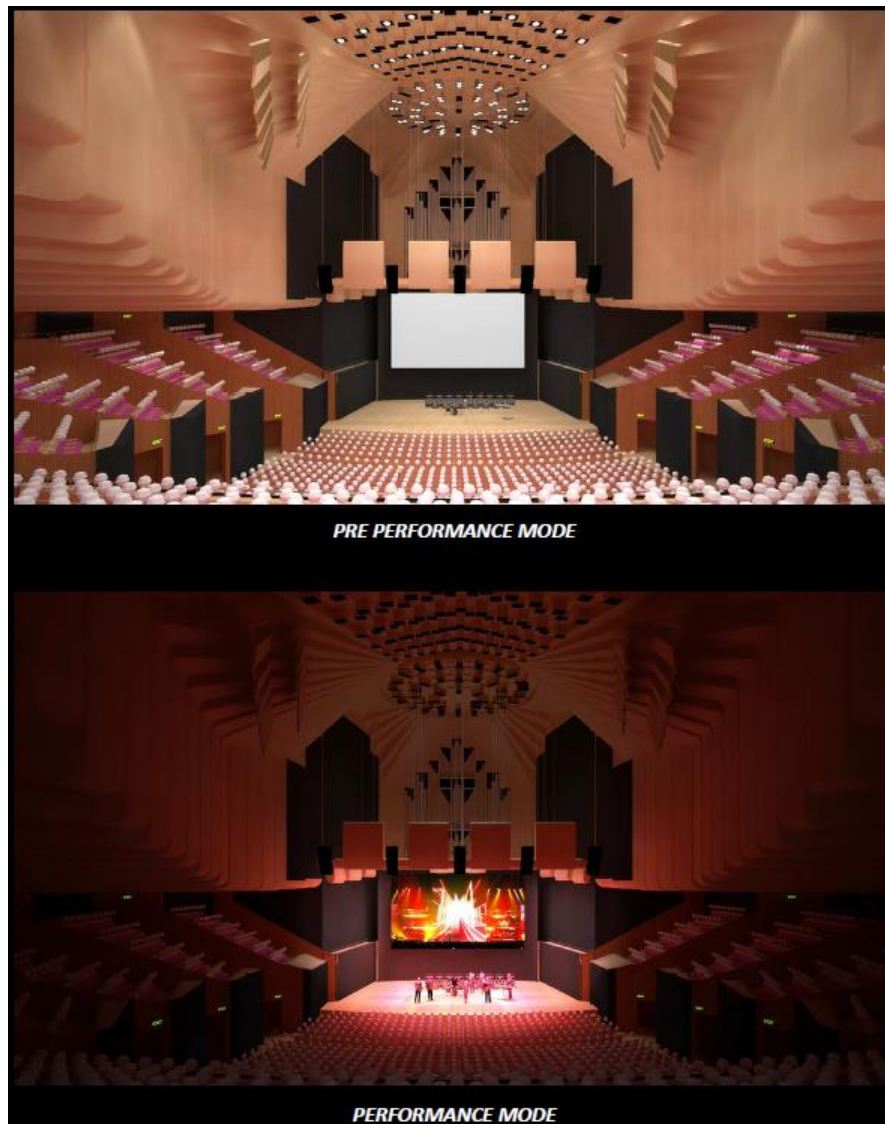
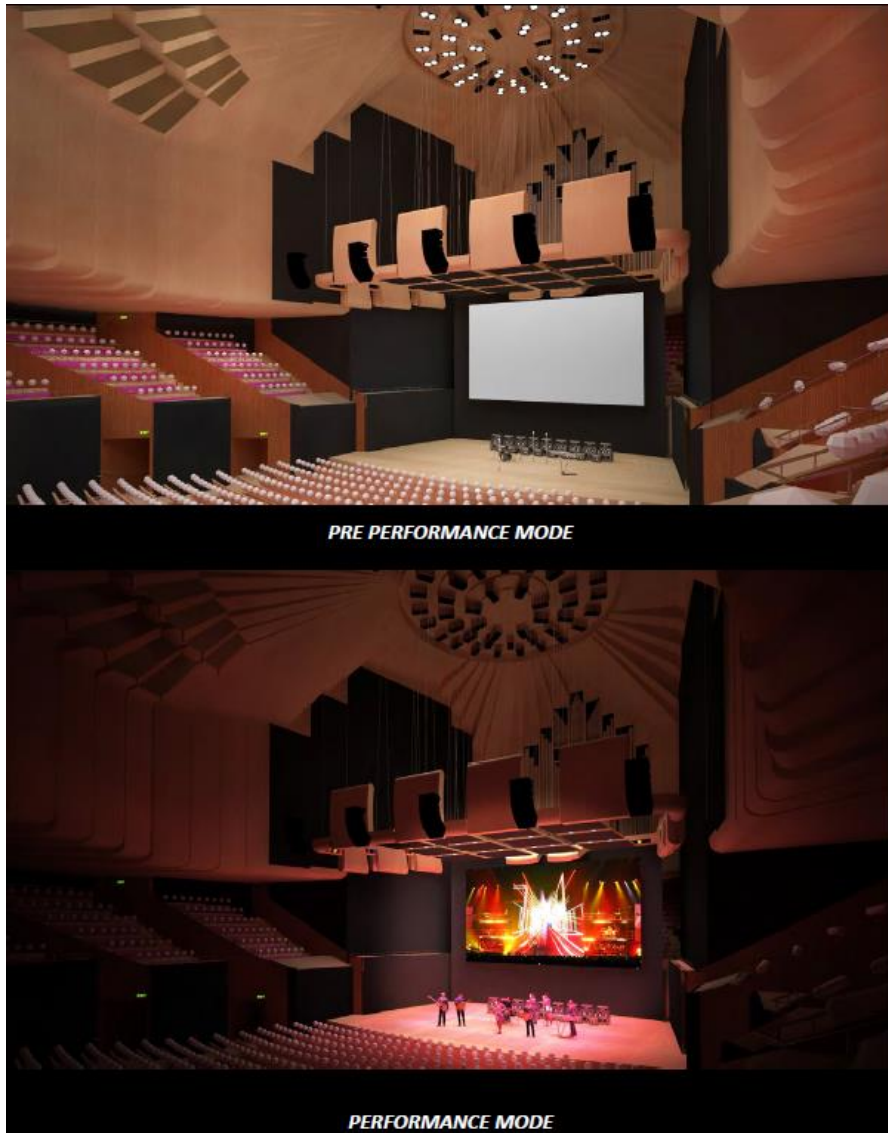
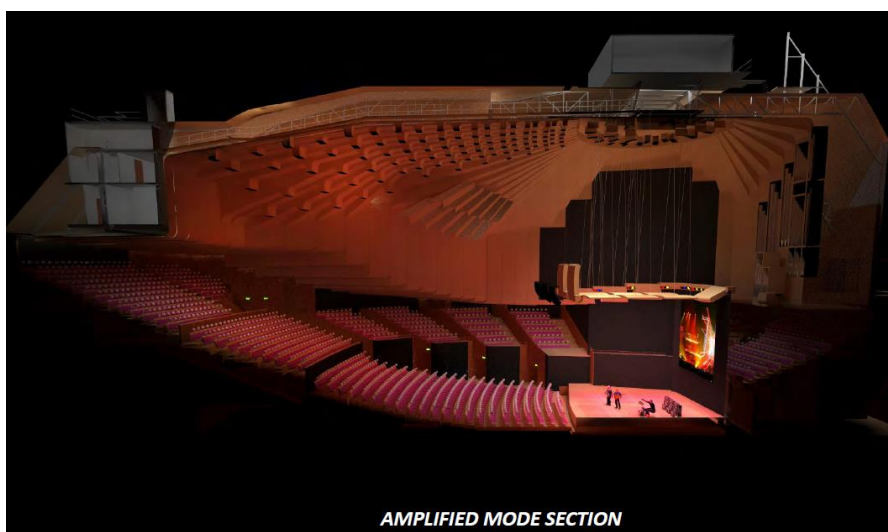
The banners in the concept design phase were to be black throughout. These proposed banners and drapes are shown in Figure 72, Figure 73 and Figure 74.

Figure 72: Concert Hall Concept Design – Acoustic Banners and Drapes (from circle)

Figure 73: Concert Hall Concept Design – Acoustic Banners and Drapes (from Box A)

Figure 74: Concert Hall Concept Design – Section showing Amplified Mode

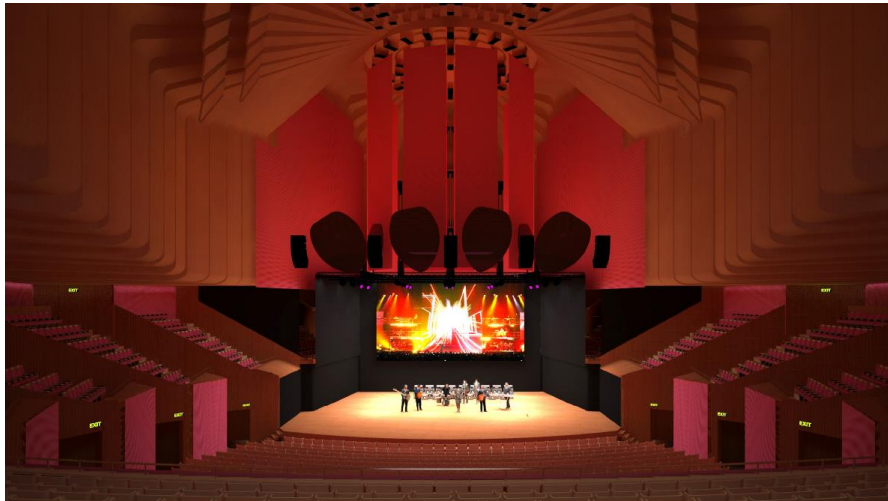
Figure 75: Concert Hall Schematic Design – Amplified Mode (from circle)

With the change of configuration for the overhead acoustic reflectors that was developed in the Schematic Design phase, a concurrent change to the automated banners and drapes was necessary. The folding, rectilinear overhead reflectors became petal shaped and their internal reflective elements were removed and a more intense pattern of drapes from the ceiling crown above the stage were proposed.

An options analysis around colours was developed and reviewed with the EAP. Black, magenta (picking up the magenta colour of the seating in the Concert Hall) and white birch were all considered. The culmination was that the EAP supported the magenta tone (or similar) for upper drapes and the drapes adjacent to the performance space on the stage remained black.

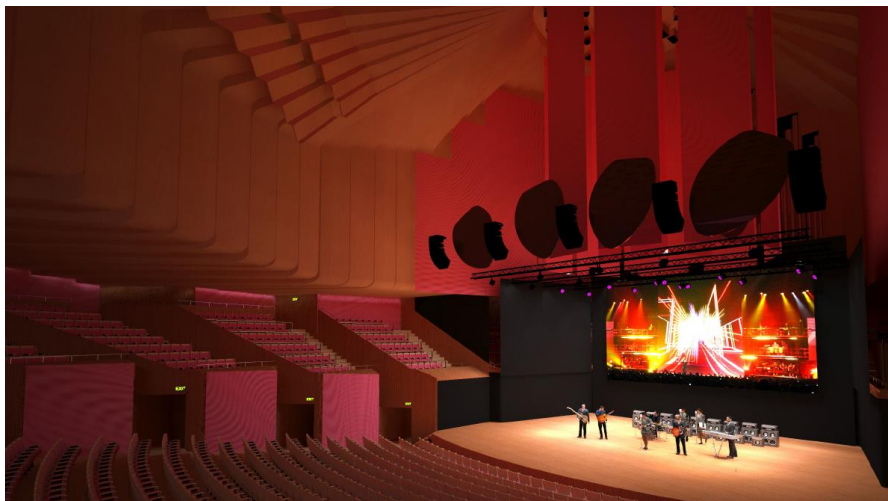
Figure 76: Concert Hall Schematic Design – Amplified Mode (from Box A)

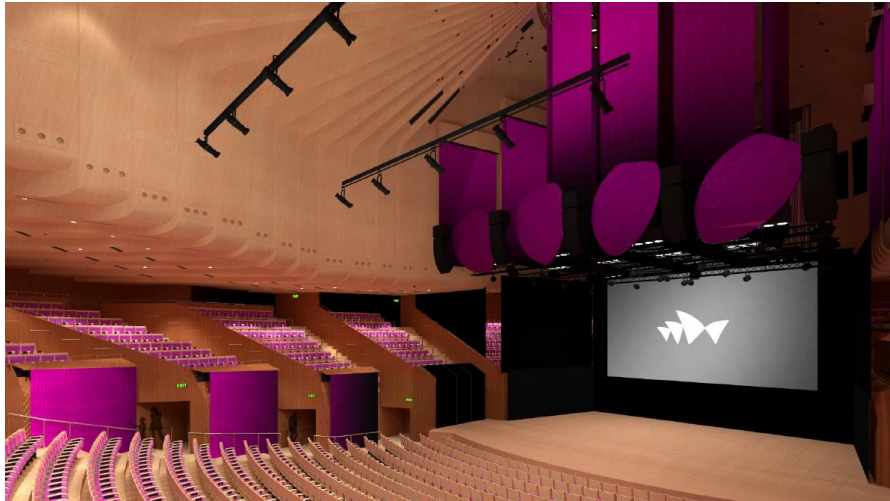
Figure 79: Concert Hall Detailed Design – Amplified Mode (house lighting, from Box A)

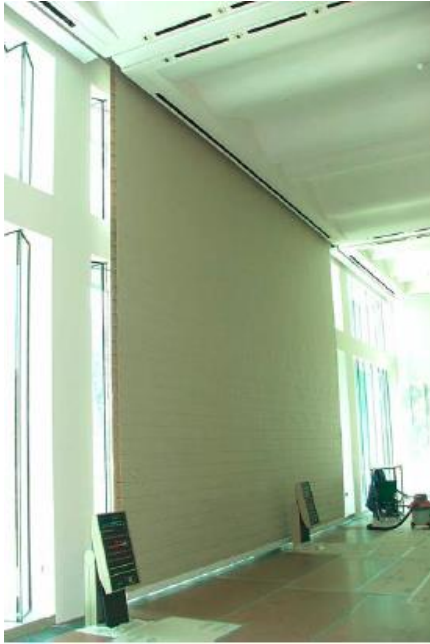
Figure 82: Varibanner in Deployed Position

The design review concluded that the “Varibanner”™ would provide a more dependable solution than roller style banners. The Varibanner is described by the manufacturer, Triple E, as a Venetian Variable Acoustic Banner. A Varibanner is shown in Figure 82 and Figure 83.

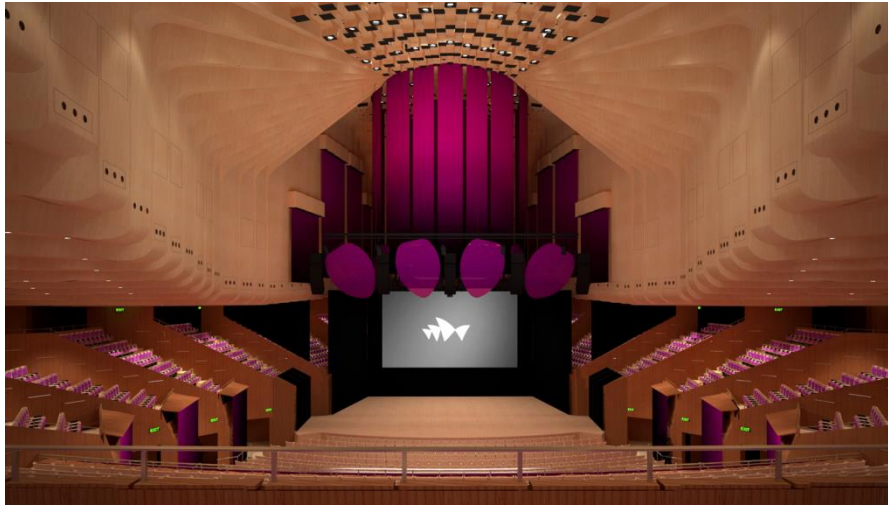
Figure 88: Crown Banners Deployed – House Lighting

number of banners in the outer ring is required to avoid the steel structure in the ceiling above the crown. This option is depicted in Figure 85 to Figure 88.

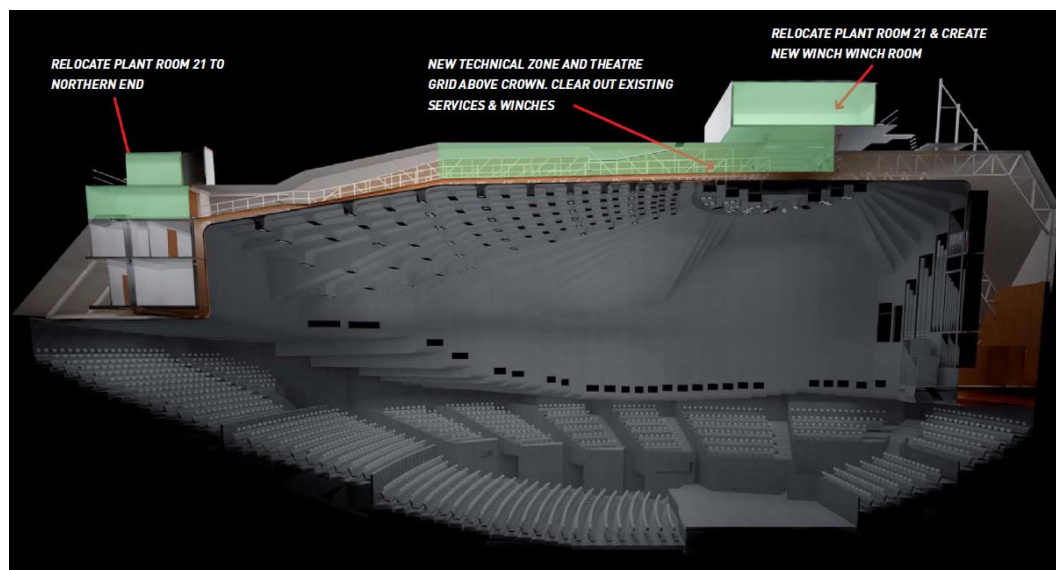
Figure 89 depicts a cross section of the Concert Hall showing the proposed changes to the Technical Zone. At this stage it was proposed that the mechanical equipment housed in Plant Room 21 would be moved to the northern end of the hall closer to the areas it services.

Figure 89: Concert Hall Concept Design – Section Showing Changes Proposed to Technical Zone
