Analysis of Design Options: Concert Hall, Creative Learning Centre

1 Options and Design Alternatives

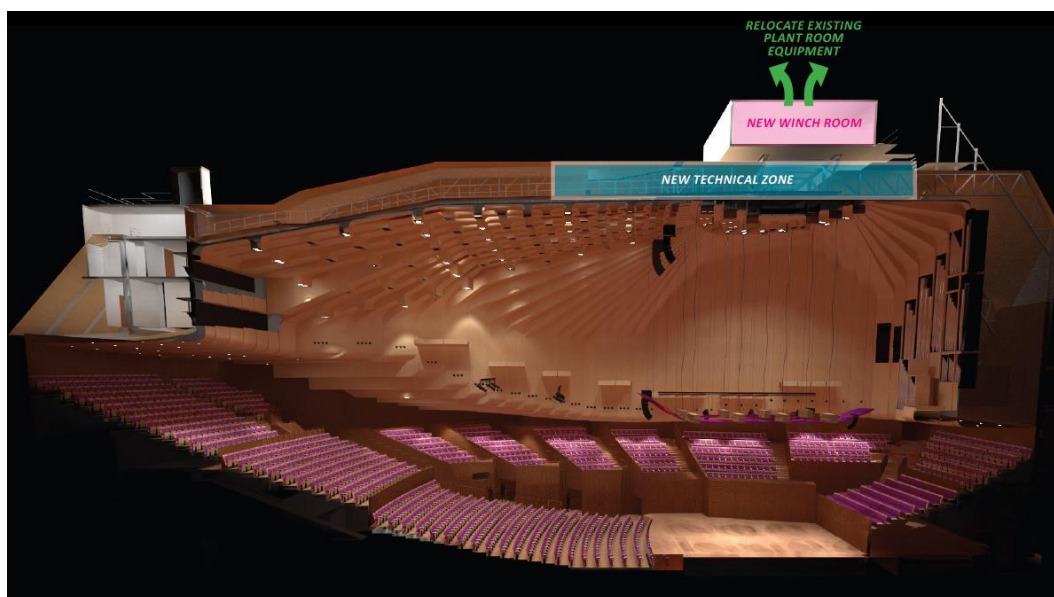
To accommodate the new winch room the existing Plant Room 21 equipment will be relocated. The plant servicing the Northern Foyer will be relocated to new wing platforms either side of the current plant room. The plant servicing the East and West Foyers will be demolished and these spaces serviced by local fan coil units. A cross section of the proposed changes to the Concert Hall is shown in Figure 90.

Figure 90: Concert Hall Design Development – Section Showing Changes Proposed to Technical Zone

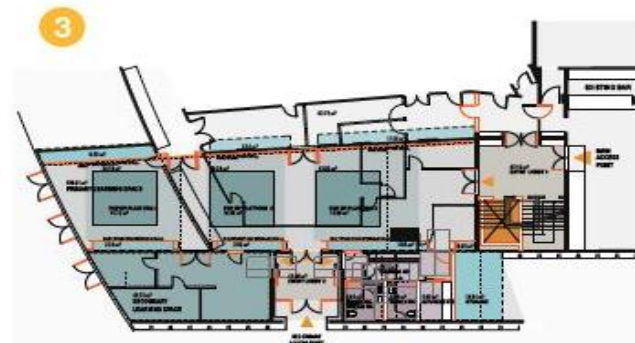
Figure 92: : Creative Learning Centre Concept Design Option 2

- Horizontal and Vertical Programming of space allowed with use of 3 stage lift platforms into basement
- 2 Learning Spaces with separate access

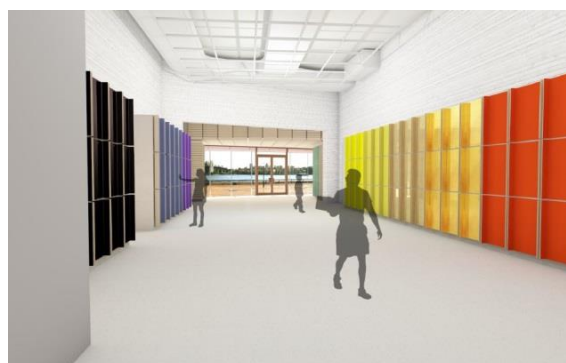
Figure 97: CLC “Wobbly” Cupboards Open

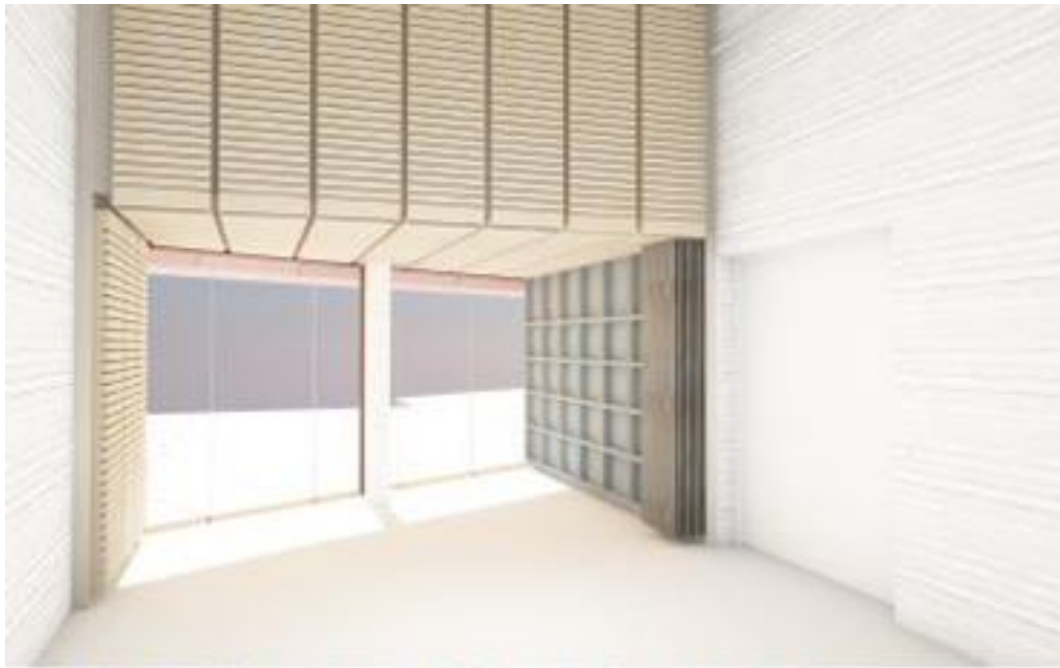
DIGITAL LEARNING- WOBBLY PANELS OPEN SHELVES

Figure 98: CLC Northern Window Space – Wobbly Panels Open

The harbour side portion of the Digital Learning Space was also developed as a useful flexible space where the opportunities for display and exhibition - as well as a night-time presence for the CLC - could be accommodated. This is shown in the following images.

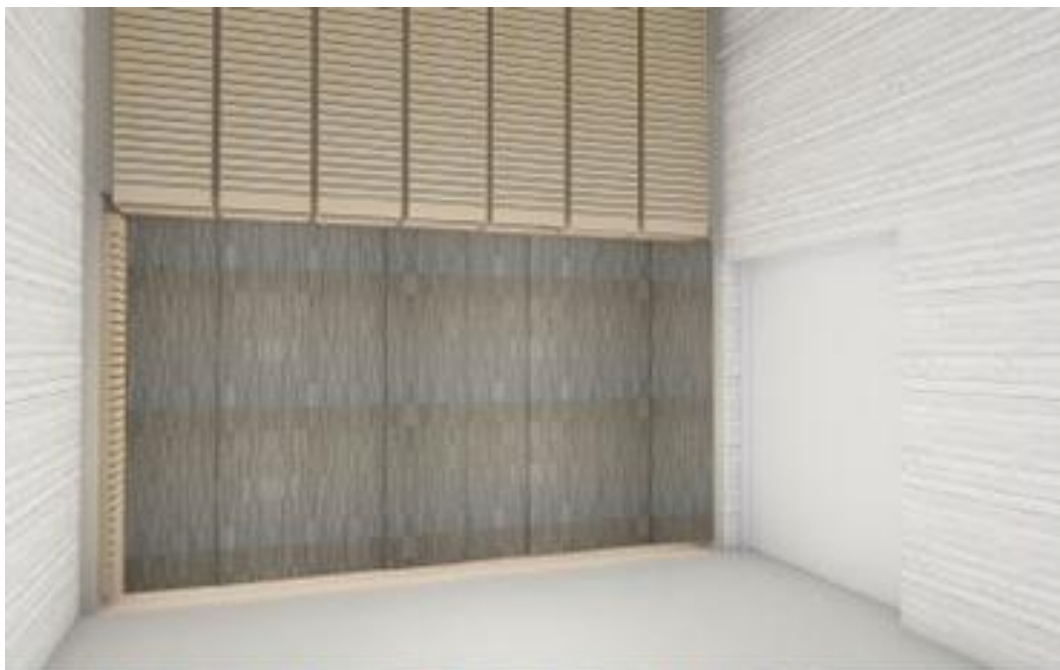
DIGITAL LEARNING- 'DISPLAY WINDOW' CLOSED OFF

Figure 99: CLC Northern “Display” Window Space Closed Off (looking from inside)

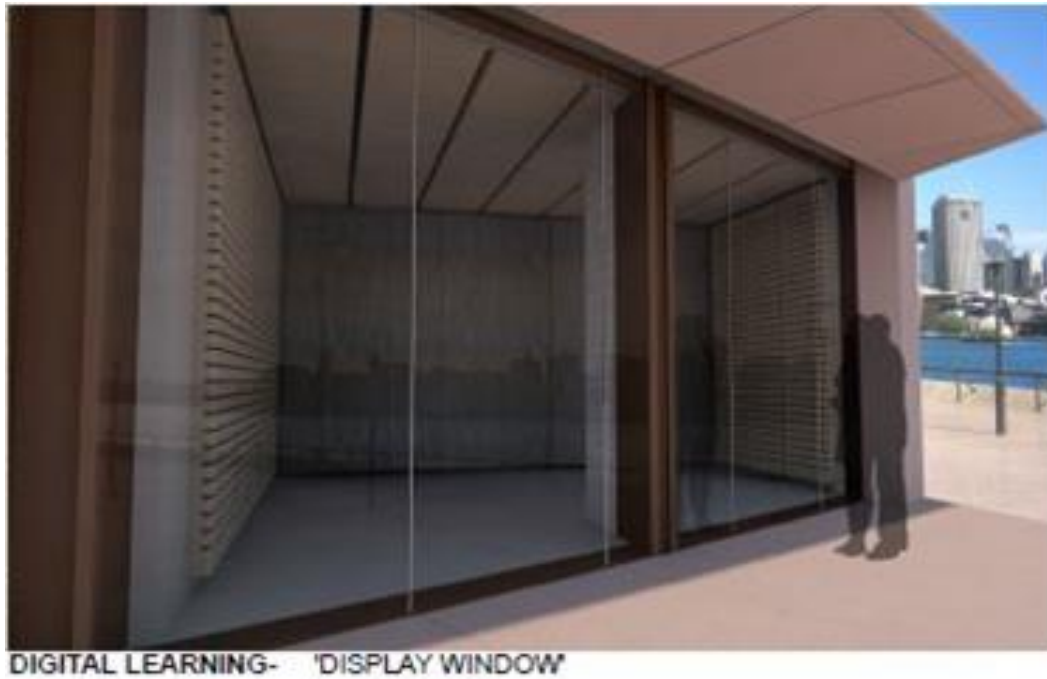
Figure 100: CLC Northern “Display” Window Space (looking from outside)

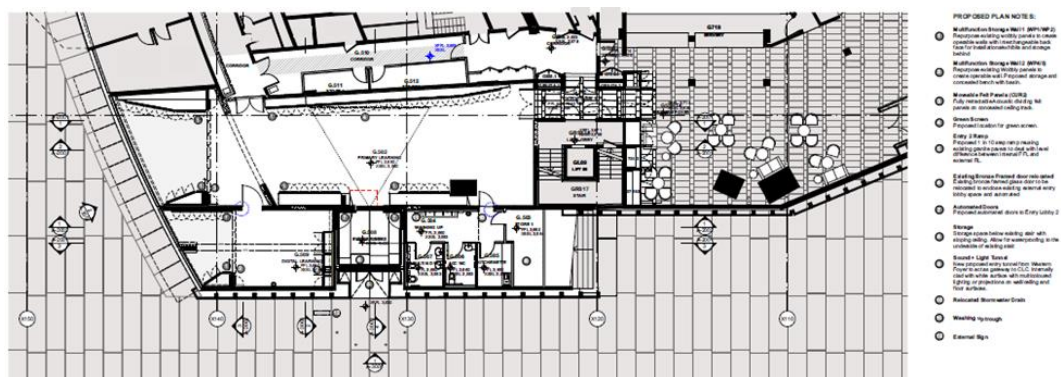
Final adjustments were made as part of the value engineering process, principally the deletion of the external door onto the Northern Broadwalk. The final floor plan is shown in the following image:
