UNEARTHED
ARCHAEOLOGY & HERITAGE

**Re: Mercantile Hotel, 25-27 George Street, The Rocks
Historic Archaeological Assessment of Ground Floor Works Area**

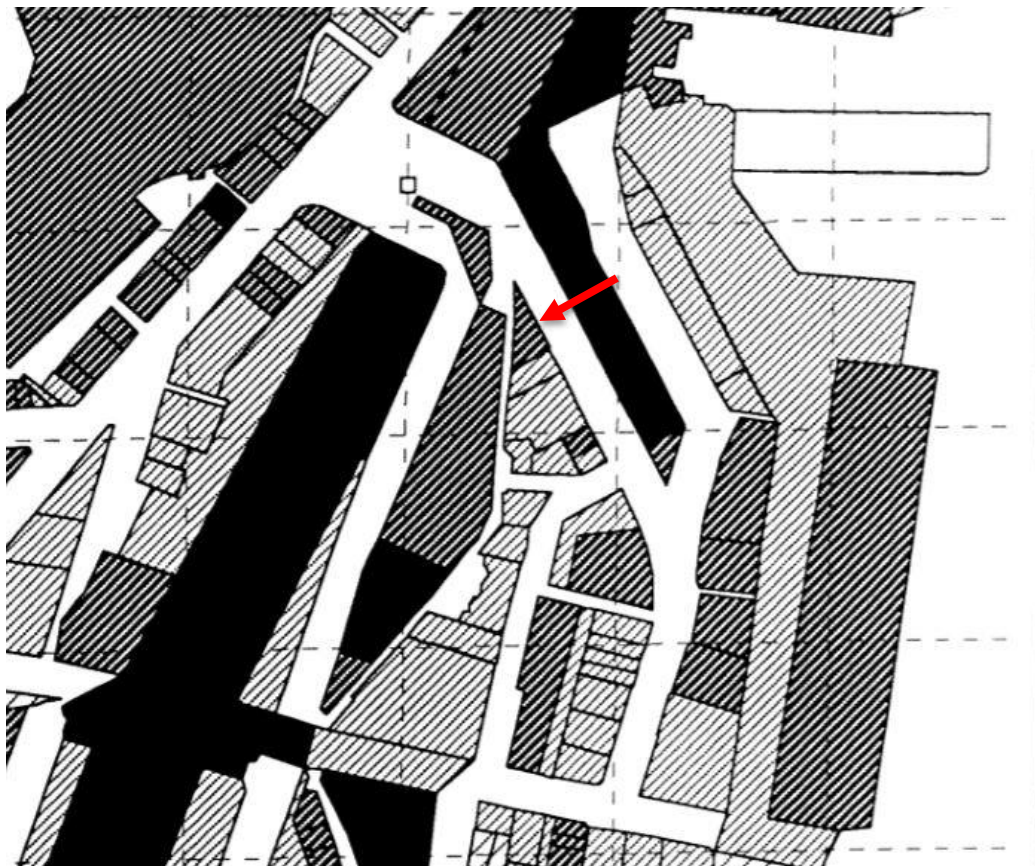
Figure 2: Plan showing the Mercantile Hotel site (arrowed) as 'mostly disturbed to destroyed'.
Higginbotham, *The Rocks and Millers Point Archaeological Management Plan*, Appendix.

The earliest plan (zoning plan) which assessed the various properties in the Rocks and Millers Point in terms of their potential to retain archaeological remains was *The Rocks and Millers Point Archaeological Management Plan*, Edward Higginbotham and Associates Pty Ltd, 1991. This assessed the ground floor of the Mercantile Hotel site as 'most disturbed or destroyed' (Figure 2). The plan also notes that 'Sandstone probably quarried out at rear' (Inventory Sheet R24, Inventory Page 220).

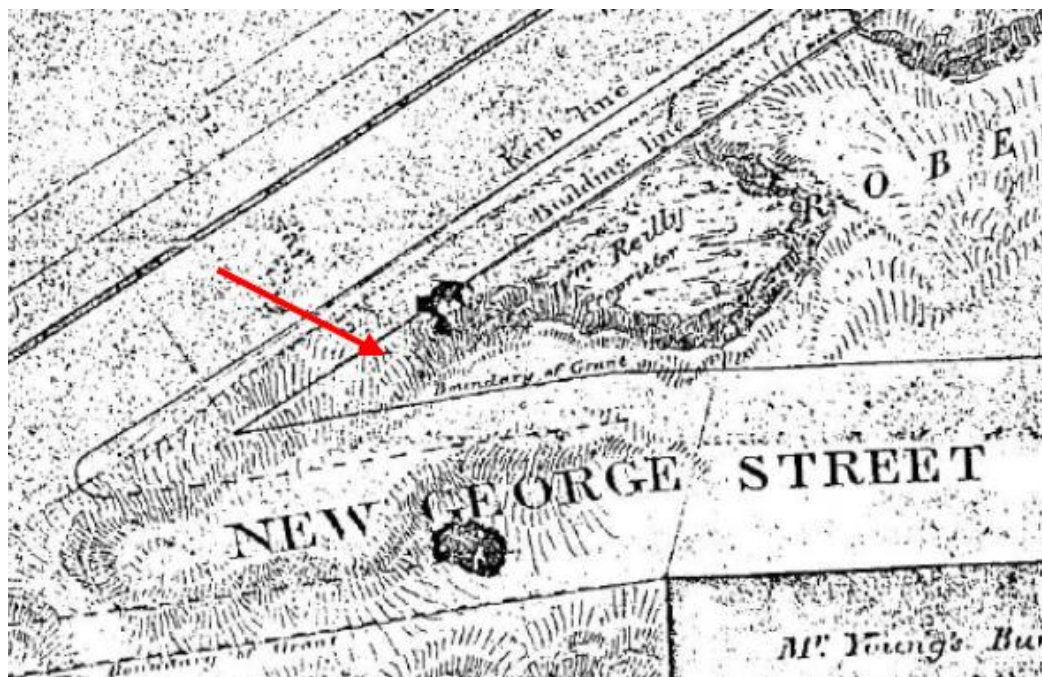
Figure 3: The site in 1849 showing rocky nature. Brooks 2007, Figure 25.

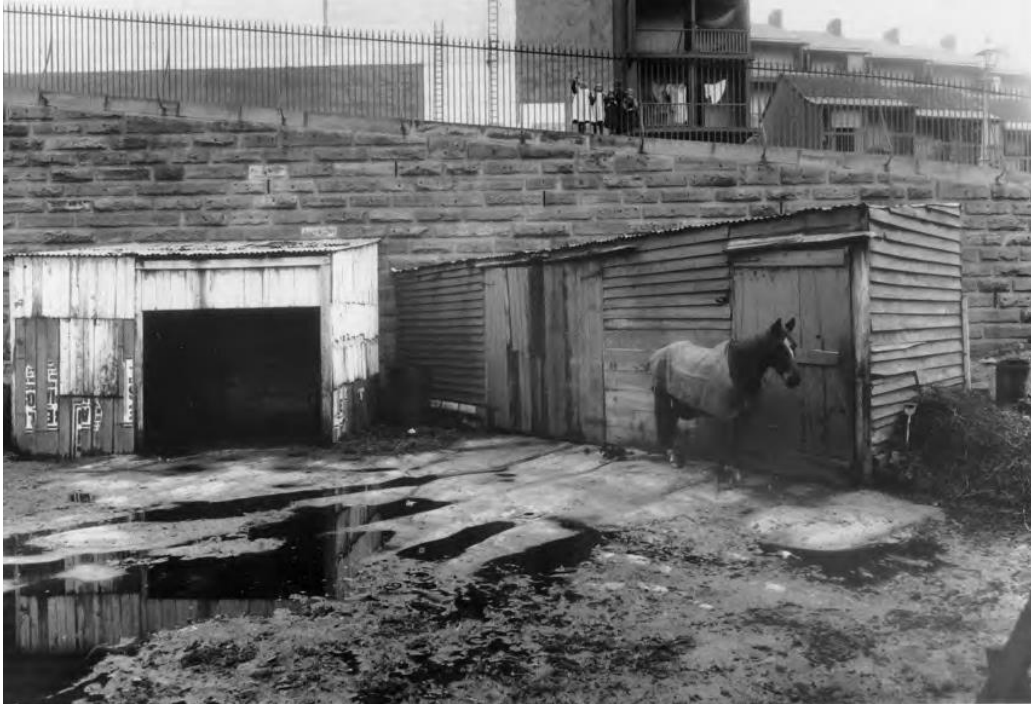
Figure 4: Photograph of the site c1903, showing stables built on bedrock. Brooks 2007, Figure 31.

The c1903 photograph of the stables on the site shows extensive exposed bedrock. The rising nature of the bedrock towards Gloucester Walk and the uniform height of the ground floor level through the hotel and into the rear yards would indicate that the bedrock level was cut down into the rear of the site to create a level building platform.

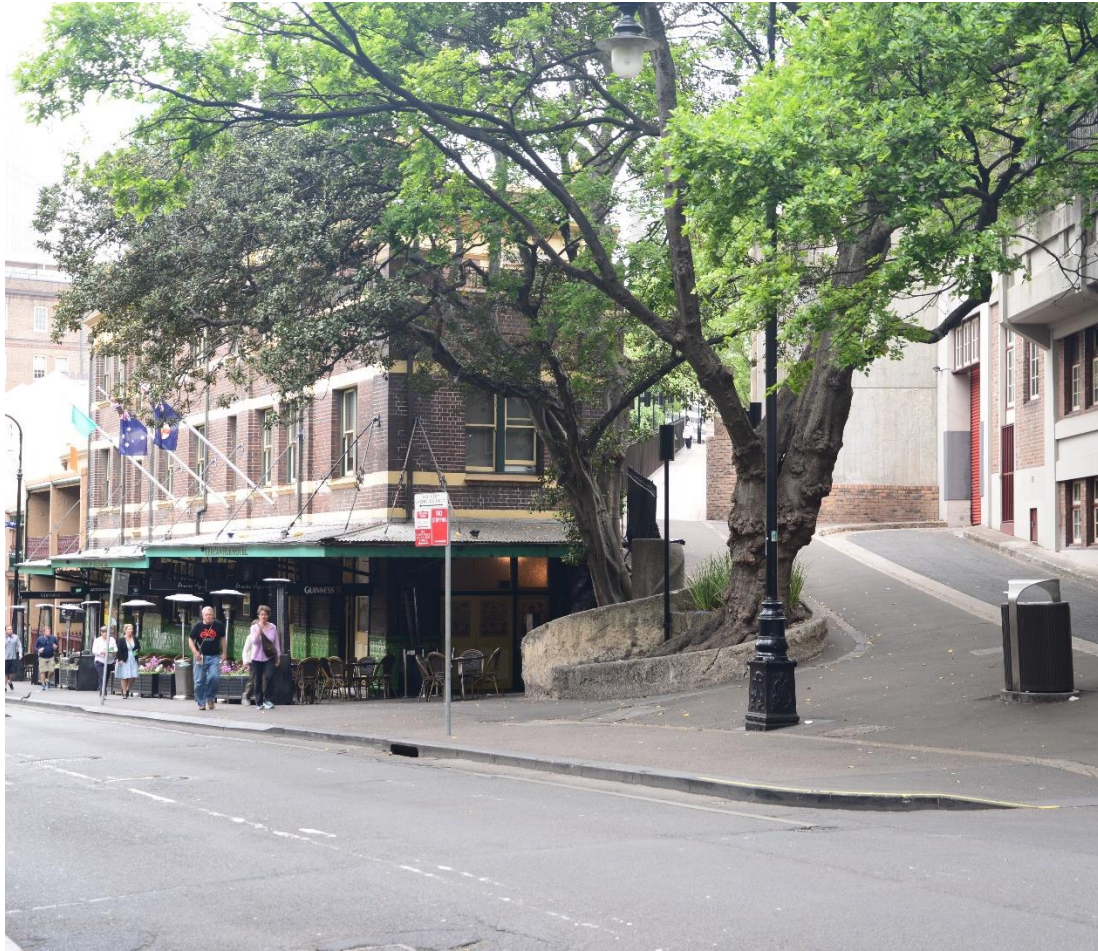
Figure 6: Comparison of height discrepancy between rising level of Gloucester Walk and the ground floor level (street level) of the hotel. 6/10/17.

I undertook a site inspection of the proposed work area on 6 October 2017. The inspection of the rear yard of the hotel and the level of the adjacent Gloucester Walk serves to emphasise the abrupt landscape at the end of George Street (Figure 5, Figure 6).
