Ref: C91109

**Addendum Report – St Aloysius College Middle School, Root mapping investigation results and final recommendations regarding proposed development work around Tree 60**

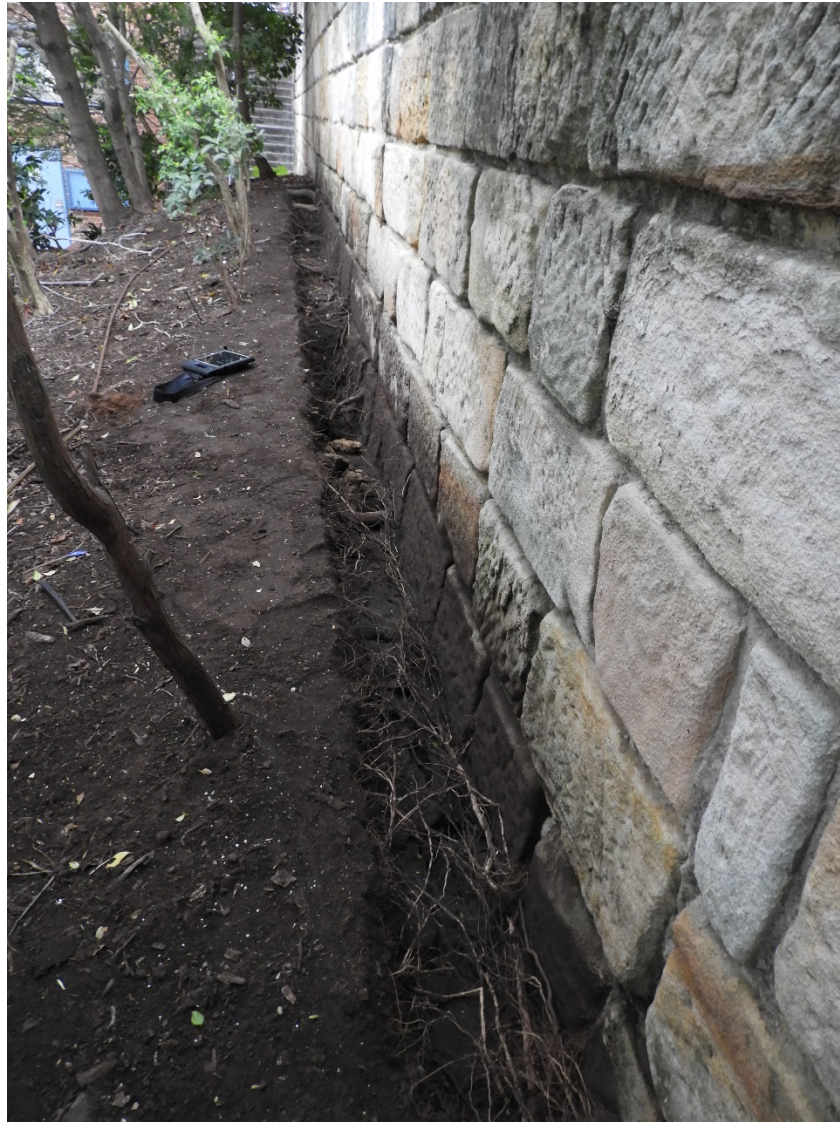
- 2.1 The exploratory trench work was undertaken on 9 October 2018 by means of a third-party contractor utilising a Hydro-Vac truck to limit any potential root impact. Tom Axford, ArborSafe AQF 8 Consulting Arborist, inspected the excavation on 10 October 2018.
- 2.2 The trench was 10m in length, 5m on either side of the subject tree's trunk alignment, with an average depth of 300mm and ~300mm width. The trench depth was significantly restricted by existing rock and large sandstone bedrock slabs and the foundation stones of the sandstone dividing wall.

Figure 1. An image of the excavated trench along the base of the sandstone retaining/boundary wall. Source: ArborSafe, October 2018

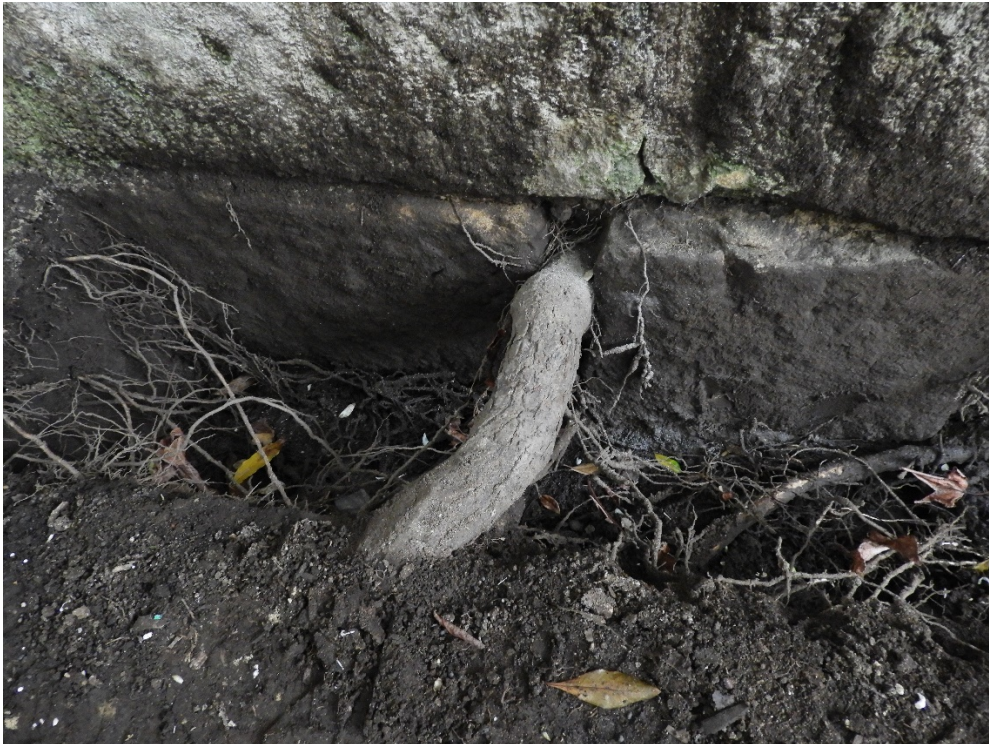
- 2.3 Three (3) roots were identified within the trench as being large enough, generally over 40mm in diameter, to warrant comment. Two of the roots were identified as originating from the stump of a previously removed tree within the garden bed, so had no bearing on the assessment, while the remaining root was identified as originating from the subject tree.
- 2.4 The root identified as being from the subject tree penetrated through a weep hole within the base of the wall 3.2m to the northwest of the subject tree's trunk alignment. The root was 60mm in diameter, measured 150mm out from the wall, with the diameter being smaller where it penetrated the weep hole. No displacement of any kind was observed within the stones of the wall.
- 2.5 Multiple smaller roots were identified within the trench and attributed to existing vegetation within the St Aloysius garden bed.

Figure 2. An image of the root identified as originating from the subject tree. Source: ArborSafe, October 2018

- 3.1 At a distance of 3.2m from the trunk alignment the root would likely be outside the theoretical Structural Root Zone (SRZ) of the subject tree. Combined with the roots relatively small size and the stability of the wall itself against the remaining root system and associated soil volume, it was considered that severing the root would have minimal to no structural bearing on the subject tree.

- 3.2 The root would be providing some nutrient and water resources, to the subject tree, which was showing good health characteristics at the time of assessment. It was considered that a minor drop in health may be observed while the tree compensates for the root loss but that a tree of this species, age and condition would have minimal trouble responding to the severance of a single root of this size, make up and location from the trunk.

- 4.1 The removal of the garden bed within the courtyard of the St Aloysius middle school, as part of the proposed development referenced within the original AIA report, would have minimal effect on the health and structure of the subject tree, Tree 60.
