# **WALSH BAY ARTS AND CULTURAL PRECINCT**

## **STATE SIGNIFICANT DEVELOPMENT APPLICATION**

### **ARCHAEOLOGICAL ASSESSMENT**

## WALSH BAY ARTS & CULTURAL PRECINCT

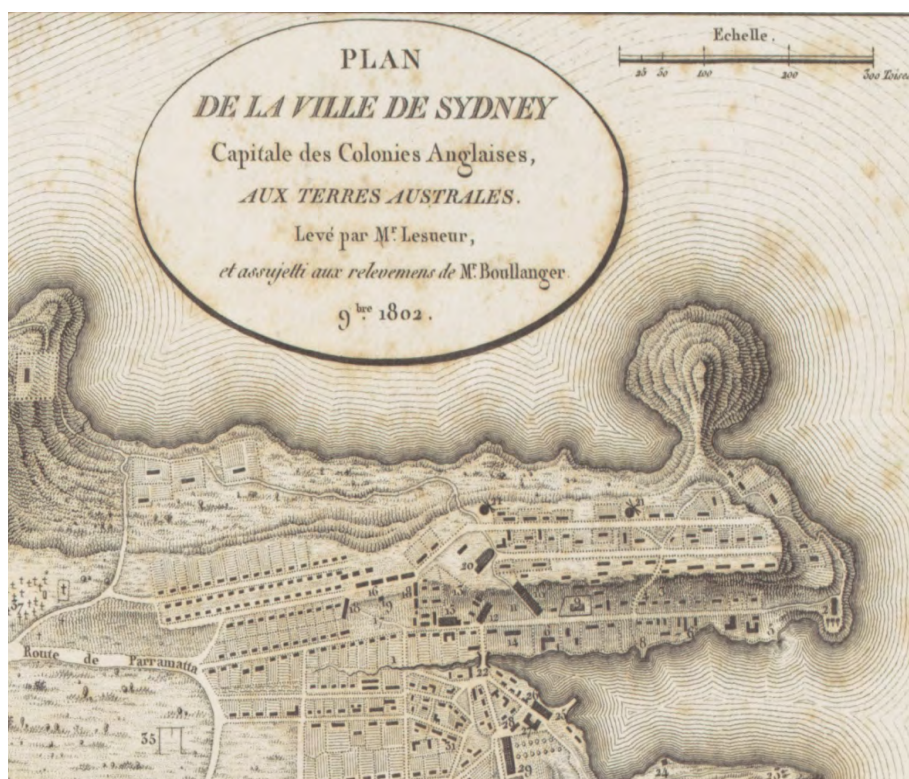
Detail of 1802 "Plan de la Ville de Sydney" showing the steep and rocky headlands of Millers Point and Walsh Bay (Source: NLA <http://trove.nla.gov.au/version/209669543>)

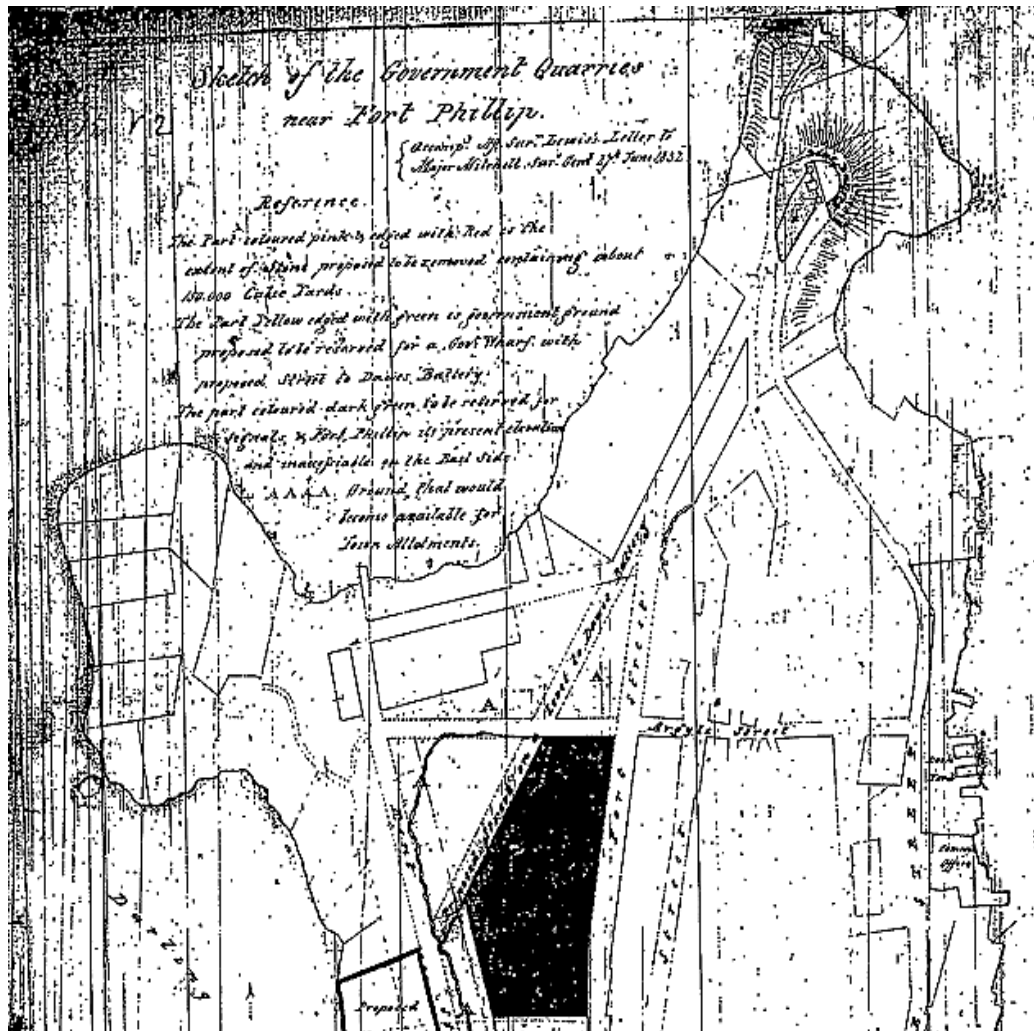
Sketch of the waterfront in Sydney Cove in 1832 showing numerous waterfront improvements but limited development at Dawes Point (Source: SRO NSW Surveyor General Sketch Books Volume 2 Folio 5)

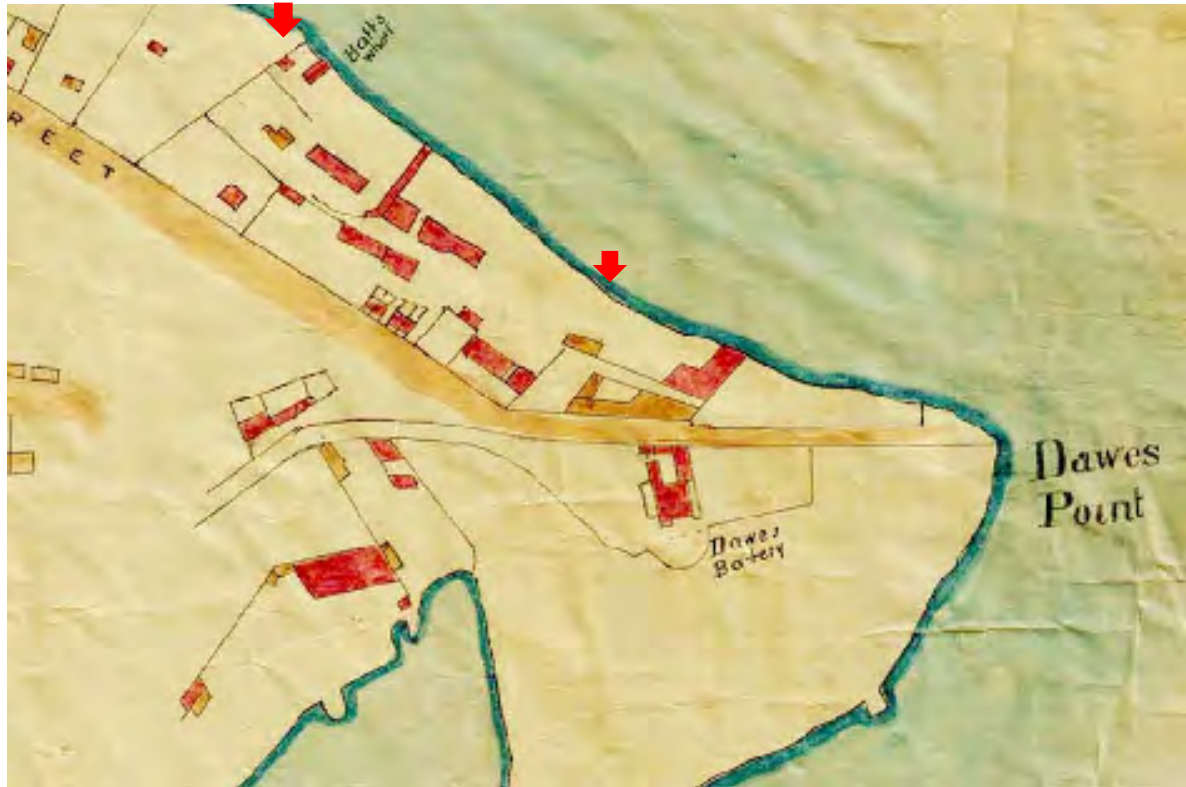
Detail from Shield's plan of the city in 1845 showing the improvements on the land within the project area; this is the foreshore between the arrows encompassing just the extreme ends of those buildings adjacent (Source: Sydney City Archives Plan Atlas: Francis Sheild, Map of the city of Sydney New South Wales)

works that had been built out into the bay in the area of present-day Wharves 4/5 and Pier 2/3 (refer to 1845 overlay, Plan 3).

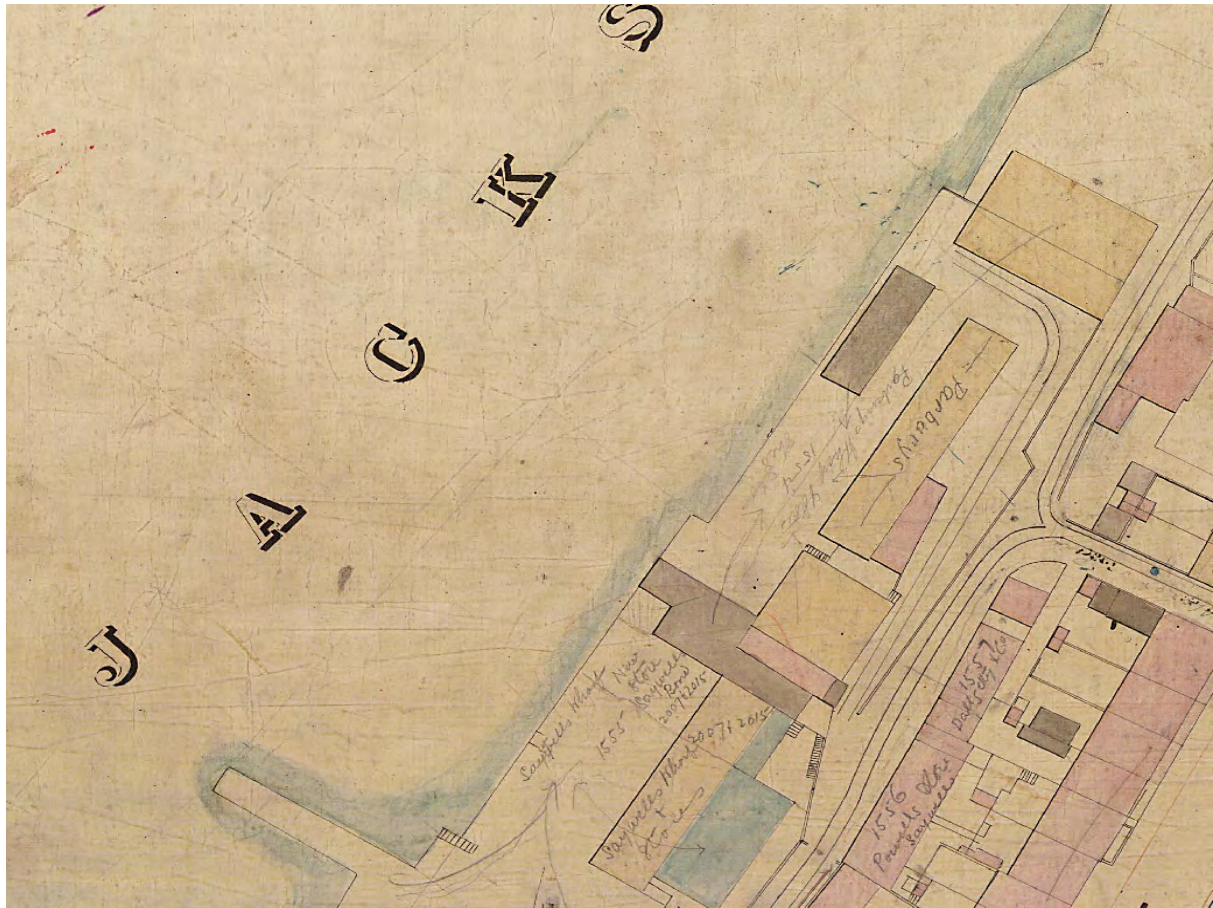
Detail from town survey of 1865 showing the waterfront encompassed by the project area with the shore buildings behind in the area of present-day Hickson Road. By this date one finger wharf had been built out into the bay from Pitman's old property now known as Saywell's Wharf (Source: *Trigonometrical Survey of Sydney 1865, Section A1*)

By this date the former Lamb's Wharf was then known by the name of Lamb's partner: Parbury's Wharf. Pitman's property was then called Saywell's Wharf and the small portion of Davis' allotment within the project area was Farrelly's Wharf. As the 1865 survey demonstrates the shore buildings for each company had been extensively added to over the previous twenty years with a mixture of stone, brick and iron sheds and stores. These sites are all largely within the area of present-day Hickson Road (refer overlay Plan 4).

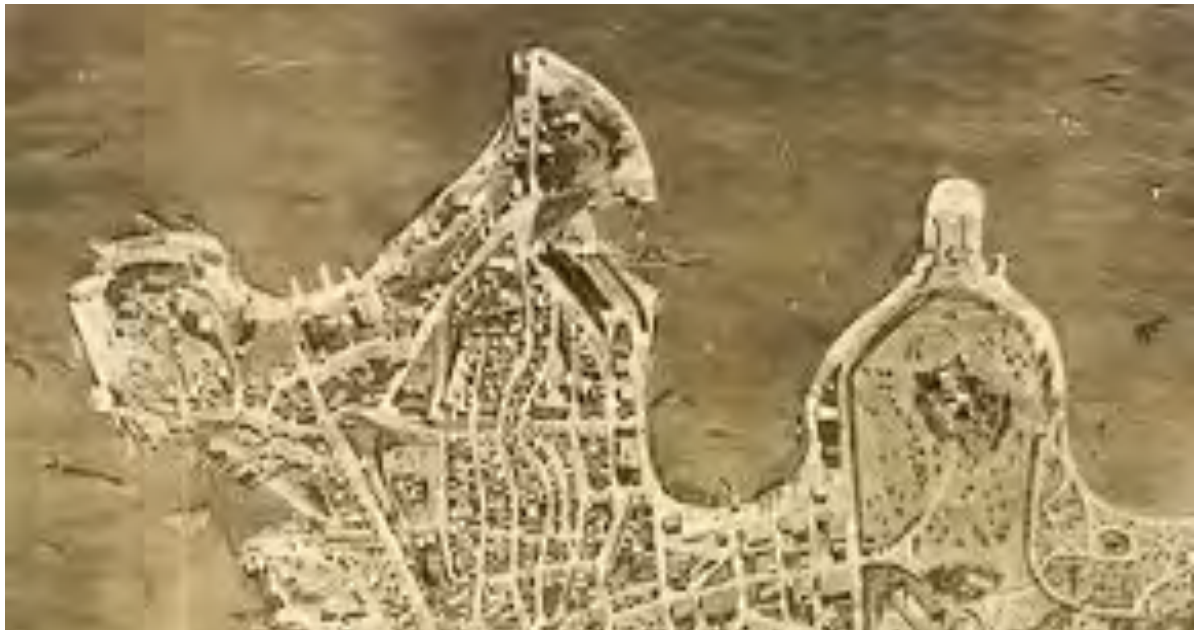
Detail from Gibbs and Shallard's, view of Sydney in 1879 showing the shoreline within the project area before redevelopment in the 1880s (Source: Supplement to *Illustrated Sydney News* 2 October 1879)

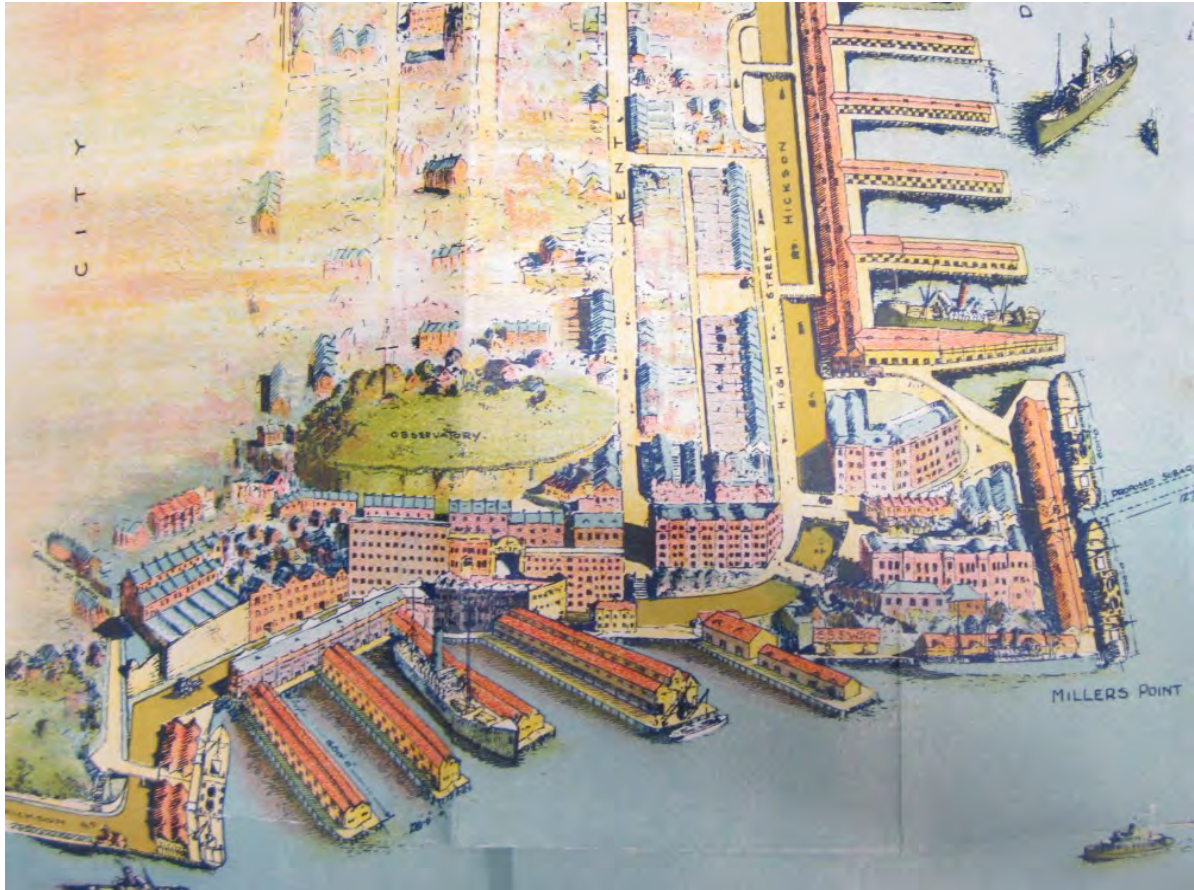
Detail from an SHT drawing showing the completed vision of the new wharfage around Dawes Point and Millers Point (Source: SHT Annual Report 1913)

Several schemes were considered before the final plan was selected of five finger wharves, two longshore wharves, a low level and upper level roadway.

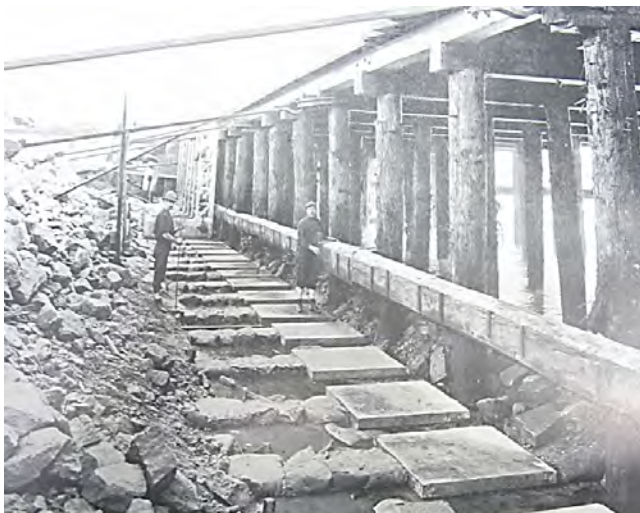
Top and Middle: Reinforced concrete walls and prefabricated elements used in the construction of the new waterfront at Millers Point, here in the area of Moore's Wharf west of the project area (Source: *SHT Annual Report 1907*)

Bottom: Reinforced trestle wall under construction at Millers Point in 1909 (Source: *SHT Annual Report 1909*)

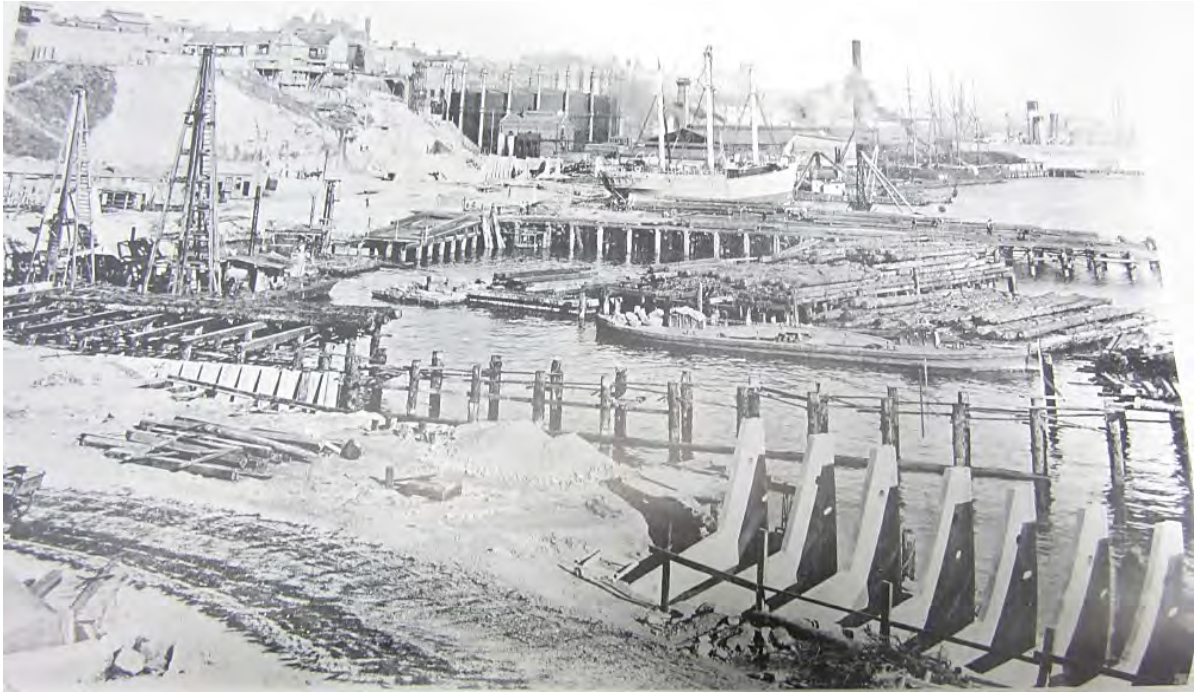
Excavation of the foreshore for the new road, here a view of these works and the construction of new wharves on the western side of Darling Harbour near the Gas Works in 1909 (Source: SHT Annual Report 1909)

An integral part of the new work was the construction of a road that would connect the new wharves at Darling Harbour with those at Millers Point and Dawes Point. The scheme required demolition of existing buildings and substantial excavation back into the face of the sandstone cliffs that bounded this waterfront. Work on Hickson Road commenced in 1909<sup>73</sup>. The excavation commenced close to the gas works on Darling Harbour; the sandstone rubble removed as part of the excavation was used as fill behind the trestle walls being built on the shore.

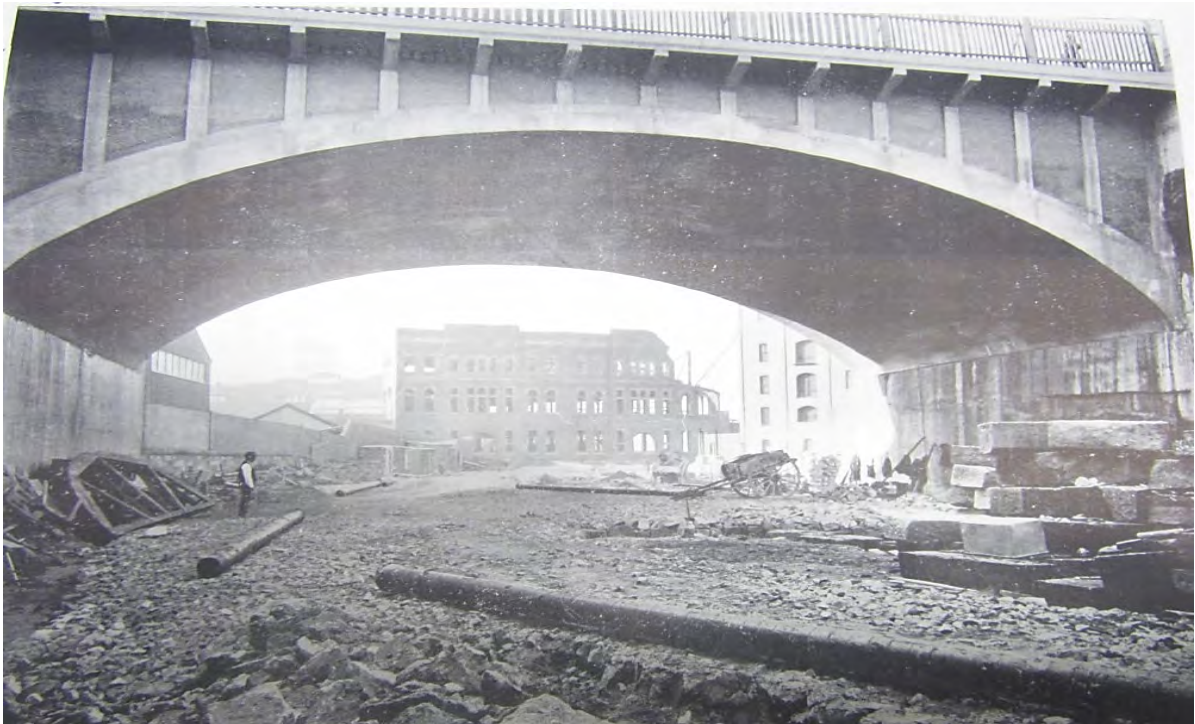
View west along Hickson Road showing the new bridge that spanned what was described as “deep rock cutting” through Millers Point. Wharf 8/9 is in the background and in the foreground can be seen some of the sandstone that has been extracted as dimension stone (Source: SHT Annual Report 1913)

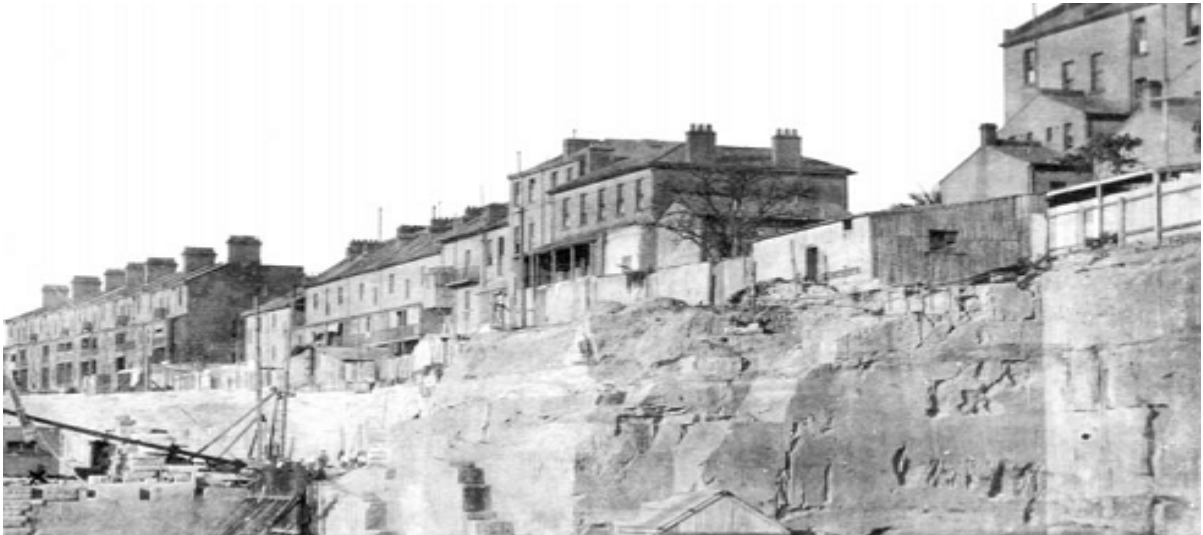
The extent of excavation of the existing landform required to create the new streets of Hickson Road and New Pottinger Street is demonstrated in this image (Source: GPO collection reproduced in Fitzgerald and Keating (1991), *Millers Point the Urban Village*)

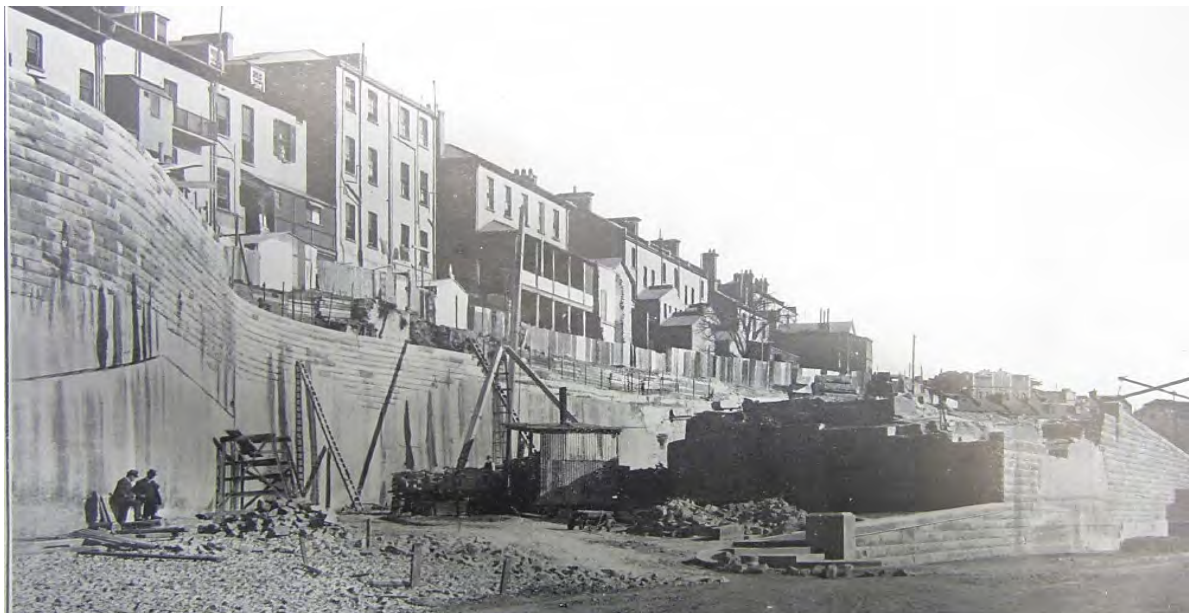
The junction of New Pottinger Street and Hickson Road in the course of construction in 1916 (Source: *SHT Annual report 1916*)

At the same time the construction of the new deviation to Pottinger Street to meet Hickson Road was in progress; 4,400 cubic yards of rock had been removed in three months<sup>76</sup>.
