5. The Twentieth Century Landscape

6. The Archaeological Profile

PIER 2/3 & WHARF 4/5
WALSH BAY

SEPTEMBER 2017

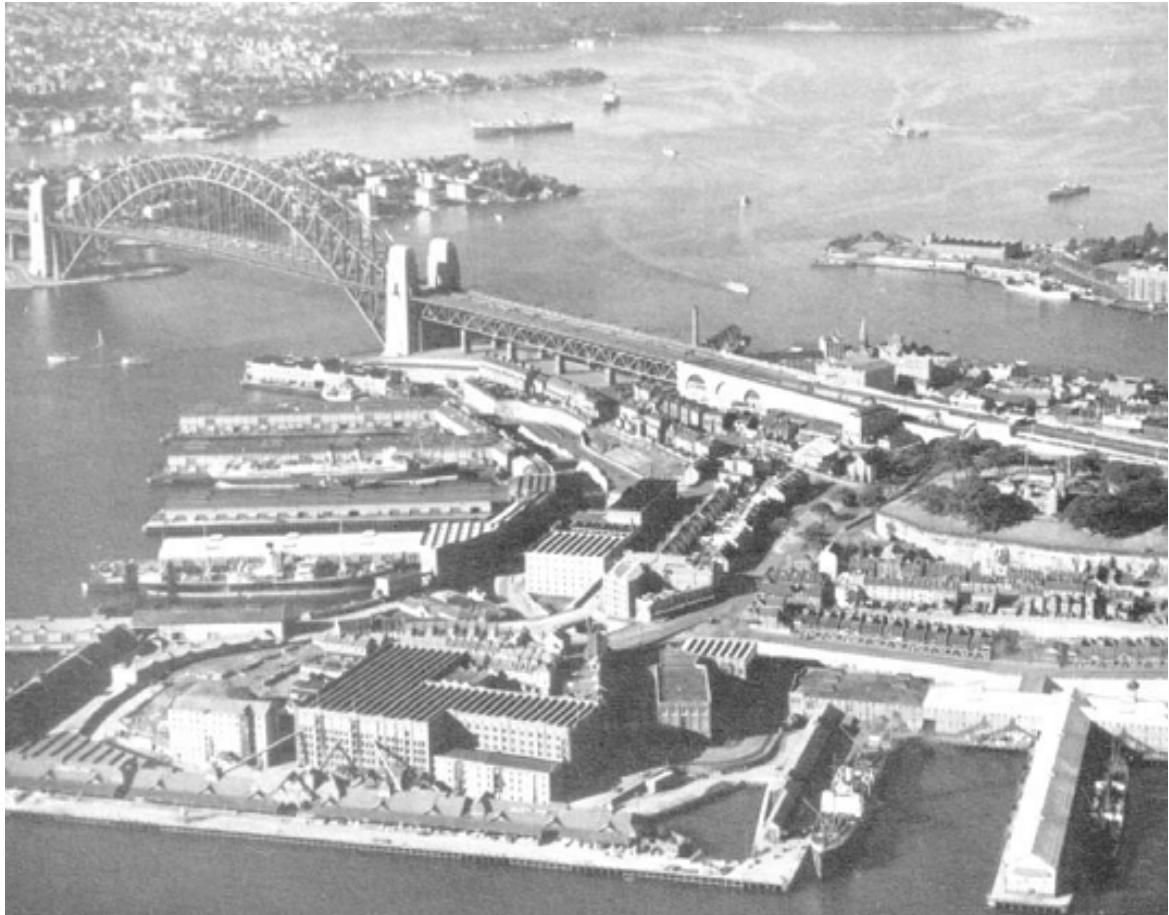
Oblique aerial view of Walsh Bay in 1937 (Source: Fitzgerald and Keating (1991); Millers Point the Urban Village)

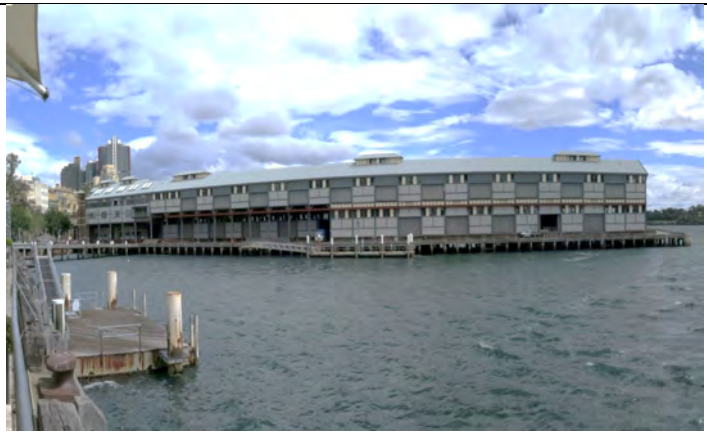
Pier 2/3: a Federation style, two level wharf structure constructed between 1913 and 1922. It consists of timber framed post and beam construction with a regular grid layout. It is clad in weatherboards, has a double-pitched roof and roof lantern. It has concrete aprons that wrap around the eastern western and northern sides. The shore-sheds have a brick facade

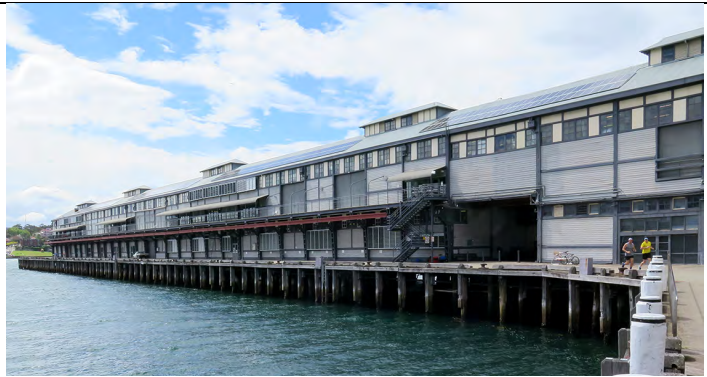
Wharf 4/5: a Federation style, two-level wharf structure similar in construction to Pier 2/3 and also constructed in the years 1913-1922. It has been altered in the 1980s to accommodate performance spaces. It has a brick façade to Hickson Road

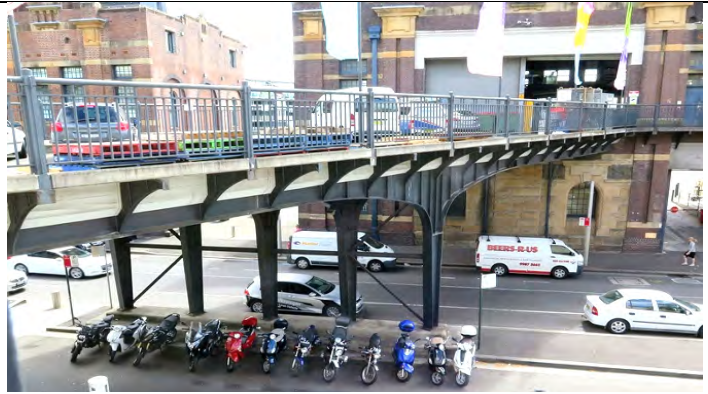
Bridge to Wharf 4/5

The original timber bridges between the upper storeys of the piers and Pottinger Street have been replaced with steel bridges set on concrete plinths or steel piers in c. 1940

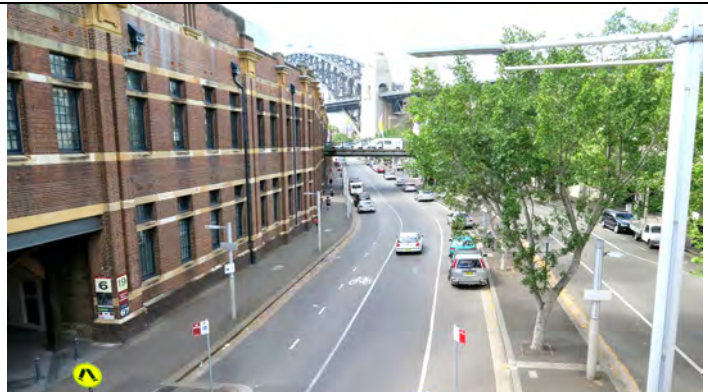
View east along Hickson Road showing light poles along the footpath; the installation would have required excavation

A number of underground services have been installed below the current footpaths including sewerage, stormwater, power and telecommunications.

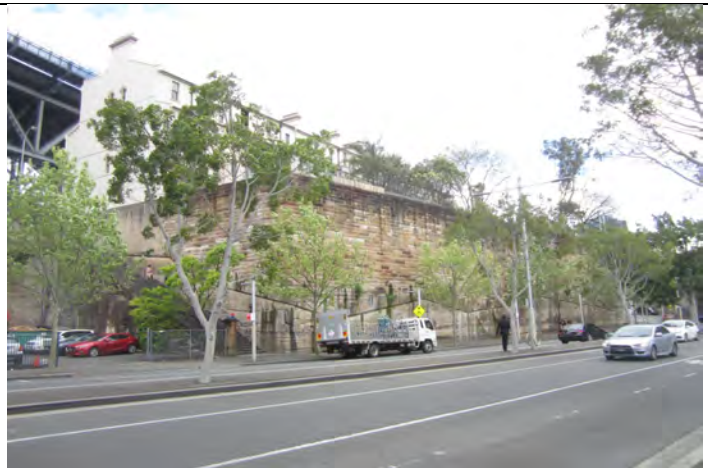
The undulating surface of the former natural topography can be seen in the levels of the sandstone retaining wall which has been constructed on top of the bedrock cliff face; this also demonstrates the steep incline of the original landform as well as the difference in levels of construction of housing at the top of the cliff and the waterfront improvements

View of terraces above Hickson Road, the retaining wall and levels of quarried bedrock at the base of the wall

Inspection of the study site confirms the historical evidence for quarrying the sandstone headland and levelling of the Walsh Bay foreshore. This is evident at the base of the retaining wall on Hickson Road.

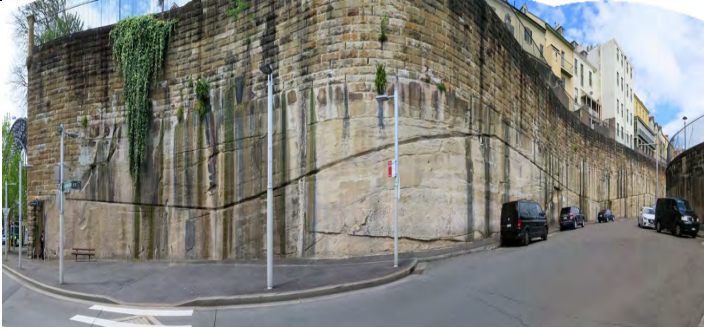
<p>The extent to which the bedrock has been quarried to provide for the construction of Hickson Road may be seen at the base of the retaining wall on the southern side of that road and in Pottinger Street</p> <p><i>Quarried sandstone bedrock at the junction of Hickson Road and New Pottinger Street</i></p>

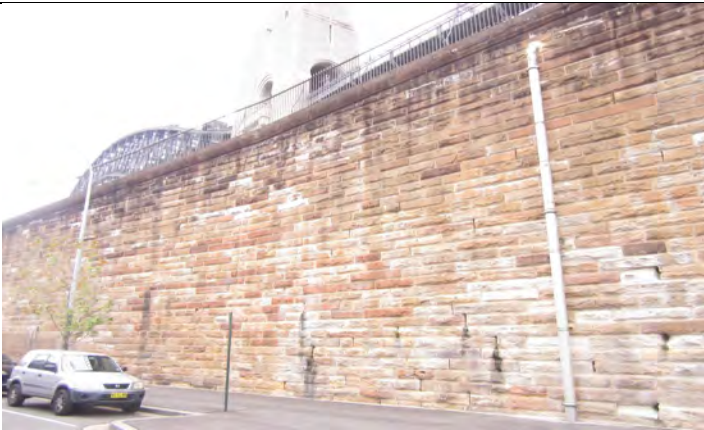
<p>Hickson Road retains its original alignment and width with later twentieth century additions such as a roundabout. The massive stone retaining walls constructed by the SHT remain on the southern side</p> <p><i>Sandstone retaining wall on the southern side of Hickson Road</i></p>

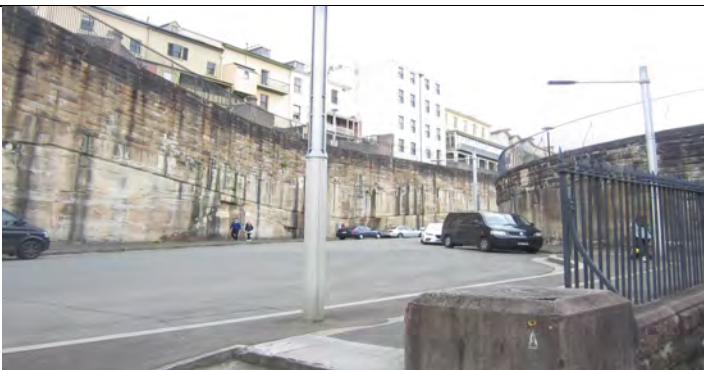
<p>New Pottinger Street is also preserved in its original form</p> <p><i>View from the junction of New Pottinger Street with Hickson Road</i></p>

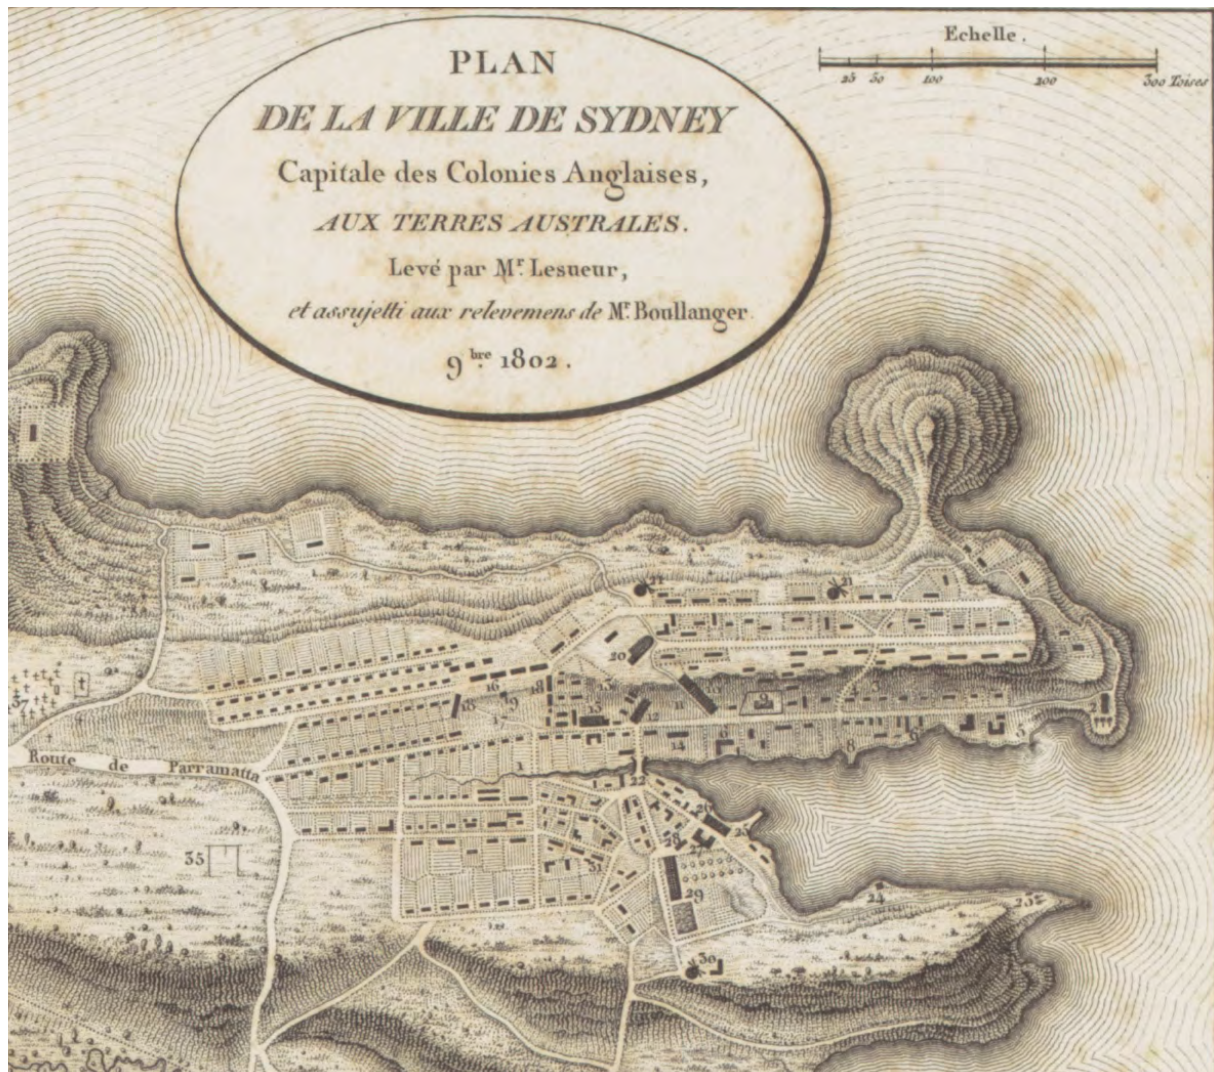
Figure 3: Detail of Milbert, Cloquet and Walker's 1802 Plan de la Ville de Sydney showing the steep rocky headlands of Millers Point and Walsh Bay. (Source: NLA <http://trove.nla.gov.au/version/209669543>)

Prior to European settlement, reclamation and construction along Walsh Bay, the study area consisted of a steep, rocky sandstone headland overlooking the deep waters of Sydney Harbour. Early plans of the town of Sydney indicate that this area comprised steep-sided cliffs leading down to a narrow rocky foreshore (*Figure 3*).

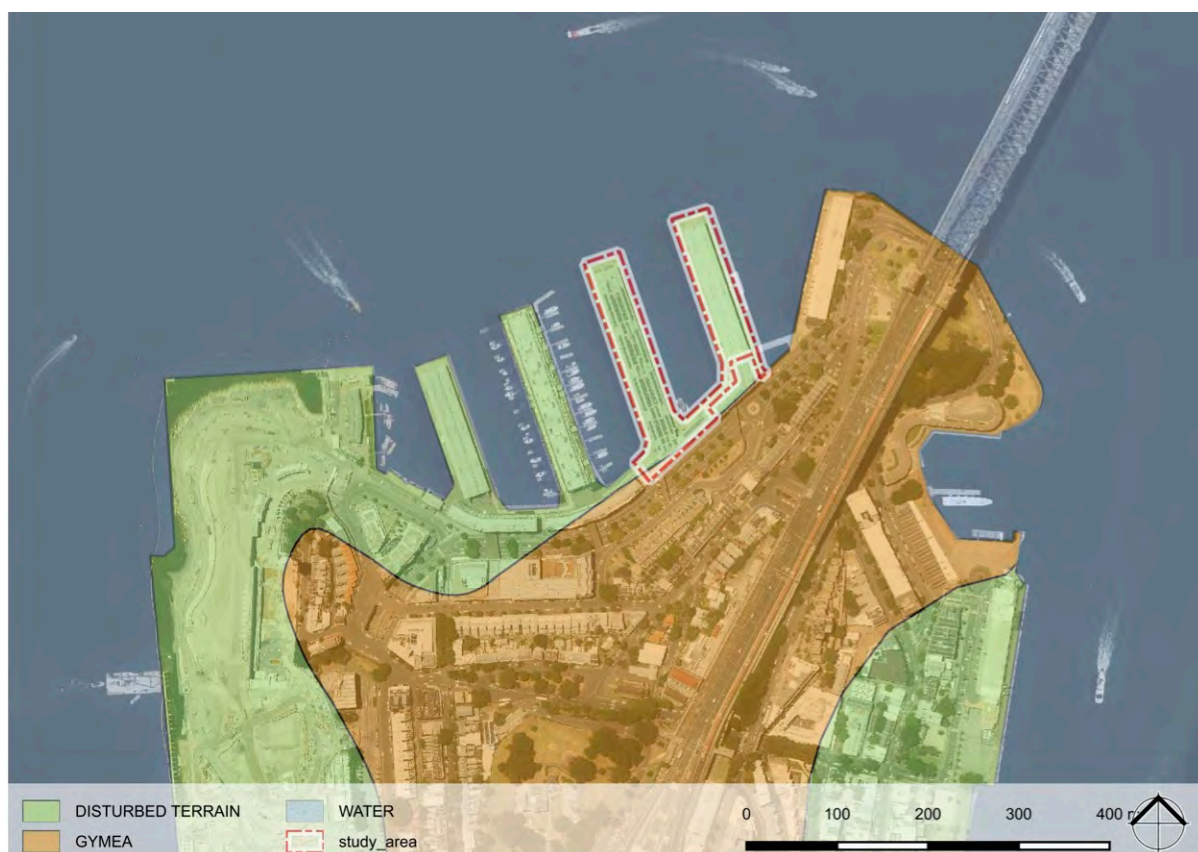
Figure 3 Map of the soil landscapes in the vicinity of the study site. (Source: Soil Landscapes of the Sydney 1:100,000 Sheet, NSW Department of Environment, Climate Change and Water with CRM additions)

The Sydney soil landscape 1:100 000 sheet indicates that the area in the vicinity of the study site is overlain with Gynea soils (*Figure 34, 5*). These shallow, loose, sandy soils are formed by the weathering of the underlying sandstone bedrock and are highly prone to erosion.² The original unaltered foreshore is likely to have been rocky with small pockets of sandy beach deposits.

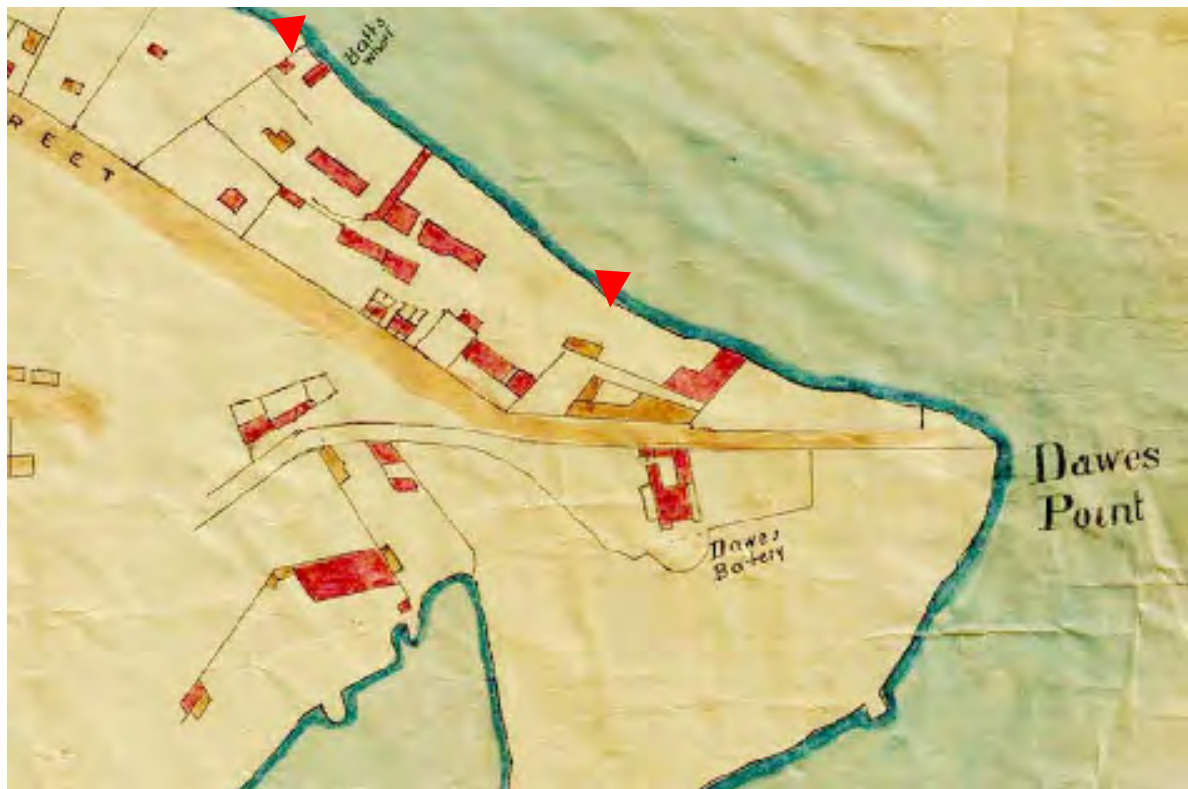
Figure 10: Detail from Shield's plan of the city in 1845 showing the improvements on the land within the project area; this is the foreshore between the arrows encompassing just the extreme ends of those buildings adjacent (Source: Sydney City Archives Plan Atlas: Francis Shield, Map of the city of Sydney New South Wales)

makers, boat builders, wharfingers and mast-makers¹⁹. During this period almost all vestiges of the former shoreline were lost through even more extensive development of wharves, jetties, stores and sea-walls although some small areas of the original shore and mud flats were still exposed particularly near Kent Street. The present street pattern had been established by 1865. A survey of this year shows how the existing properties had been more closely developed in the preceding twenty years (*Figure 10*).

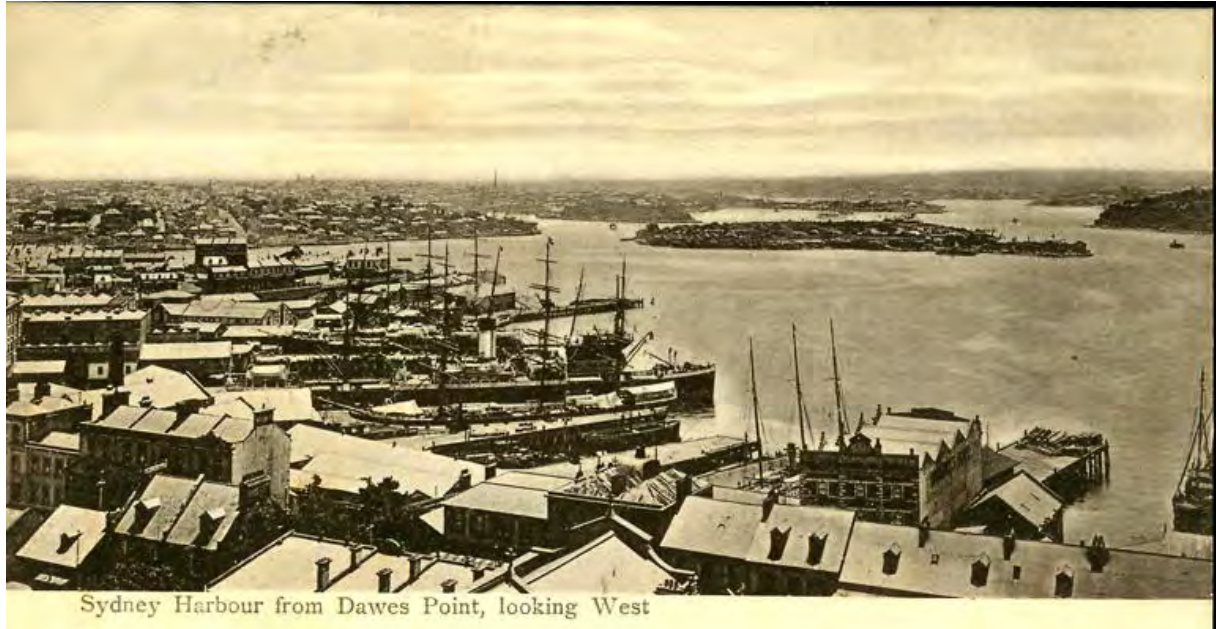
Figure 7 Walsh Bay Wharves circa 1900 before the Sydney Harbour Trust redevelopment. (Source: City of Sydney Archives, Graeme Andrews 'Working Harbour' Collection: 77950)

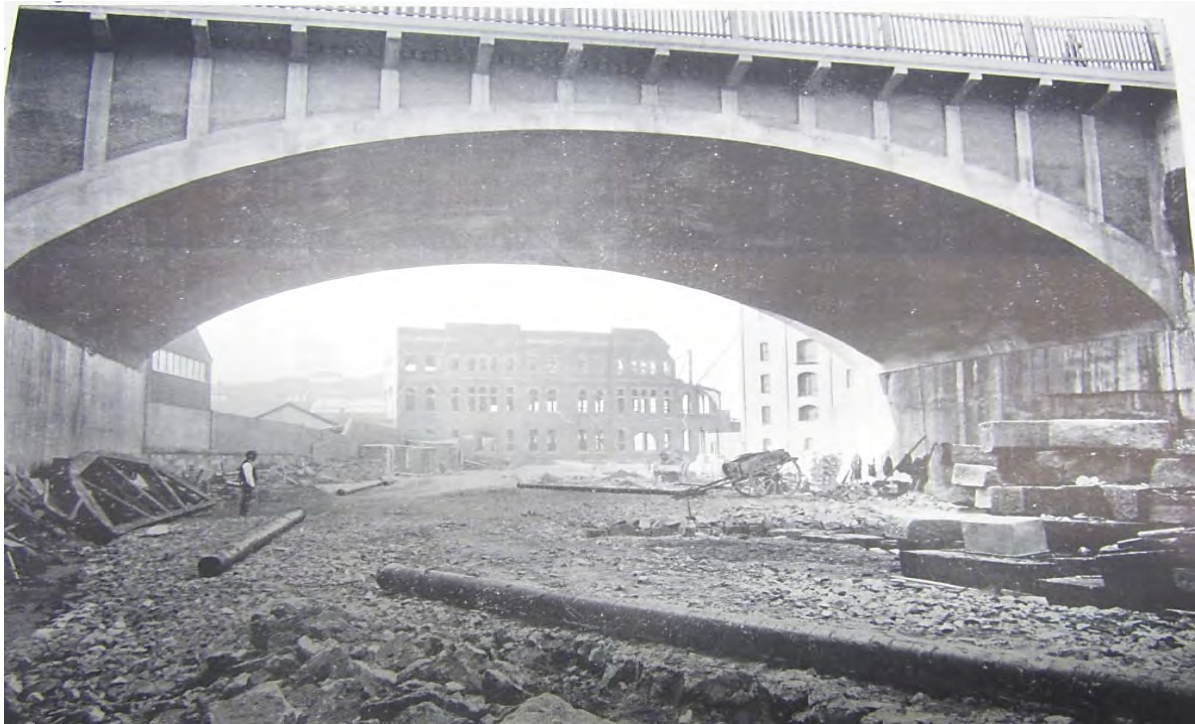
Figure 12: View west along Hickson Road showing the new bridge that spanned what was described as “deep rock cutting” through Millers Point. Wharf 8/9 is in the background and in the foreground can be seen some of the sandstone that has been extracted as dimension stone (Source: *SHT Annual Report 1913*)

Apart from the construction of the wharves and sheds redevelopment of the waterfront also entailed the creation of Hickson Road. The road would connect the new wharves at Darling Harbour with those at Millers Point and Dawes Point. The scheme required demolition of existing buildings and substantial excavation back into the face of the sandstone cliffs that bounded this waterfront. Work on Hickson Road commenced in 1909. The excavation commenced close to the gas works on Darling Harbour; the sandstone rubble removed as part of the excavation was used as fill behind the trestle walls being built on the shore. It was completed in 1916. New Pottinger Street was constructed at the same time

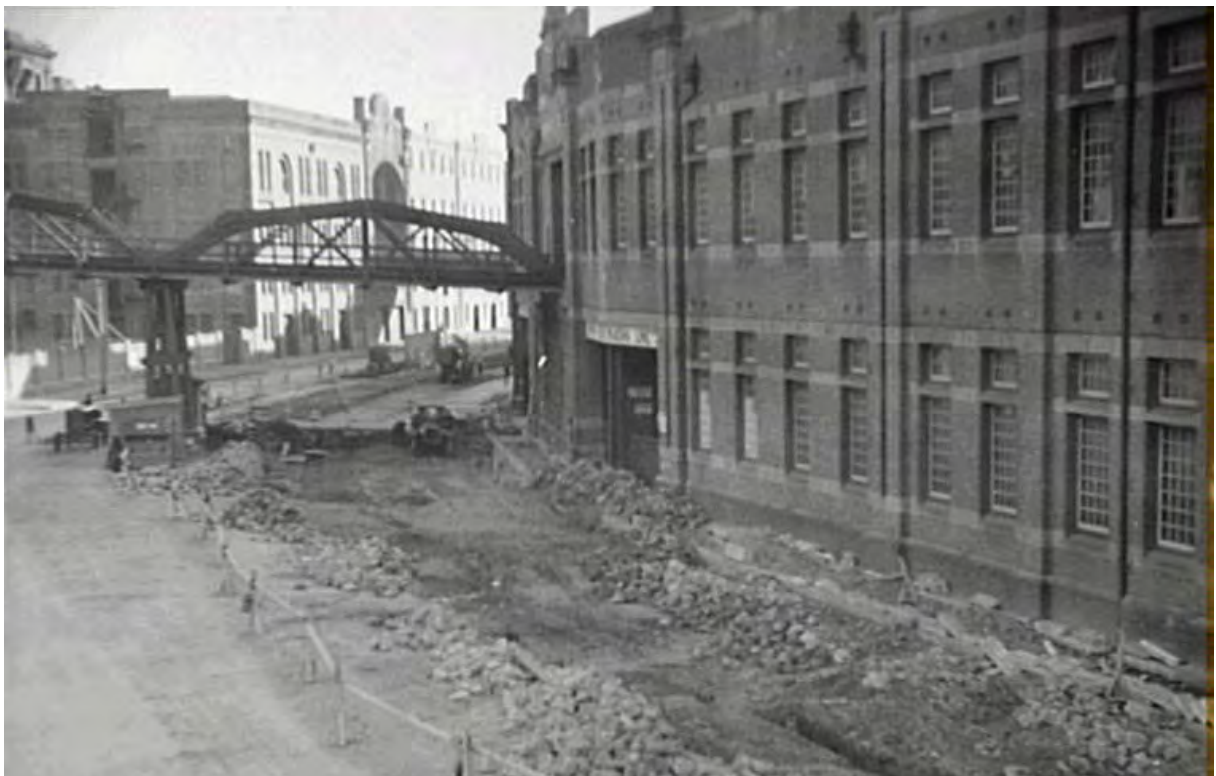
Figure 13: Looking southwest along Hickson Road opposite Walsh Bay Wharves 6-9, circa 1933 (Source: *City of Sydney Archives SRC6609*)

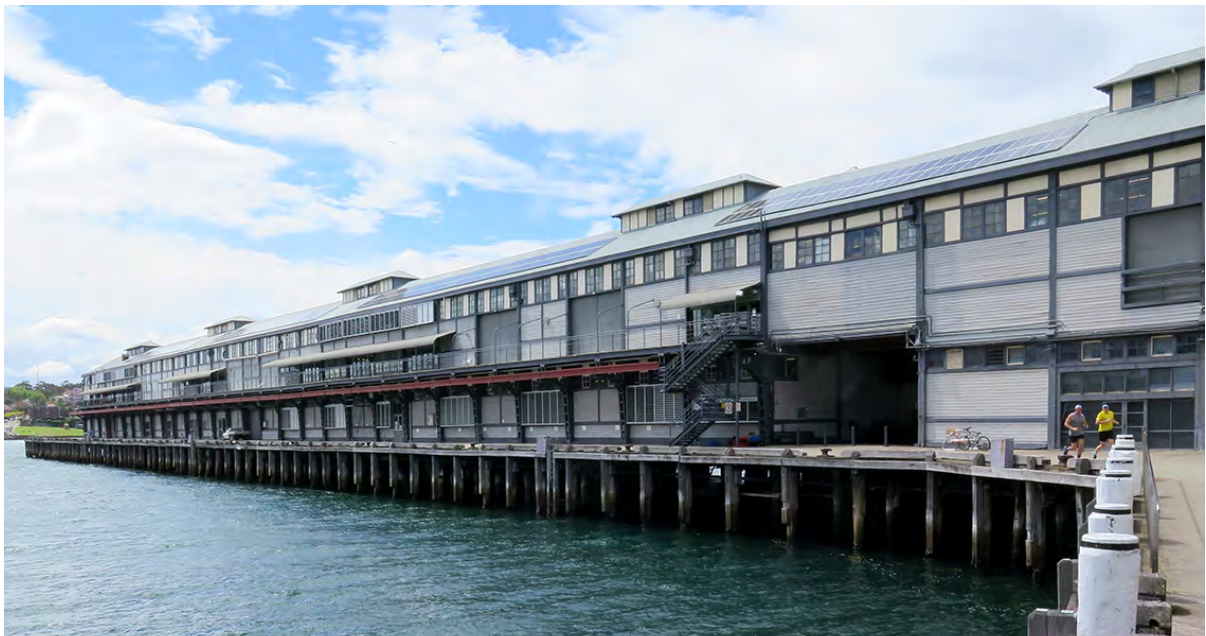
Figure 14: Western side of Wharf 4/5. (Source: CRM 2016)

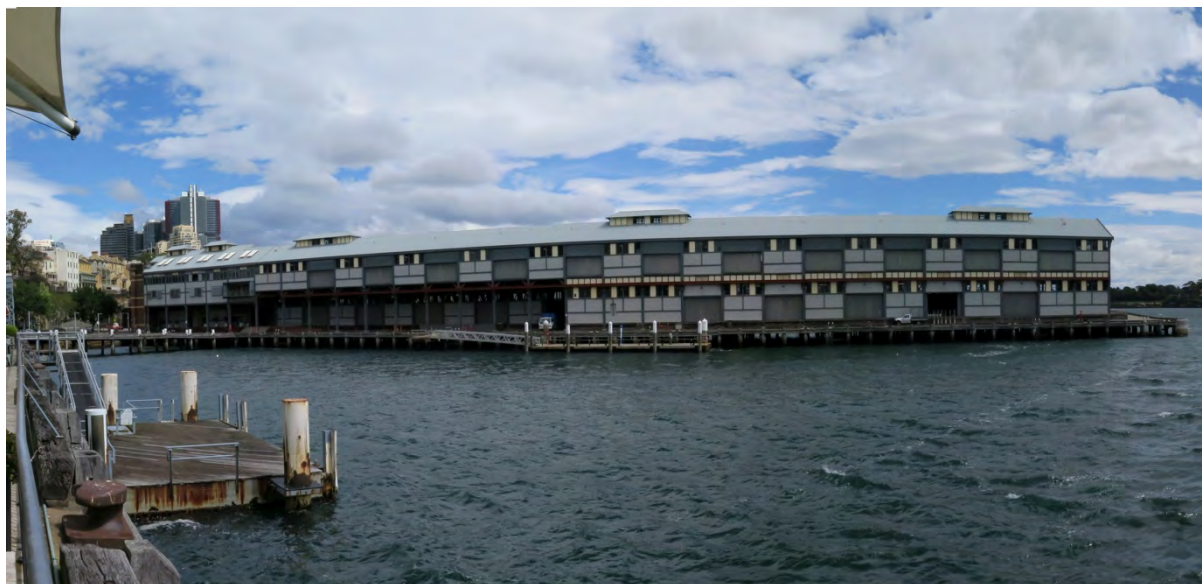
Figure 15: Eastern side of Pier 2/3. (Source: CRM 2016)

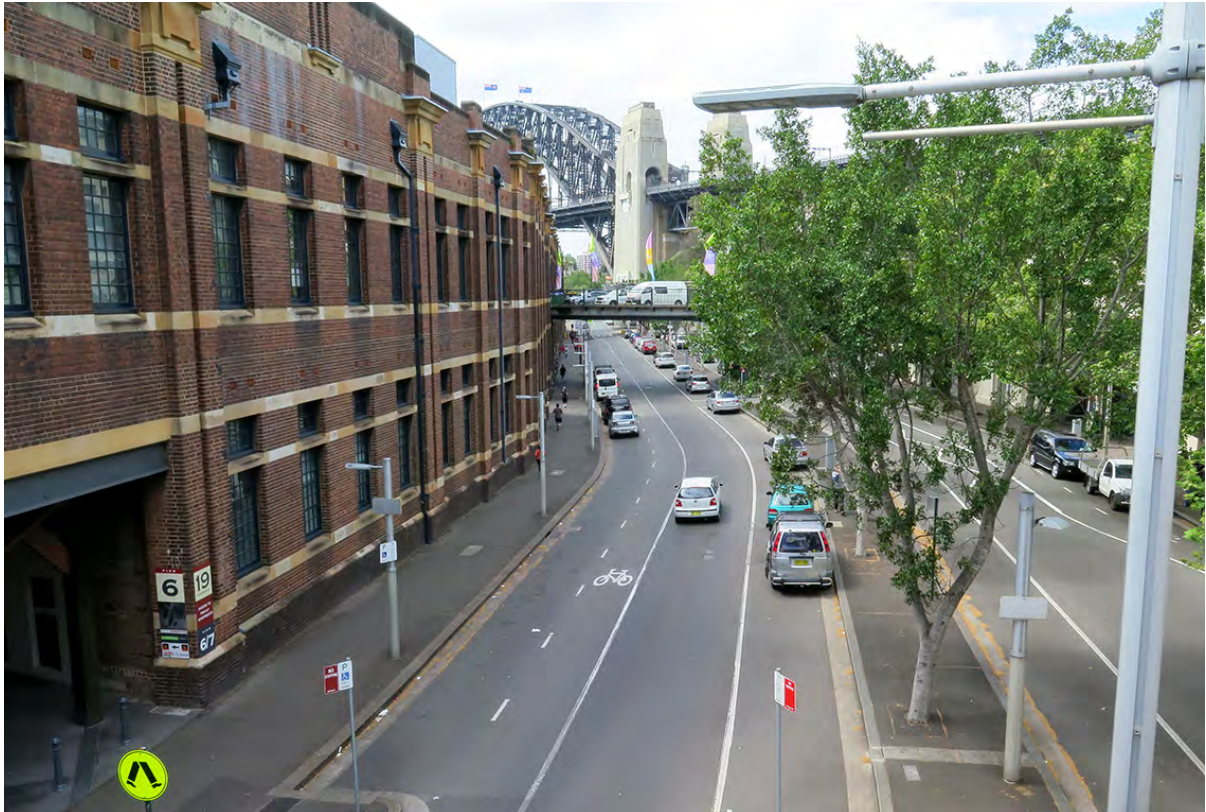
Figure 80: View east along Hickson Road. (Source: CRM 2016)

- Pier 2/3 and Wharf 4/5 are constructed on a series of timber piles and comprise of a two storey warehouse structures (*Figure 17*).
- The current sea wall comprises a dressed sandstone wall running below the wharves (*Figure 18*).
- The quarried sandstone bedrock can be seen on the south side of Hickson Road and Pottinger Street (*Figure 19*).
- The undulating surface of the former natural topography can be seen in the undulating levels of the sandstone retaining wall which has been constructed on top of the bedrock cliff face (*Figure 19*).
- The original timber bridges between the upper storeys of the piers and Pottinger Street have been replaced with steel bridges set on concrete plinths or steel piers (*Figure 21*).
- A number of underground services have been installed below the current footpaths including sewerage, stormwater and telecommunications.

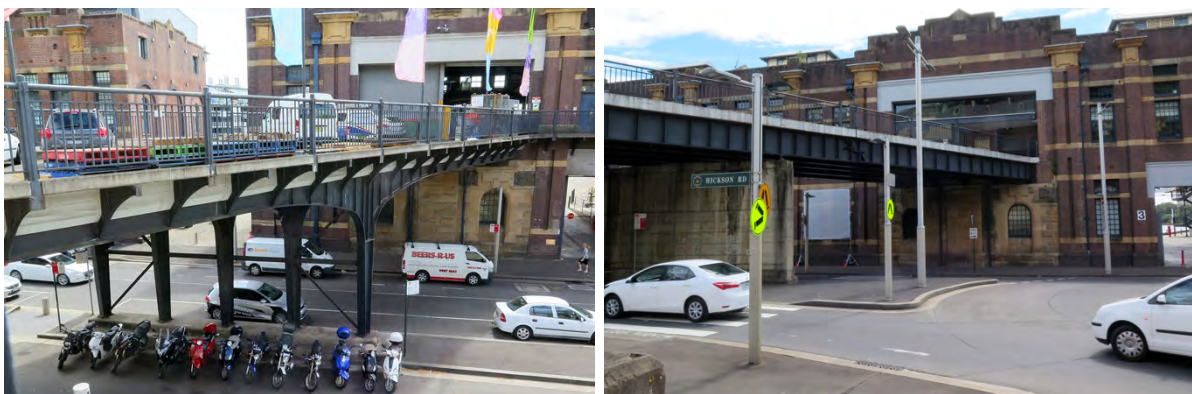
Figure 21: Bridges from Pottinger Street to Wharf 4/5 (L) and Pier 2/3 (R). (Source: CRM 2016)
