EXPANSION OF THE CONCRUSH RESOURCE RECOVERY FACILITY, TERALBA

Prepared for Concrush Pty Ltd
Prepared by RCA Australia
RCA ref 13589-803/2
June 2020

# REMEDIAL ACTION PLAN PROPOSED CONCRUSH FACILITY EXPANSION RACECOURSE ROAD TERALBA

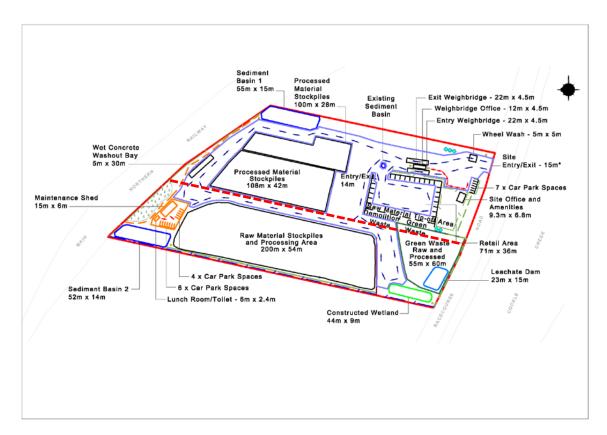
Figure 1 Stage 1 of the "Increase to Capacity" Project (approximate boundary between current facility and expansion portion in red dashed line).

The schematic of Stage 1 is presented in **Figure 1** below.

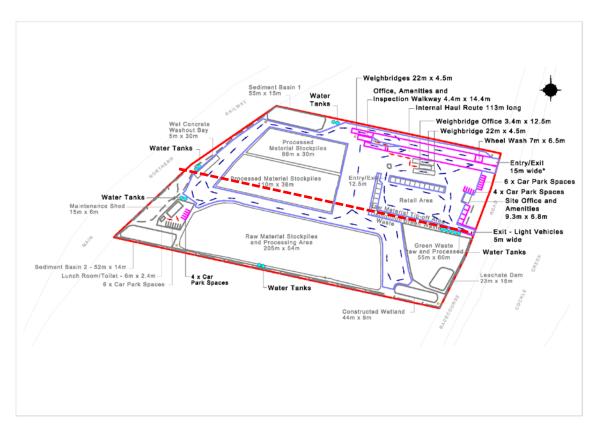
Figure 2 Stage 2 of the "Increase to Capacity" Project (approximate boundary between current facility and expansion portion in red dashed line).

The schematic of Stage 2 is presented in Figure 2 below.

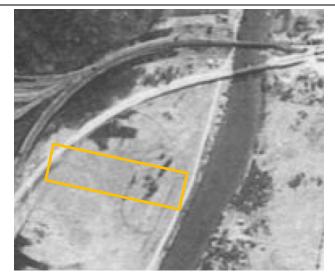
1954

The site appears to be vacant with the exception of what may be a racecourse. There doesn't appear to be any significant development within the area.

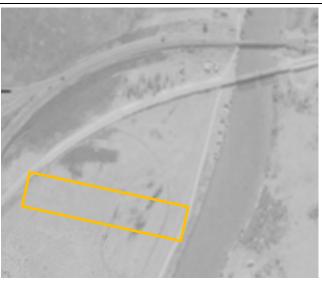
1961

The site appears to be unchanged: the definition of the presumed racecourse may be due to the photograph quality or it may be more formalised. There doesn't appear to be any significant development within the area.

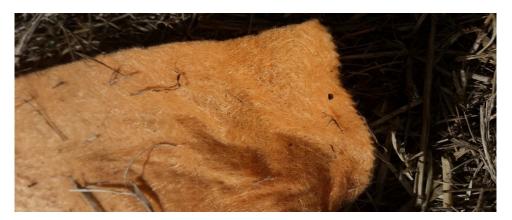
Figure 4 High Visibility Marker Layer

- Placement of the marker layer across the surface of the site to the extent as shown in Drawing 2, Appendix A.
  - An indication of the type of marker layer to be used in shown in Figure 3 below.

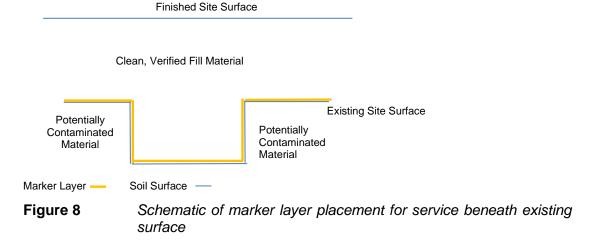
Marker layer is to be placed on the walls and base of any excavations below the
existing surface. A schematic of the treatment of services trenches below the
potentially contaminated surface, if any, is shown in Figure 8 below.

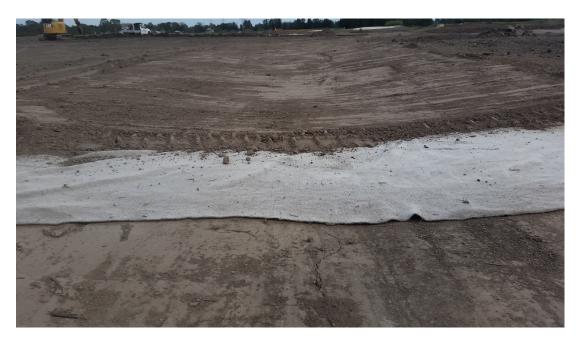
Figure 10 Geomembrane

**HOLD POINT** At least one inspection by the contaminated land consultant is to sight placement of the membrane.

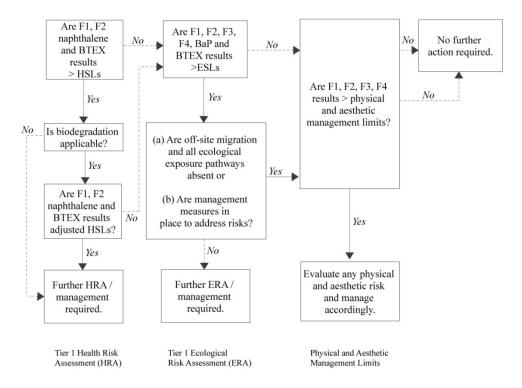
Figure 12 Flowchart for the Tier 1 human and ecological risk assessment of petroleum hydrocarbon contamination – application of HSL and ESL and consideration of management limits

The following figure has been taken from the ASC NEPM (Ref [7]) to illustrate the assessment methodology in regard to petroleum contamination.
