## Karuah South Quarry Resource Assessment

# Karuah South Quarry

## Resource Assessment

Prepared for Wedgerock Pty Ltd

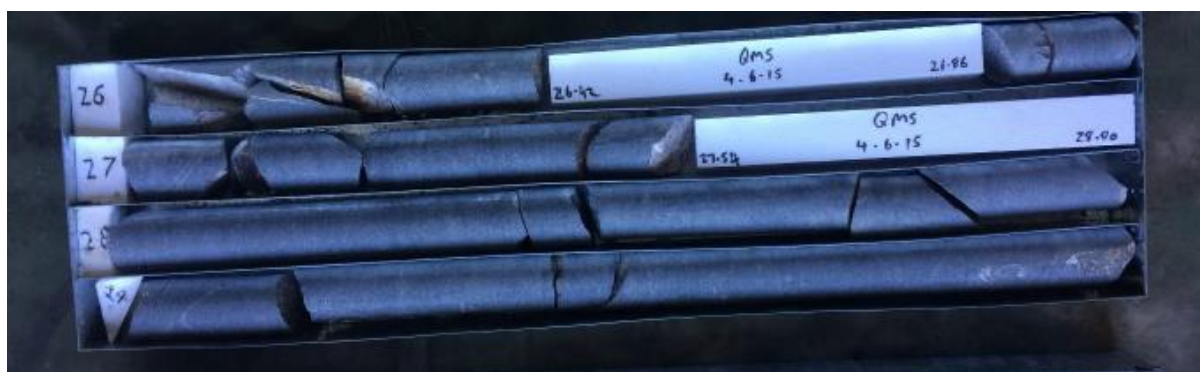
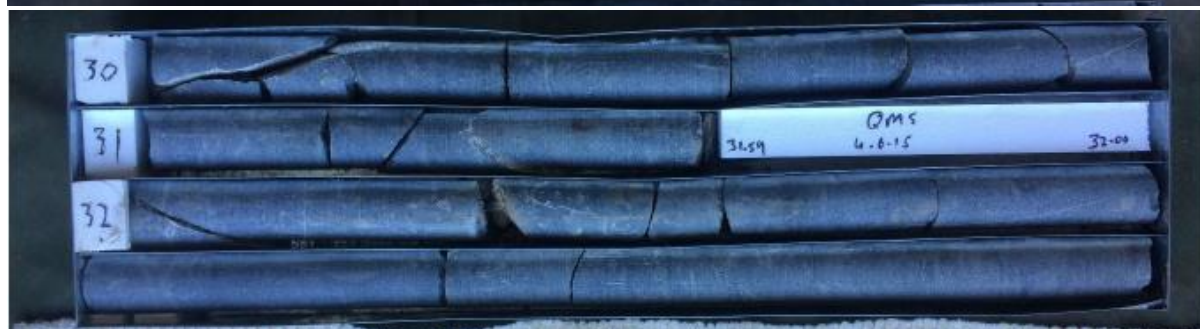
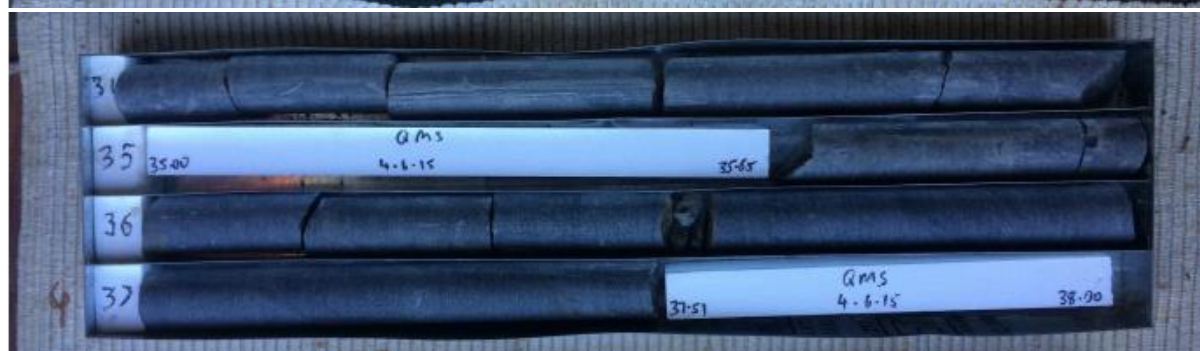
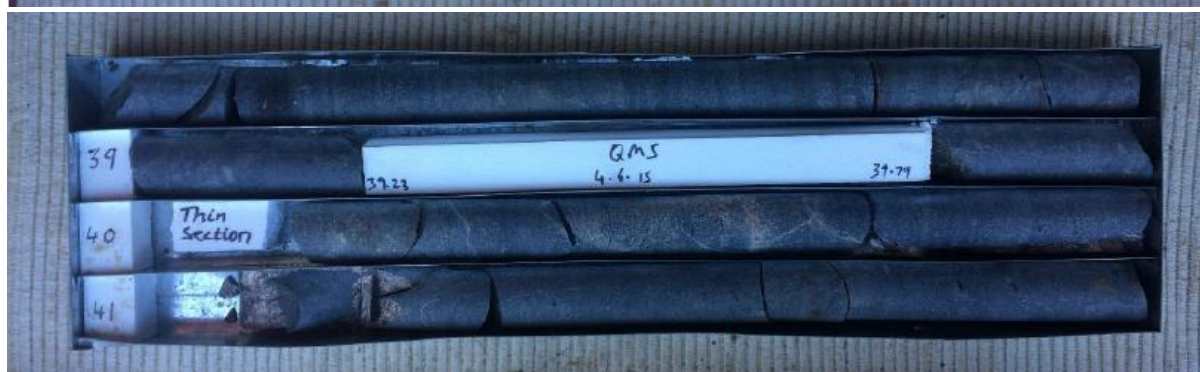
## Core Trays BH4A

Core - blue/grey crystalline rock, medium grained, with numerous joints/fractures horizontal to steeply inclined with brown weathered margins, faint sub-horizontal banding. Some small (up to 5cm) inclusions of fine grained rock (shale?)  
at 6.5m, rock becomes increasingly massive with depth, with decreasing number of parting planes. Some thin veins filled with white mineral (calcite?) Some small patches (1 - 2cm) of black fine grained rock with crystal inclusions.  
Significant water loss between 32m and 35m; no core loss but note thin band of crumbly brown weathered material at 32.4m in fracture inclined at 25-30° (regional dip?)  
End of hole at 42.0m
