Report on  
Geotechnical Investigation

Parramatta Leagues Club Hotel  
1 Eels Place, Parramatta

Prepared for  
Parramatta Leagues Club

Project 94523.00  
December 2018

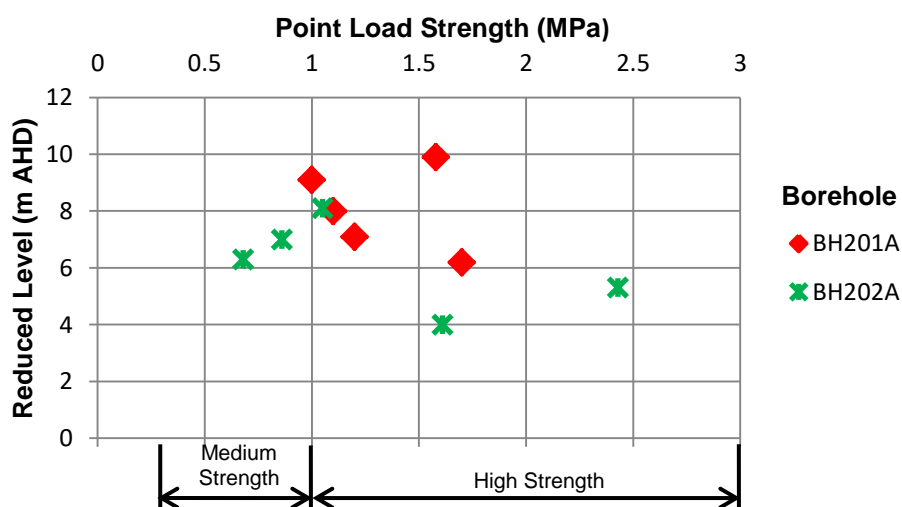
Figure 2: Point Load Strength ( $Is_{50}$ ) Results at various depths

Point Load Strength Index ( $Is_{50}$ ) testing was carried out on selected rock core specimens. The results of the tests are given on the borehole logs at the appropriate depths. Figure 2 below shows the range of  $Is_{50}$  results at the various depths (shown as Reduced Levels relative to AHD).

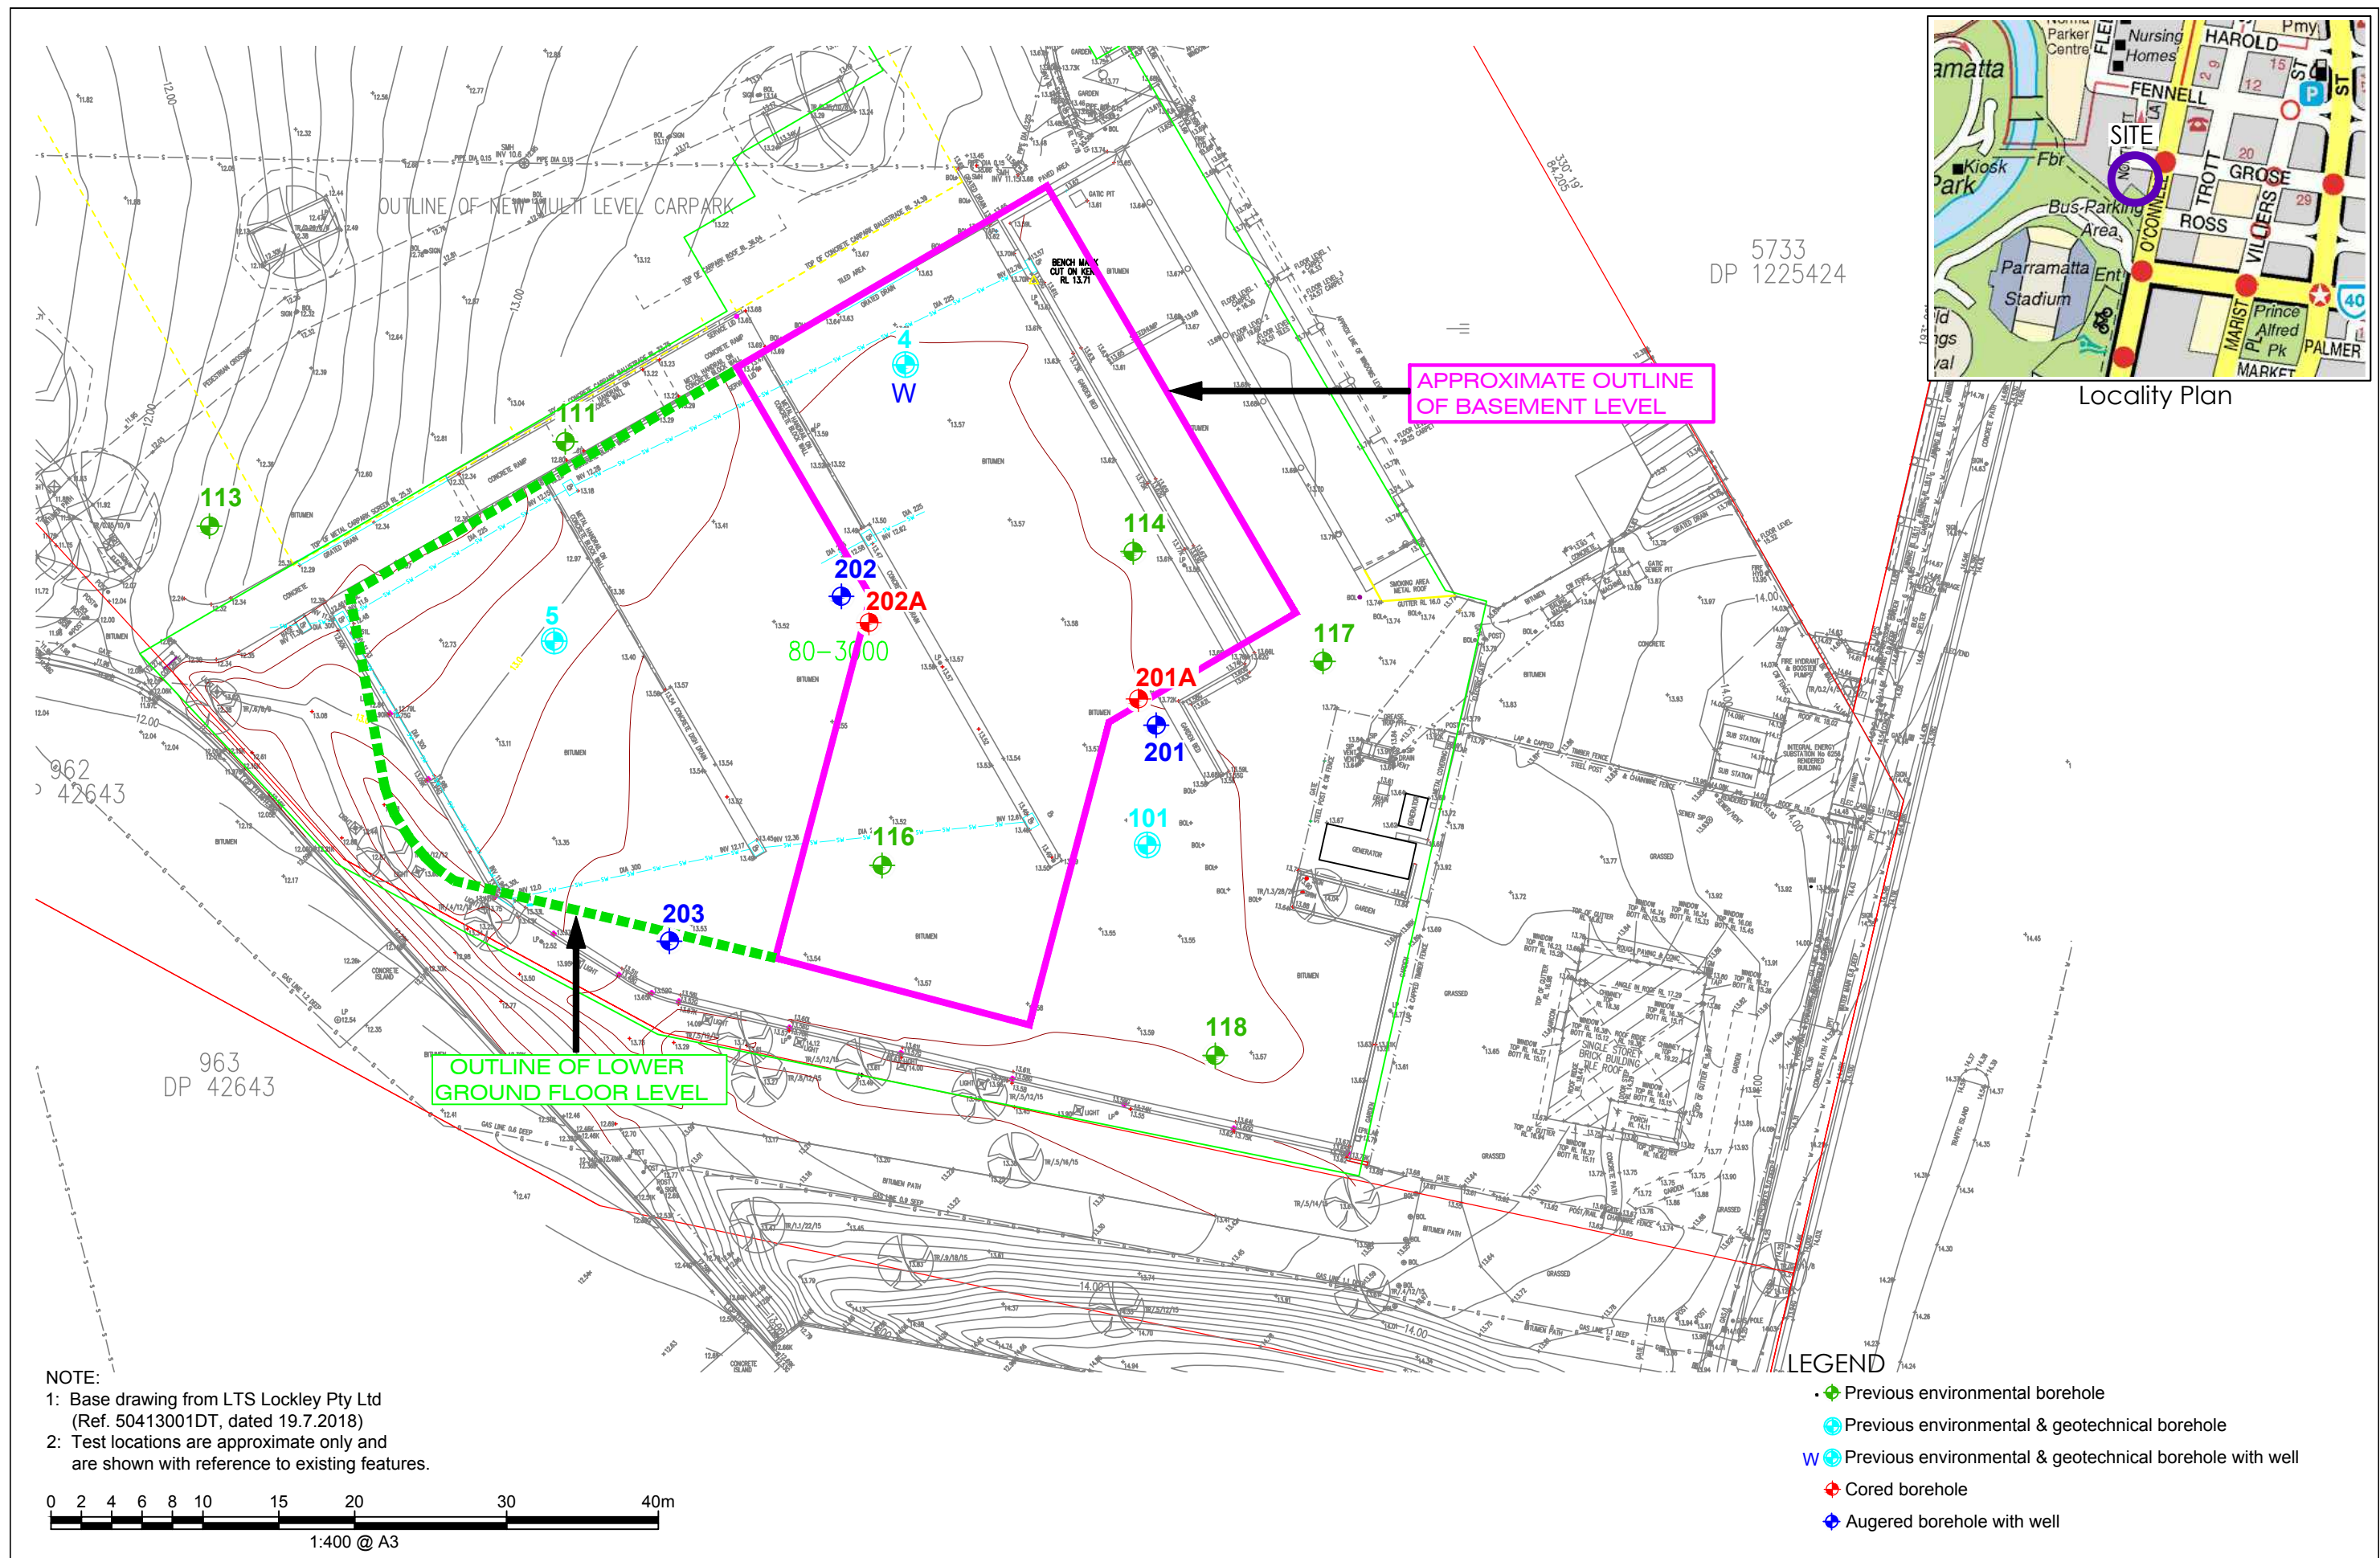
| | OFFICE: Riverstone | DRAWN BY: PSCH | | | DRAWING No: 1 |

| | CLIENT: Parramatta Leagues Club | | TITLE: <b>Location of Tests</b><br><b>Parramatta Leagues Club Hotel</b><br><b>1 Eels Place, PARRAMATTA</b> | | PROJECT No: 94523.00 |
