Jemalong Hybrid Solar Park

PV Field Existing Conditions Technical Summary

Rev 1 | 16 November 2017

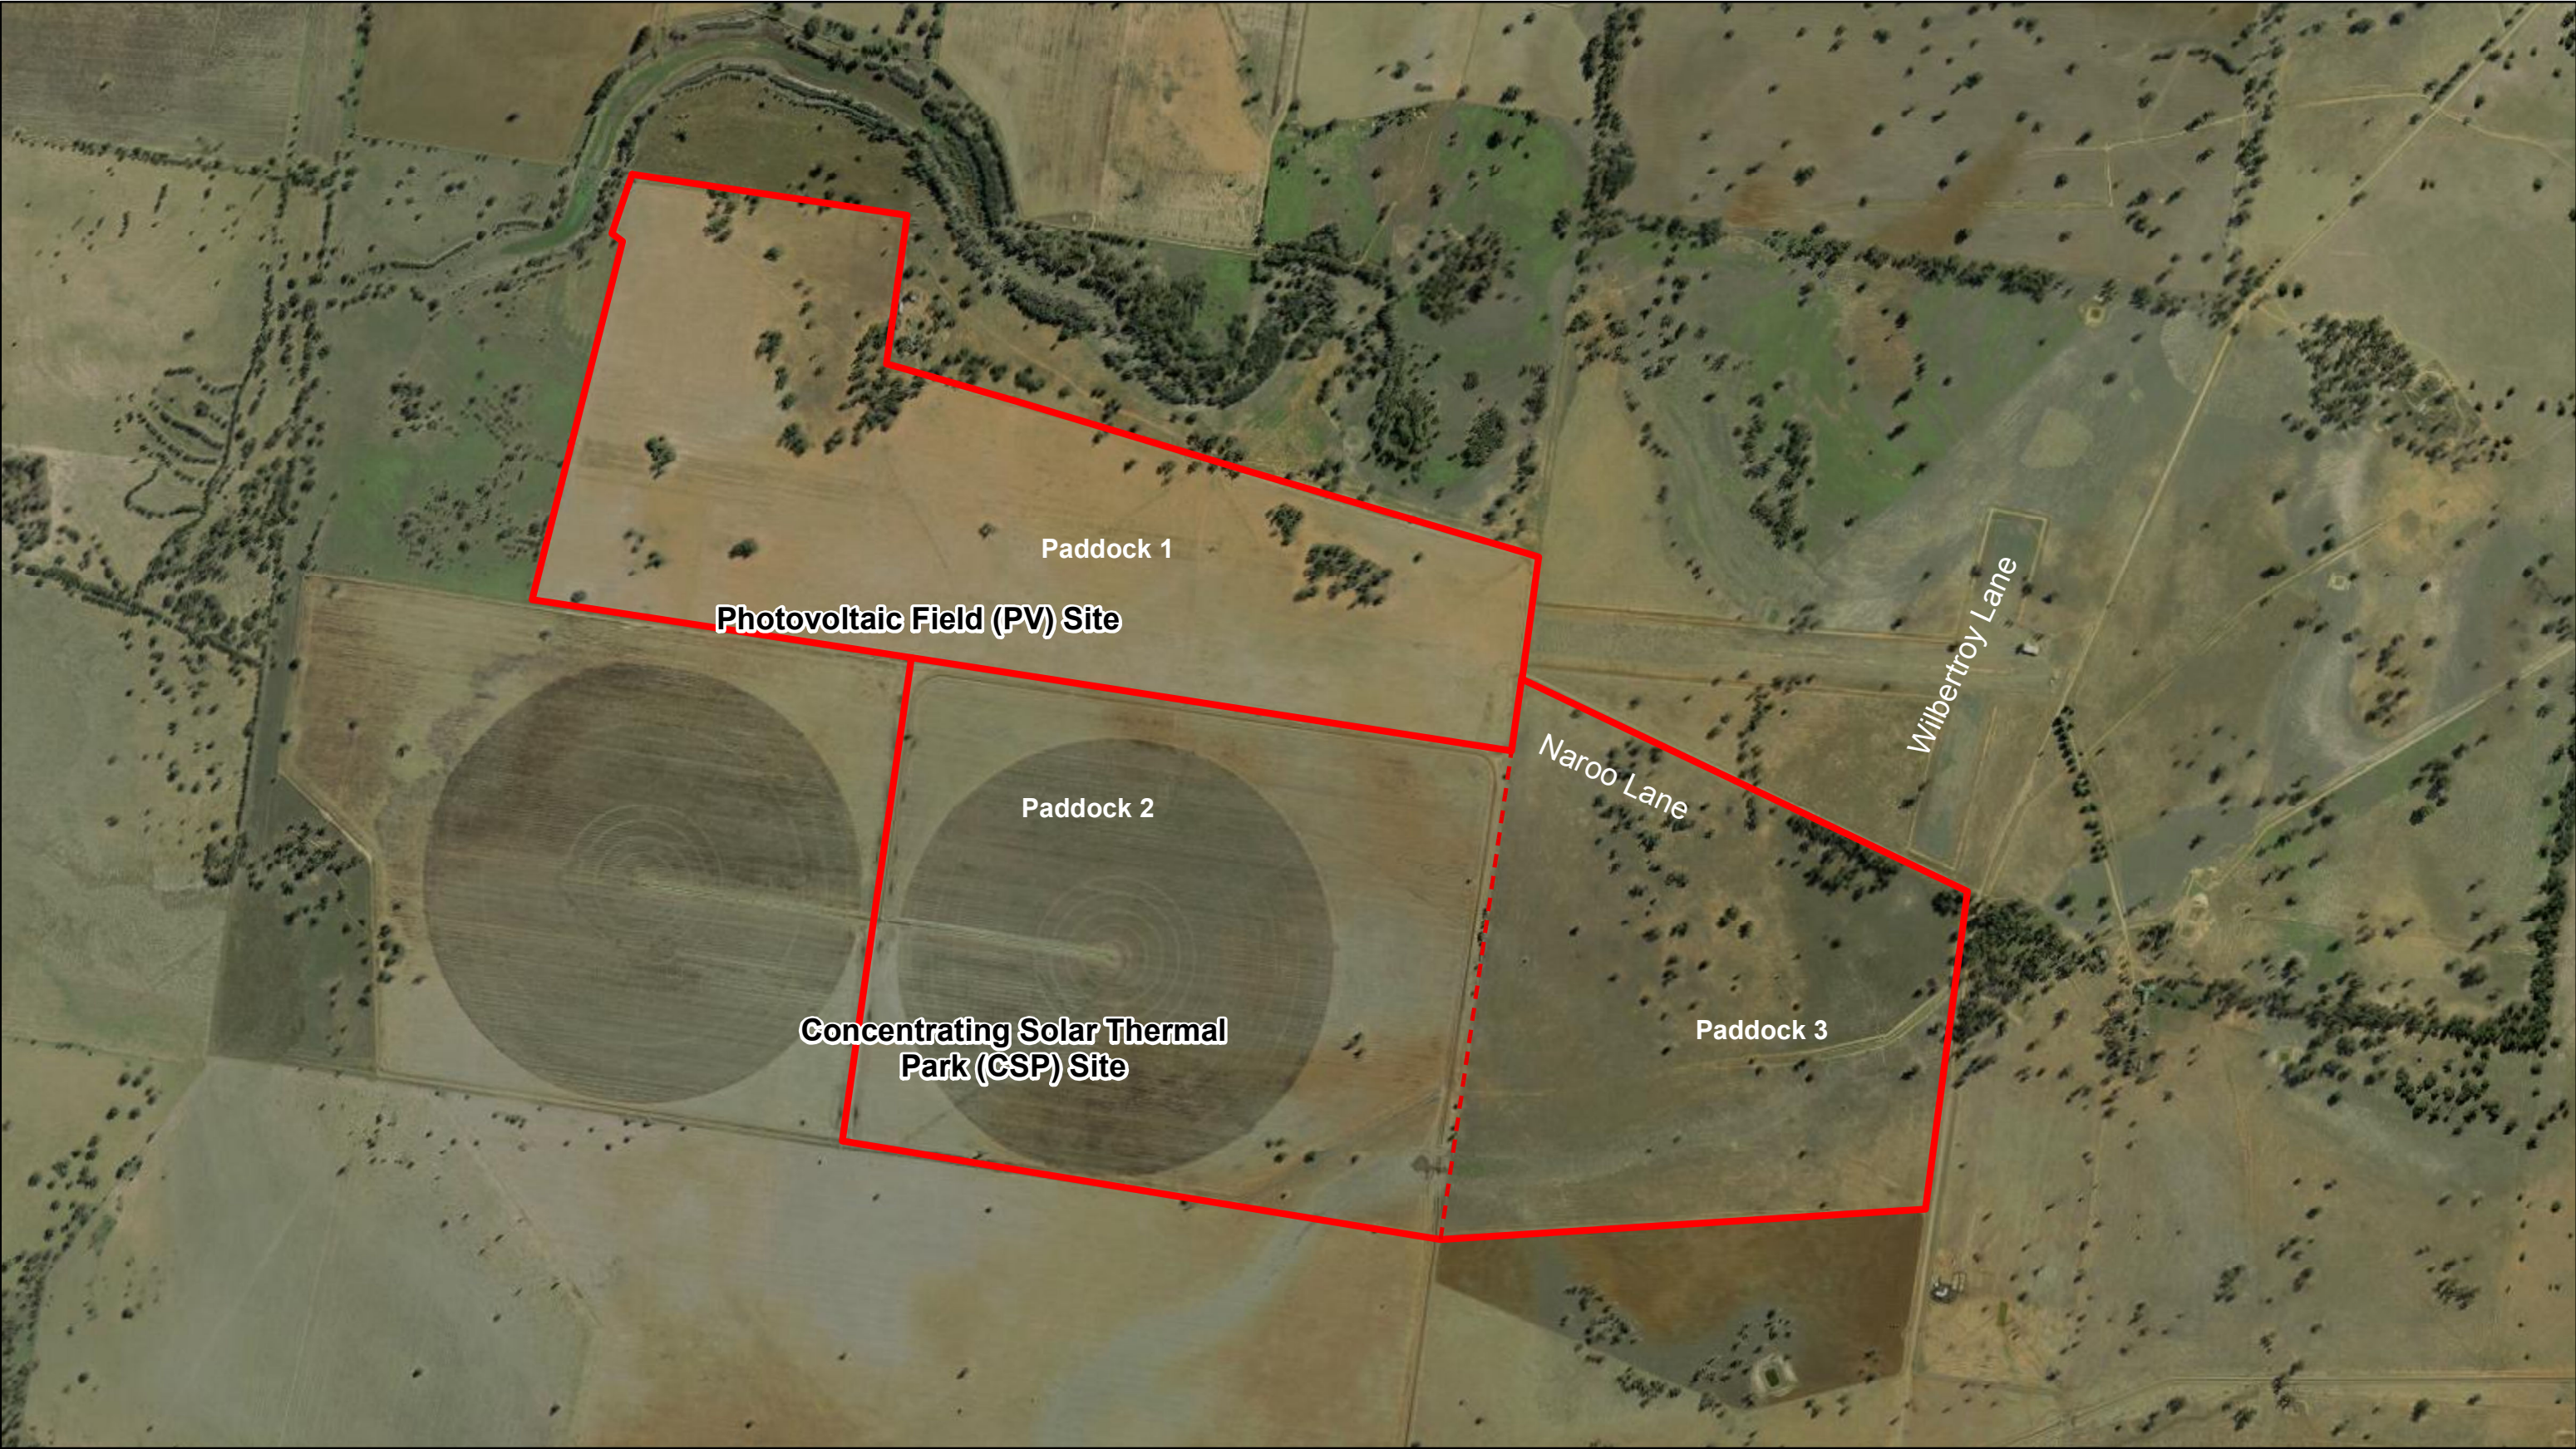
Site Location Plan

The site is located along Naroo Lane in Jemalong, approximately 3.5km southwest of the town of Jemalong and 36km west of the town of Forbes in western NSW.

The PV field occupies approximately 86 hectares and consists of generally open terrain with some areas of vegetation at the northern boundary of the site.

A site plan is included in Figure 1.

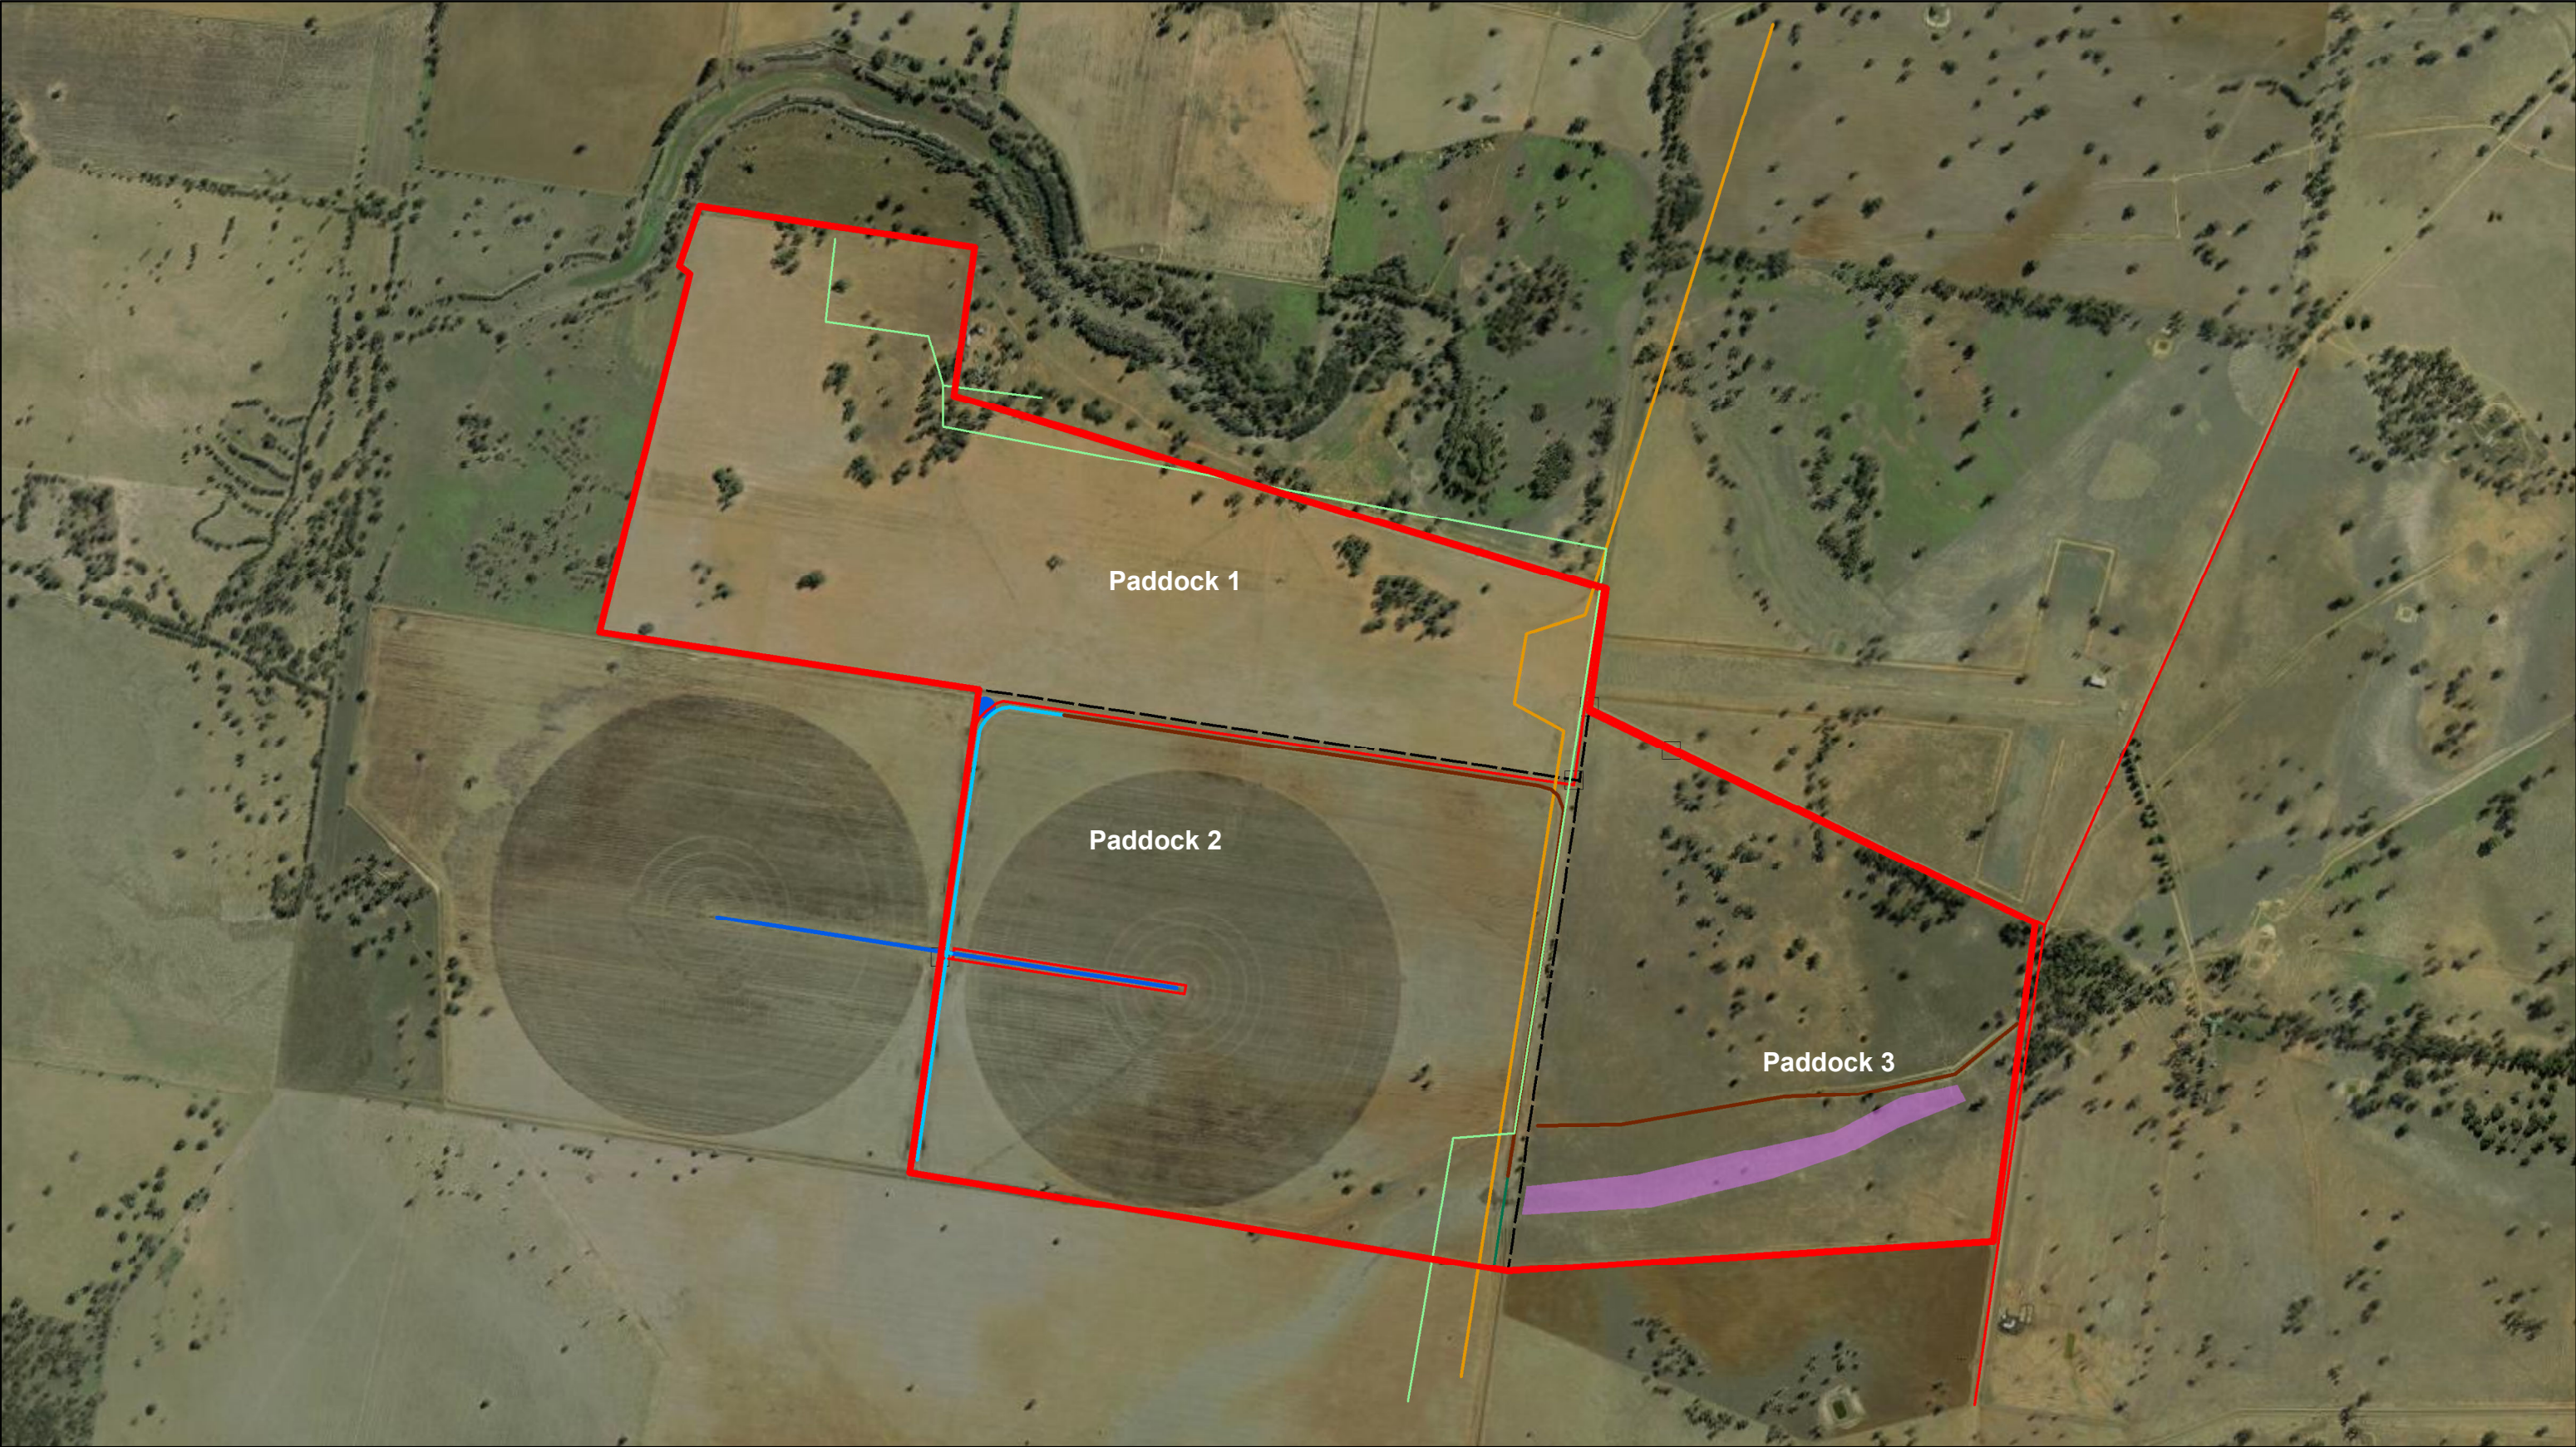
Site Observations

The site is on private property which is currently vacant and seasonally used as a grazing field. Desiccation cracks were observed across the site at ground surface with an aperture of up to 10 mm approximately 60 mm deep. Other site observations are shown on Figure 6.

The plans show two Telstra trenches. The first traverses east to west along the northern boundary of the CSP site. The second traverses from north to south along the eastern boundary of the CSP site. The plans also showed power lines present on

There is one underground irrigation pipe at the southern edge of the study boundary. This pipe transports water from one irrigation channel under an area of low ground to the next irrigation channel.
