Preliminary Salinity and Geotechnical
Assessment:
1111-1141 Elizabeth Drive, Cecil Park,
NSW

P1706121JR02V02
September 2018

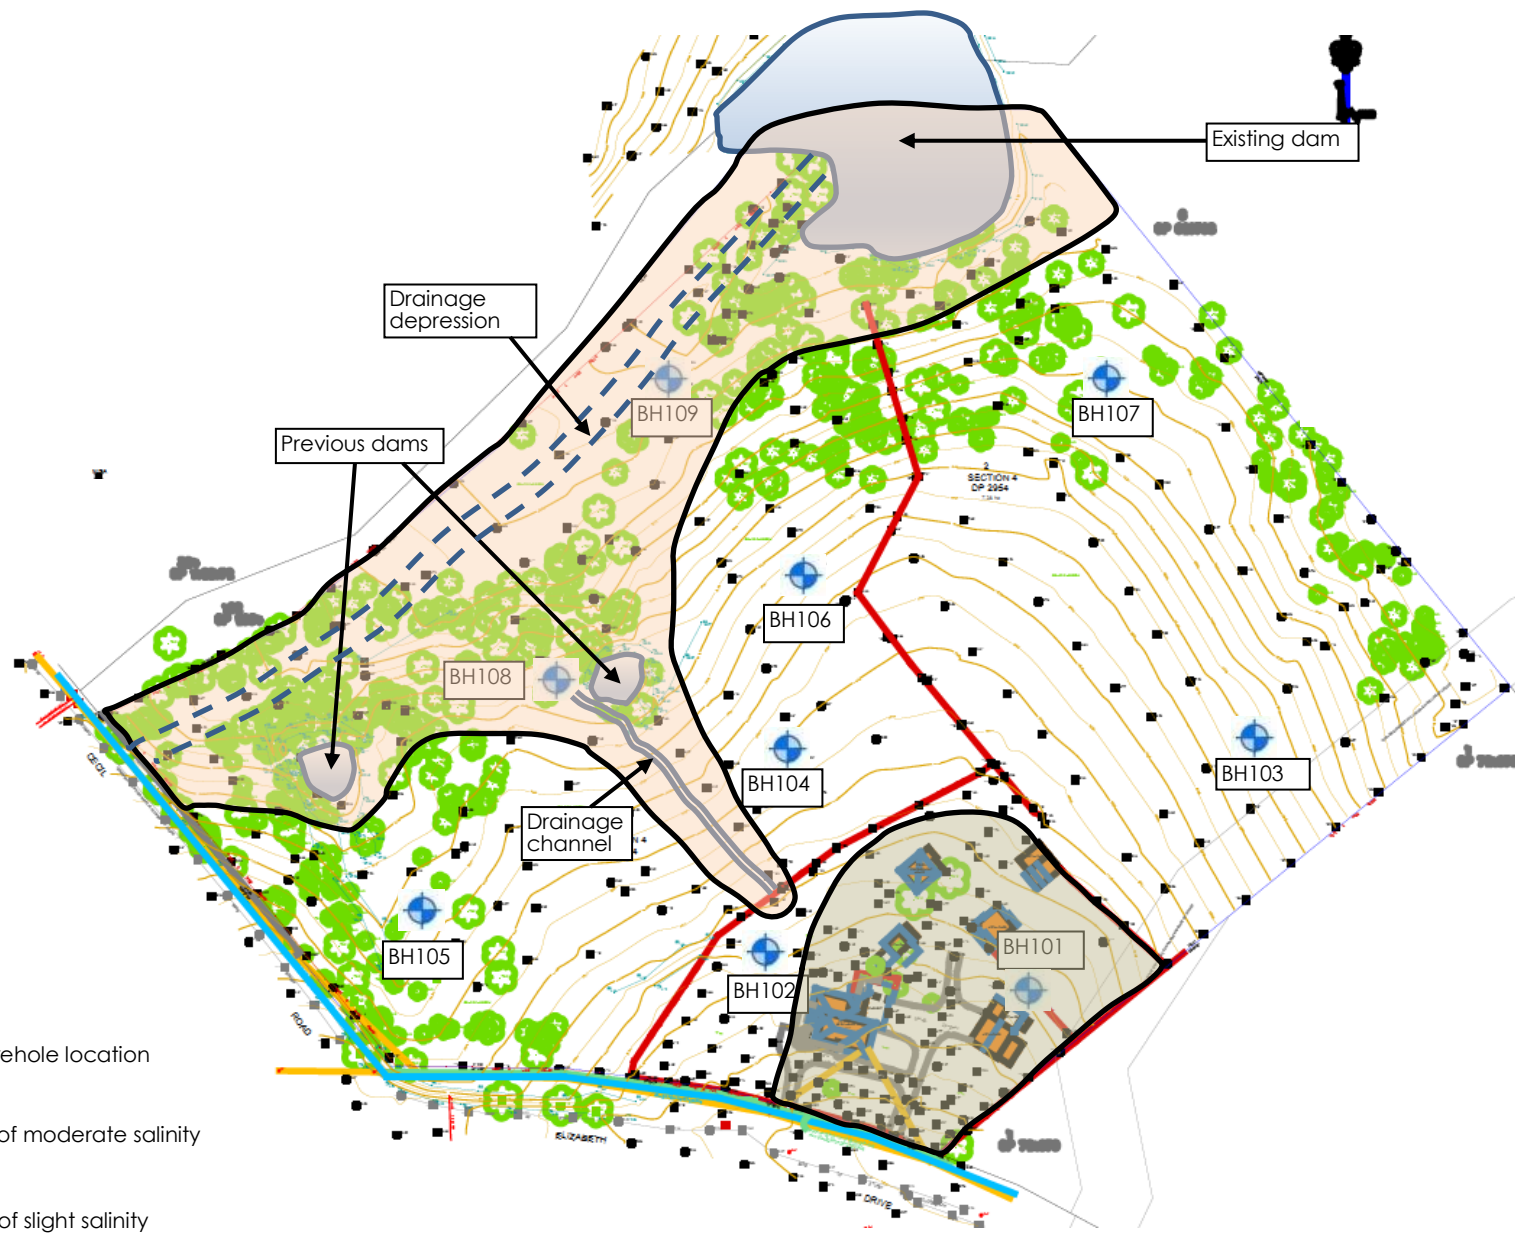
Drawing:	FIGURE 1
Job No: P1706121JR02V02

GEOTECHNICAL TESTING PLAN
1111-1141 Elizabeth Drive, Cecil Park, NSW
 (Source: Survey plan by Project Surveyors, Job Ref. B03838, dated July 2017)

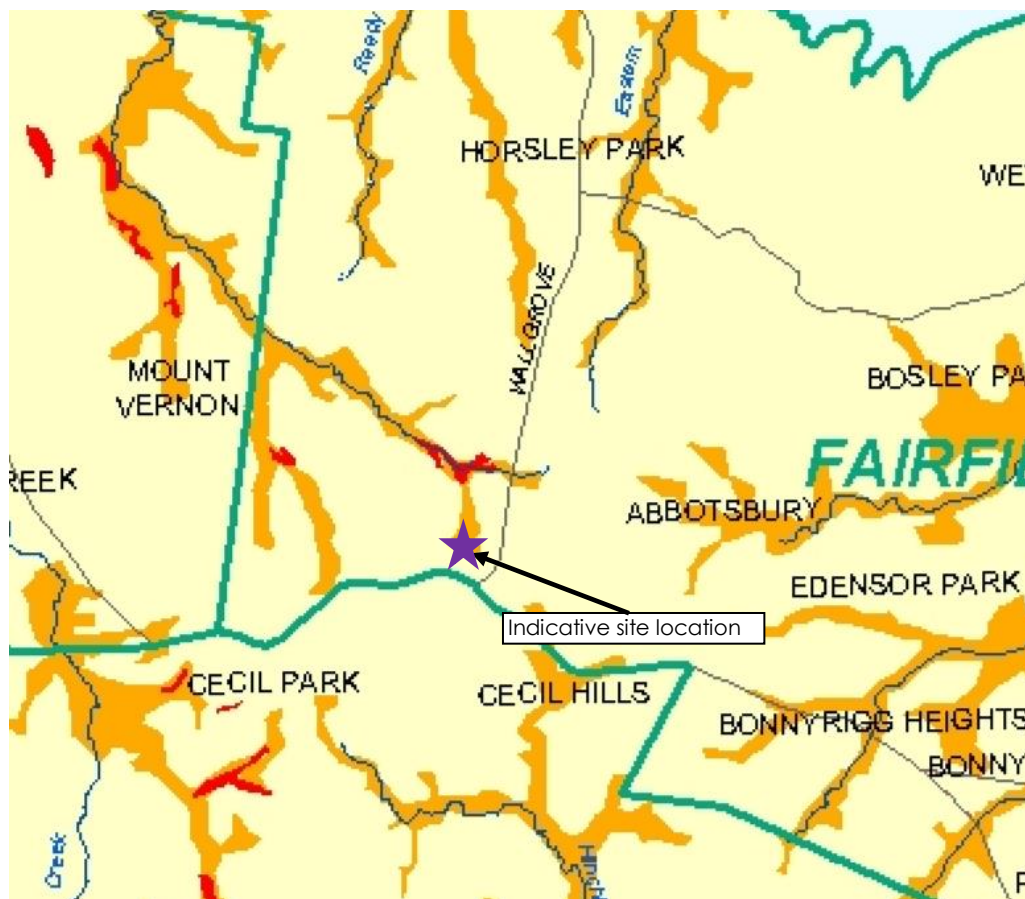
MAPPING CATEGORY	ASSOCIATED SOIL LANDSCAPES	LANDFORM - GEOLOGY
KNOWN SALINITY Areas where there is a known occurrence of saline soil, or where air photo interpretation and field observations have confirmed more than one of these: a - scalding b - salt efflorescence c - vegetation dieback d - salt tolerant plant species e - waterlogging A high relative wetness index occurs in these areas.	* Salinity outbreaks occur in Blacktown (bt), Luddenham (lu) and Richmond (ri) Soil Landscapes - common at breaks of slope, lower slopes and drainage lines. * Berkshire Park (bp) and Upper Castlereagh (up) Soil Landscapes have localised salinity due to the impermeable nature of the clay parent material. * South Creek (sc), Monkey Creek (mk), Freemans Reach (fr) and Theresa Park (tp) Soil Landscapes have common saline outbreaks due to high run-on and low local relief. * Soils in the above landscapes have high clay content in subsoils and are imperfectly to poorly drained.	* Break of slope, lower slope and drainage lines of Wianamatta Shales (Rwb, Rwa and Rwm). * Localised salinity also occurs at the geological boundary between Tertiary Gravels (Tl, Tr) and underlying Wianamatta Shales (Rwb, Rwa/Quaternary Alluvials (Qpd, Qpa, Qpl, Qal). * Localised salinity occurs in Quaternary Alluvium (Qal, Qpn, Qpd) which underlies many of the drainage systems and wetland margins.

HIGH SALINITY POTENTIAL Areas where soil, geology, topography and groundwater conditions predispose a site to salinity. These conditions are similar to areas of known salinity (see above). These areas are most common on lower slopes and drainage systems where water accumulation is high (i.e. high relative wetness index).	* Soil Landscapes include Birrong (bi), Blacktown (bt) Berkshire Park (bp), Freemans Reach (fr), South Creek (sc), Theresa Park (tp), Richmond (ri) and Luddenham (lu). Drainage systems and convergent slopes are areas of highest risk. * Soils in these landscapes have high clay content in the subsoils, low permeability and high run-on. * Soil profiles may display signs of high salt concentrations at depth (i.e. >0.5m).	* Salinity is most likely to occur in lower slopes, foot-slopes, floodplains and creek lines on Quaternary Sediments (Qal, Qpn, Qpd, Qpc, Qpp, Qha) Wianamatta Shales (Rwb, Rwm, Rwa) where run-on is high, resulting in seasonally high water tables and soil saturation.

MODERATE SALINITY POTENTIAL Areas on Wianamatta Group Shales and Tertiary Alluvial Terraces. Scattered areas of scalding and indicator vegetation have been noted but no concentrations have been mapped. Saline areas may occur in this zone, which have not yet been identified or may occur if risk factors change adversely.	* Areas of Agnes Banks (ab), Berkshire Park (bp), Blacktown (bt), Luddenham (lu) and Lucas Heights (lh). * Steeper areas with moderate to high local relief and well drained subsoils such as Pidgin (pn), West Pennant Hills (vp) and Glenorie (gn) are at a lower risk of developing salinity. * Soils are moderate to well-drained due to their elevated position in the landscape.	* Hill-slopes and hill-crests on Wianamatta Shales (Rwb, Rwm, Rwa). * Raised abandoned alluvial terraces and drainage lines on Quaternary Alluvium (Qal, Qpn, Qpd, Qpc, Qpp) from Richmond to Camden and east to Rookwood. Localised areas of elevated, well-drained Tertiary Gravels (Ta, Tl, Tr).

VERY LOW SALINITY POTENTIAL Areas where salinity processes do not operate or are of minor significance. Soils are rapidly drained and underlying strata (Hawkesbury/Narrabeen Sandstone) are highly permeable, resulting in continual flushing and removal of salts in the landscape. No salinity has been observed in these areas and is not expected to occur.	* Rapidly drained soil landscapes with shallow soils include Warragamba (wb) and Hawkesbury (ha). * Gymea (gy) and Faulconbridge (fb) Soil Landscapes consist of highly permeable sands with well-drained subsoils. * Soils are well to rapidly drained. * Soils have high sand content.	* Occurring on Hawkesbury and Narrabeen Sandstone (Rh, Rno). * Groundwater is relatively fresh in these areas due to the sandstone's elevated position in the landscape and highly permeable nature, resulting in continuous flushing of the system (removal of any accumulated salts).

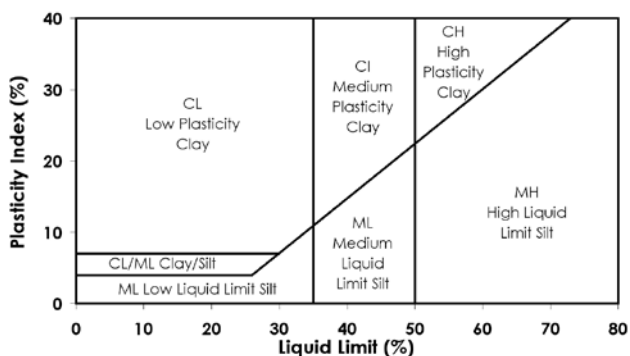
Plasticity Properties

Plasticity properties of cohesive soils can be assessed in the field by tactile properties or by laboratory procedures.
