## **SOIL SURVEY REPORT**

### **WELLINGTON NORTH SOLAR FARM**

**March 2018**

**DM McMahon Pty Ltd**

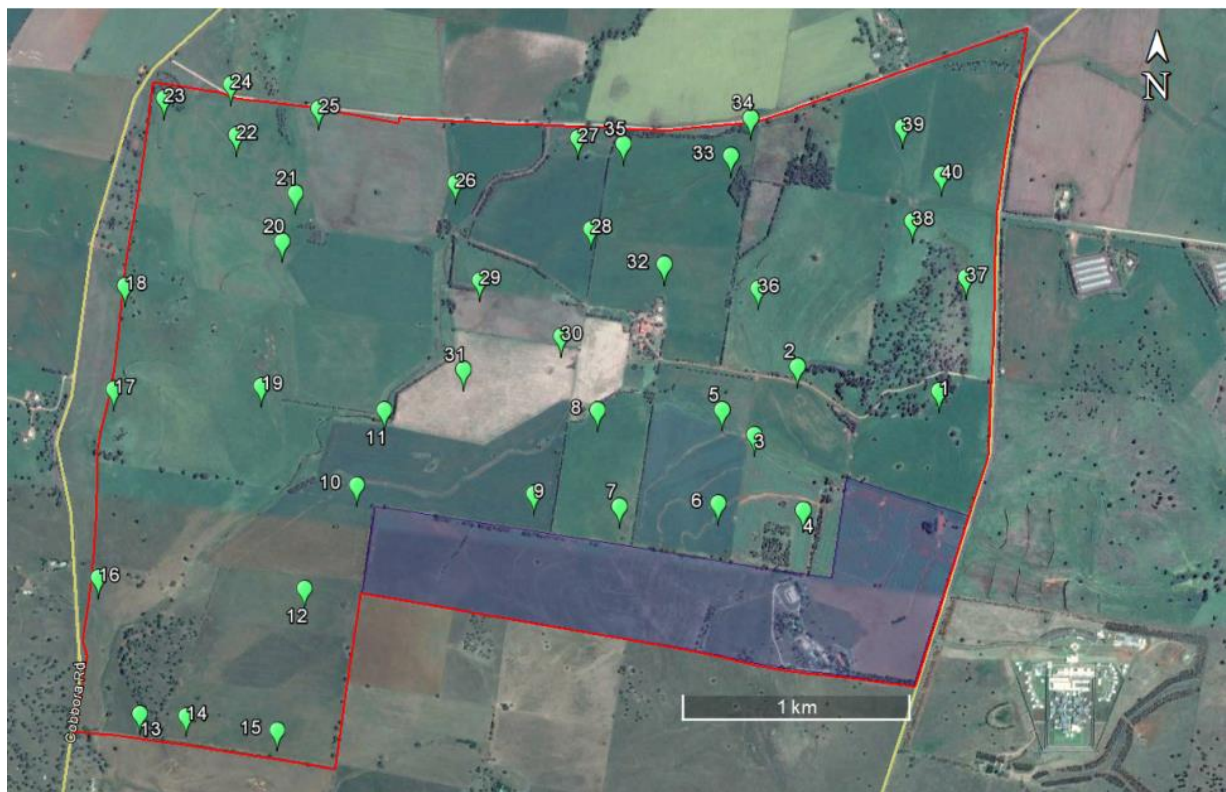
**Figure 1:** Soil survey investigation pit locations.

As follows is a map of the investigated site and investigation pit locations, **Figure 1**.

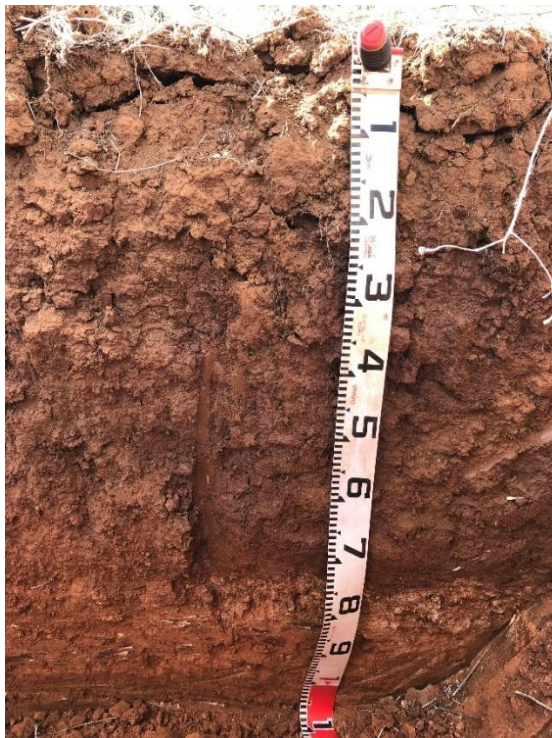
Dark reddish-brown clay loams to light clays, moderately well-structured with sub-angular or angular blocky peds. Field pH increases from 5.5 to 7.0 in the A horizon; to 35cm depth. Gradual boundary to-

Moderately to strongly structured reddish-brown light to medium clays with smooth-faced, sub-angular or polyhedral peds. Gravel increases with depth and soft nodules of calcium carbonate begin to appear at about 90cm depth. Field pH 8.0 to 8.5.

**Figure 2:** Typical soil profile with A and B horizons.

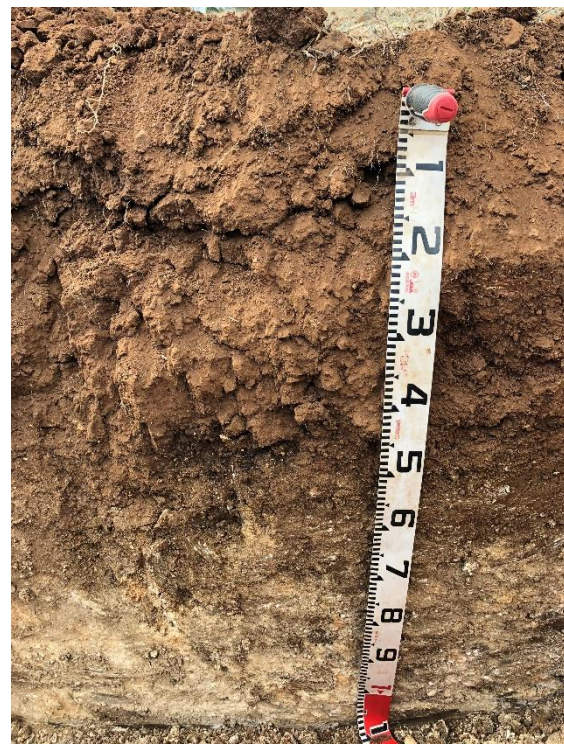
**Figures 2 and 3** represent typical soil profiles on site.

**Figure 3:** Typical soil profile with A, B and C horizons.

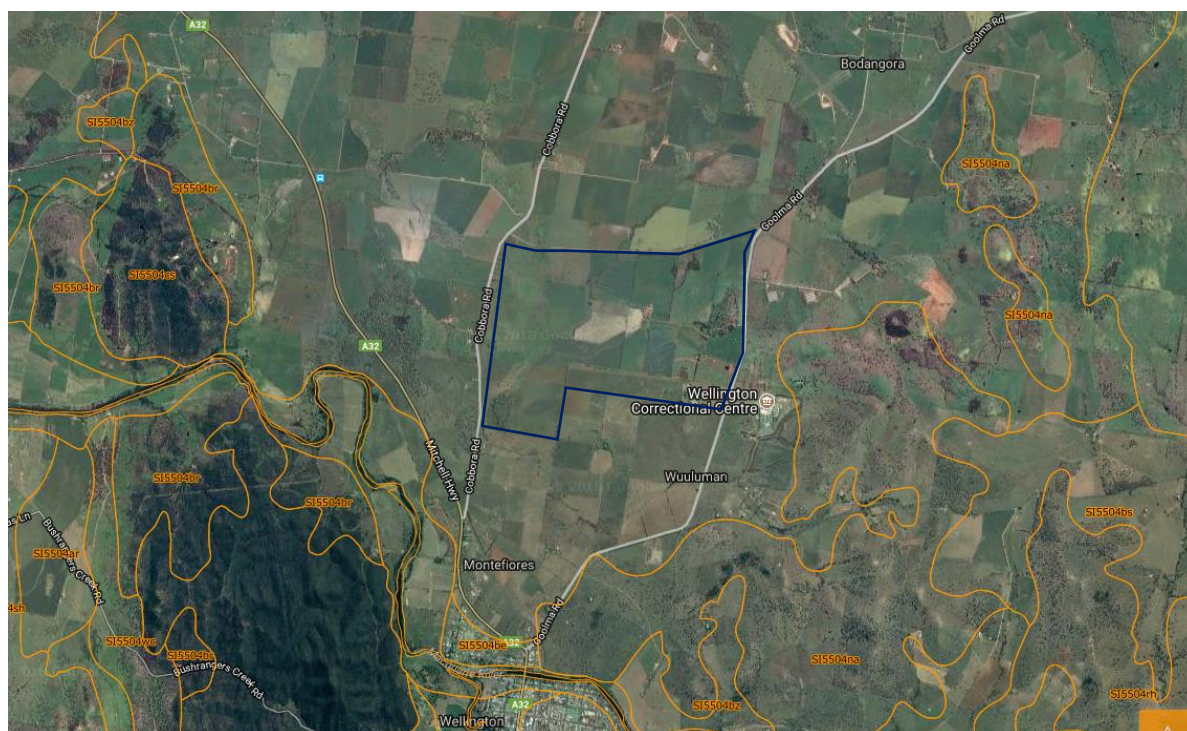
As follows is the soil landscape map (eSpade, 2017) that has been generally validated by the soil survey through laboratory and field techniques, **Figure 4**. As such, management practices can be grouped into management classes of either soil landscape units or Australian Soil Classification units. This report identifies management practices for ASC units in section 6.5 below.

**Figure 4:** Bodangora soil landscape with site overlay.

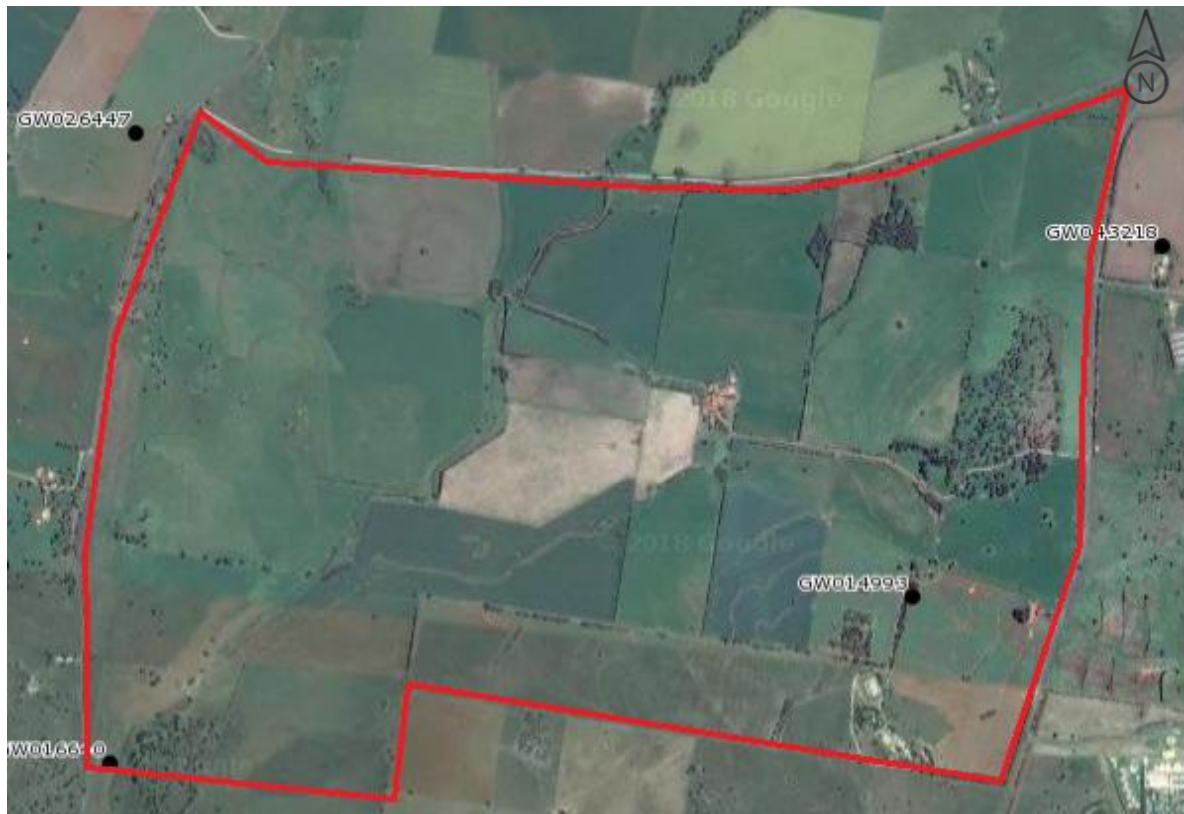
There are four groundwater bores found within and around the subject site as can be seen in **Figure 5** below.

**Figure 5:** Registered groundwater bores on and near the site.

The details of the bore construction for the bores located above are shown as follows in **Table 6** (DPI, 2018).
