## **Site Audit Report**

**Ivanhoe Estate  
Macquarie Park, NSW 2113**

**Report Reference: 600138\_0301-1803**

# Remediation Action Plan

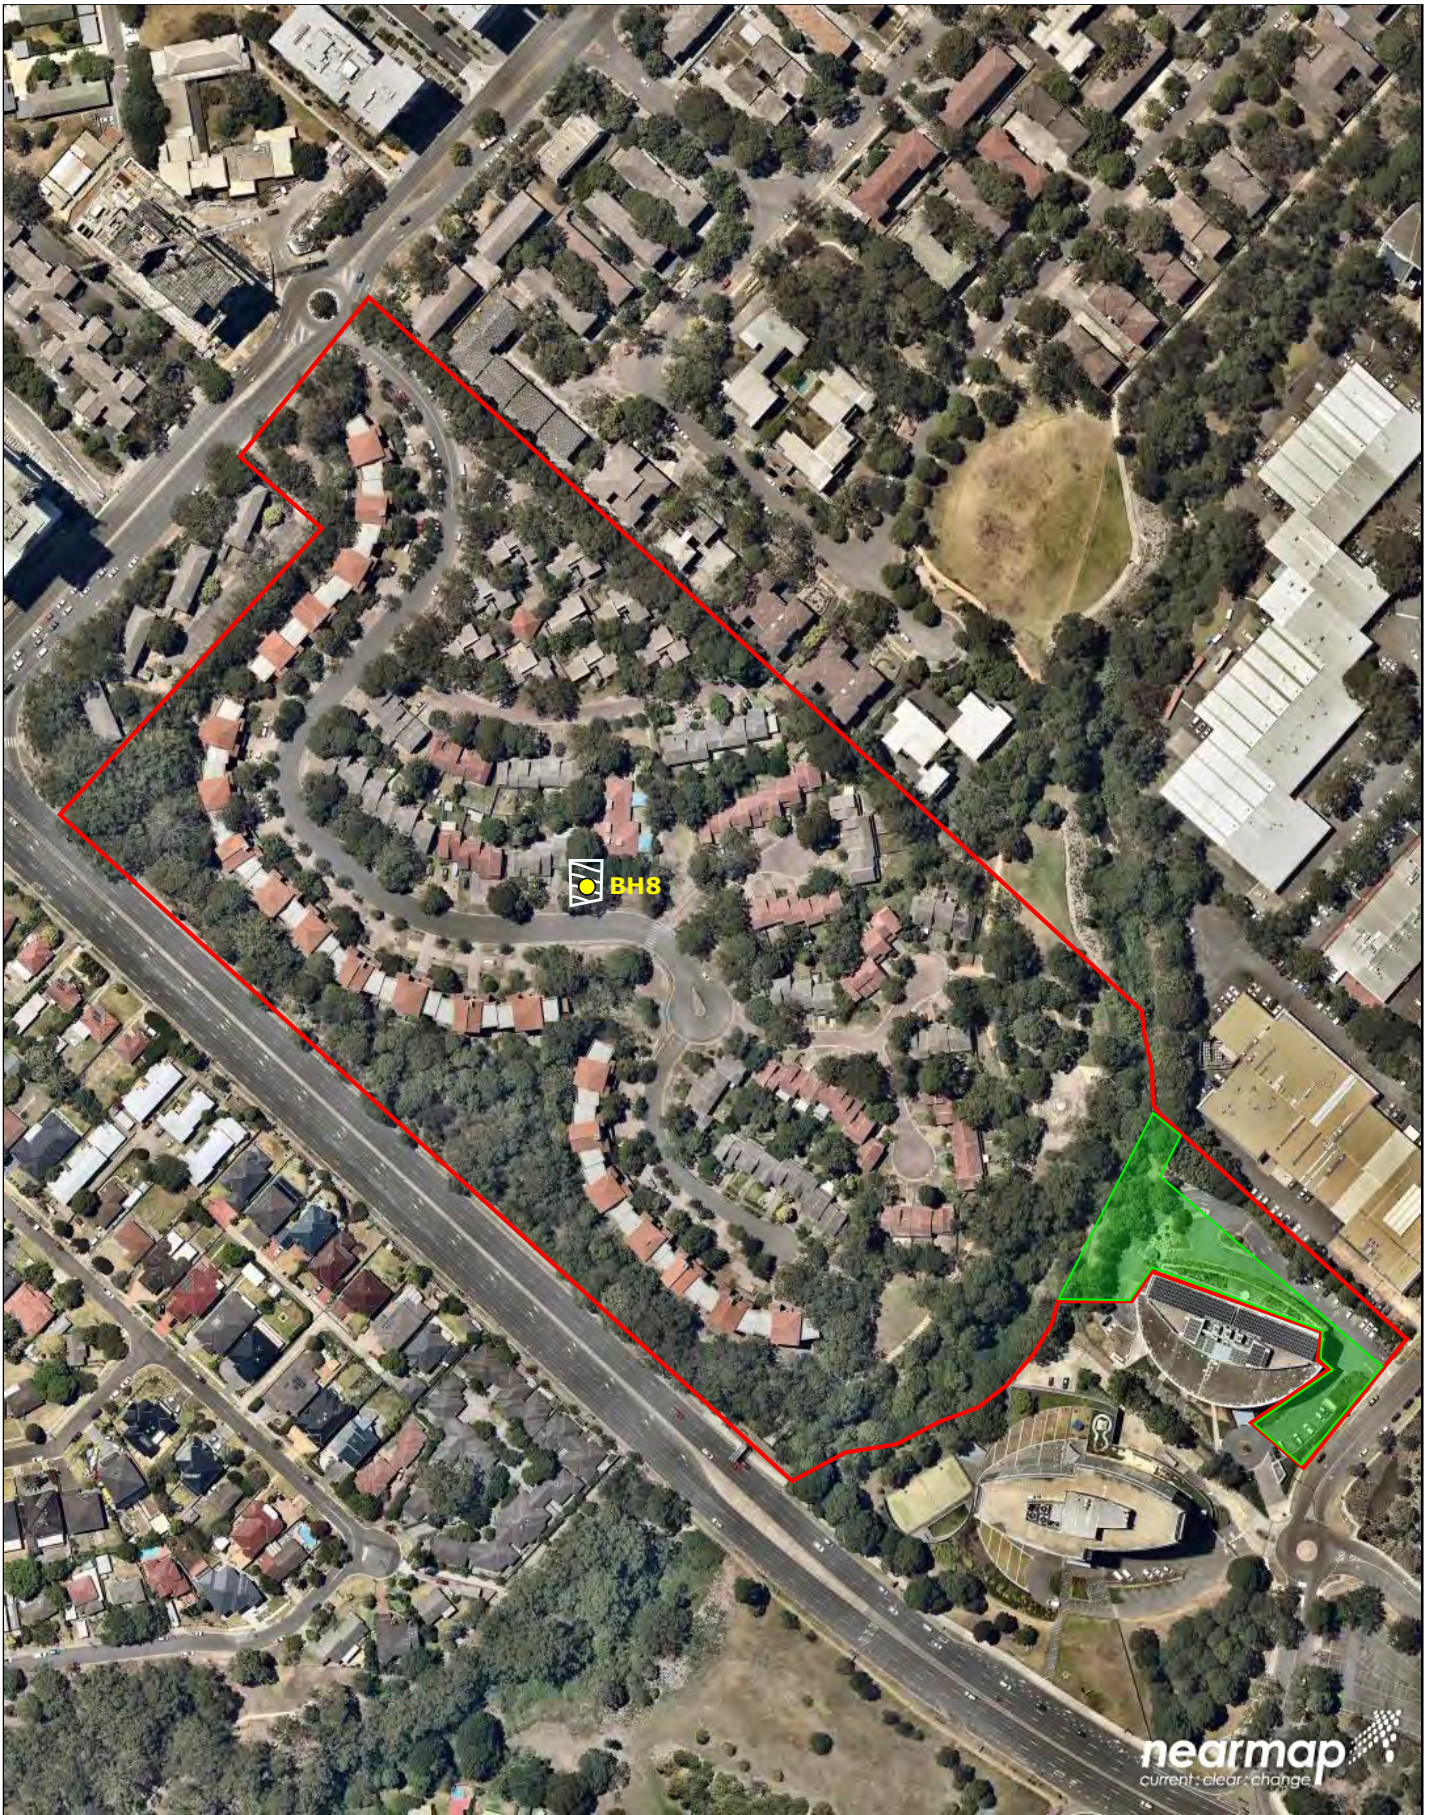
1

- Site Boundary
- TRH Exceedance Location
- Remediation Area
- No investigations have been conducted in this area

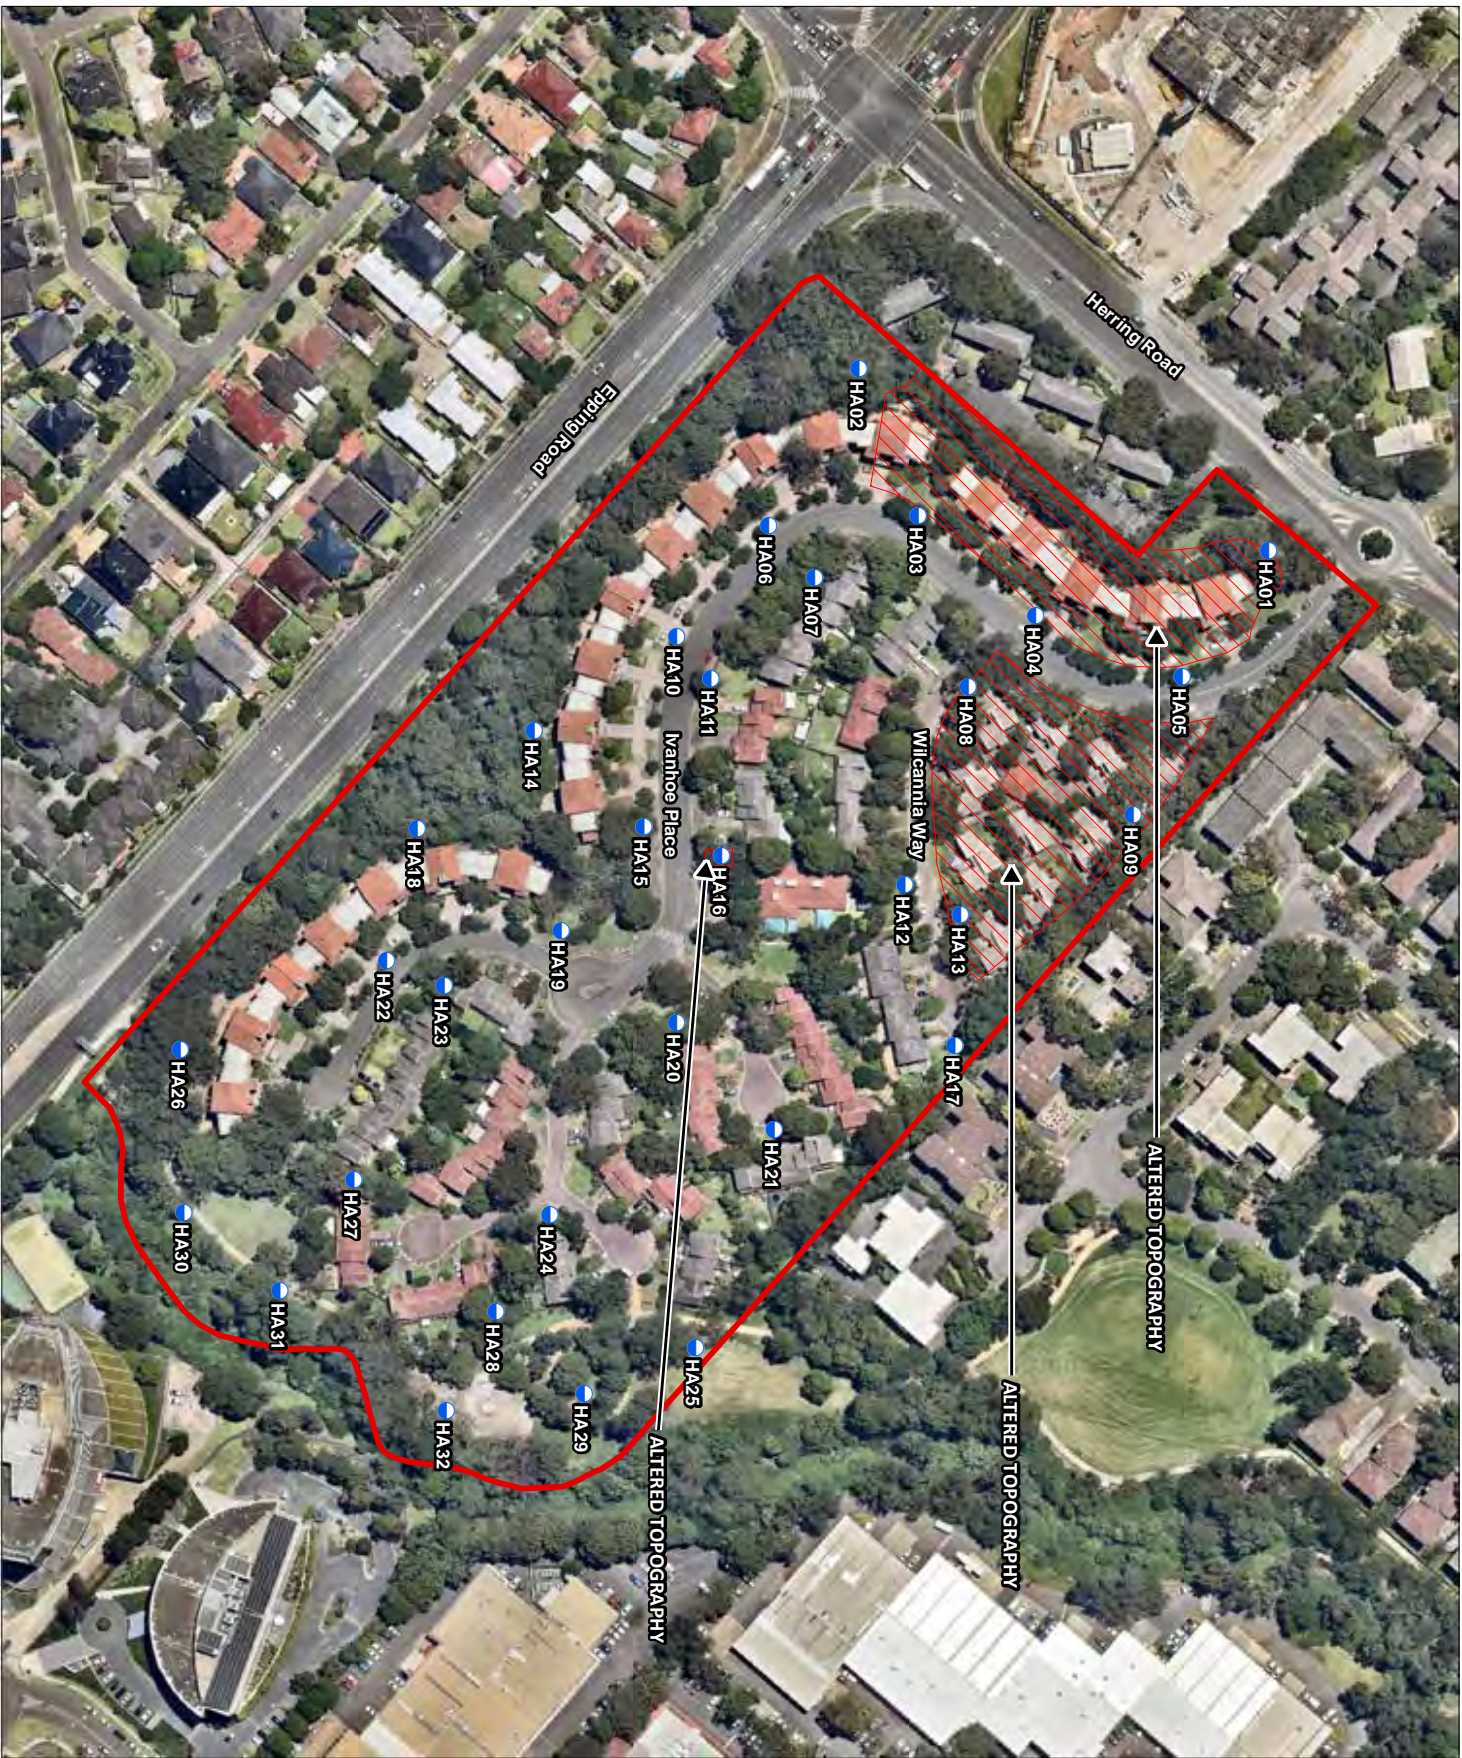
## **Appendix C: JBS&G Detailed Site Investigation Location Plans**

**Legend:**  
[Red outline] Approximate Site Boundary  
[Red hatched] Areas of Environmental Concern  
[Blue dot] Sample Location

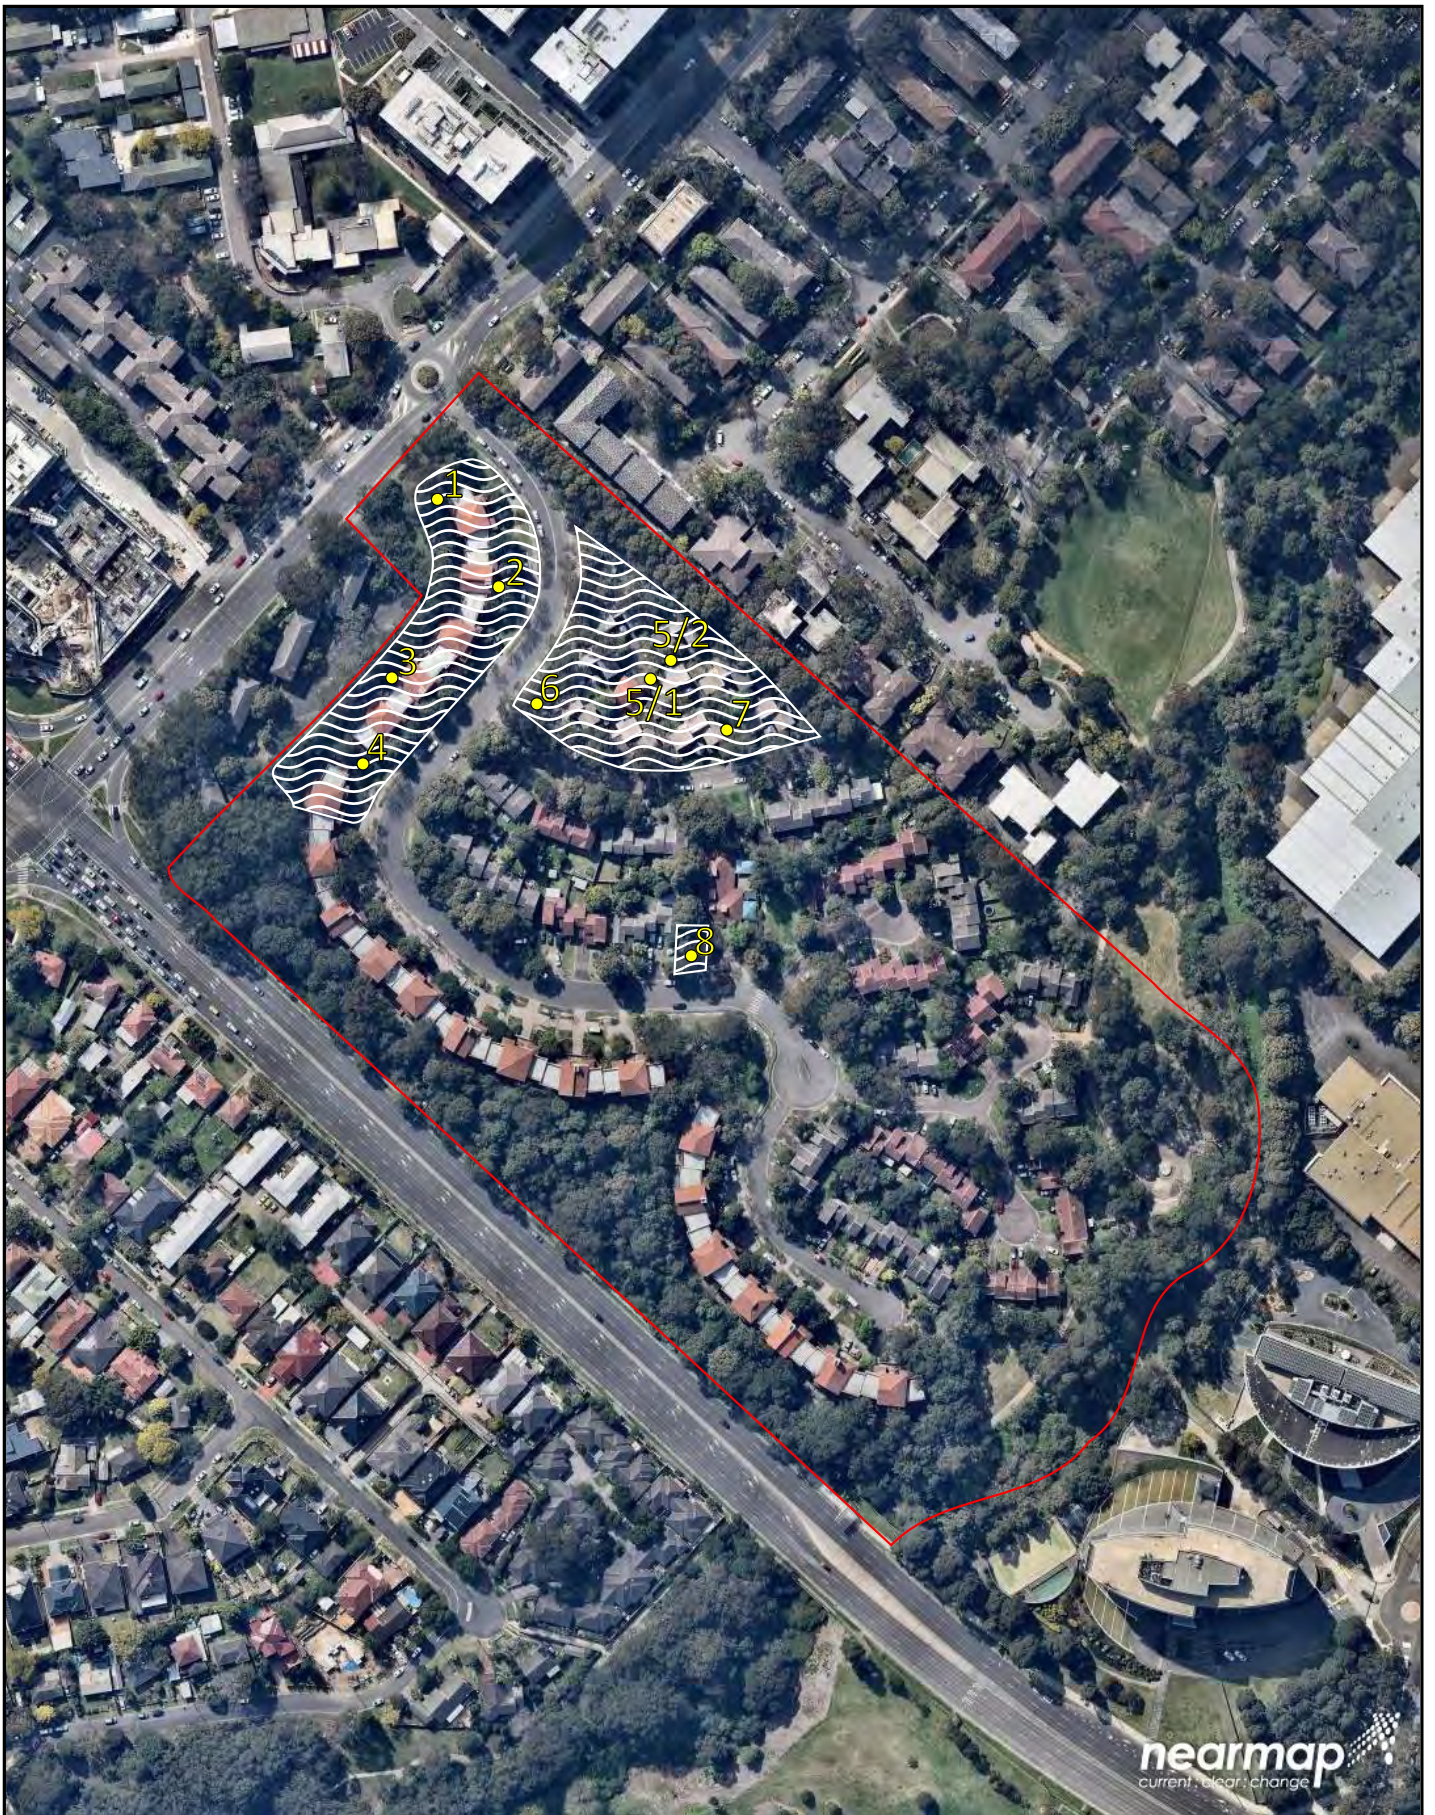
**Appendix E:**  
**DLA (June 2017) Supplementary Site Investigation Location**  
**Plans**

- Site Boundary
- Sample Locations (approximate)
- Altered Topography Areas

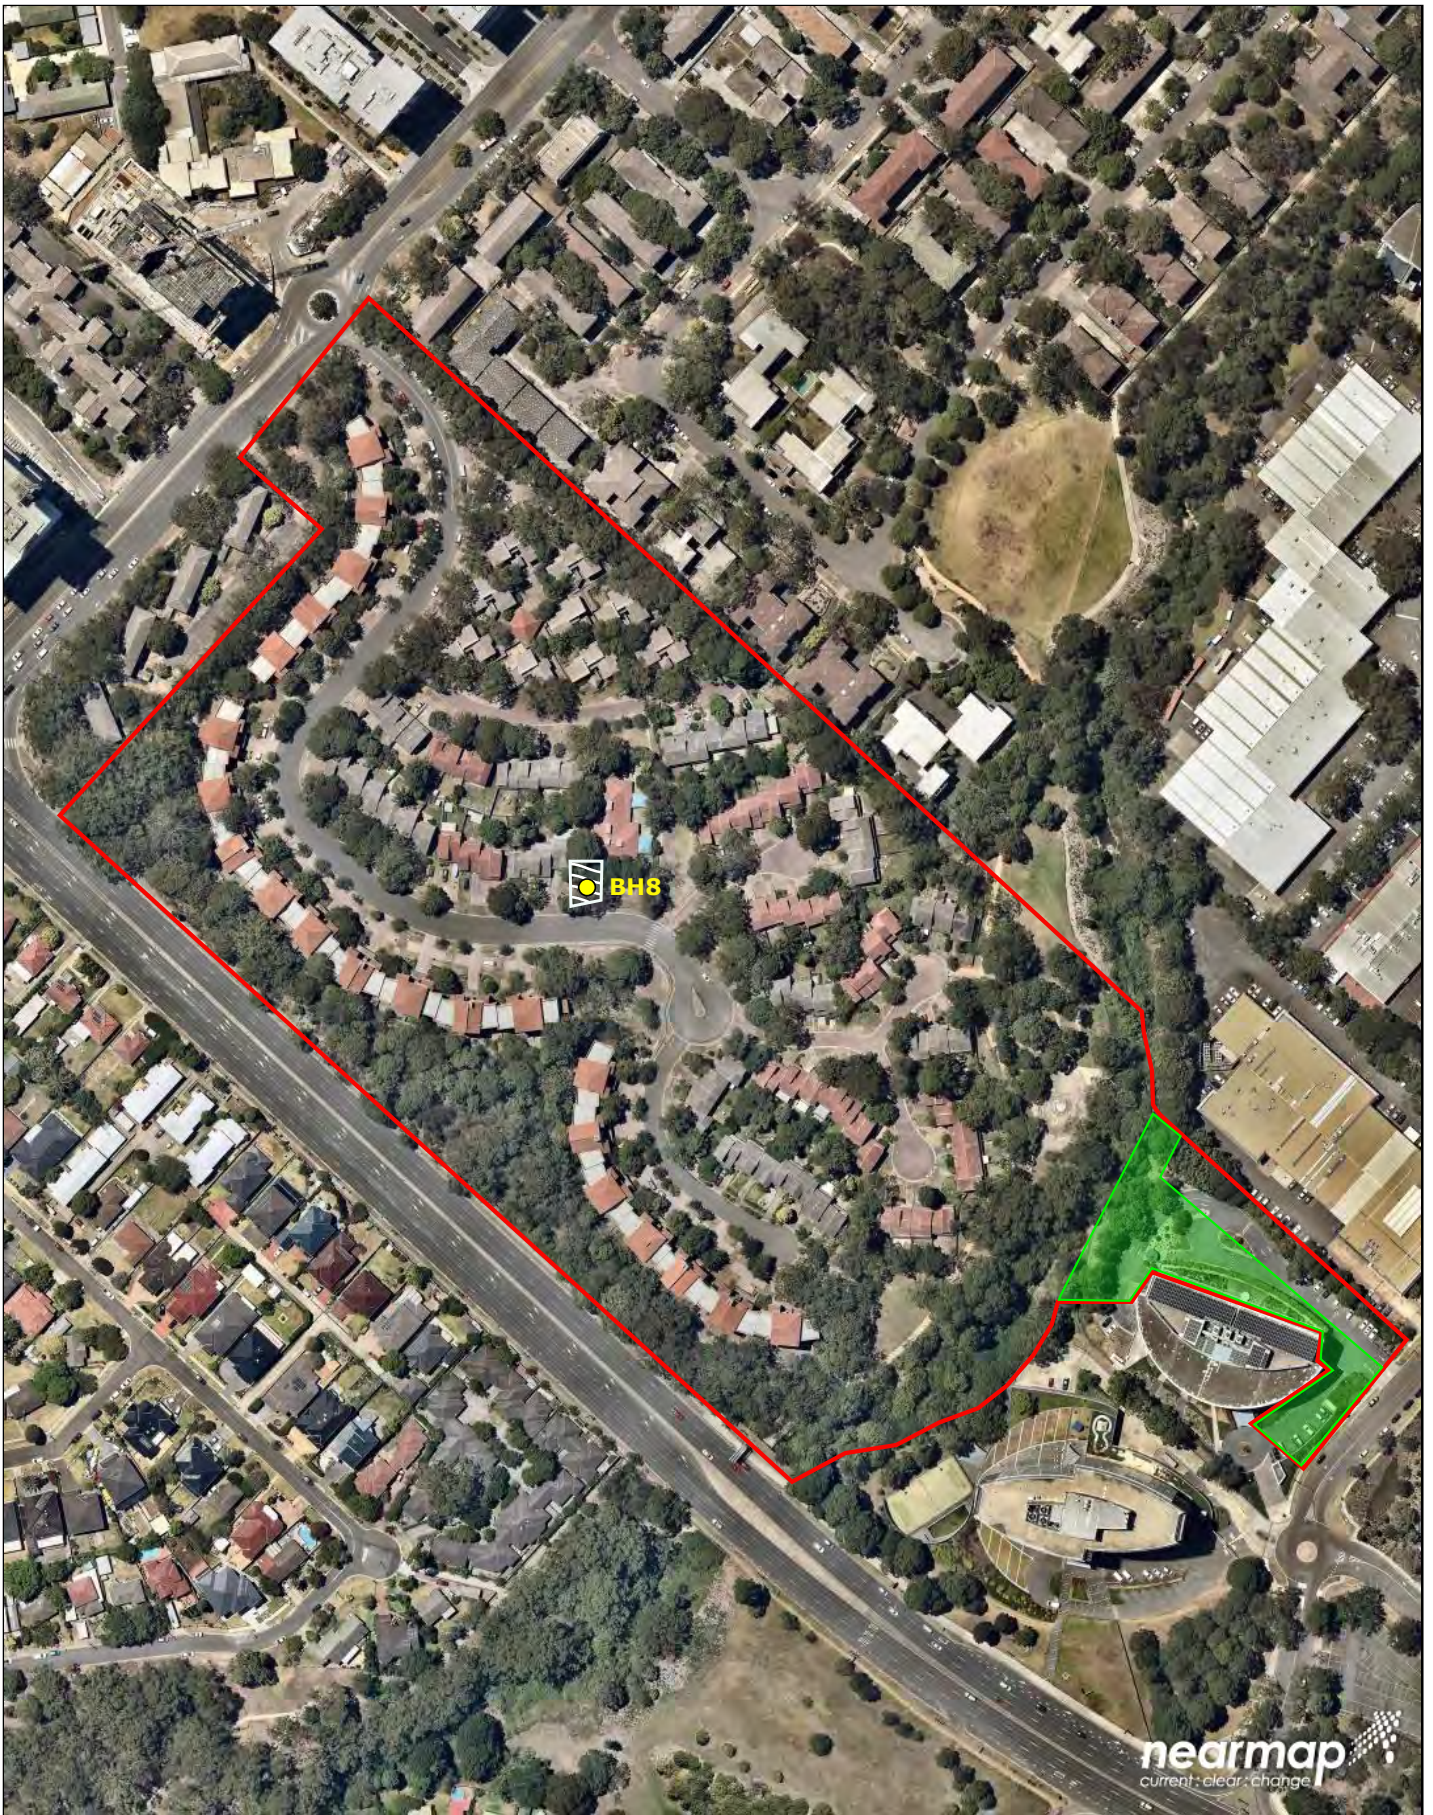
## Appendix I: Remediation Action Plan Figures

- Site Boundary
- TRH Exceedance Location
- No investigations have been conducted in this area
- Remediation Area

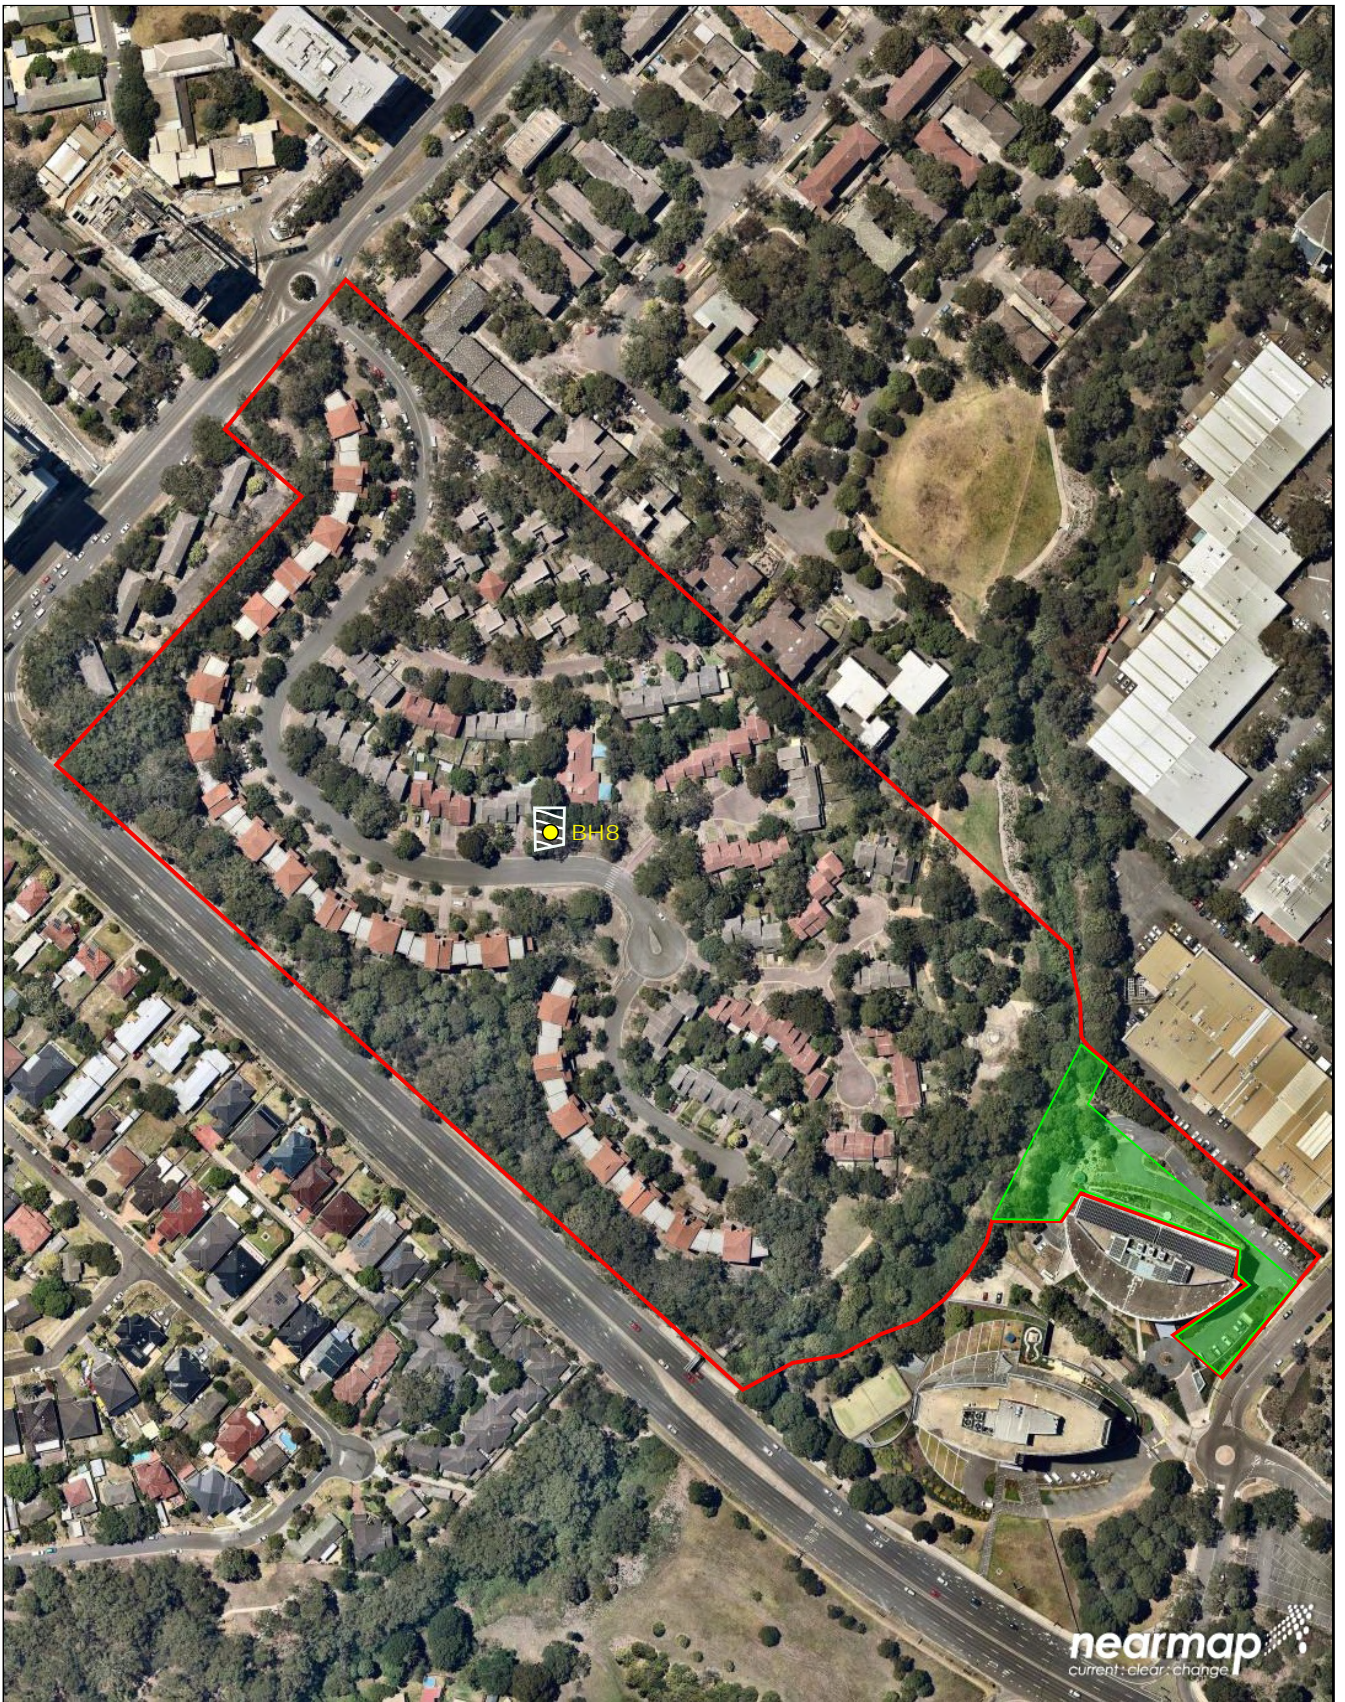
**FIGURE 2 – SITE LAYOUT AND REMEDIATION AREA**

- Site Boundary
- TRH Exceedance Location
- Remediation Area
- No investigations have been conducted in this area
