25 August 2021

**RE: INTERIM AUDIT ADVICE LETTER NO. 2 - CONDITION B93 OF SSD 8924 MOD 4, THE NEW SYDNEY FISH MARKET**

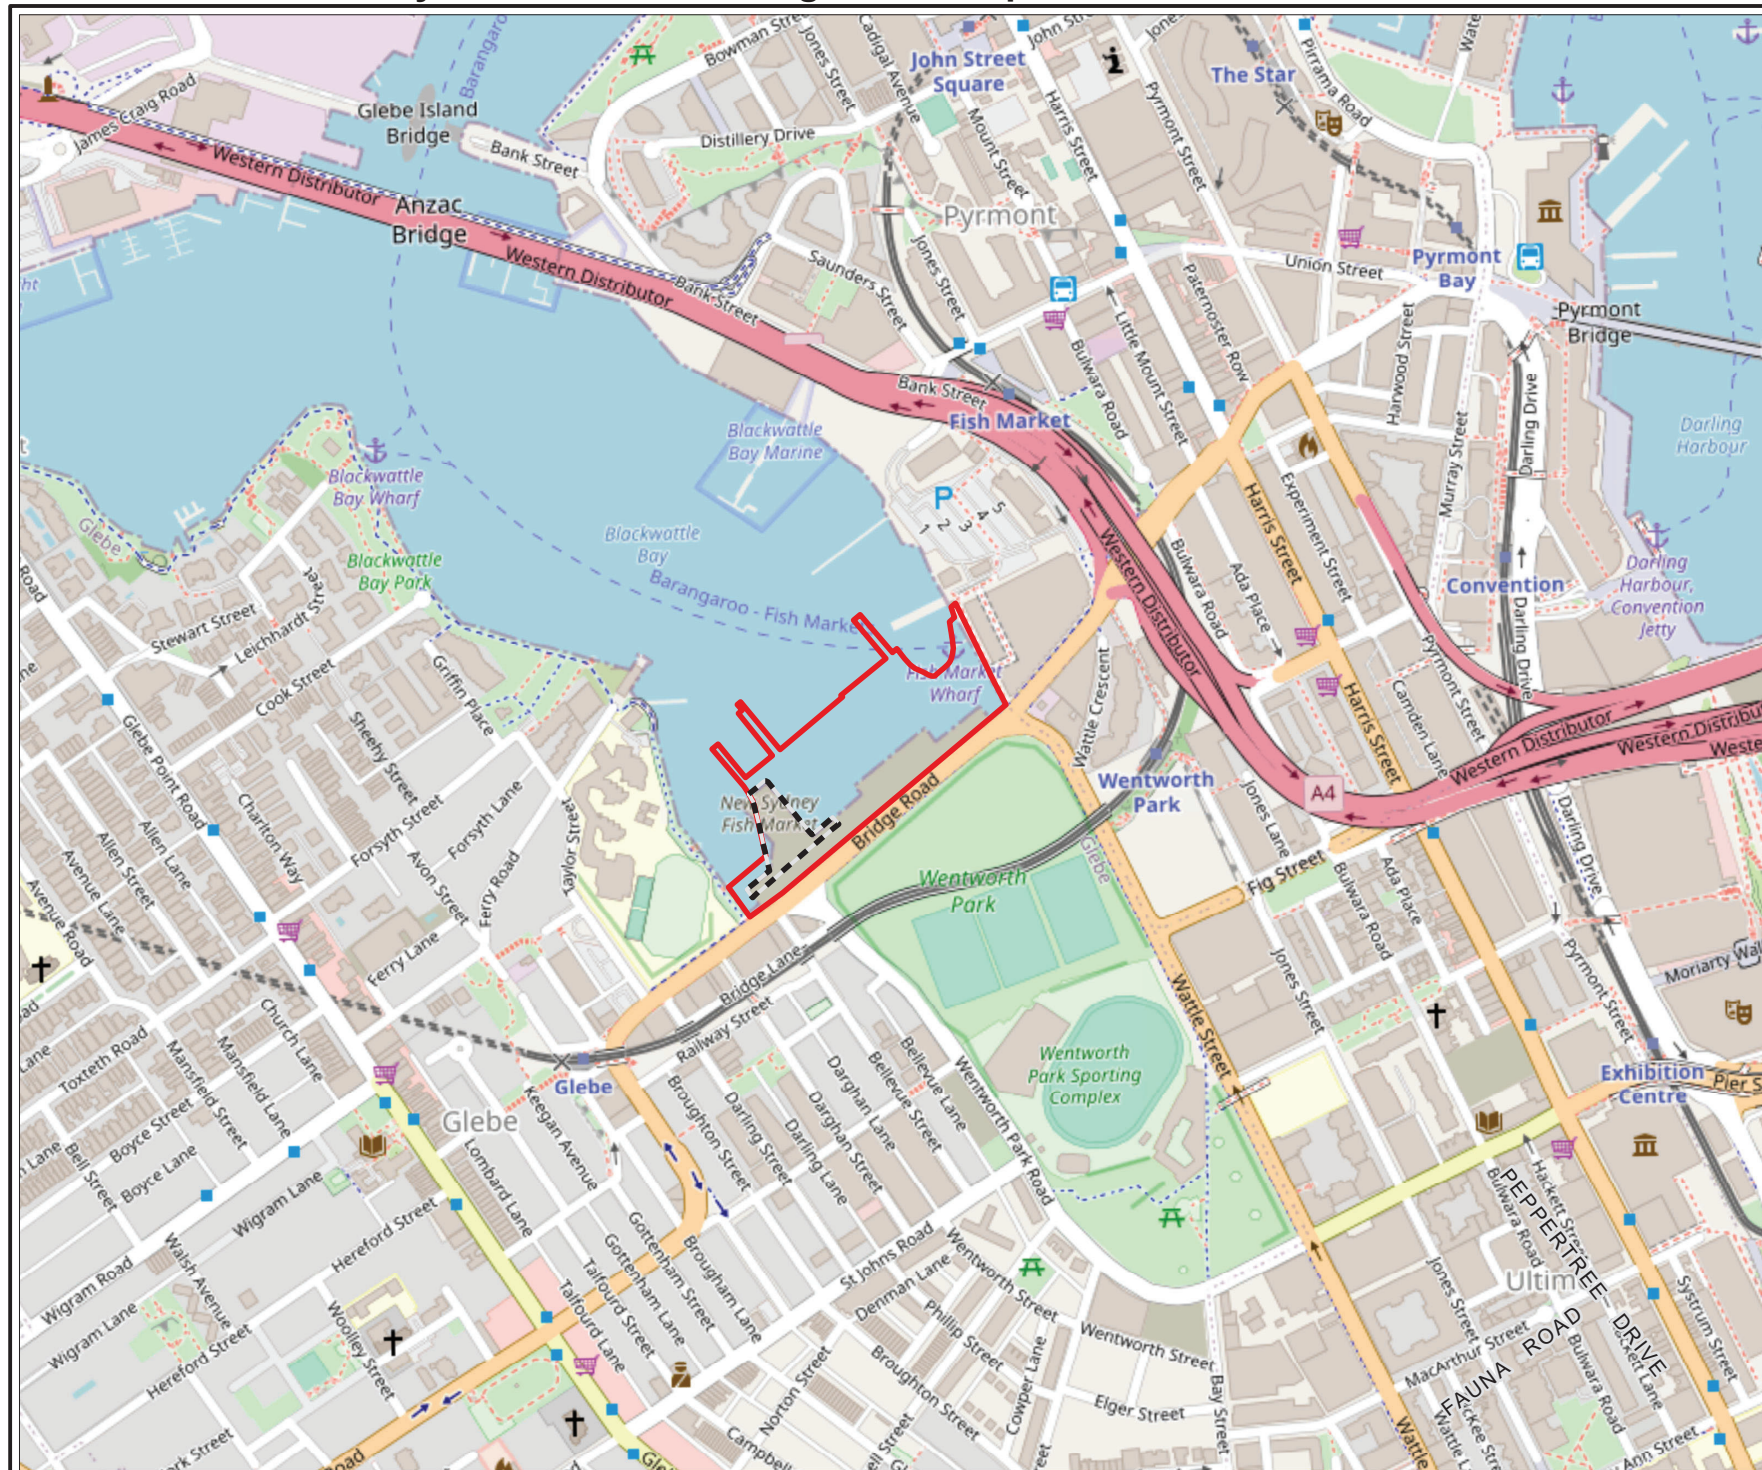
# Attachment 1 - Site Layout and SCA Investigation Footprint

As a NSW Environment Protection Authority (EPA) accredited Contaminated Sites Auditor, I am conducting an Audit in relation to the site at 1A to 1C Bridge Road, Glebe, NSW and part of 56-60 Pyrmont Bridge Road, Pyrmont, NSW. The site location is shown on Attachment 1.

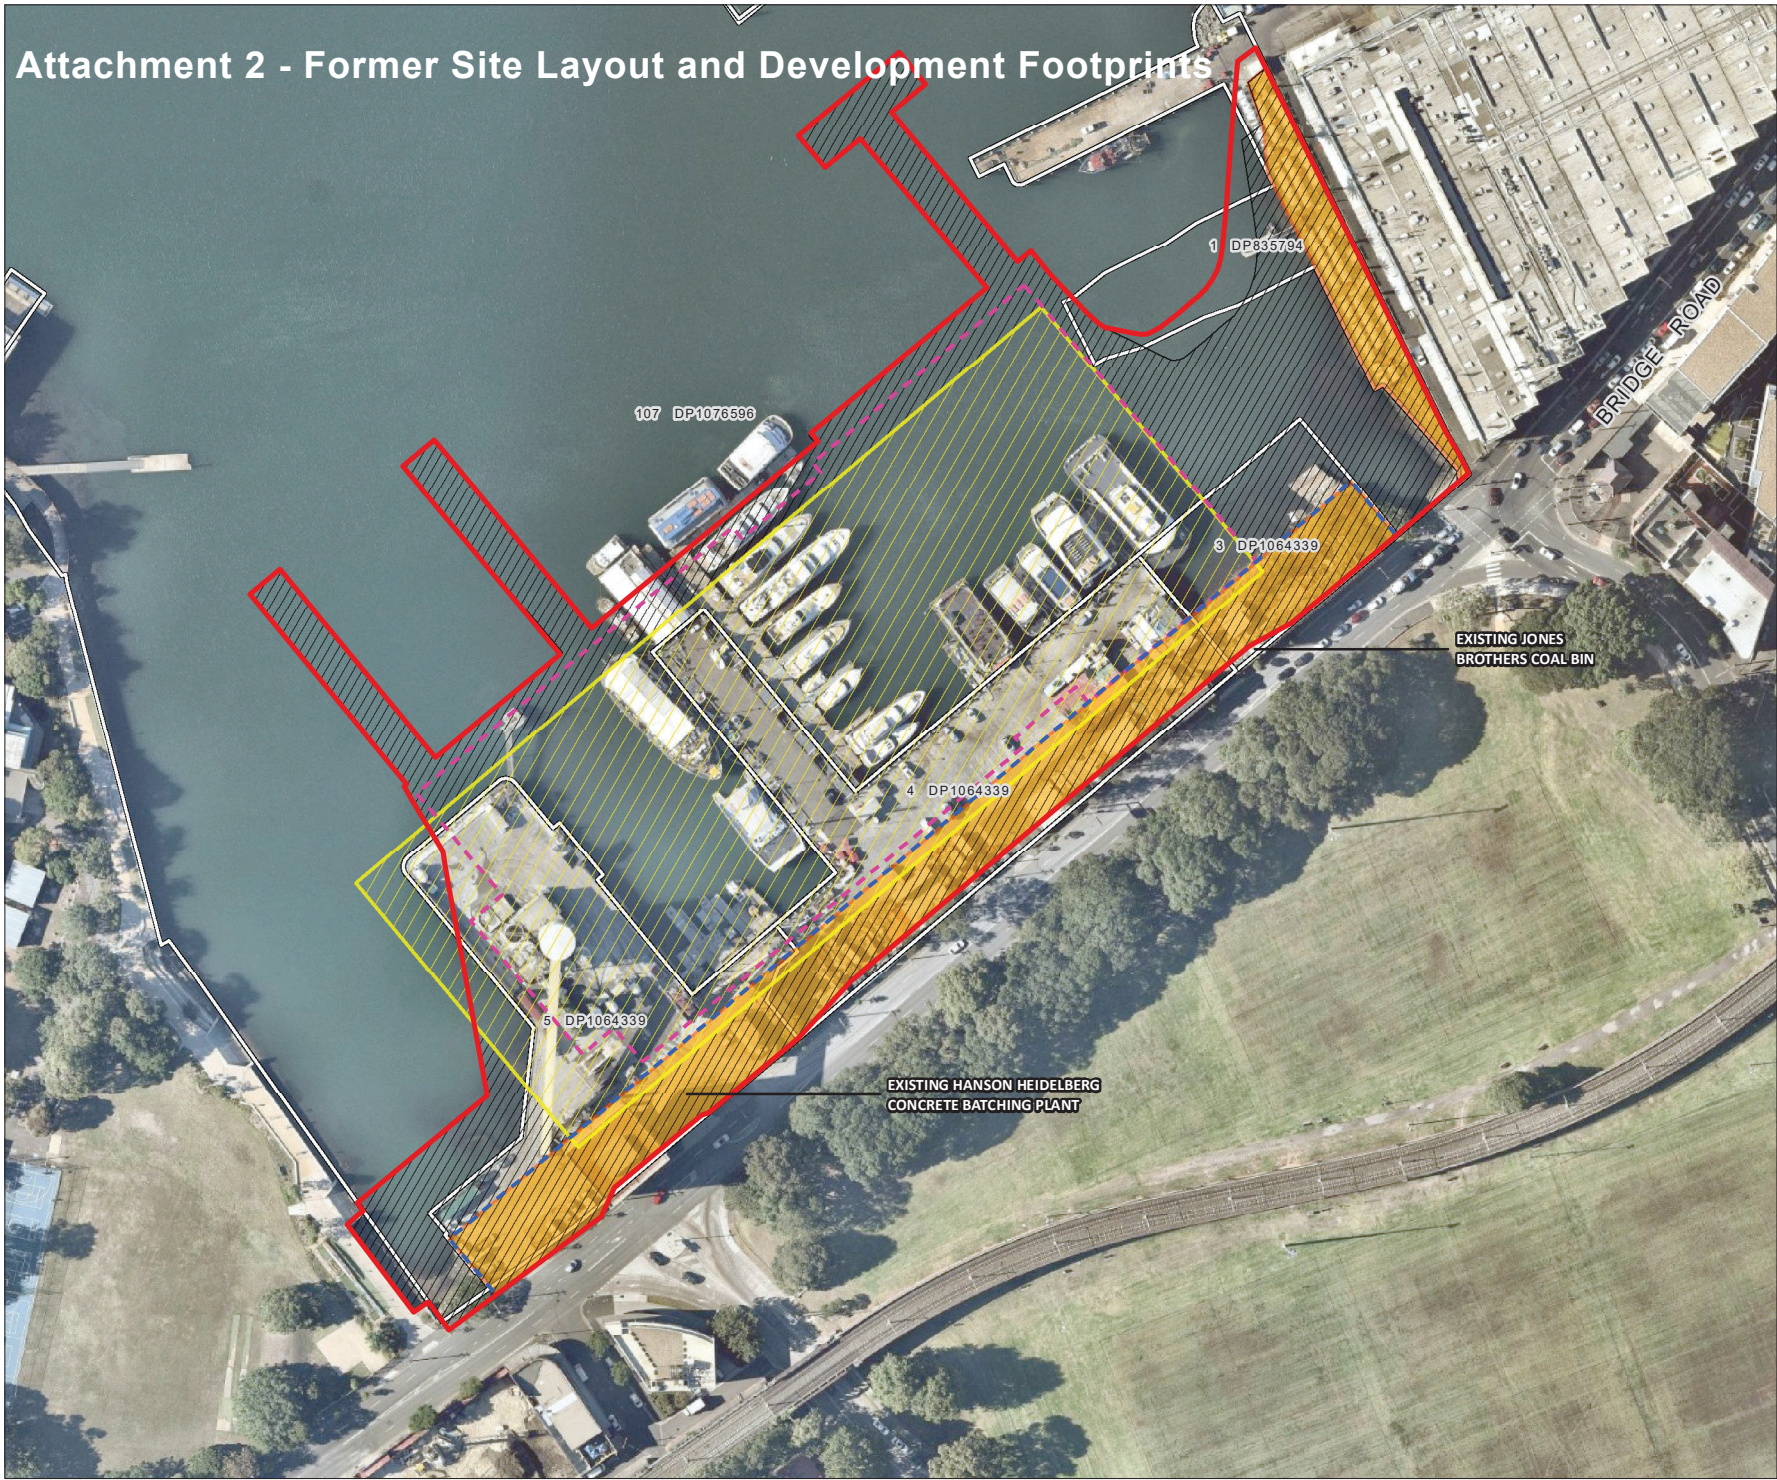
# Attachment 2 - Former Site Layout and Development Footprints

The former site layout and the footprints of the proposed development are shown on Attachment 2.

The basement footprint is shown on Attachment 2 and the proposed coffer dam is shown on Attachment 4.

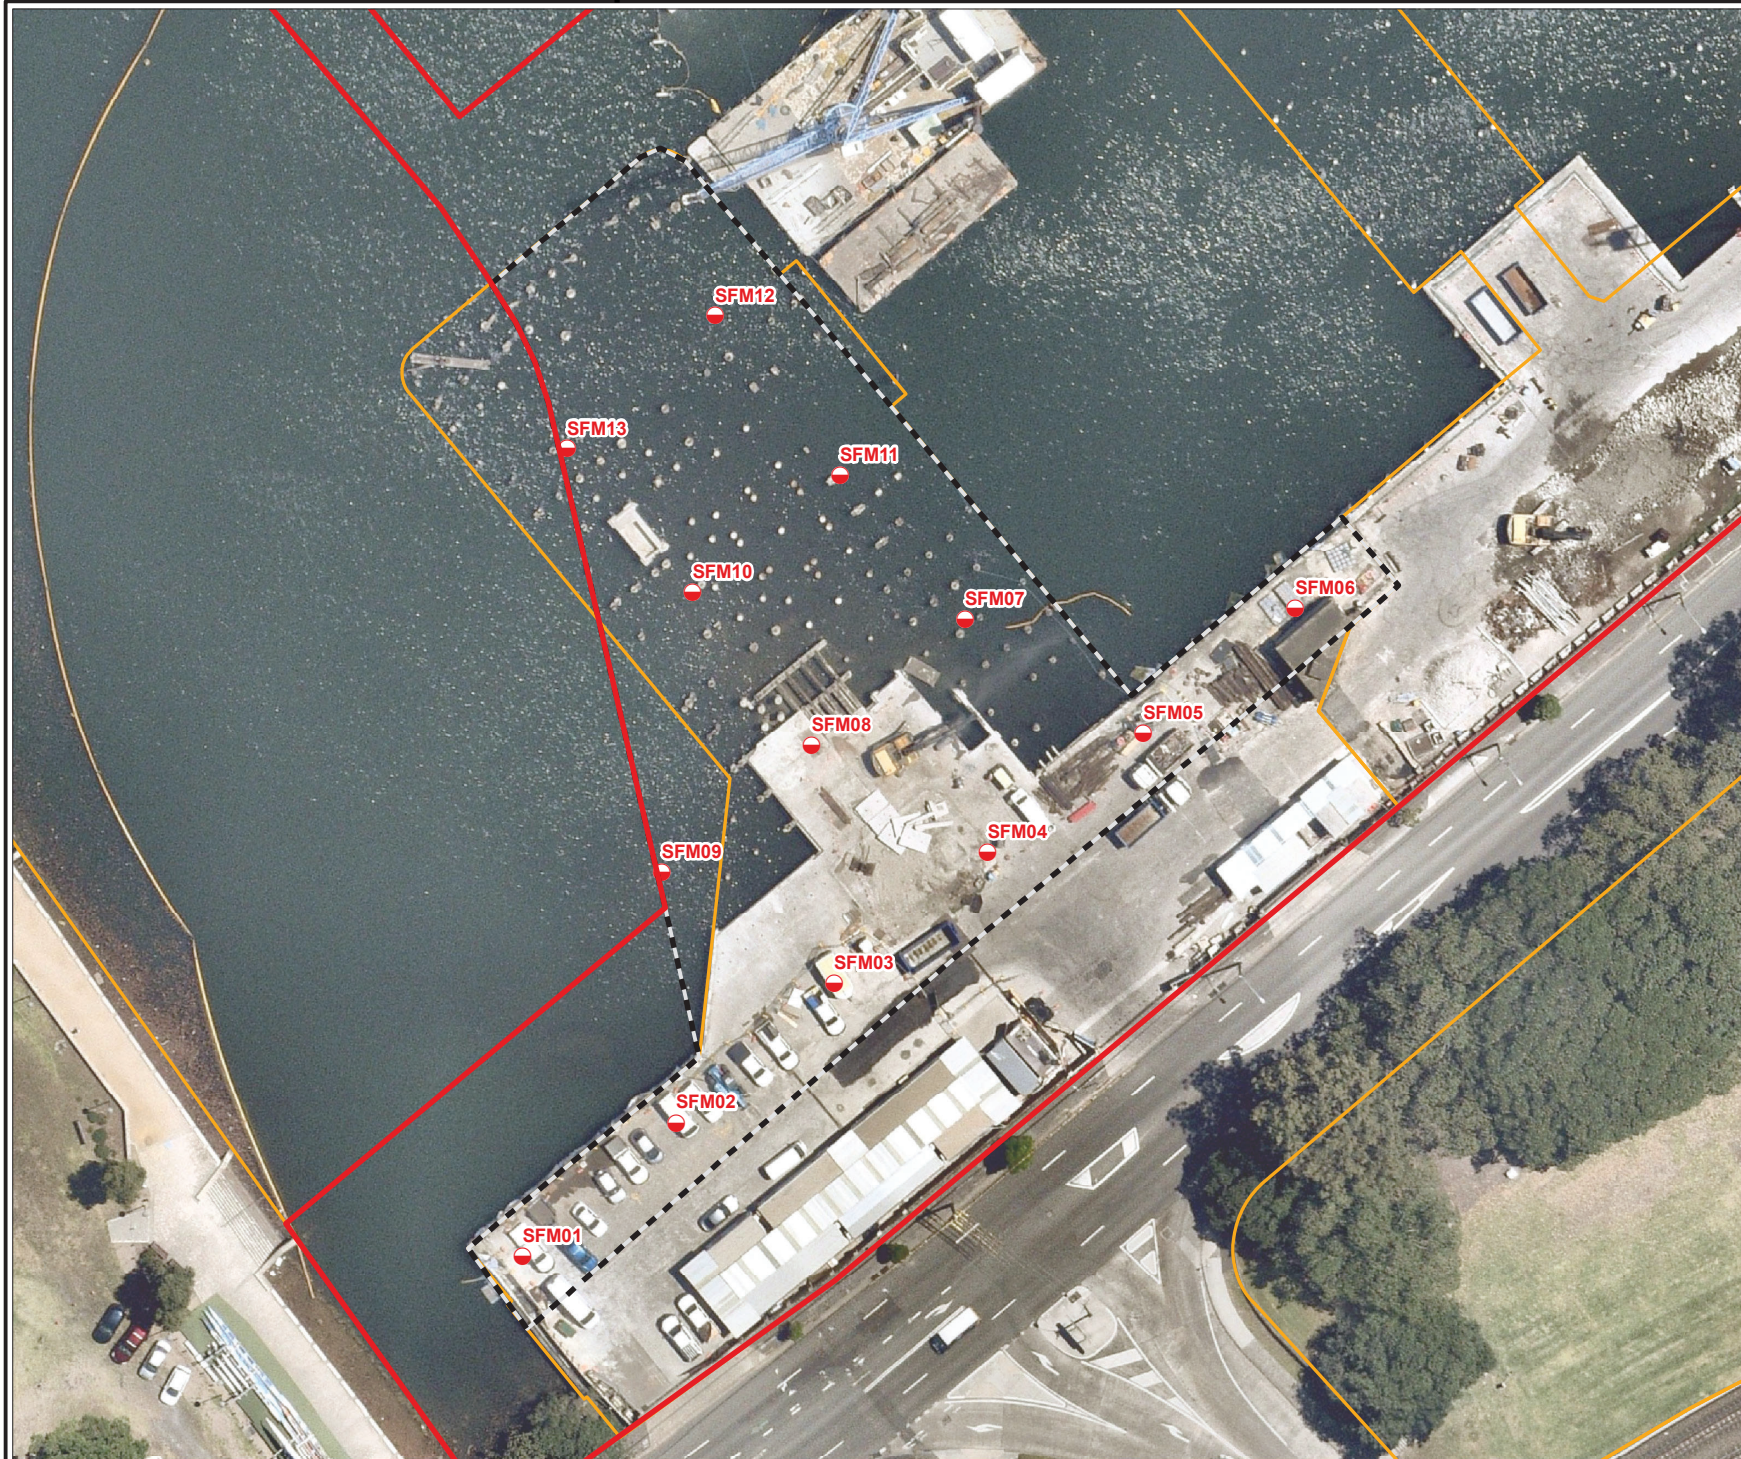
# Attachment 3 - SCA Sediment Sample Locations

Thirteen sediment sample locations were investigated for the SCA (SFM01 to SFM13) on a 20 m grid within the additional area of sediment. This area and the sample locations are shown on Attachment 3.
