**Targeted contamination investigation - St Joseph's College, Mary Street, Hunters Hill NSW**

Targeted environmental contamination and geotechnical investigation  
St Joseph's College, Mary Street, Hunters Hill NSW

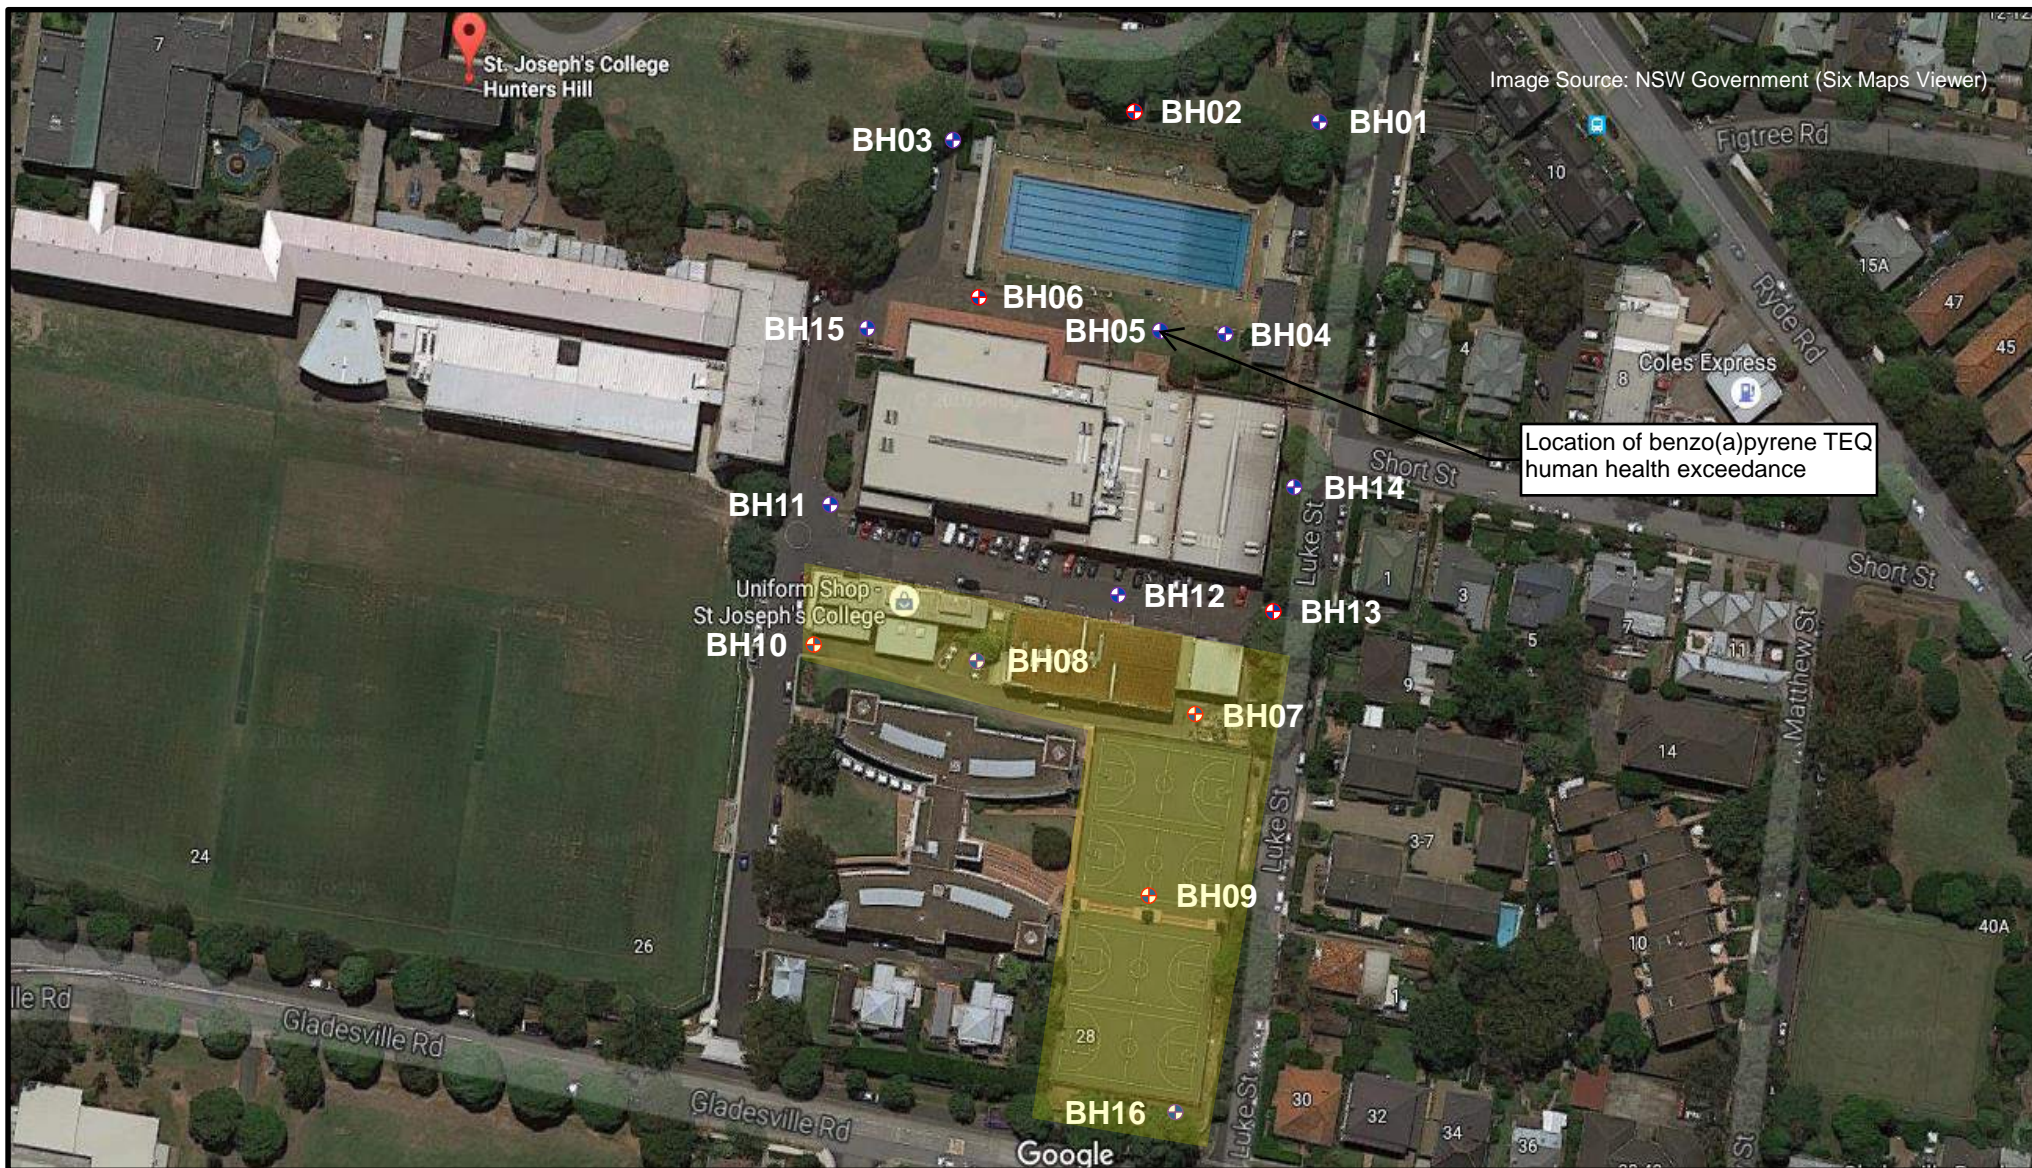
## Figure 1

WSP understand that the PESPP does not involve development in area of BH05 where the ashy material was encountered. The location of BH05 is show in Figure 1 in Attachment A. Because the BH05 location is outside of the PESPP footprint no remedial works are required for the proposed development.

Bore locations and PESPP location

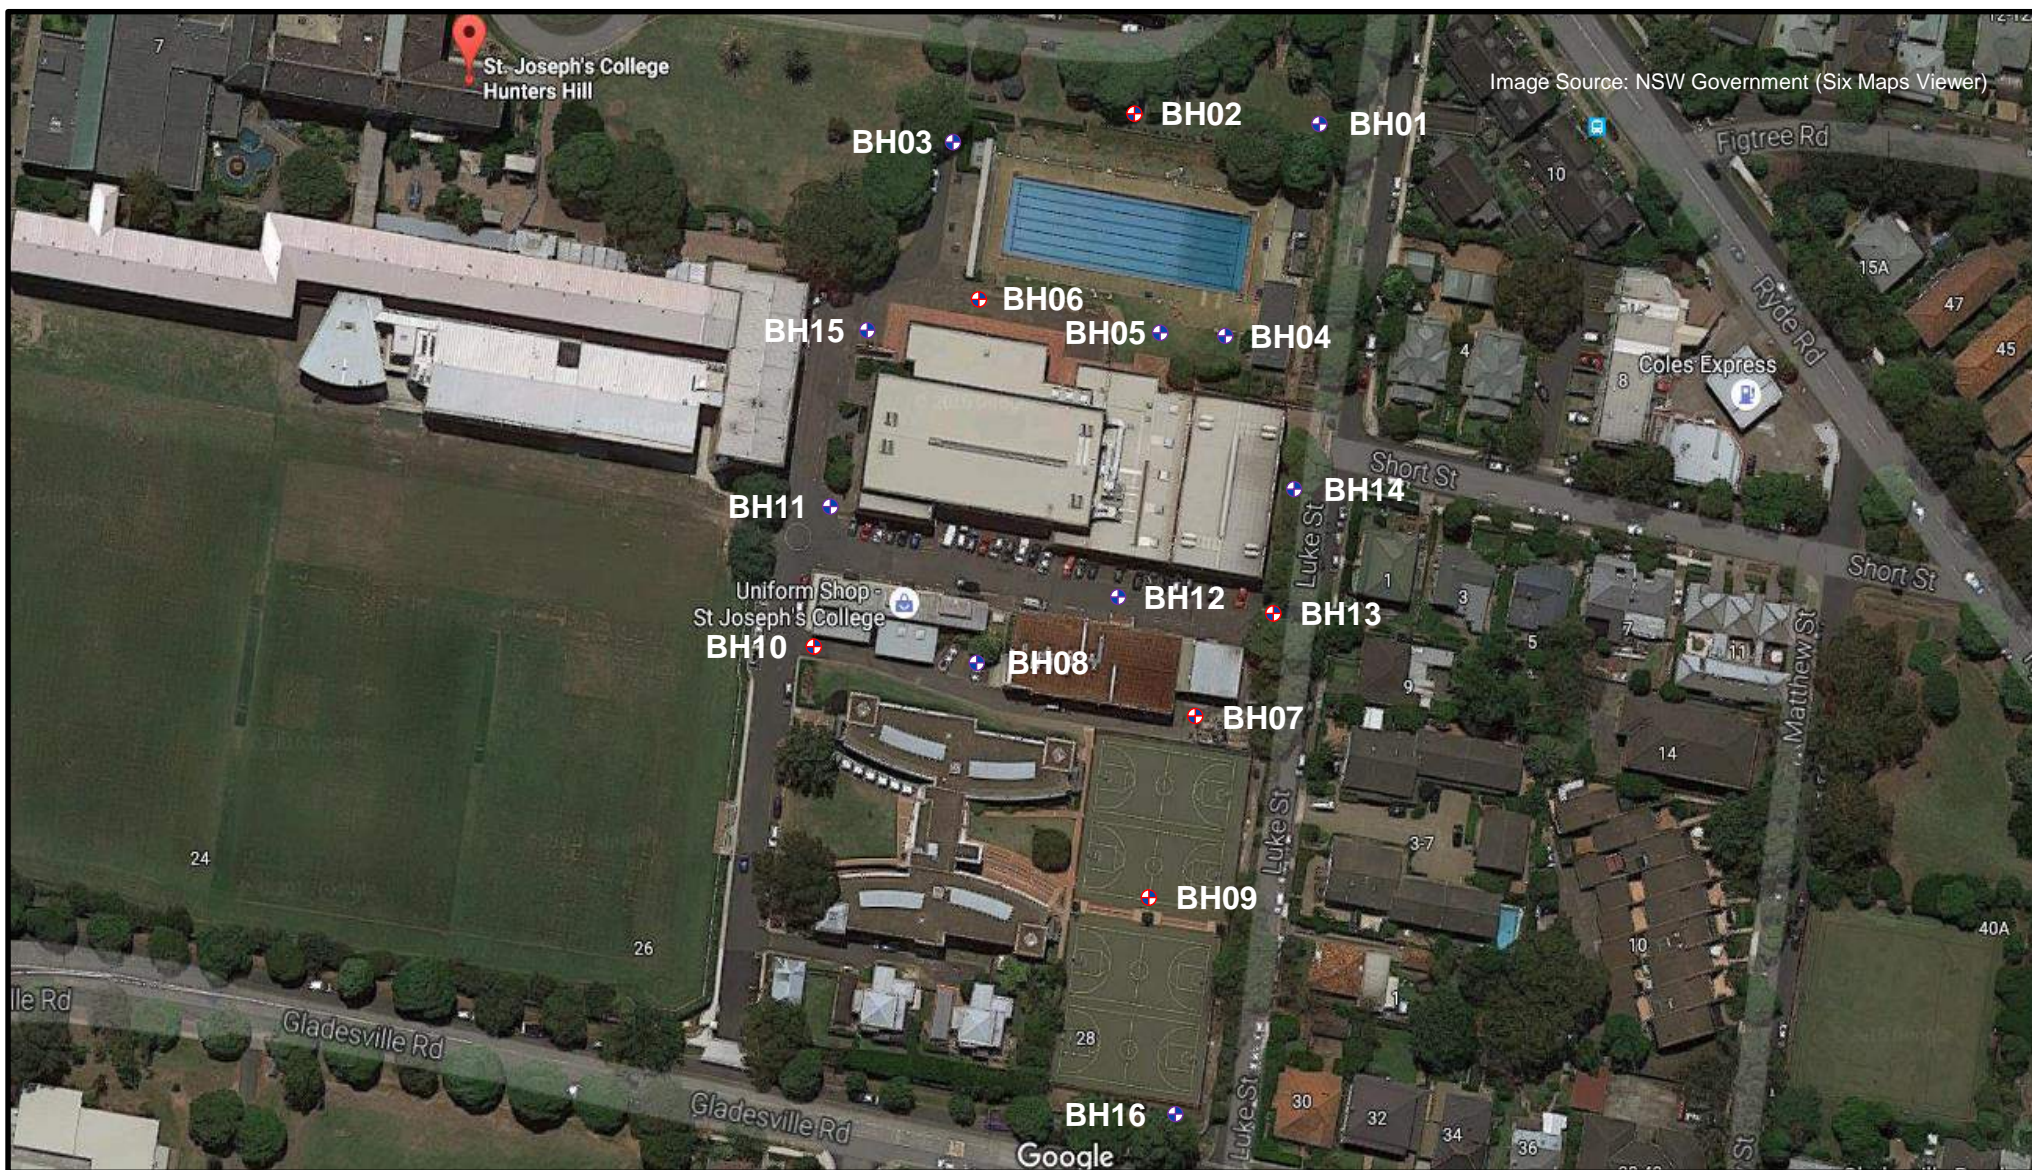
## Figure 2

Sampling Locations
