ENVIRONMENTAL SITE ASSESSMENT

**PROPOSED BOWRAL & DISTRICT HOSPITAL
REDEVELOPMENT**

97-103 BOWRAL ROAD, BOWRAL, NSW

REF: E31452Krpt

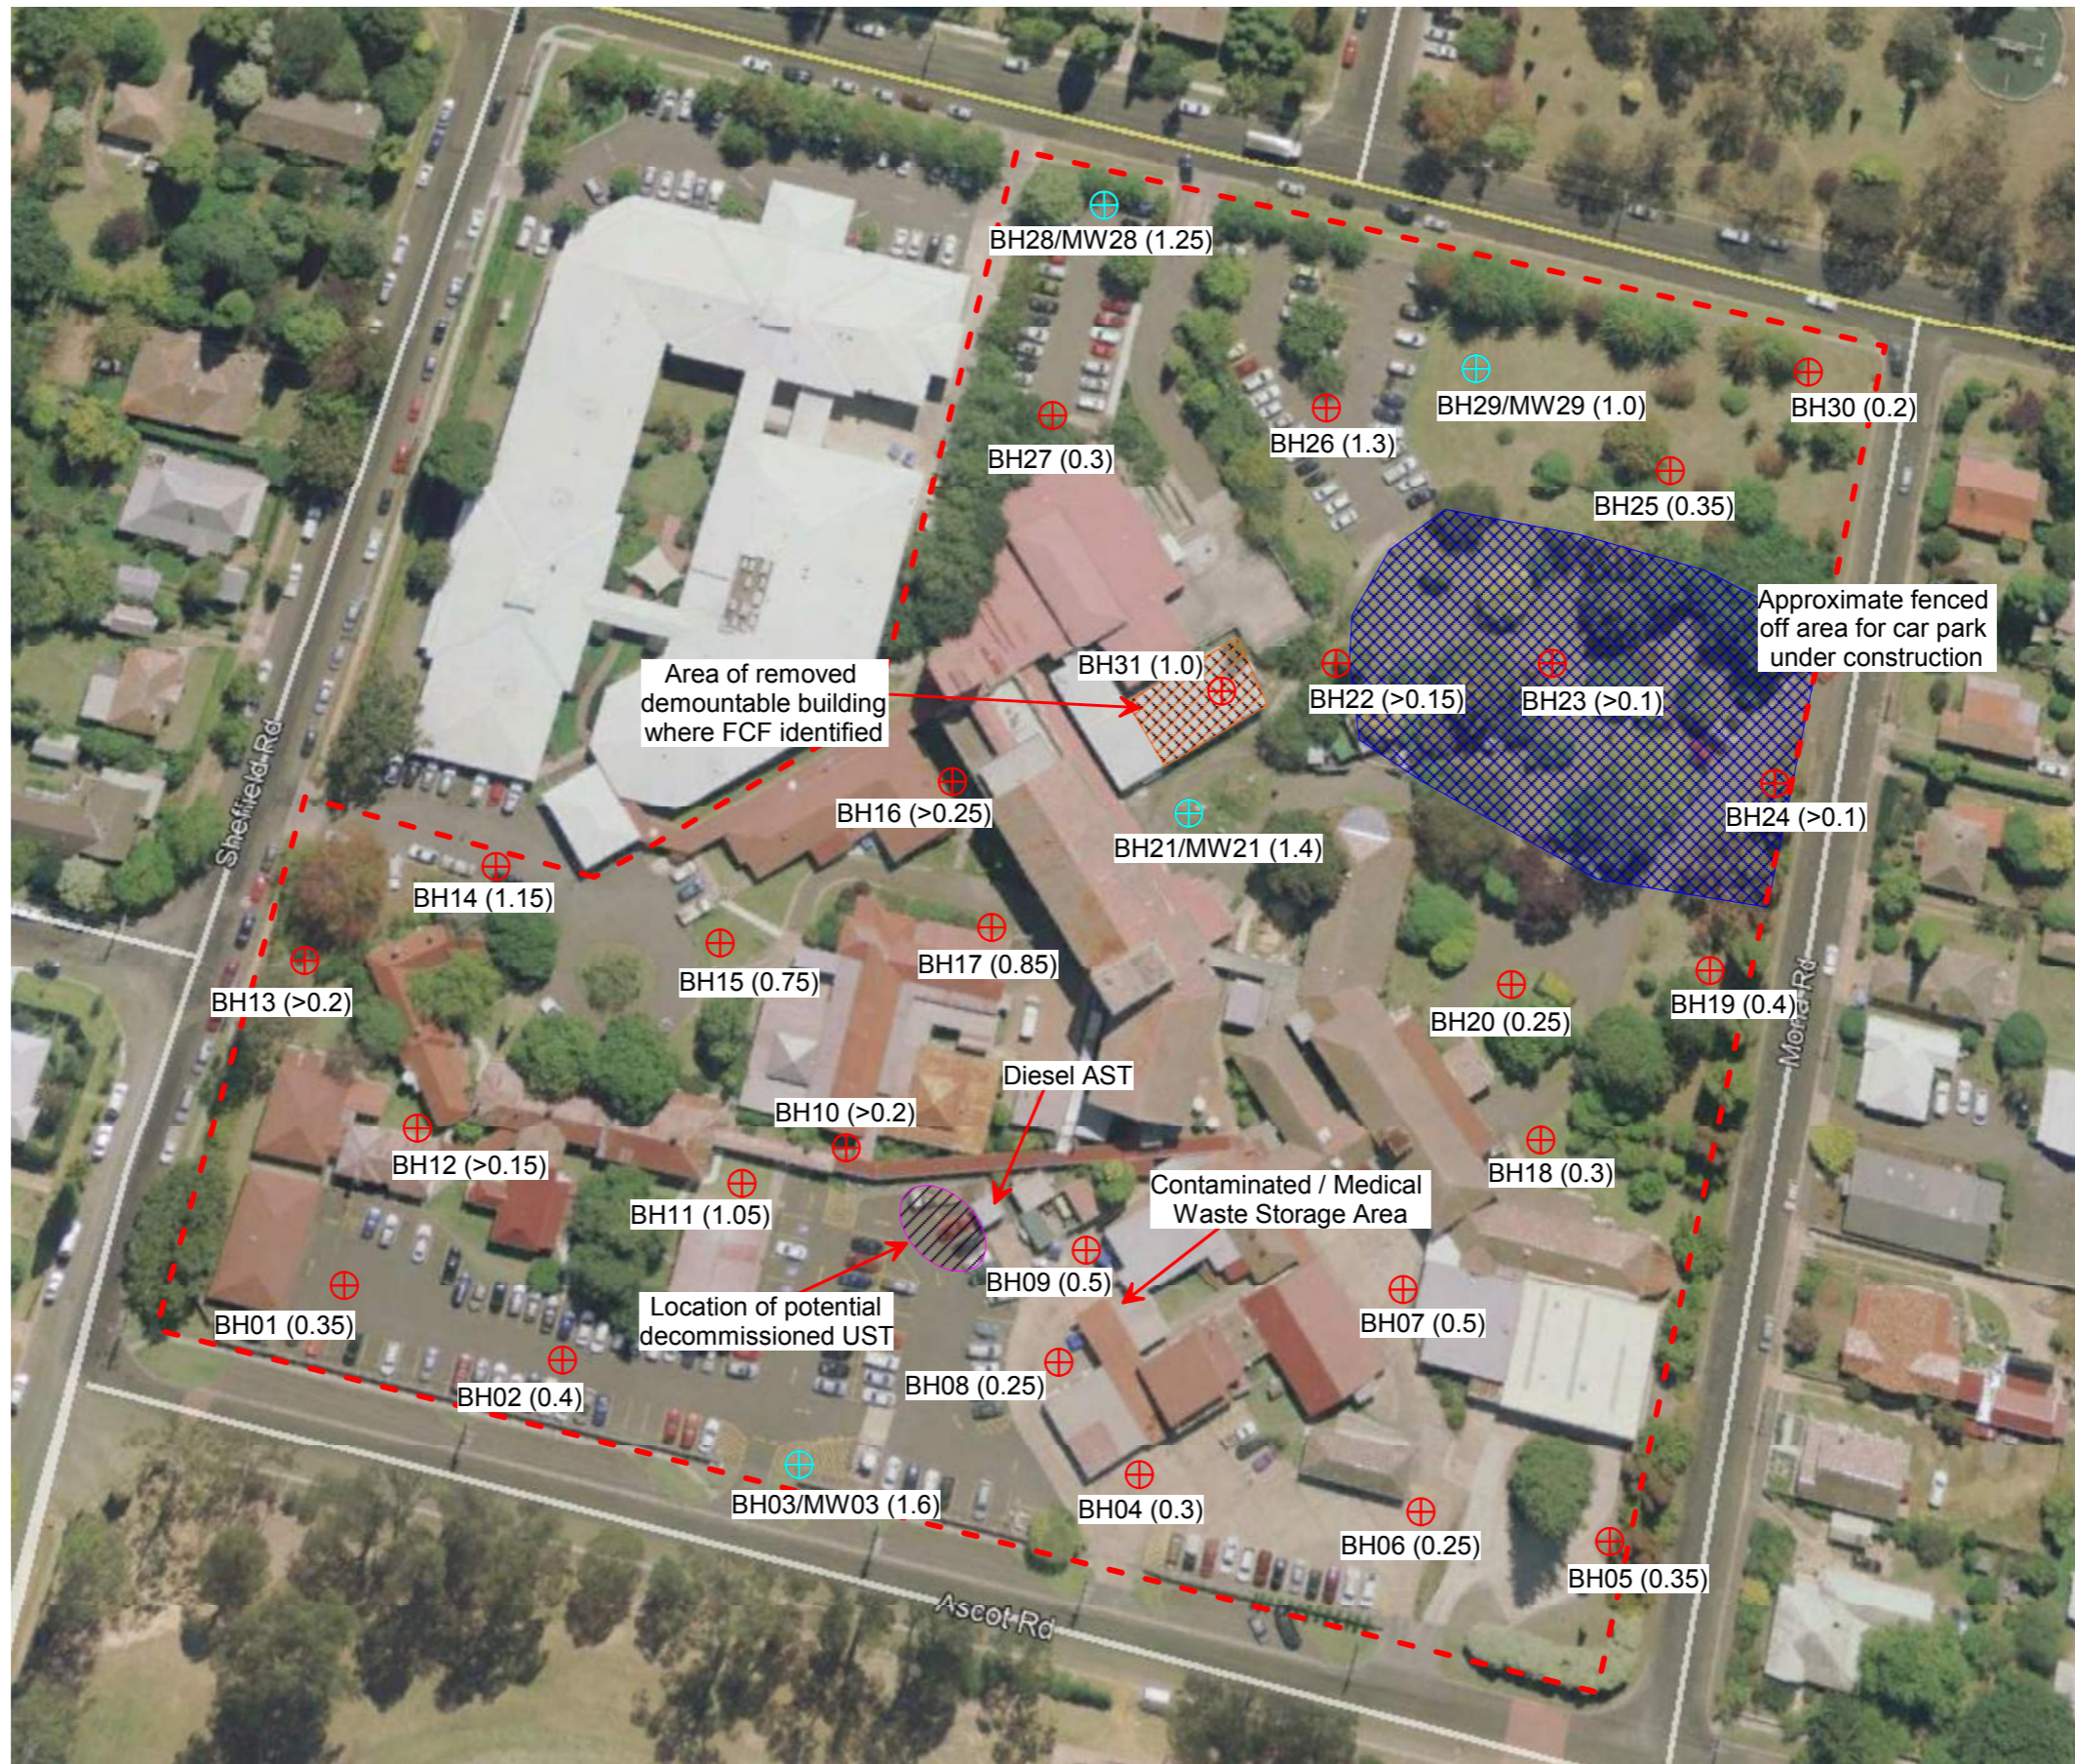
Title: SAMPLE LOCATION & SITE FEATURES PLAN	
Location: 97-103 BOWRAL ROAD, BOWRAL, NSW	
Report No: E31452Krpt	Figure No: 2
ENVIRONMENTAL INVESTIGATION SERVICES

Fieldwork was undertaken between the 8th and 11th of May 2018. Soil samples were collected from 31 locations as shown on the attached Figure 2. Based on the accessible areas of the site (20,000m²), this number of locations corresponded to a sampling density of approximately one sample per 645m². Groundwater monitoring wells were installed in four of the boreholes: BH03 (MW03), BH21 (MW21), BH28 (MW28) and BH29 (MW29). The monitoring wells were installed to depths of between approximately 5.0m to 6.0m below ground level.

Fibre cements fragments (suspected to contain asbestos) were observed on the site surface in the a location of exposed fill in the central section of the site to the north of the main hospital building where a demountable had recently been removed (see Figure 2).

Medical and contaminated waste storage areas were observed in the central south section of the site (refer to Figure 2) and was stored in locked cages and/or bins stored on concrete pavements.

2. Conduct an emu-bob for removal of FCF across the exposed fill soils in the vicinity of BH31 by a suitably licenced asbestos contractor. All FCF disposed of to a NSW EPA licenced facility. Following removal a surface clearance should be undertaken by a SafeWork NSW licenced asbestos assessor. This will provide a safe working environment for site personnel and form part of the waste classification; and
