## REMEDIATION ACTION PLAN

## PROPOSED HOSPITAL REDEVELOPMENT

## 97-103 BOWRAL ROAD, BOWRAL, NSW

REF: E31452Krpt2-RAP

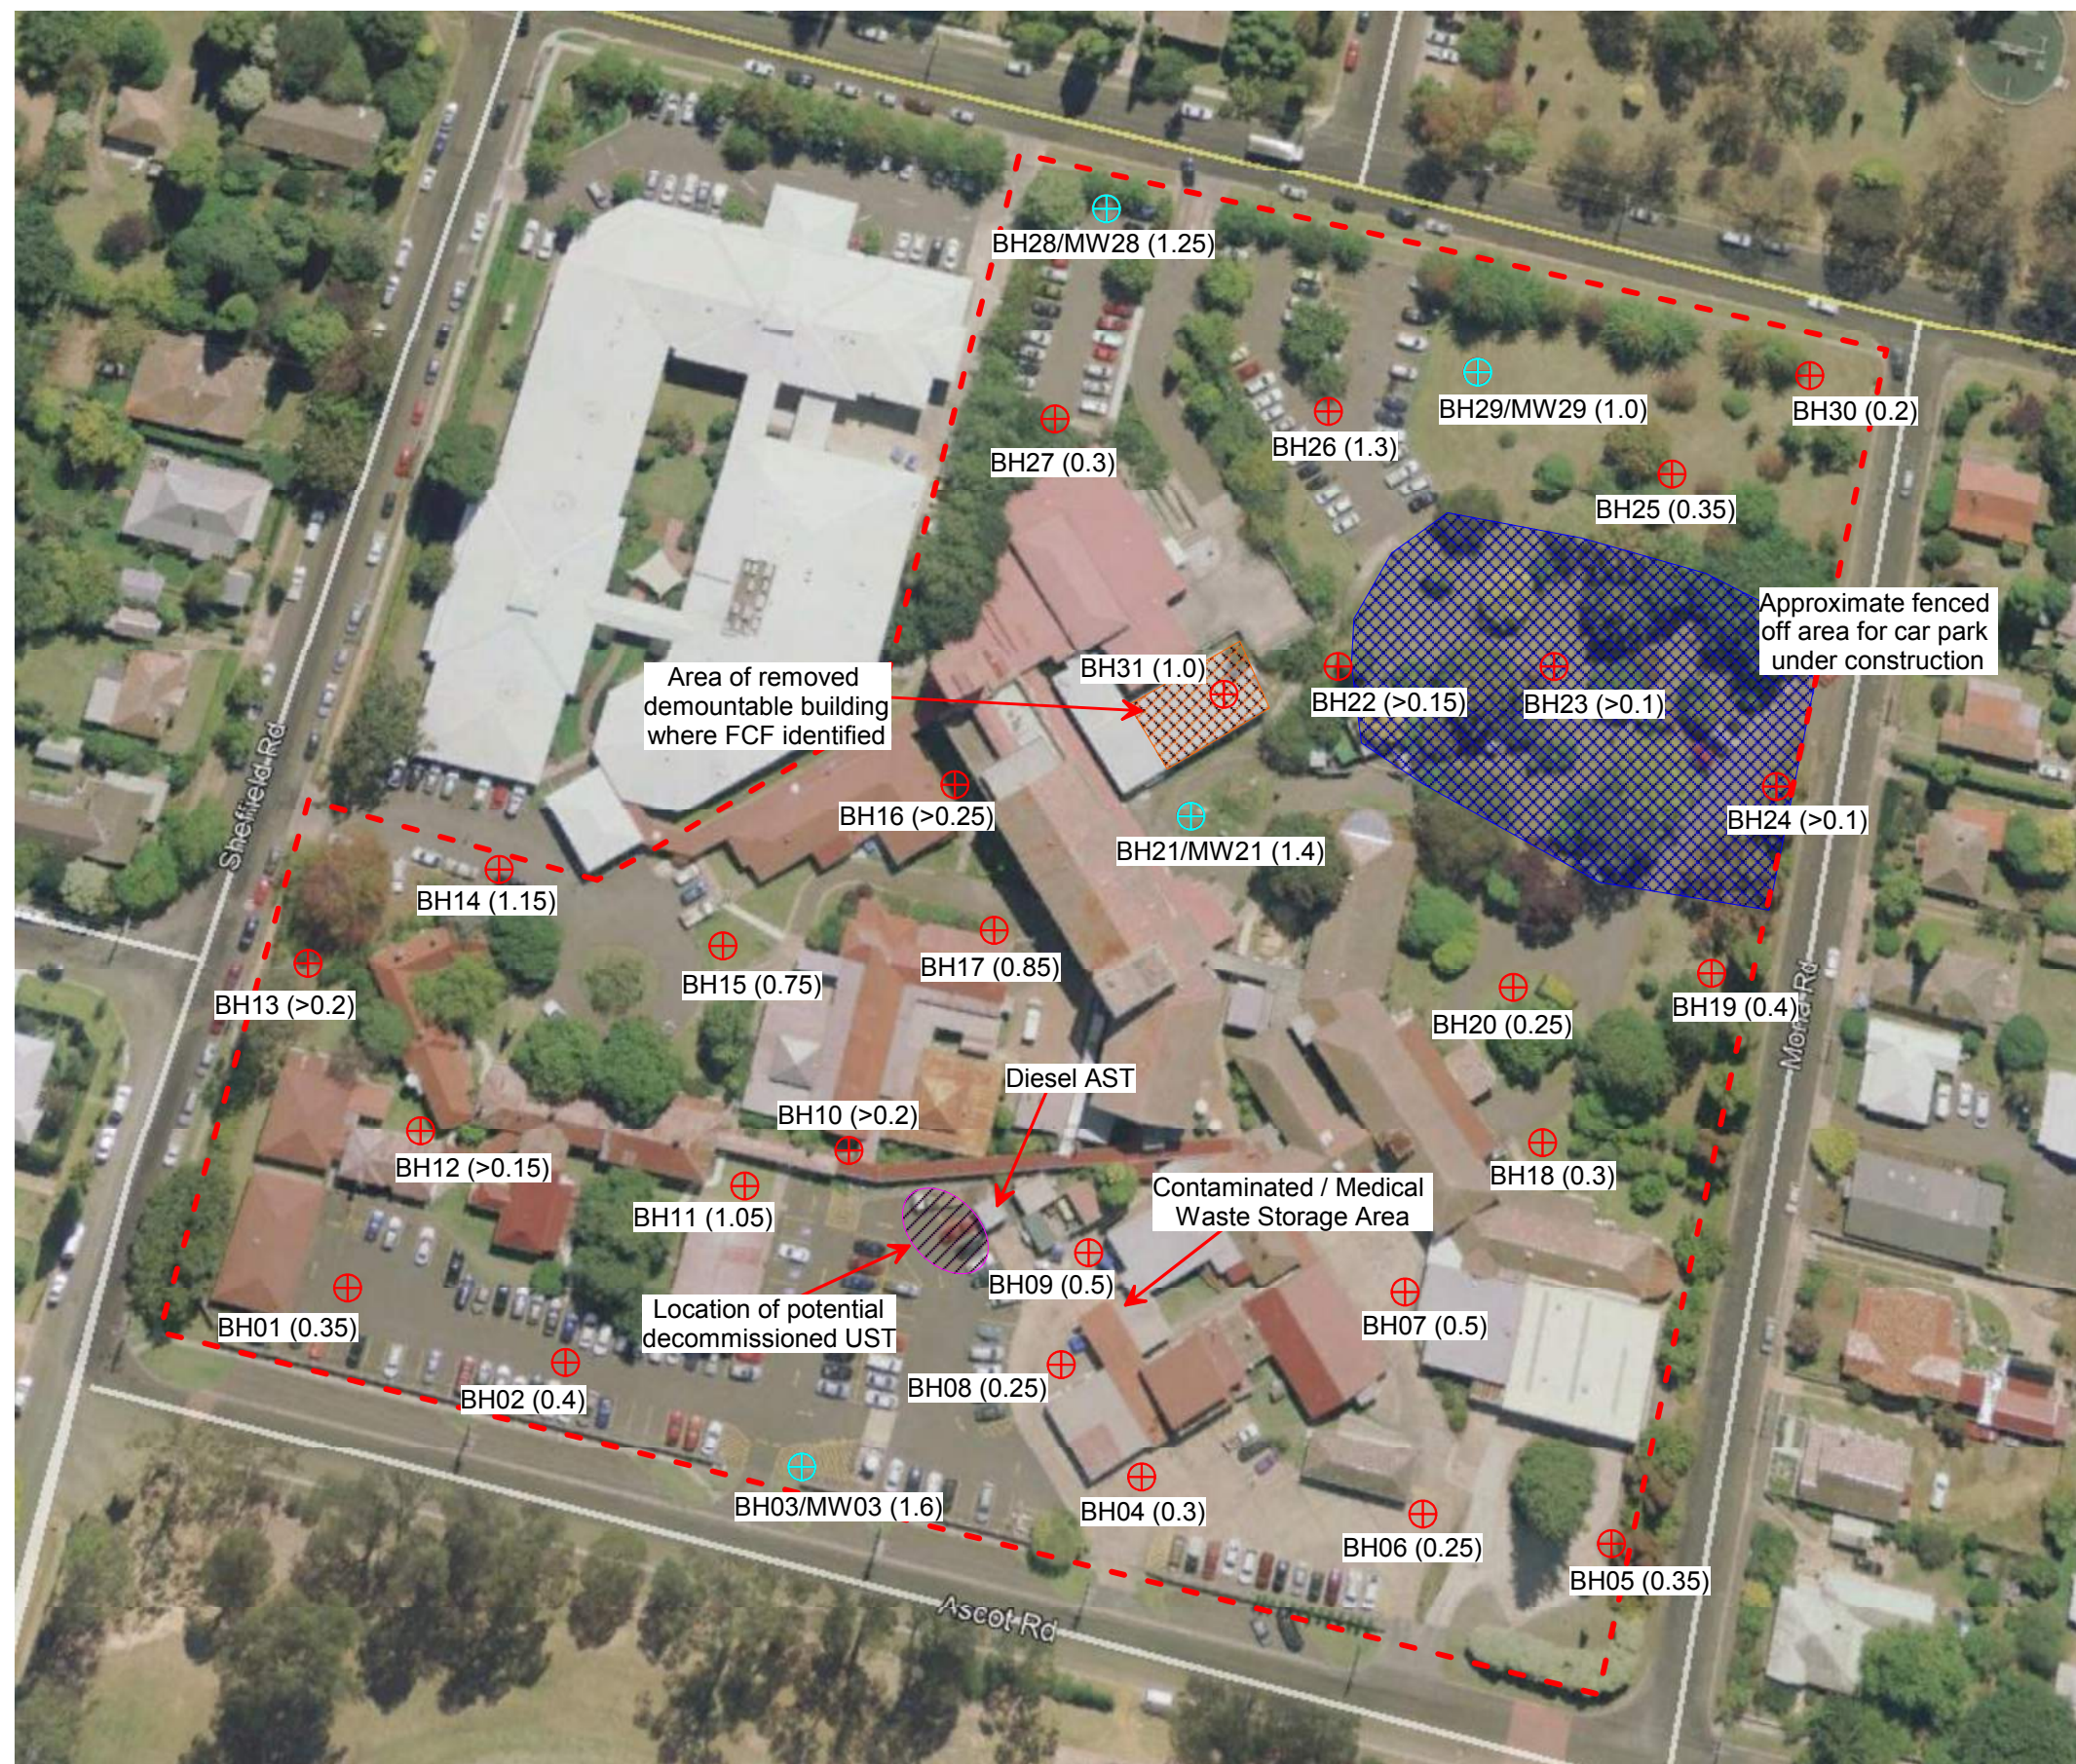
Title: <b>SAMPLE LOCATION &amp; SITE FEATURES PLAN</b>	
Location: 97-103 BOWRAL ROAD, BOWRAL, NSW	
Report No: E31452Krpt	Figure No: 2
<b>ENVIRONMENTAL INVESTIGATION SERVICES</b>

- - - APPROXIMATE SITE BOUNDARY
- ⊕ BOREHOLE LOCATION, NUMBER AND DEPTH OF FILL
- ⊕ BOREHOLE/GROUNDWATER WELL LOCATION, NUMBER AND DEPTH OF FILL

In all sample locations undertaken during the previous EIS investigation, fill was encountered at the surface or beneath pavements of the site overlying shallow natural (residual) soil and shale bedrock (see Figure 2).

Building and demolition rubble was not observed within the fill profile at BH21 nor BH22, these boreholes were located approximately 20m to the south and 21m to the north-east of BH31 respectively (refer to Figure 2). Based on the site observations made during the fieldwork, the asbestos contaminated fill potentially limited to the former demountable building footprint in the vicinity of BH31 and to extend to an approximate depth of 0.2m bgl. At the time of the fieldwork this area was secured with man-proof fencing preventing access by the general public however, contractors were observed to be operating in this area. Due to the identification of the FCF on the site surface and within shallow fill soils, there is a complete source-pathway-receptor (SPR) linkage. EIS are of the opinion that the risk posed to human receptors is low to moderate and will require remediation and/or management.

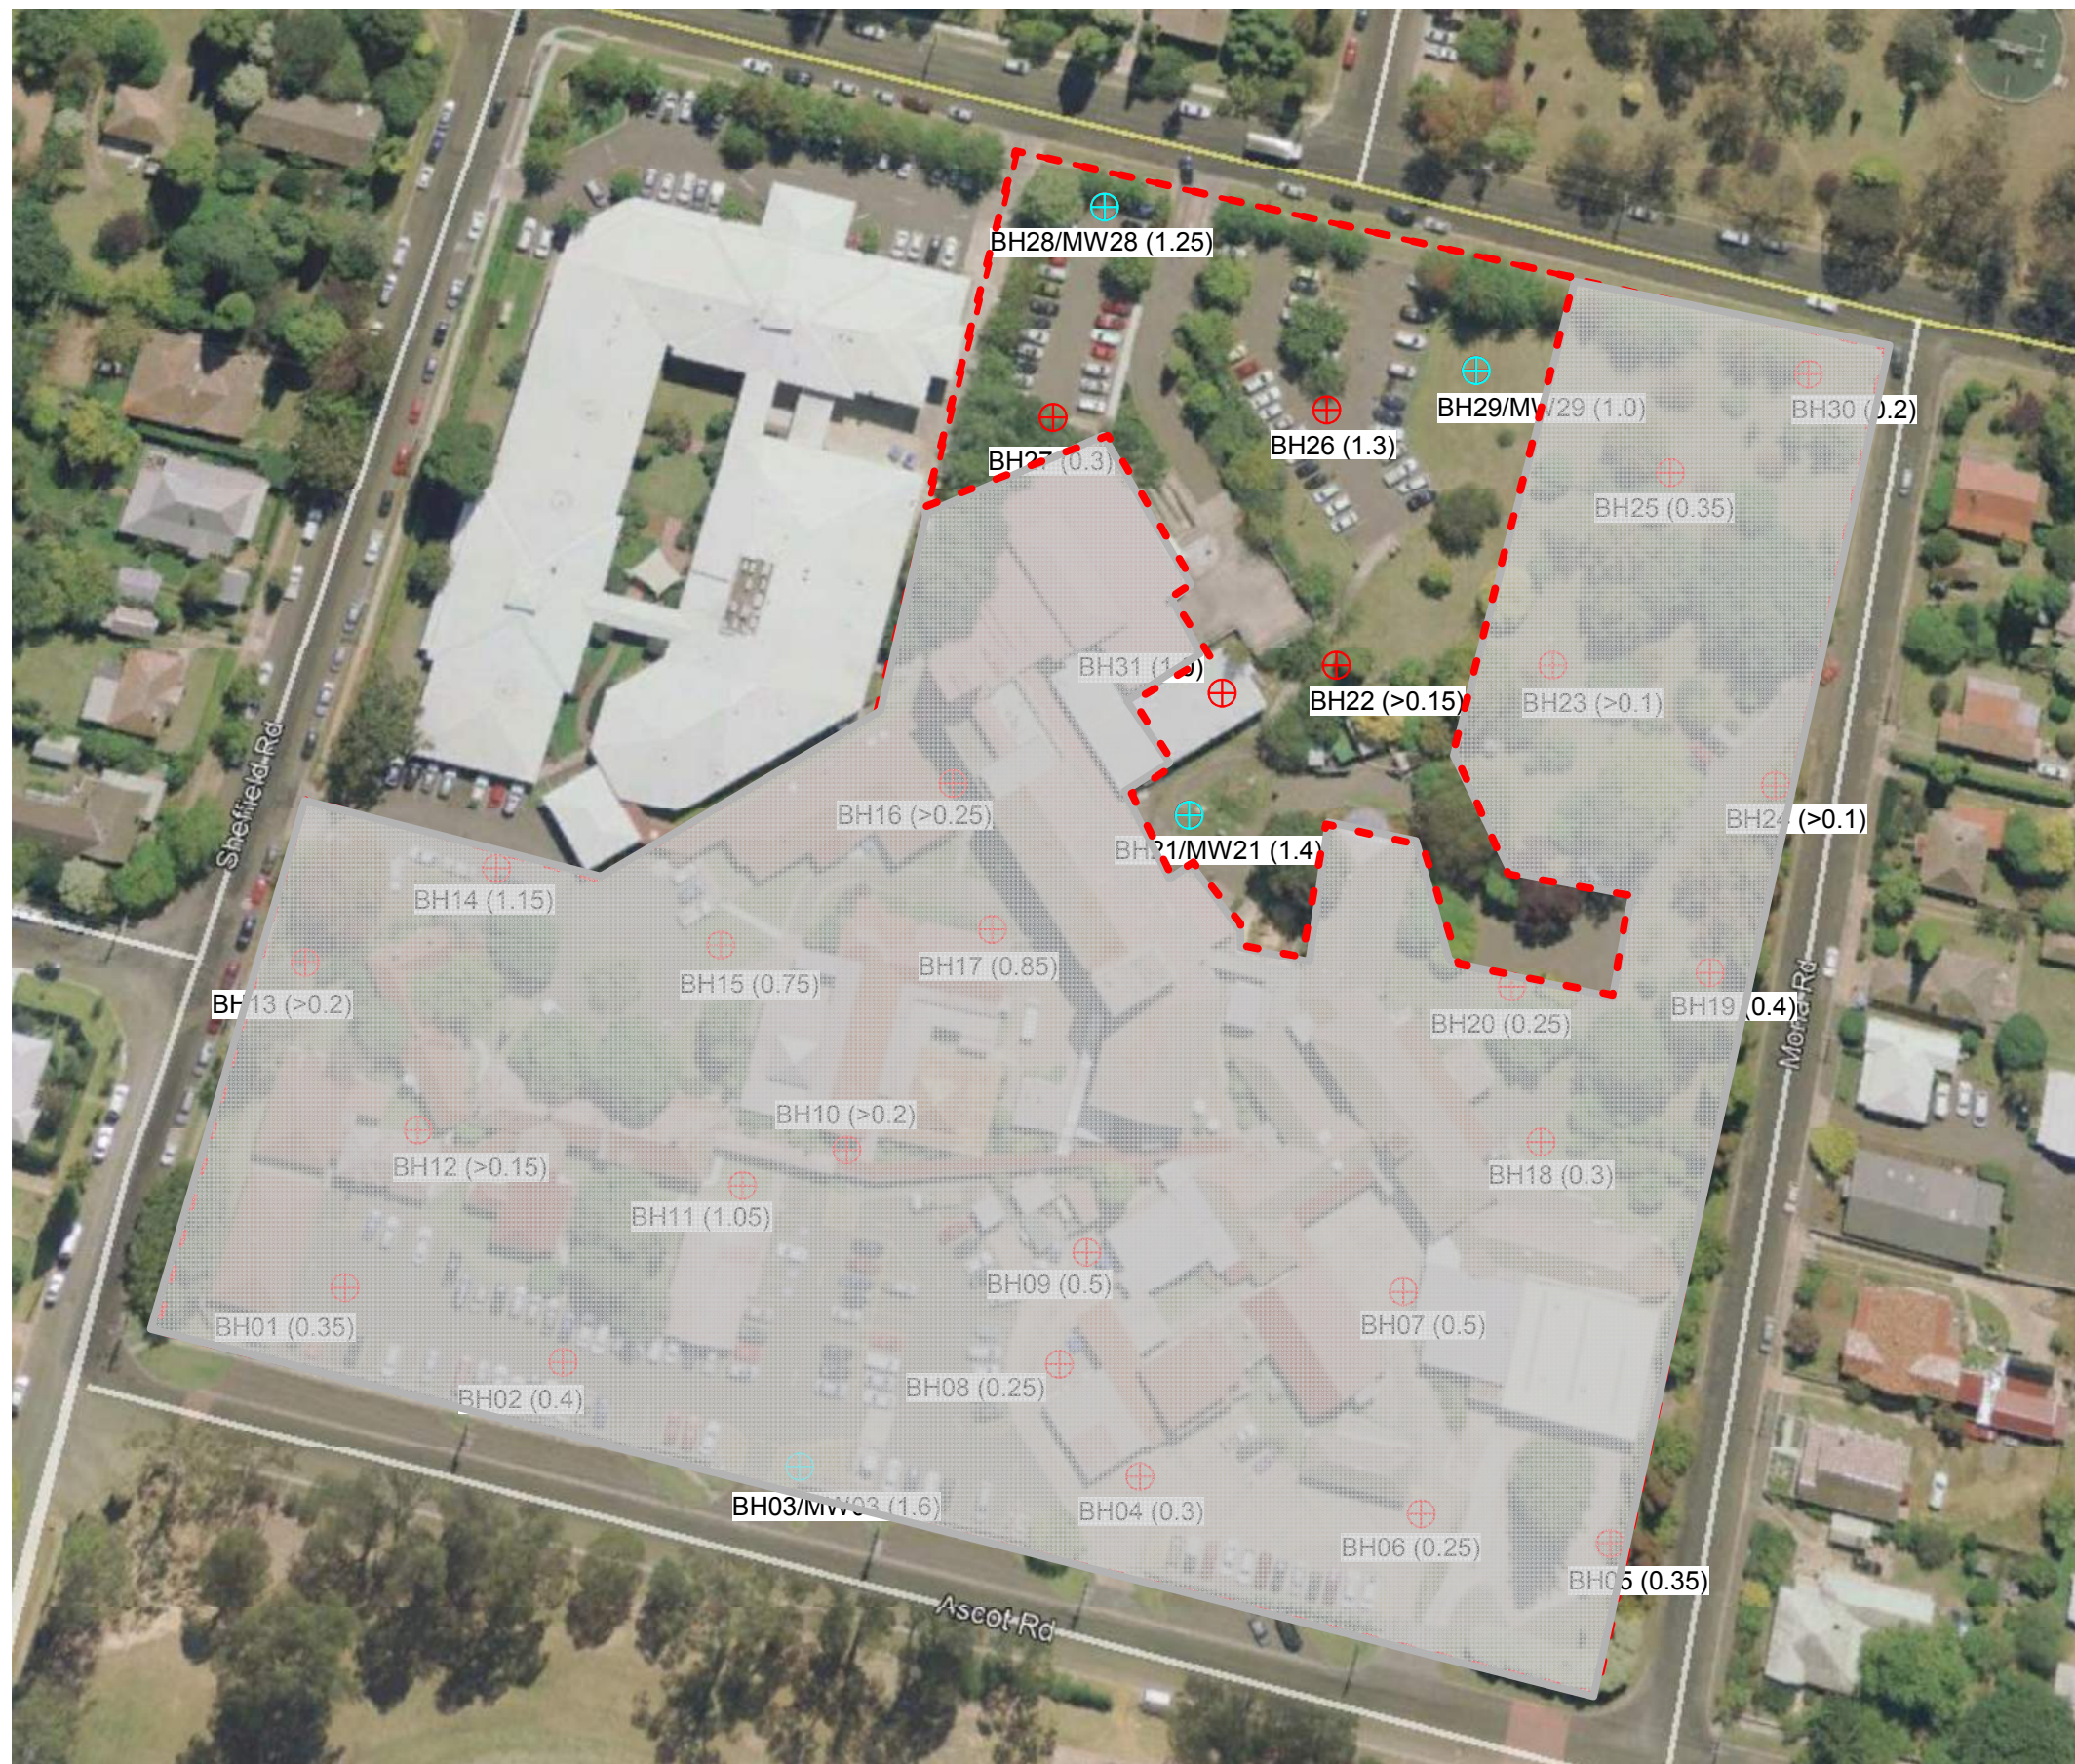
- APPROXIMATE SITE BOUNDARY
- ⊕ BOREHOLE LOCATION, NUMBER AND DEPTH OF FILL (EIS MAY 2018 INVESTIGATION)
- ⊕ BOREHOLE/GROUNDWATER WELL LOCATION, NUMBER AND DEPTH OF FILL (EIS MAY 2018 INVESTIGATION)
