Report on
Preliminary Geotechnical Investigation

Proposed Hospital Upgrade
Bowral & District Hospital, Mona Road, Bowral

Prepared for
Health Infrastructure

Project 89199
October 2016

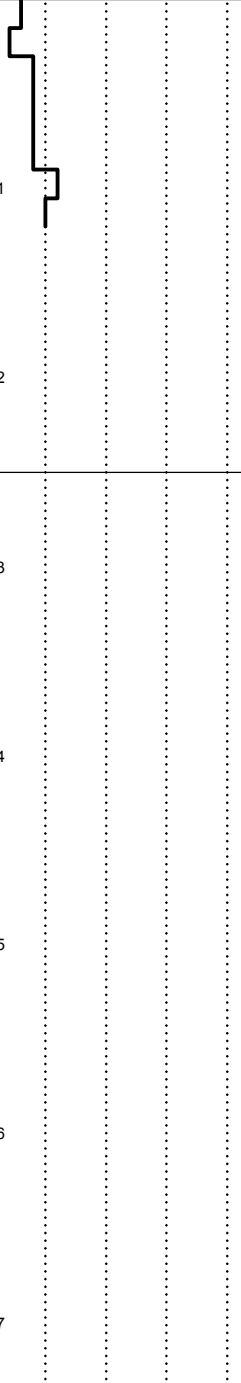
RL	Depth (m)	Description of Strata	Graphic Log	Sampling & In Situ Testing				Water	Dynamic Penetrometer Test (blows per 150mm)					
				Type	Depth	Sample	Results & Comments		5	10	15	20		
		TOPSOIL - dark grey, silty clay, moist

D		0.5										
		SILTY CLAY - stiff, grey, silty clay, moist		B	0.7									
		SILTY CLAY - stiff, orange brown, silty clay, moist		D	1.0									
		- saturated and very soft at 1.2m												
		SANDSTONE - extremely low to low strength, highly weathered, orange brown, sandstone

Free groundwater was observed at depths of 1.1 m (RL 679) and 1.2 m (RL 678.4) in Bores 3 and 4 respectively during drilling. No free groundwater was observed in the remaining boreholes during auger drilling. It is noted that the use of water as a drilling fluid precluded groundwater observations whilst coring. Furthermore, all boreholes were backfilled following the field work which precluded long term monitoring of groundwater level. Groundwater levels are dependent on preceding climatic conditions and soil permeability and can therefore fluctuate with time.

For service trench excavation, the presence of shallow groundwater seepage may require localised dewatering via sump and pump techniques, together with shoring or battering. In particular, it is noted that free groundwater was observed at depths of 1.1 m in Bore 3 and 1.2 m in Bore 4 during drilling.

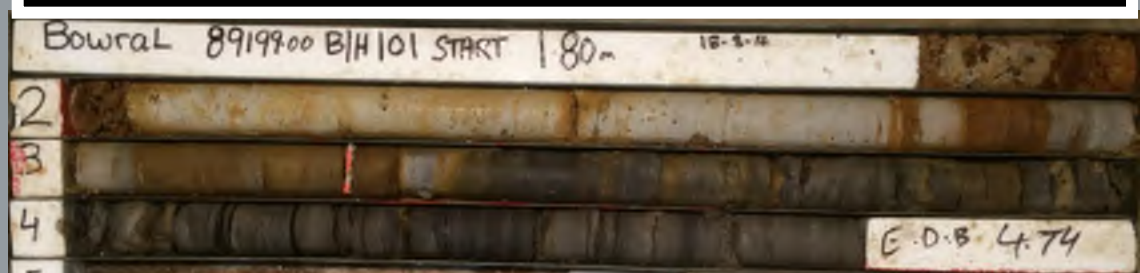
1.80 – 4.74 m

677.20	SILTY CLAY - very stiff, light grey mottled orange brown, medium plasticity, silty clay with some extremely low strength, extremely weathered, sandstone bands, moist																									
	677																										
	676

675.72	SHALE - extremely low strength, extremely weathered, fractured to slightly fractured, grey orange brown, shale																									
	675.20	SHALE - very low strength, slightly weathered to fresh stained, fractured to slightly fractured, mid to dark grey, shale																									
	675

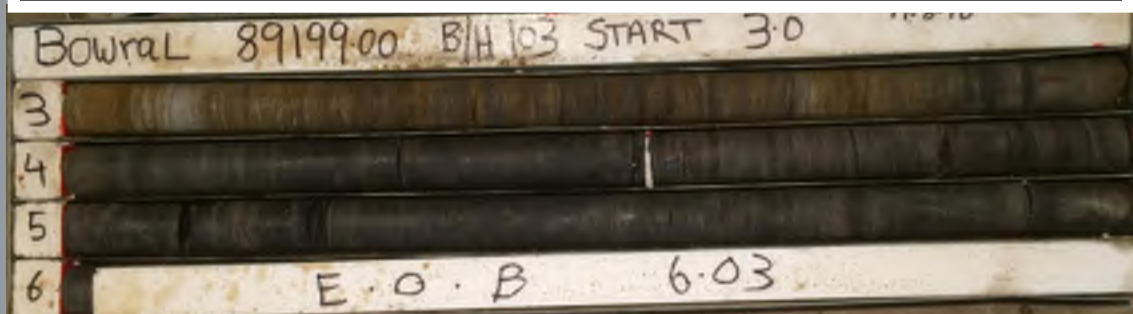
DOUGLAS PARTNERS PTY LTD
PROPOSED HOSPITAL UPGRAD – BOWRAL DISTRICT HOSPITAL
BORE 103 PROJECT 89199.00 SEPT 2016

3.0– 6.03 m

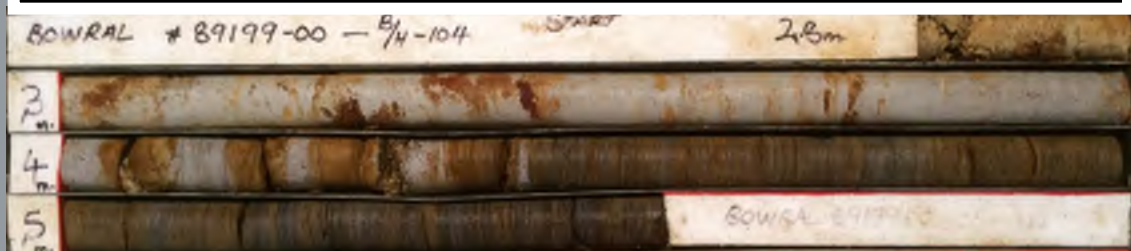
DOUGLAS PARTNERS PTY LTD
PROPOSED HOSPITAL UPGRAD – BOWRAL DISTRICT HOSPITAL
BORE 104 PROJECT 89199.00 SEPT 2016

2.8 – 5.55 m

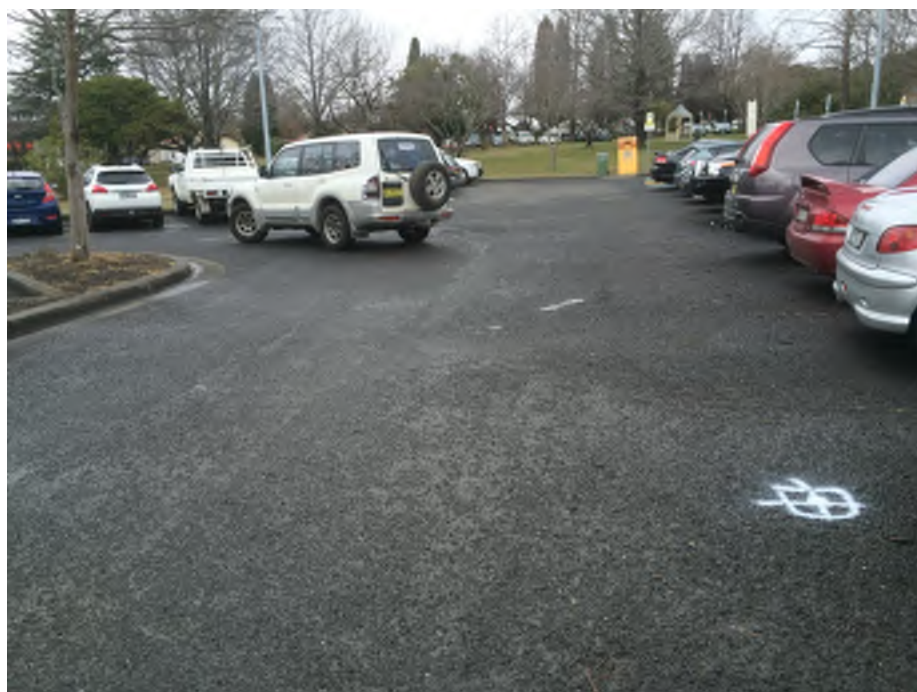
Photo 4 – Existing car park. Bore 3 marked on pavement.

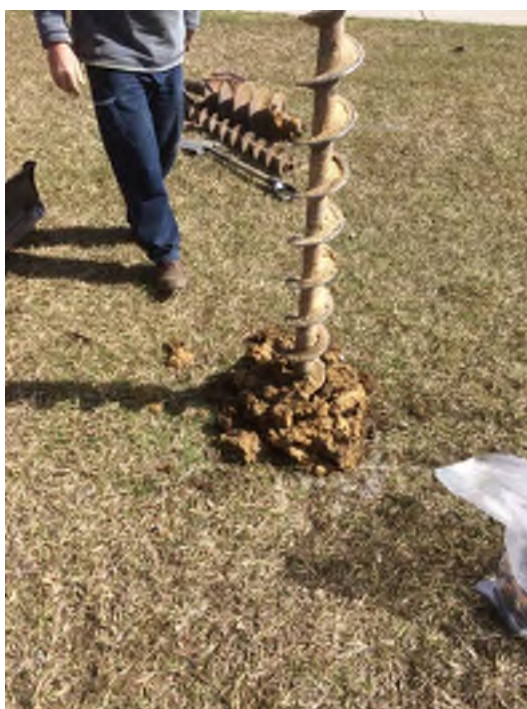
Photo 5 – Drilling at Bore 4

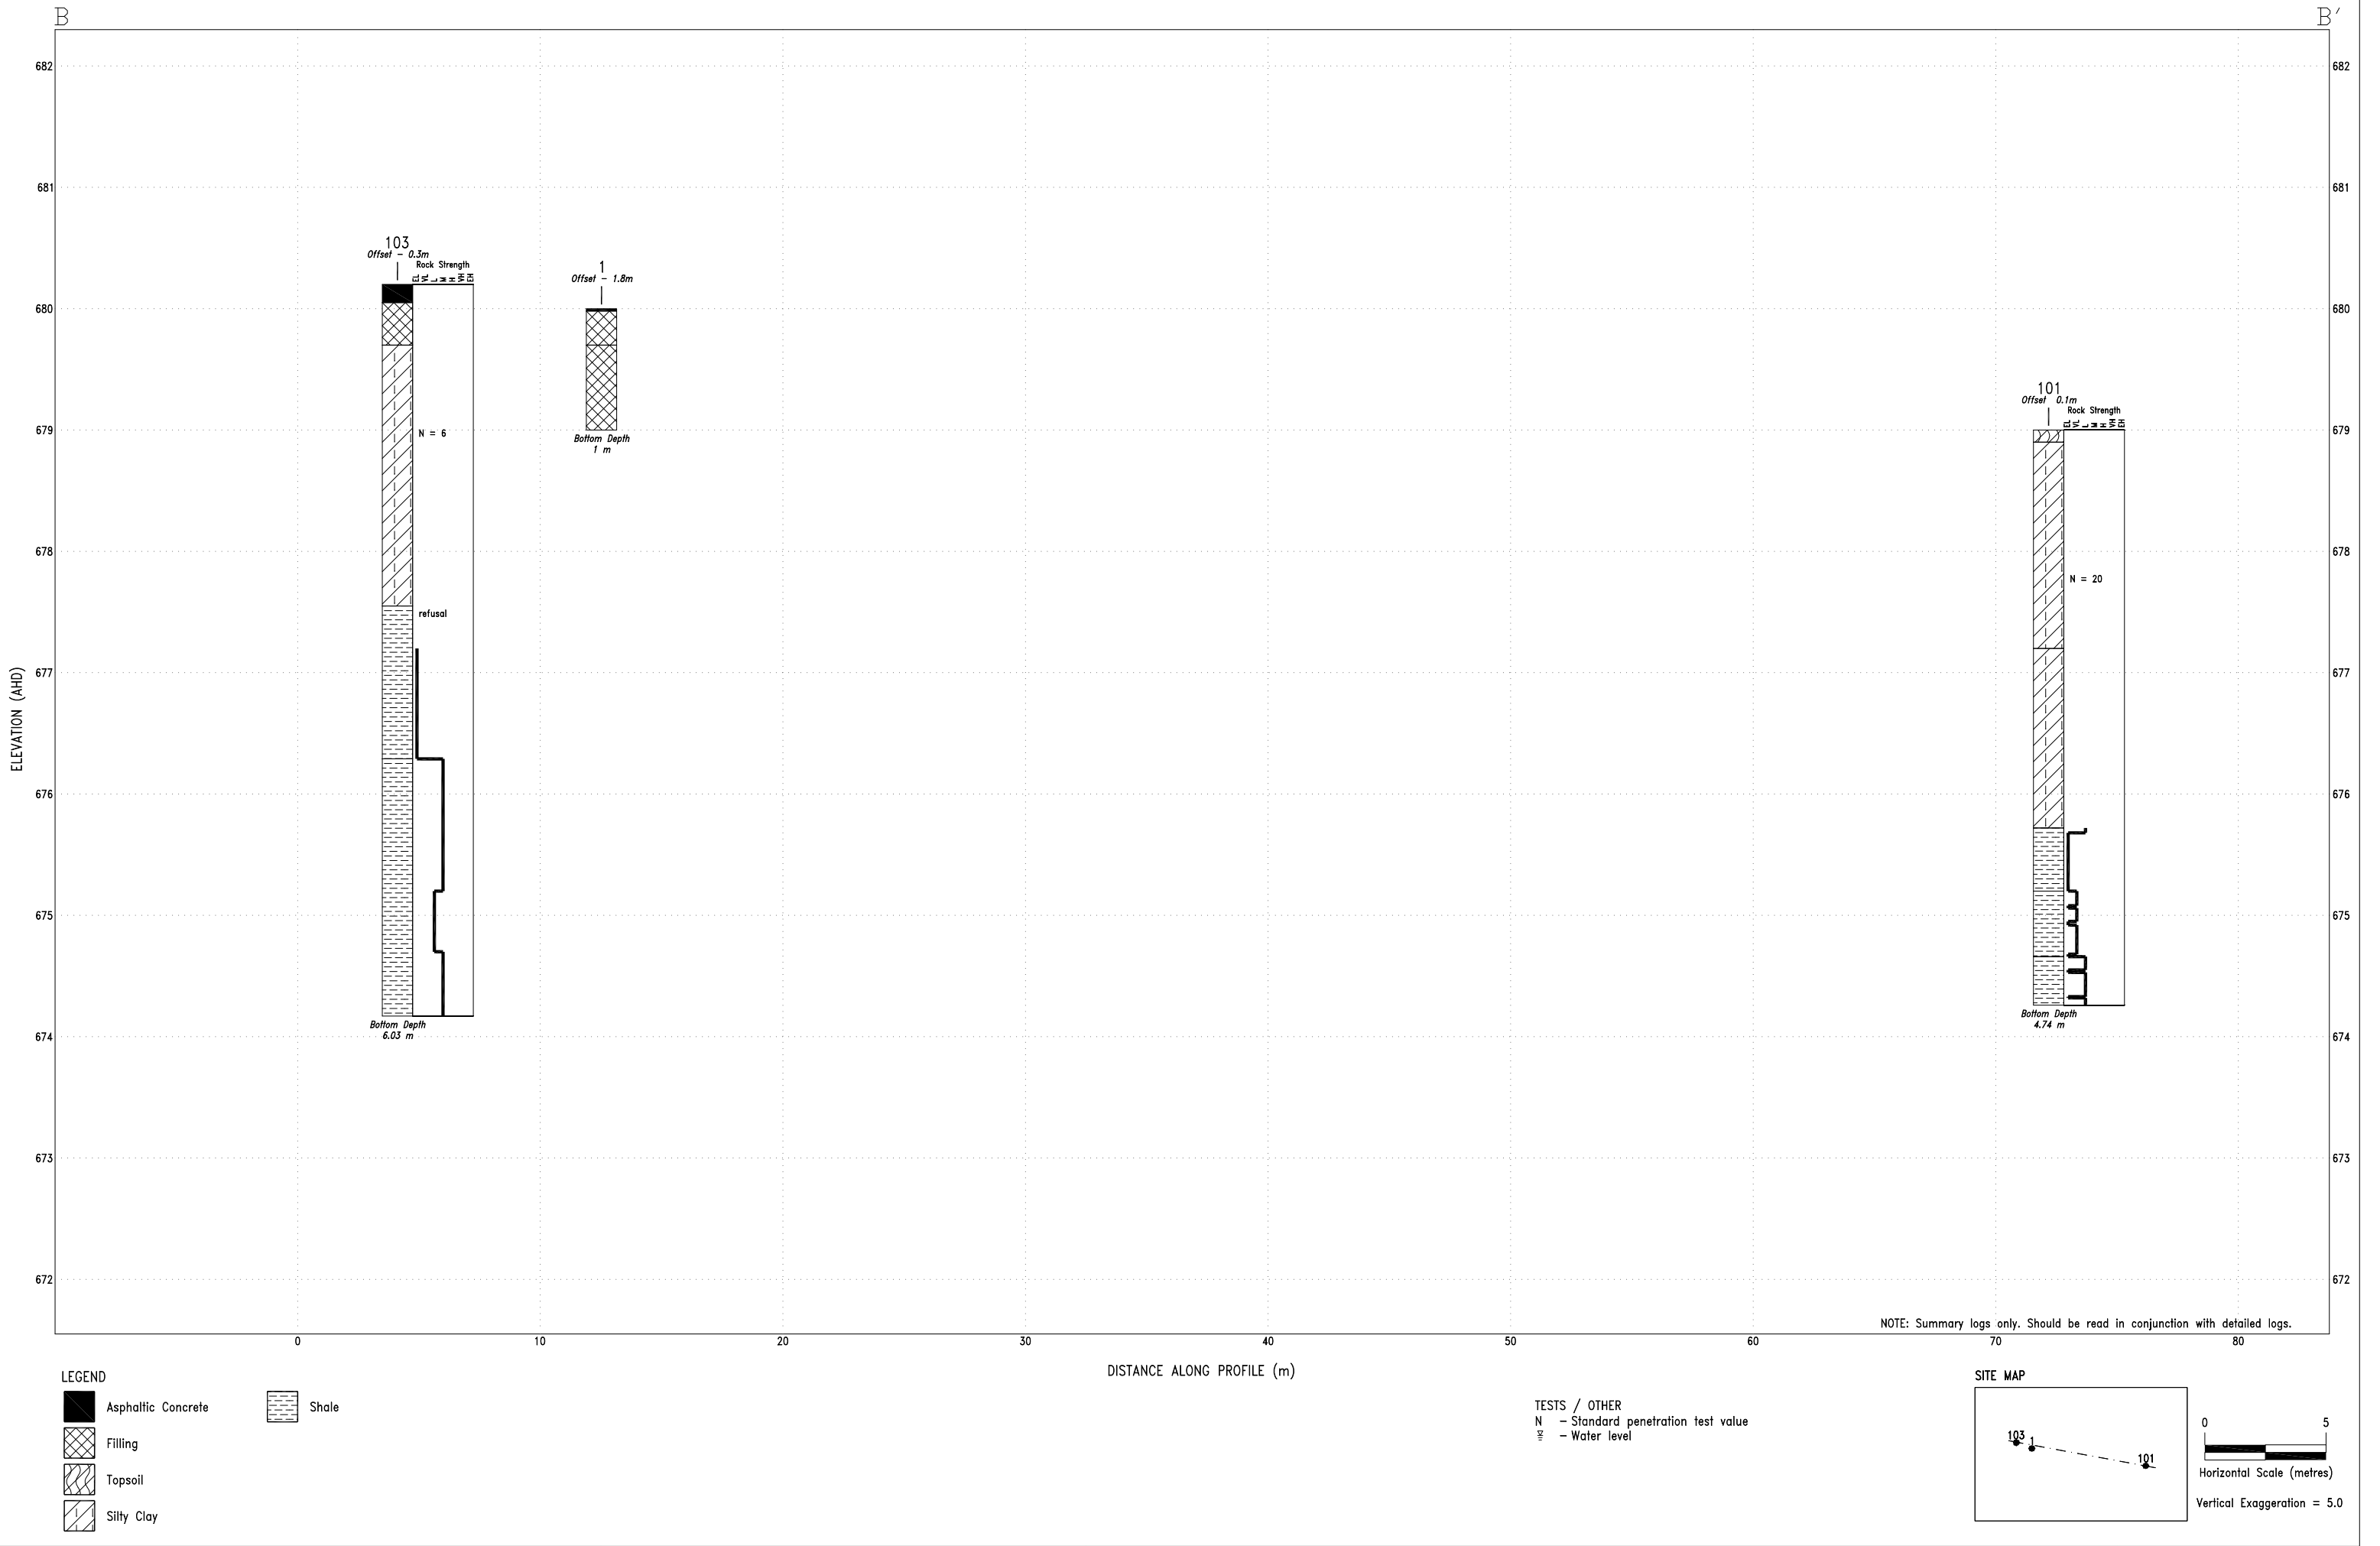
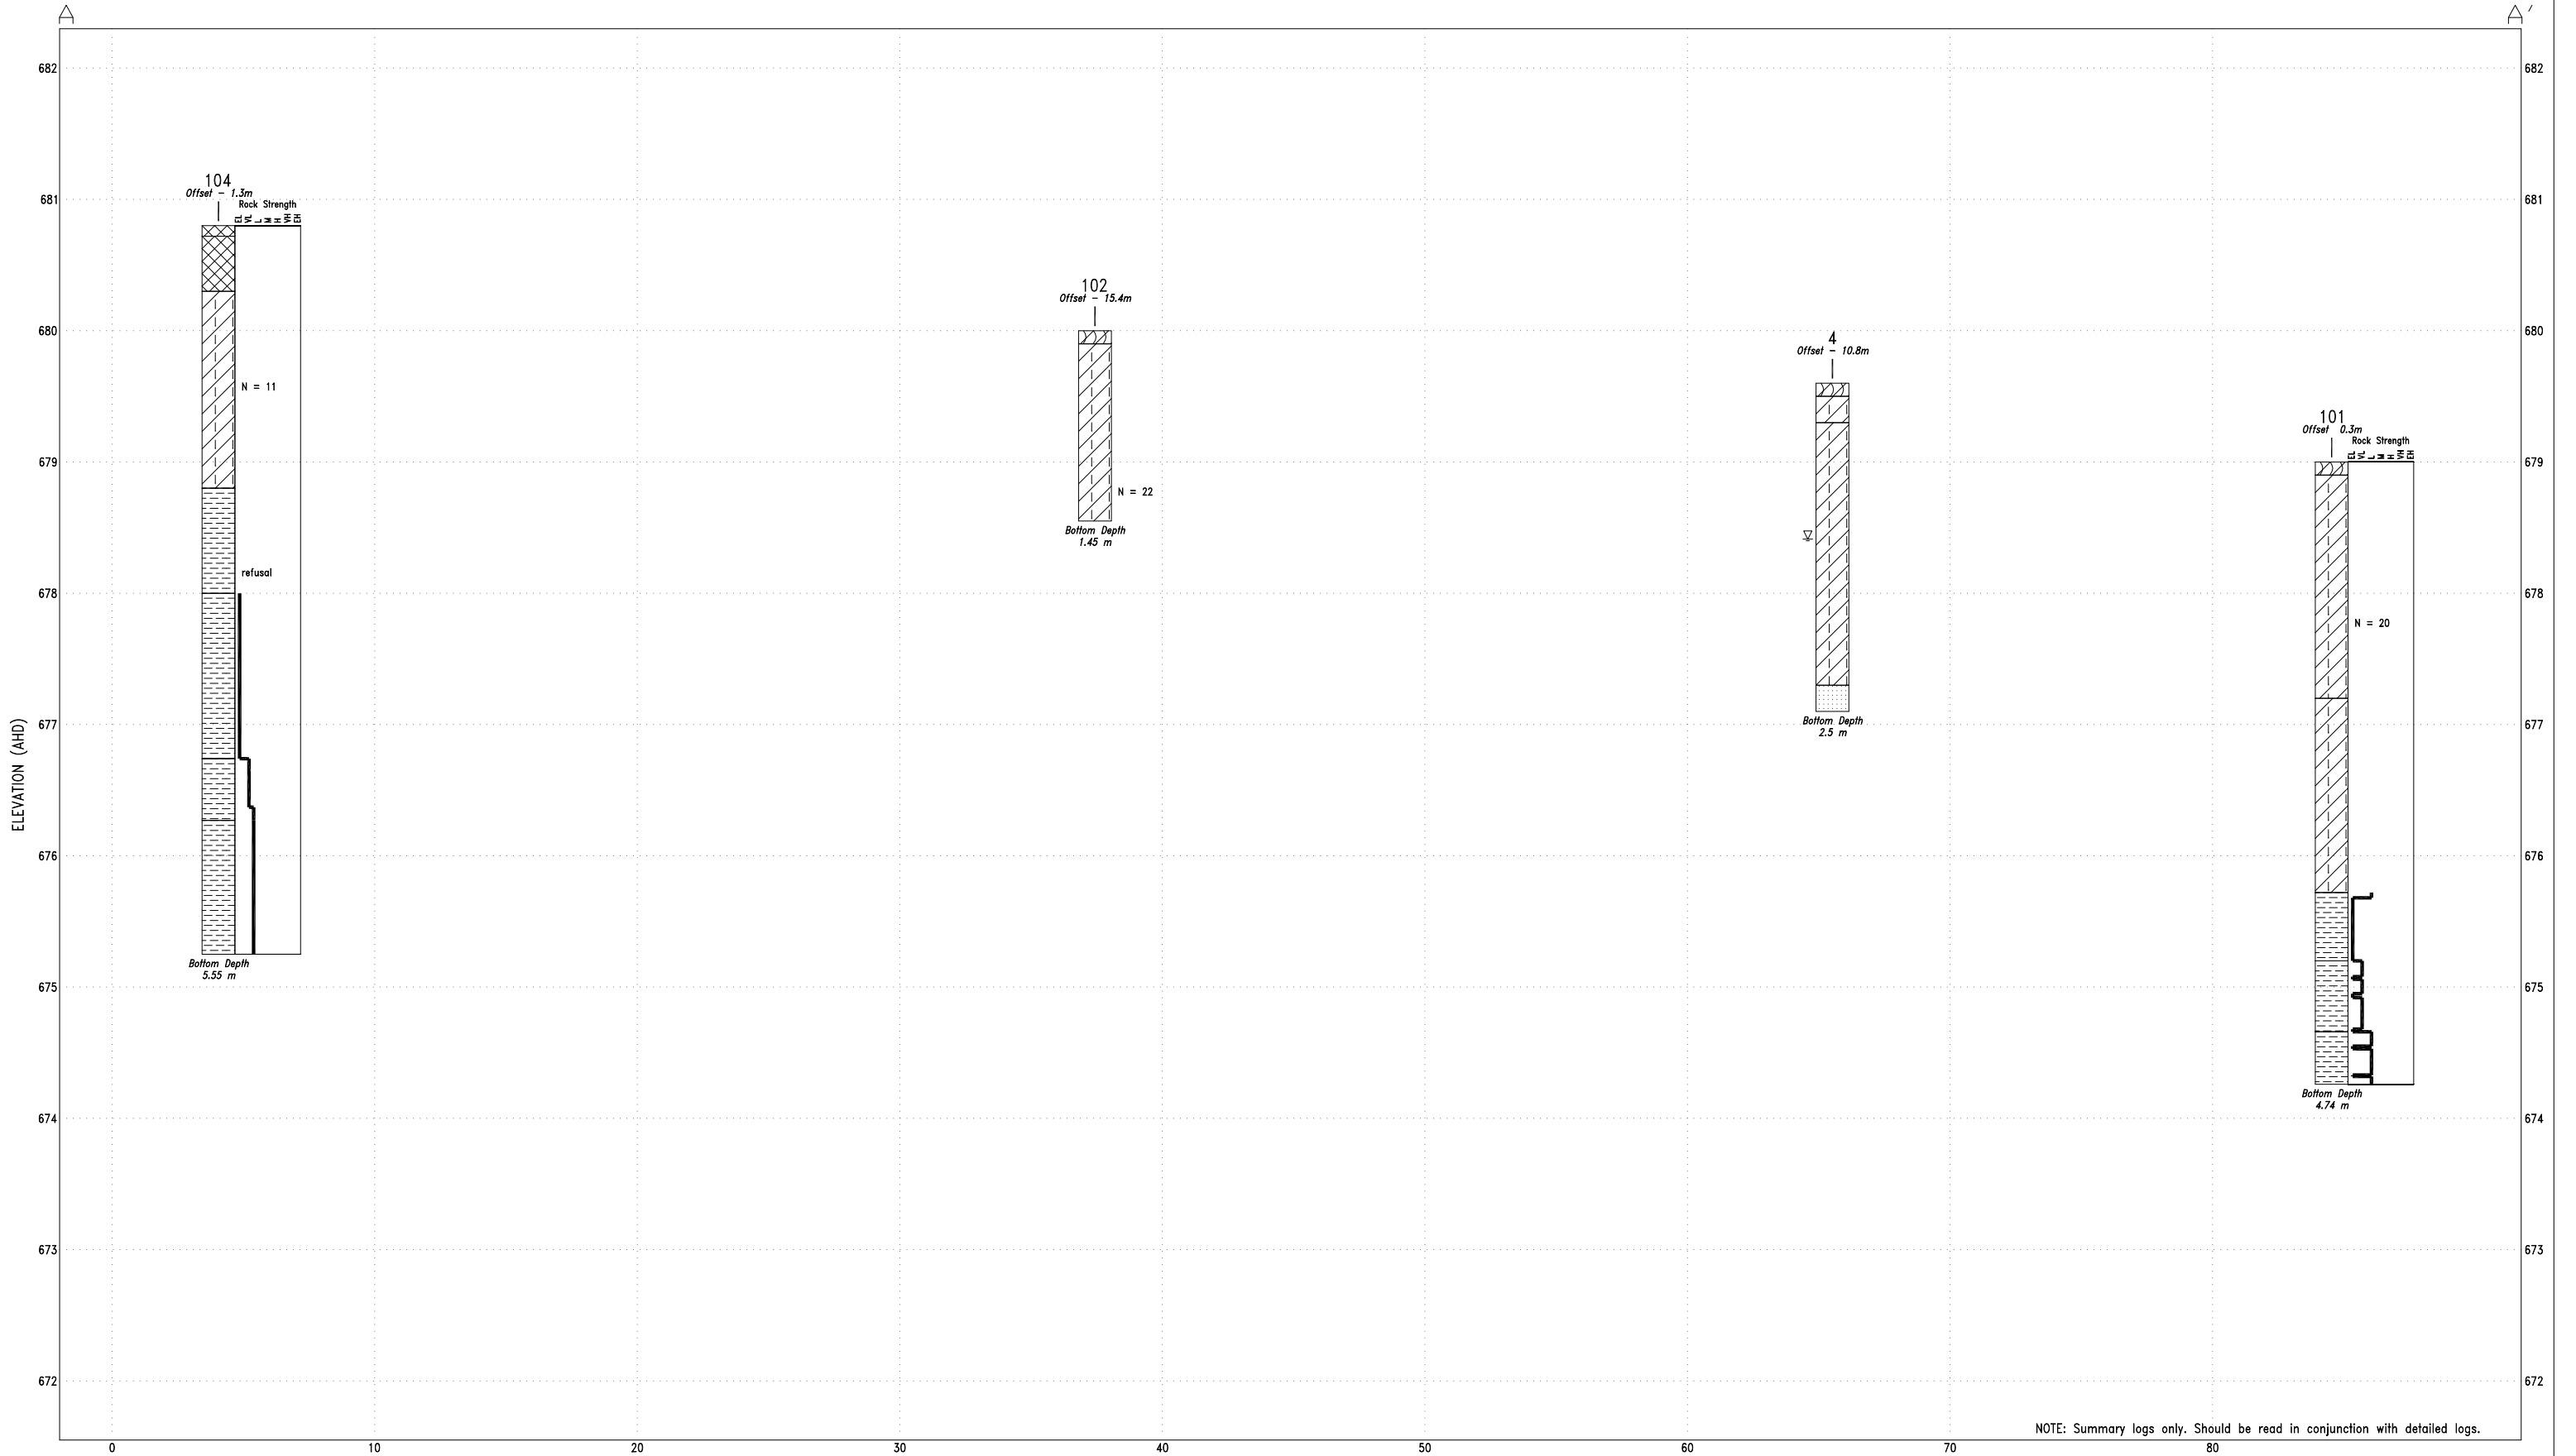
PROJECT No:	89199
DRAWING No:	2
REVISION:	0

TITLE: Cross-section B-B'
Proposed Hospital Upgrade
Bowral District Hospital, Mona Road, Bowral

NOTE: Summary logs only. Should be read in conjunction with detailed logs.

The subsurface conditions encountered during the investigation are given on the borehole logs in Appendix B. These should be read in conjunction with the accompanying notes defining classification method and descriptive terms. Geotechnical sections are included in Appendix B.

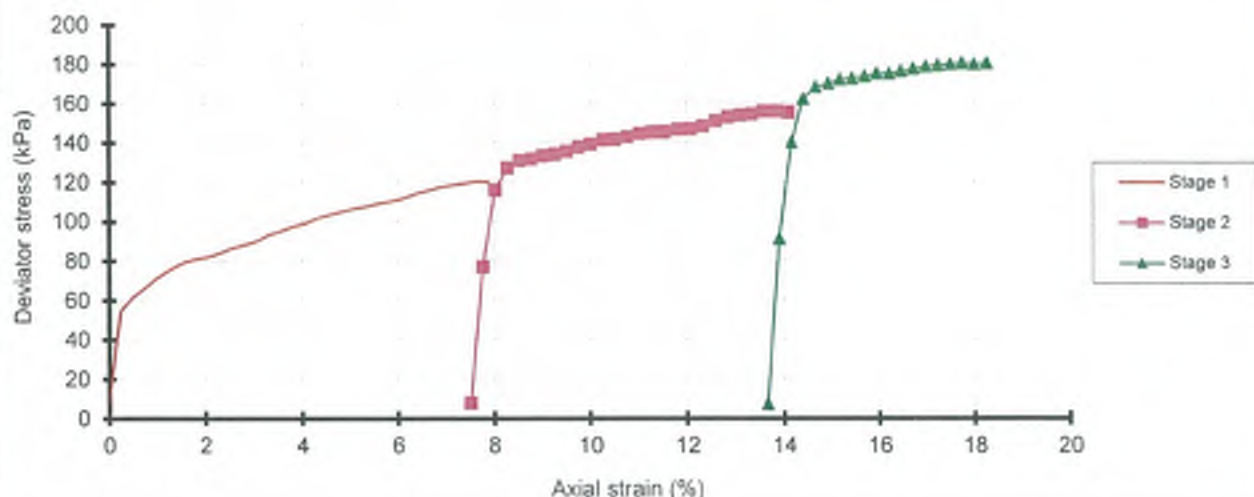
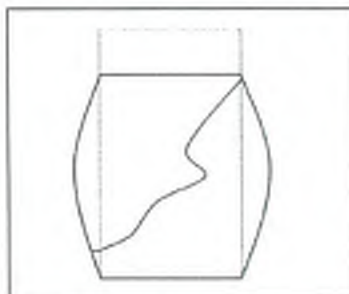
Triaxial Compression Test Results

UNDRAINED SHEAR STRENGTH C_u (kPa)

Stage 1	Stage 2	Stage 3
60	78	90

Stage 1	Stage 2	Stage 3
Cell pressure (kPa):	50	100	200
Strain rate (mm/min):	1.50	1.50	1.50
Strain at failure (%):	7.64	6.87	4.73
Maximum deviator stress (kPa):	121	156	181

The results of the strength testing indicated that the clay samples tested are of 'stiff' consistency and confirm the field logging. The Shrink-Swell result indicates that the sample tested is of low plasticity and as such, would be slightly susceptible to shrinkage and swelling movements with changes in soil moisture content.

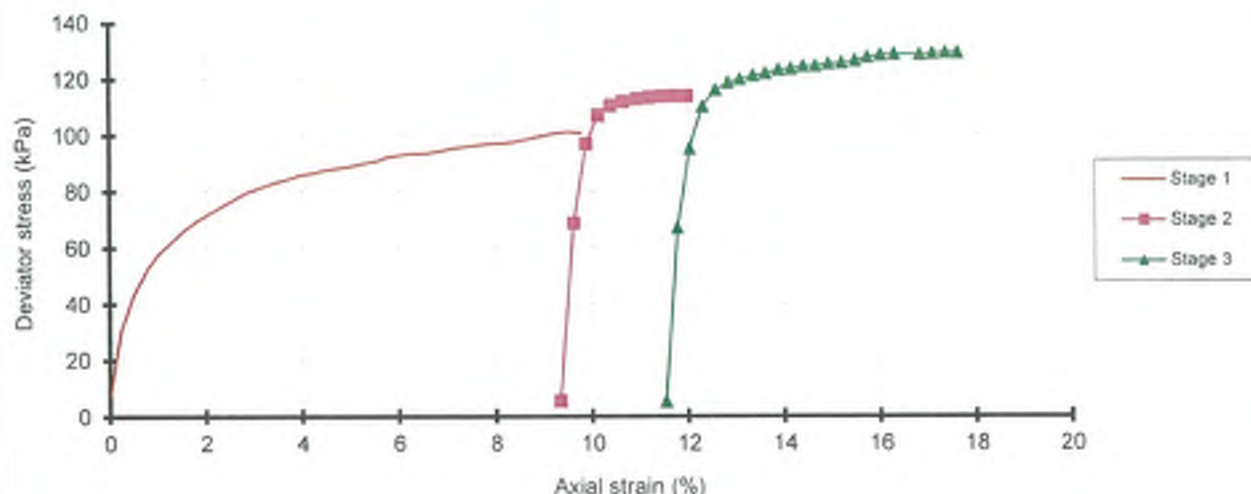
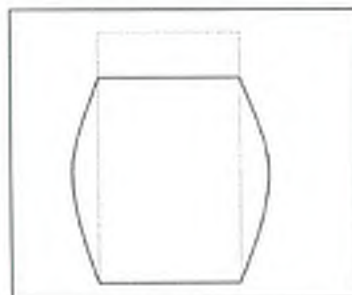
UNDRAINED SHEAR STRENGTH C_u (kPa)

Stage 1	Stage 2	Stage 3
51	57	65

Cell pressure (kPa):	50	100	200
Strain rate (mm/min):	1.50	1.50	1.50
Strain at failure (%):	9.50	2.95	6.60
Maximum deviator stress (kPa):	101	114	129

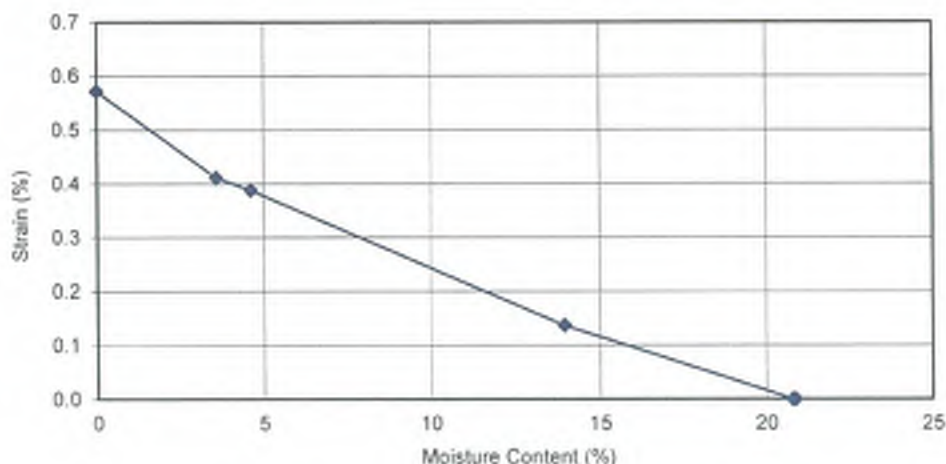
SWELL TEST

Pocket penetrometer reading at initial moisture content	- kPa
Pocket penetrometer reading at final moisture content	400 kPa
Initial Moisture Content	20.5 %
Final Moisture Content	20.9 %
Swell under 25kPa	0.0 %

SHRINK-SWELL INDEX I_{ss} 0.3% per ΔpF

Notwithstanding the P classification, the underlying stiff clay profile would be equivalent to Class M (moderately reactive) conditions. It is noted however that classification is based on the subsurface conditions at the time of the investigation and is independent of proposed construction and site works, and is aimed at classifying the site from the reactivity viewpoint only. Following earthworks under controlled conditions (refer Section 6.2), the resulting site classification would be primarily dependent on the shrink-swell capacity of the fill materials. For example, fill materials placed to depths of up to 1.5 m would need to have a Shrink-swell Index no greater than $2.5\%/\Delta pF$ to achieve an M classification. Alternatively, upper Shrink-swell limits of $3.5\%/\Delta pF$ and $4.6\%/\Delta pF$ would result in H1 and H2 classifications respectively.
