ENVIRONMENTAL INVESTIGATION SERVICES

REMEDIATION CONCEPT PLAN

LORETO NORMANHURST MASTER PLAN

91-93 PENNANT HILLS ROAD, NORMANHURST, NSW

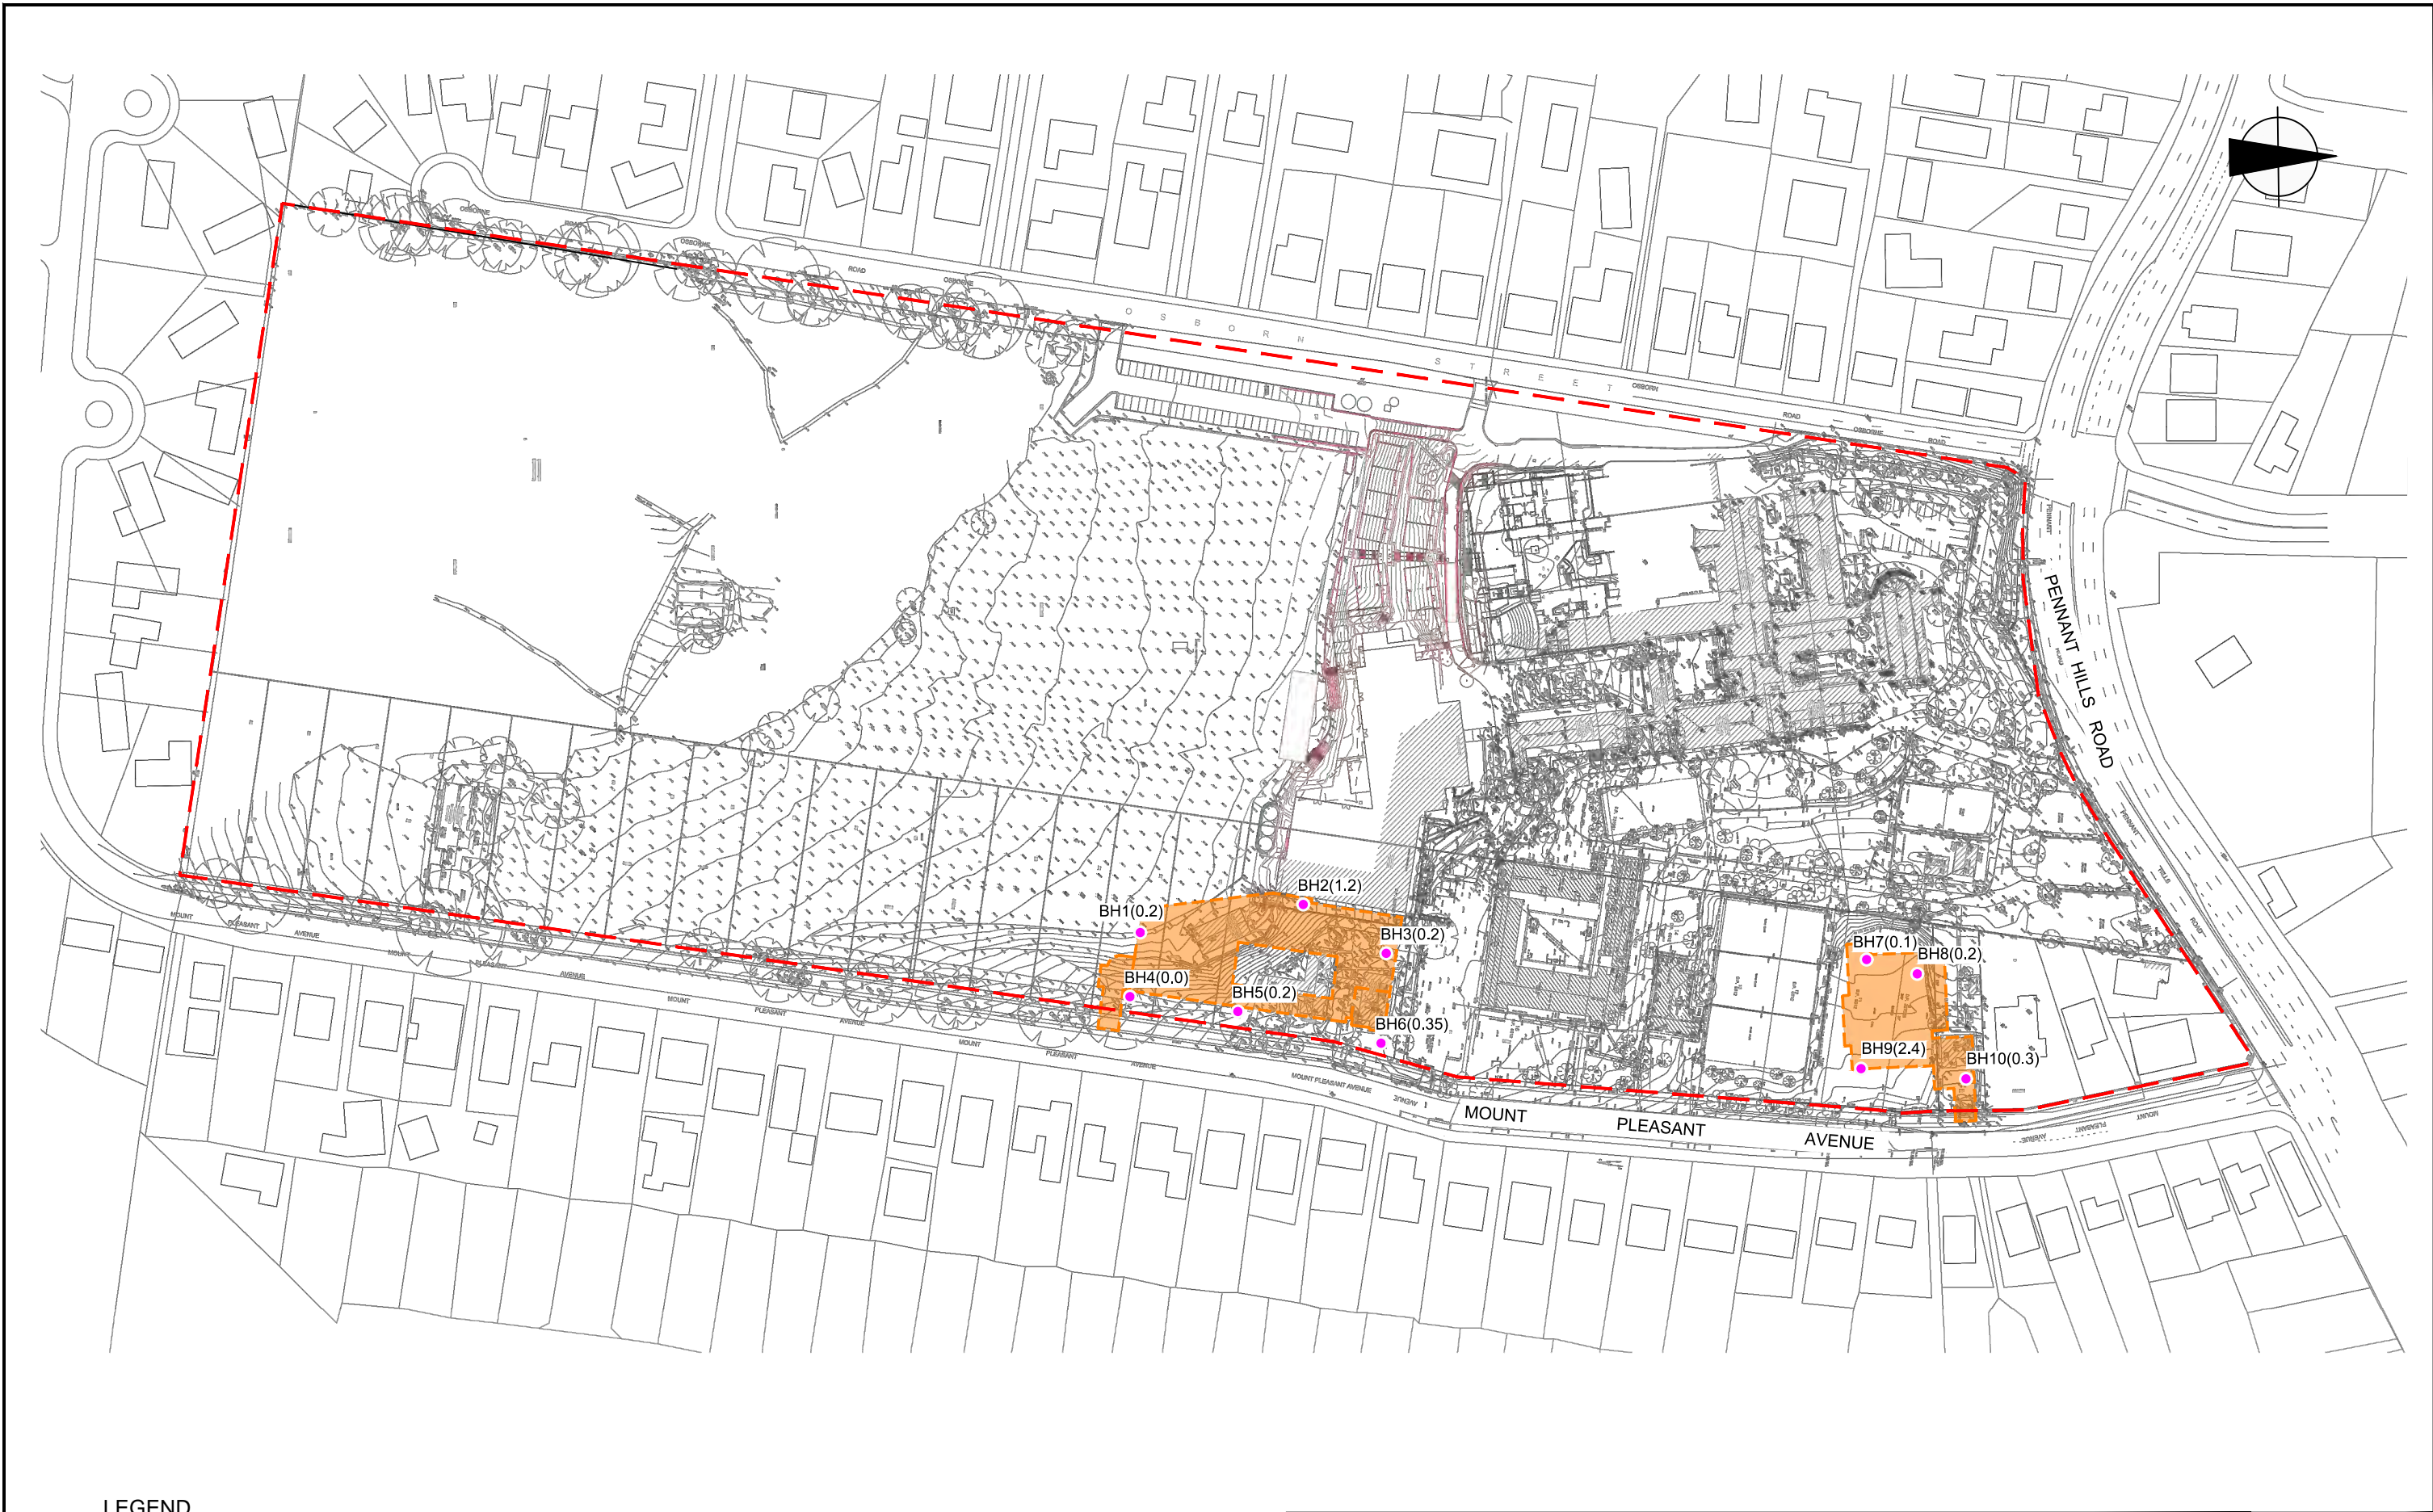
Appendix B: EIS 2018 Sample Location Plan

- APPROXIMATE SITE BOUNDARY
- BH (Fill Depth) BOREHOLE LOCATION, NUMBER AND DEPTH OF FILL (m)
- APPROXIMATE OUTLINE OF PROPOSED BUILDING
