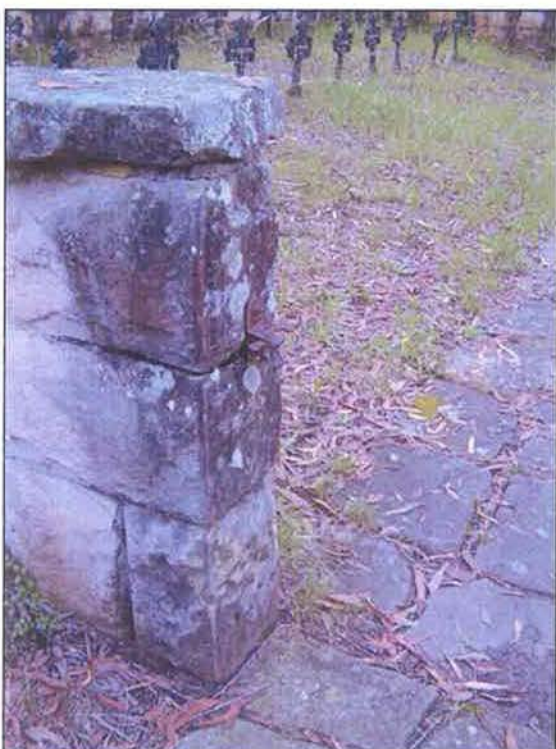
**Figure 3.48** It is would appear that the opening in the northern wall featured a wrought iron gate. Only part of the latch now remains.

- The area around the cemetery should be kept clear and periodic maintenance and removal of weeds from the sandstone walls is recommended. It is not necessary to repair or reinstate the original gate, however, remnants of the gate should be retained in-situ and stabilised.

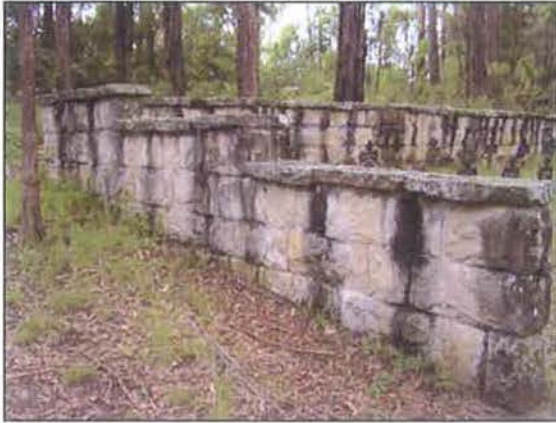
**Figure 3.49** The stepped stone wall appears to be intact and in sound and good condition.

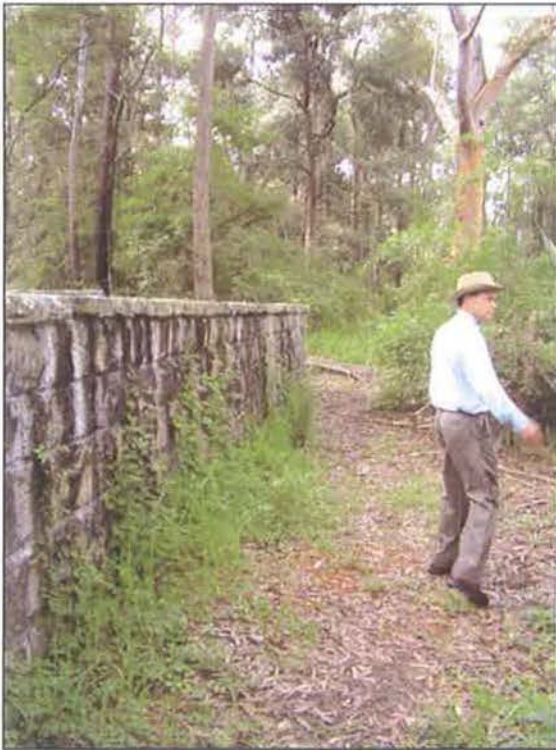
**Figure 3.50** The cemetery is generally in good condition and had been maintained. The area around the cemetery wall has generally been kept clear.

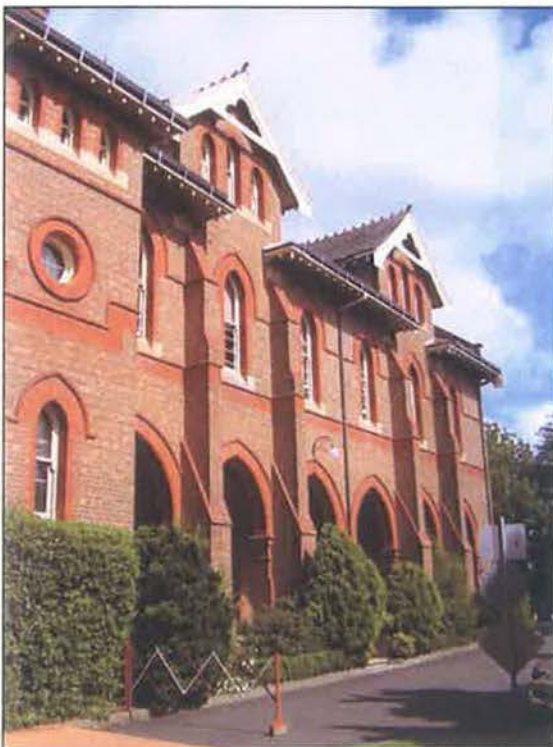
**Figure 3.57** The eastern façade of the 1897 building which features open verandah on the ground floor and other features typical of the style and works of Hennessy including wall buttresses that delineate the building bays, pointed arched openings and distinctive dormer windows.

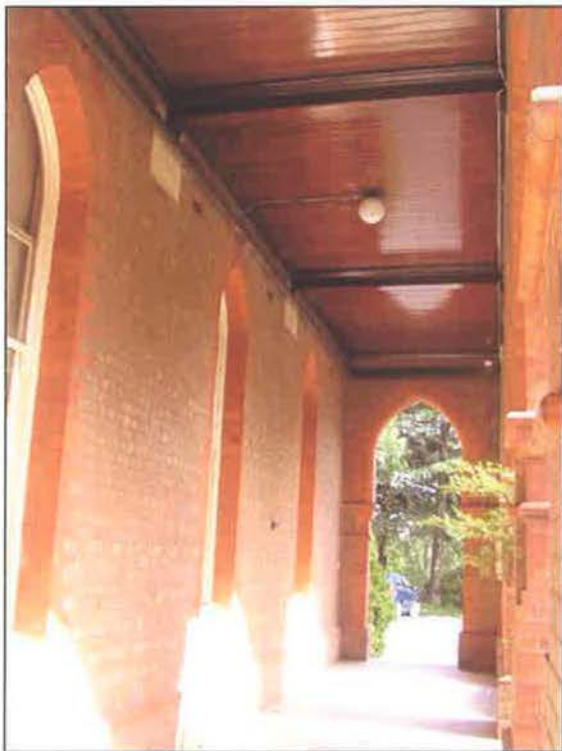
**Figure 3.59** The ground floor verandah features simple concrete slab and timber boarded, bayed ceiling which appears to be in good condition and well maintained.

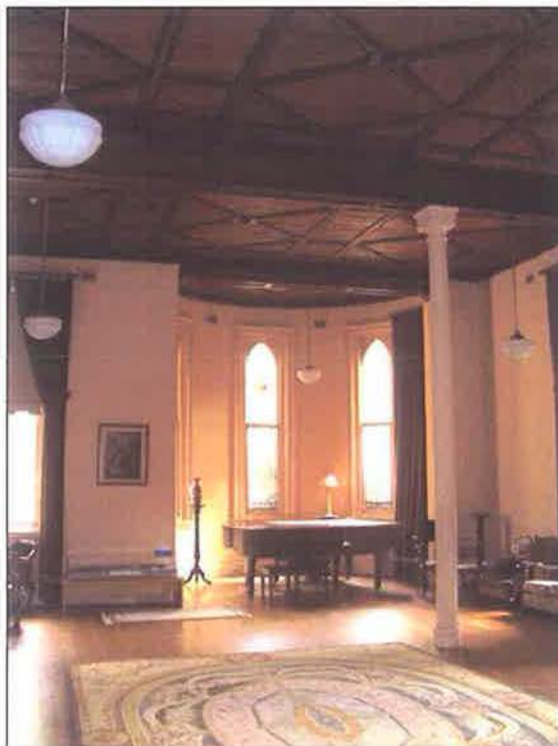
**Figure 3.60** The interior of original classroom, now used as a reception room. The room features timber floors, rendered and set walls, timber joinery including deep profiled skirtings and profiled architraves and lead light windows. Note the cast iron columns and decorative timber ceiling.

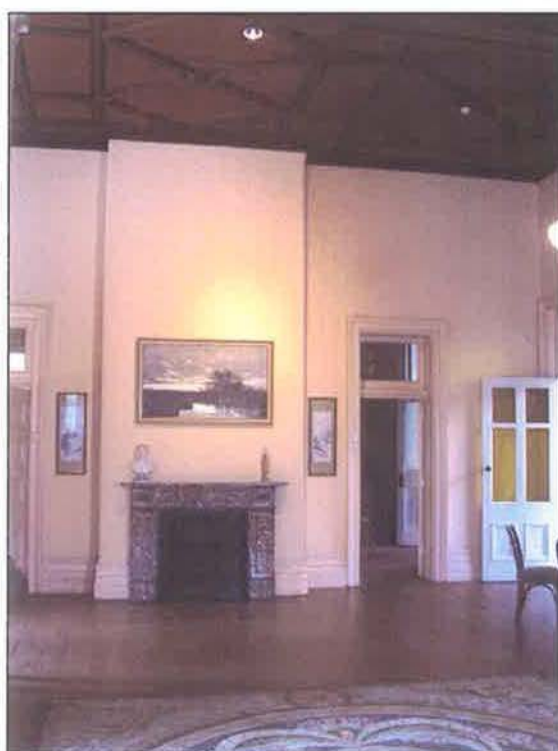
**Figure 3.61** The southern wall also features a chimney breast with marble fireplace surround and cast iron grate and ceramic tiled hearth.

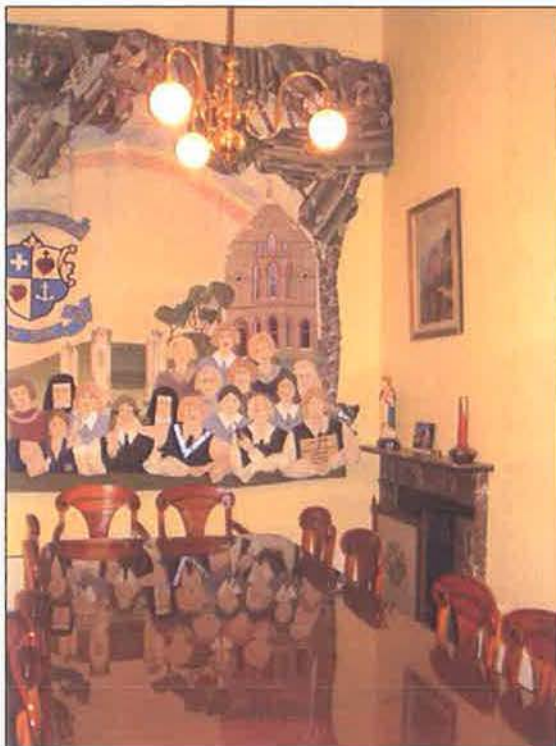
**Figure 3.65** The Brewer Room which is located to the immediate south of the Reception Room is similarly finished. A fireplace also occupies the south western corner of the room, however, has no chimney breast.

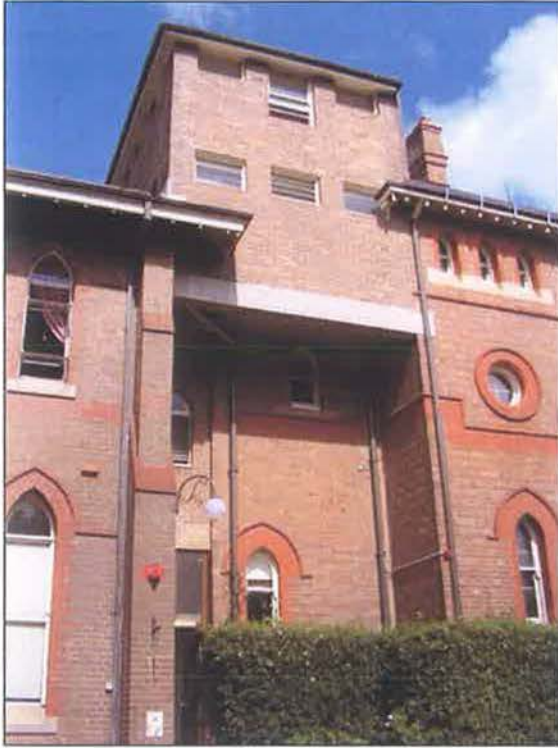
**Figure 3.67** The rear of the building originally featured a smaller, two storey brick structure containing the nuns' quarters and kitchen (refectory). This has been successively amalgamated into later additions to the building.

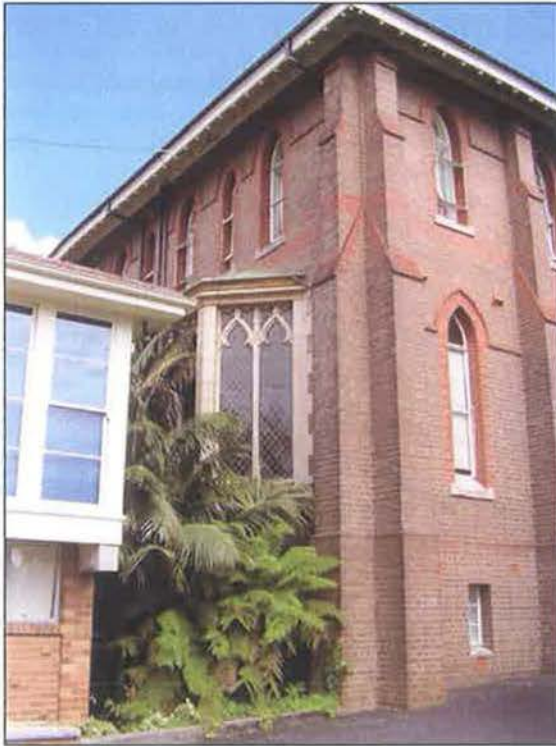
**Figure 3.70** The northern façade of the Givendale wing incorporates a bay window with gothic style tracery and diamond patterned leaded window.

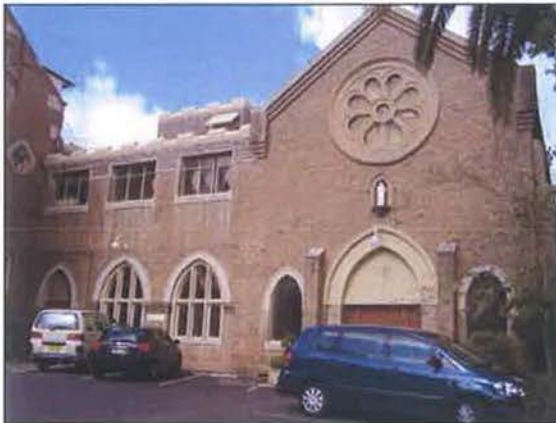
**Figure 3.73** The 1953 Chapel building and cloister is constructed of face brick with rendered and stone details. The main entry is surmounted by a prominent gable with decorative stepped and rendered gable cap over the rose window.

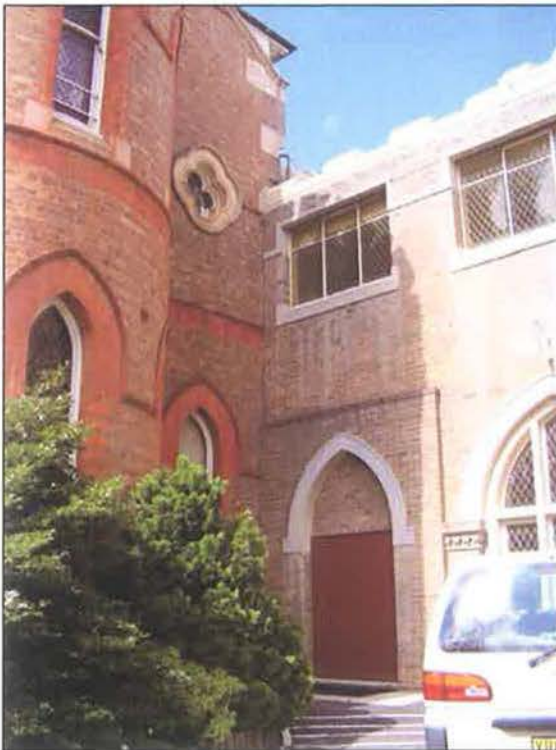
**Figure 3.74** Detail of the junction between the 1897 building and 1953 Chapel. The building also features castellated parapet, pointed arched openings with profiled mouldings on the ground floor and leaded windows.

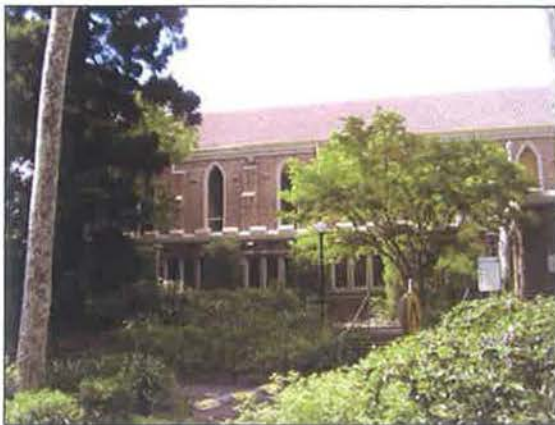
**Figure 3.76** The northern façade of the Chapel also features crenellated parapet which conceals the roof over the Cloister. The Cloister extends around the north, west and eastern sides of the central double height Chapel.

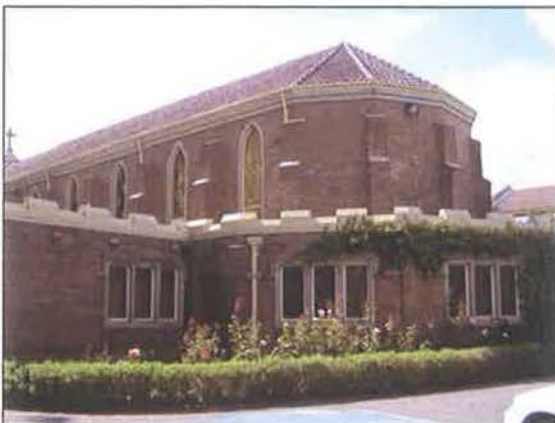
**Figure 3.77** The Chapel features a gabled roof clad in terracotta tiles with faceted hip over the curved western end. Buttresses/engaged piers also delineate the bays of the building. Each bay also features a set of leadlight windows with stone surround.

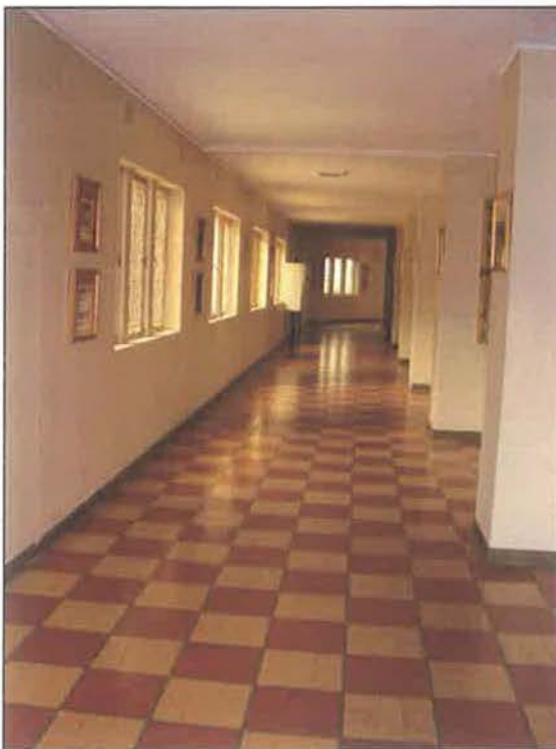
**Figure 3.83** View of one of the Cloisters around the Chapel. The space features distinctive terracotta floor tiles and diamond pattern leaded windows.

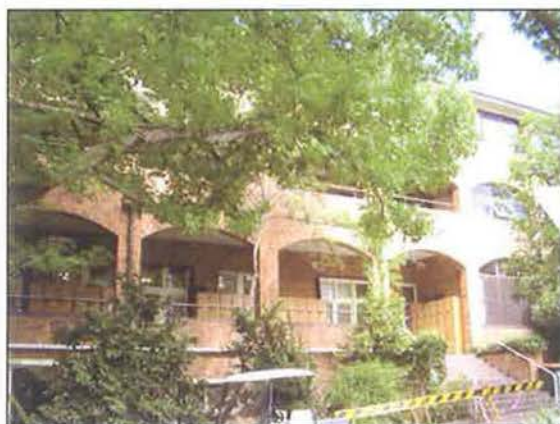
**Figure 3.86** Part of the eastern façade of the Mary Ward Wing. The building is a three storey building over basement constructed of face bricks with hipped terracotta roof clad in tiles. Open verandahs extend along the east and western facades of the building.

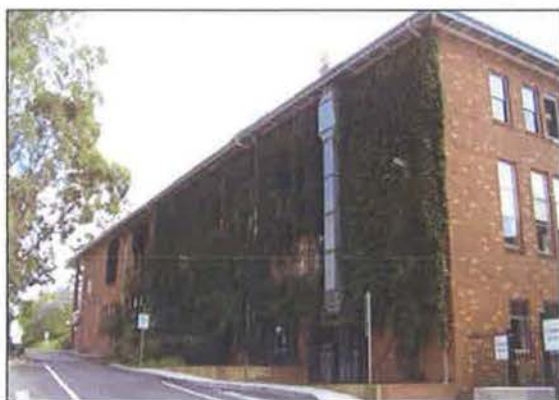
**Figure 3.101** The western façade of the building visible from Osborn Road is partially covered in vines. Note the service road at left.

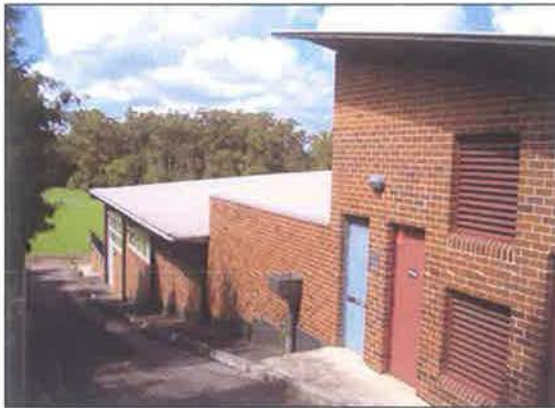
**Figure 3.123** The eastern façade of the Swimming Pool complex. Note the grade of the side access road (at left) which indicates the difference in level between the northern section of the school and southern section of the site.

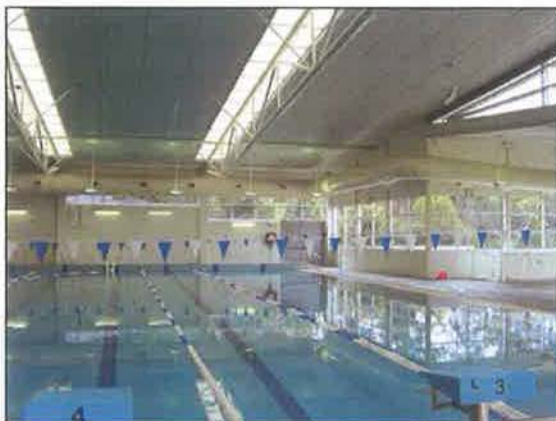
**Figure 3.126** The building is a modern brick, steel and glass structure.

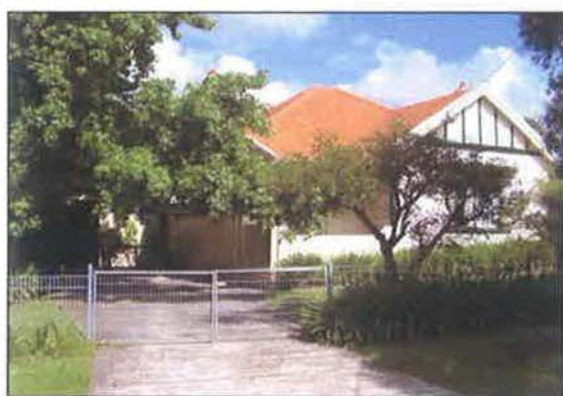
**Figure 3.130** It is clear that the original cottage and nuns' residence has undergone some alterations and additions. The building is also connected to another cottage to its south.
