PRELIMINARY SITE INVESTIGATION (PSI)

**LORETO NORMANHURST GIRLS SCHOOL
MASTER PLAN**

**LORETO NORMANHURST GIRLS SCHOOL,
91-93 PENNANT HILLS ROAD, NORMANHURST, NSW**

REF: E31772KLrpt3

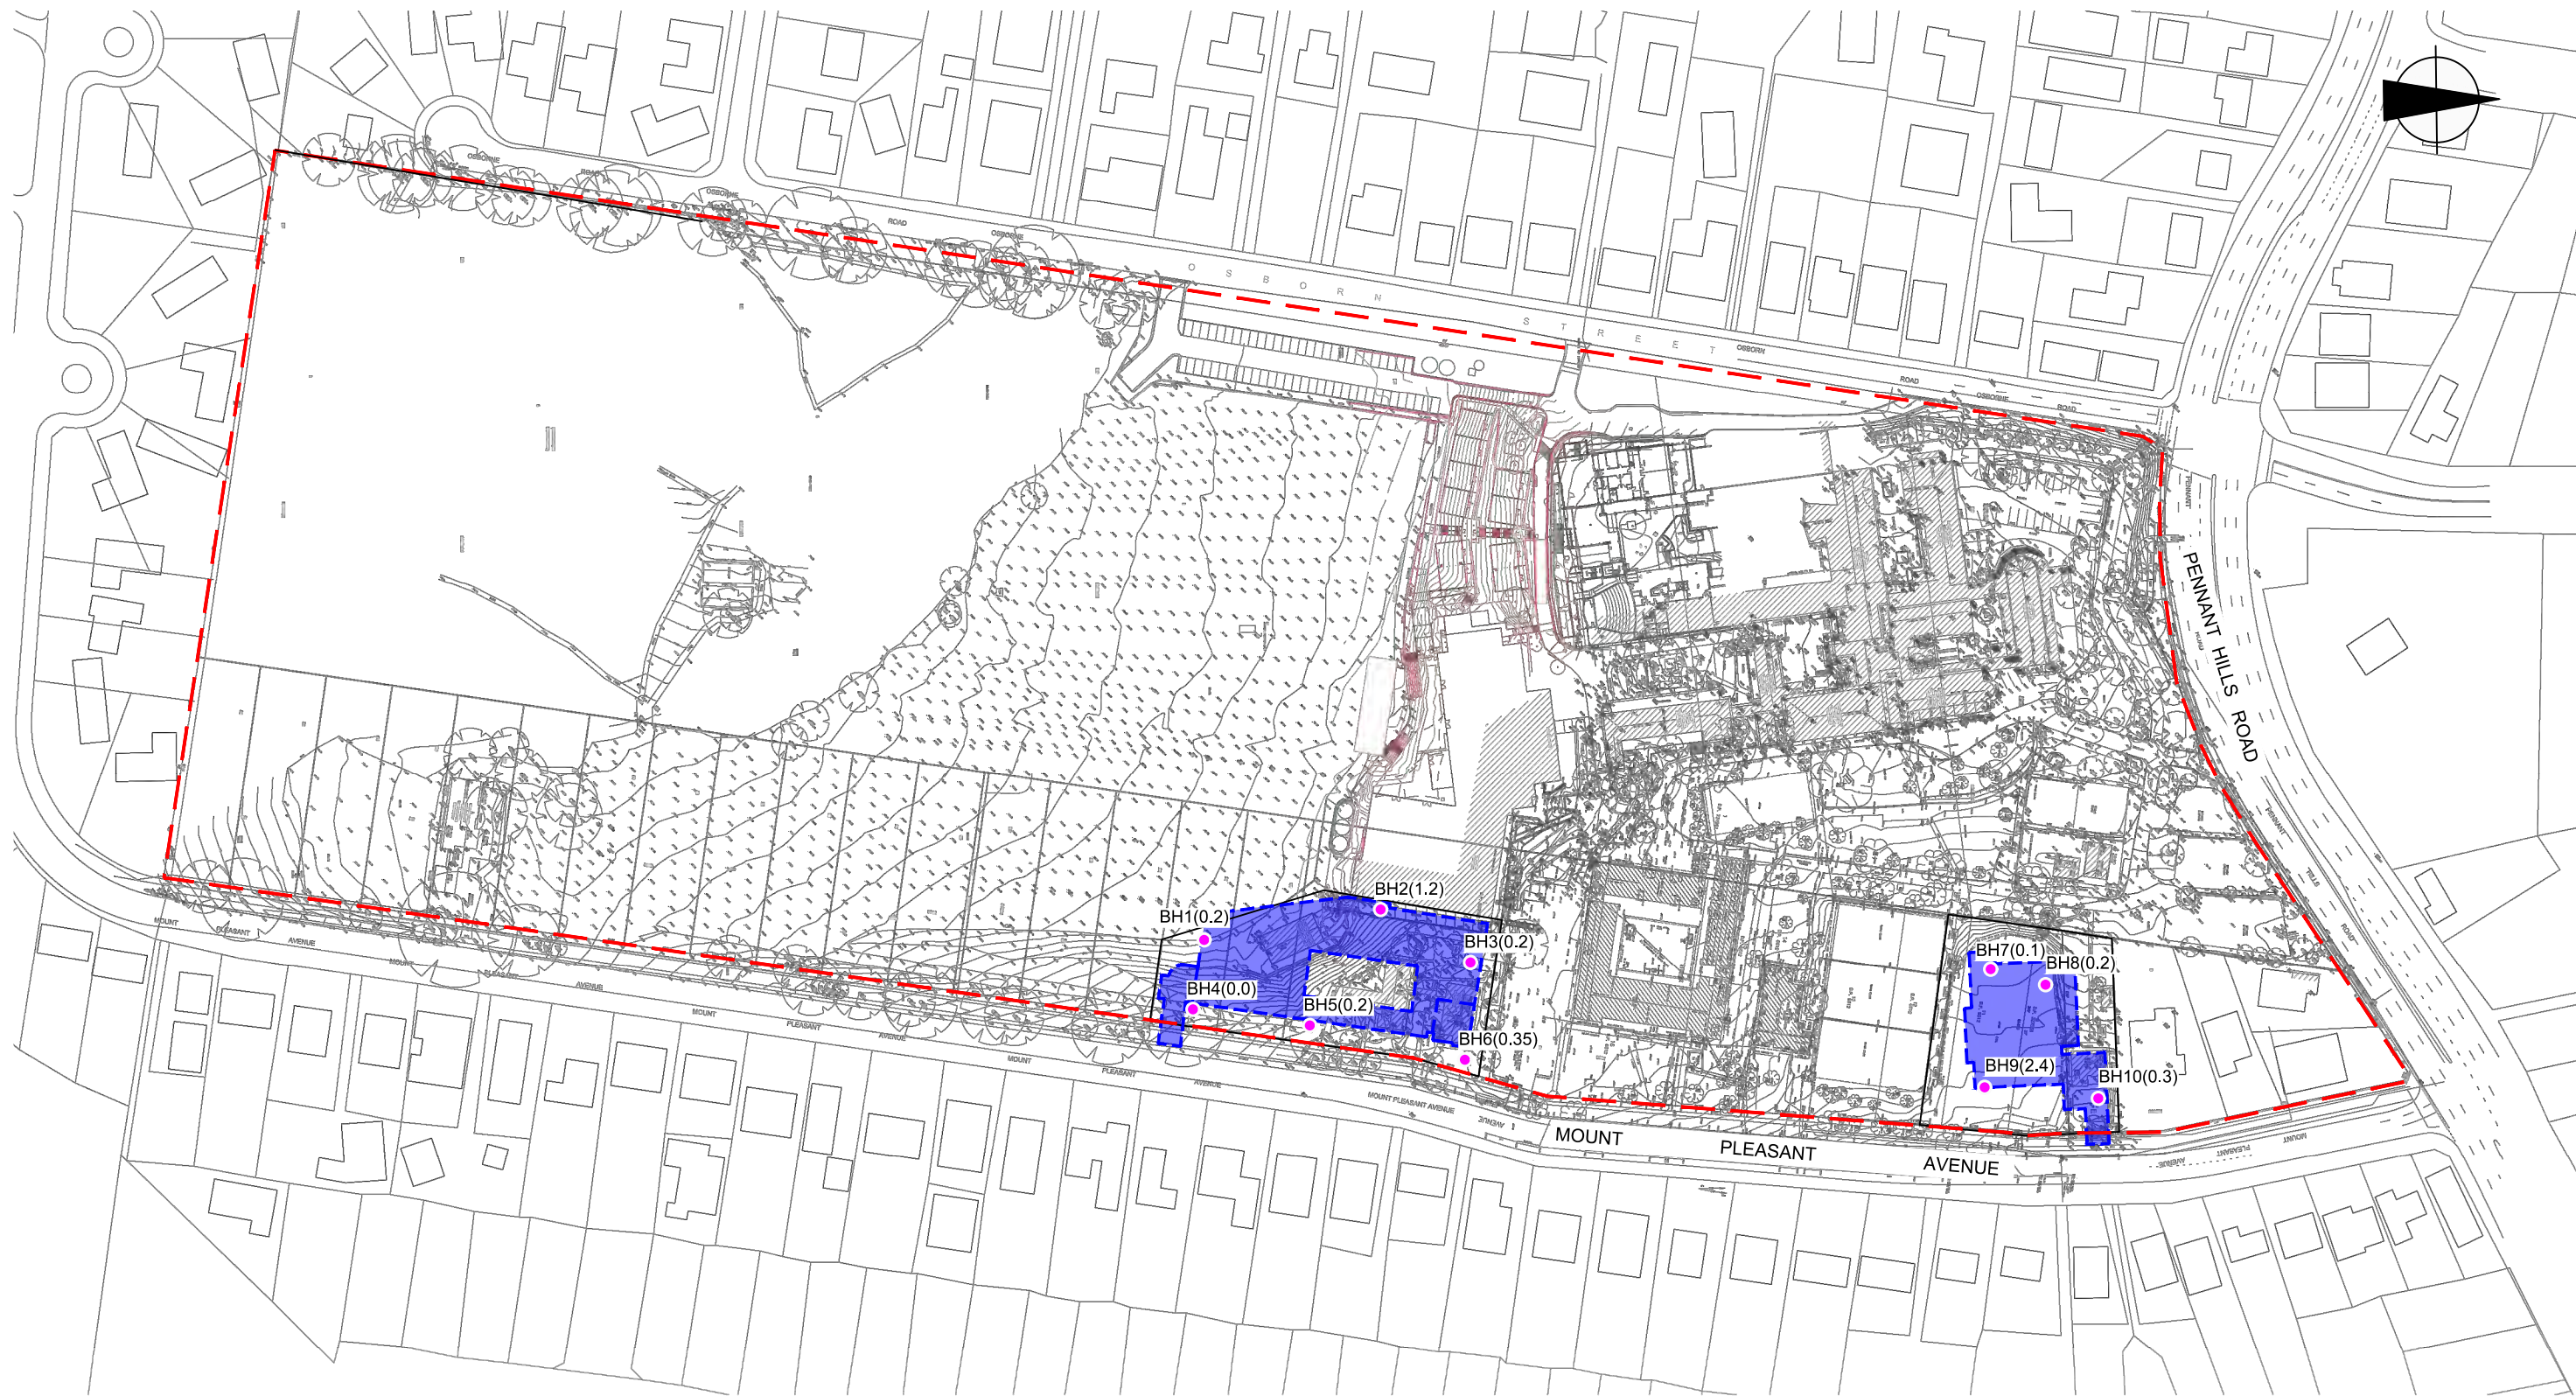
Title:		SAMPLE LOCATION PLAN	
Location: LORETO NORMANHURST, 91-93 PENNANT HILLS ROAD NORMANHURST, NSW			
Report No:		E31772KL	Figure No: 2
ENVIRONMENTAL INVESTIGATION SERVICES

- APPROXIMATE SITE BOUNDARY
- BH (Fill Depth) BOREHOLE LOCATION, NUMBER AND DEPTH OF FILL (m)
- APPROXIMATE OUTLINE OF PROPOSED BUILDING

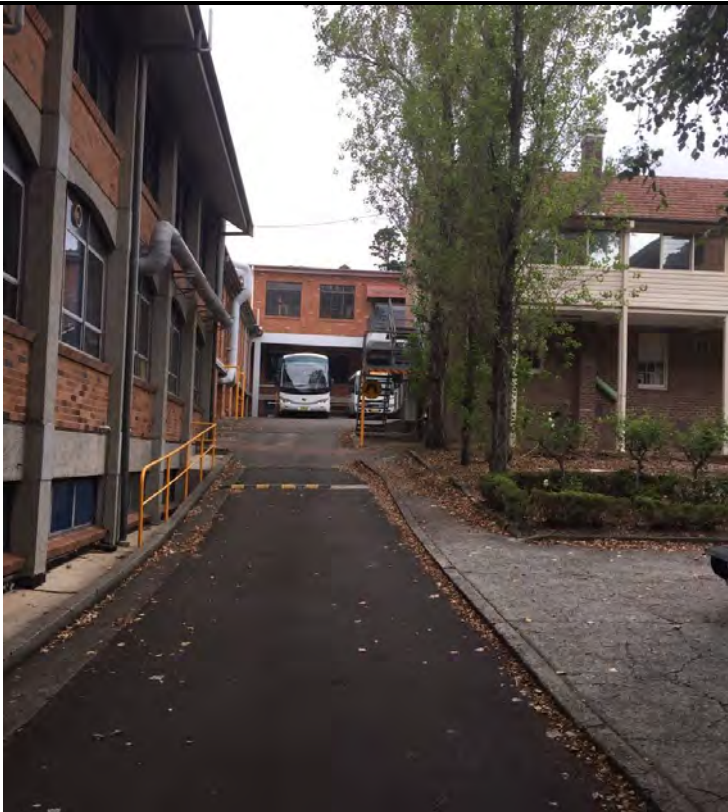
Photograph 1: Taken showing the Mary Ward Wing in the central section of the site, facing north. This is the location of the proposed landscaped portion of Site 1B.

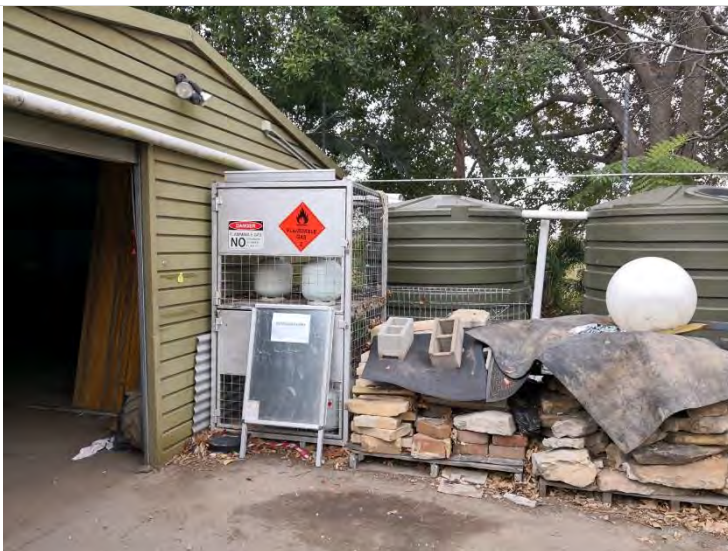
Photograph 2: Taken showing the maintenance shed in the northern portion of the site. Note the storage of gas and other materials.

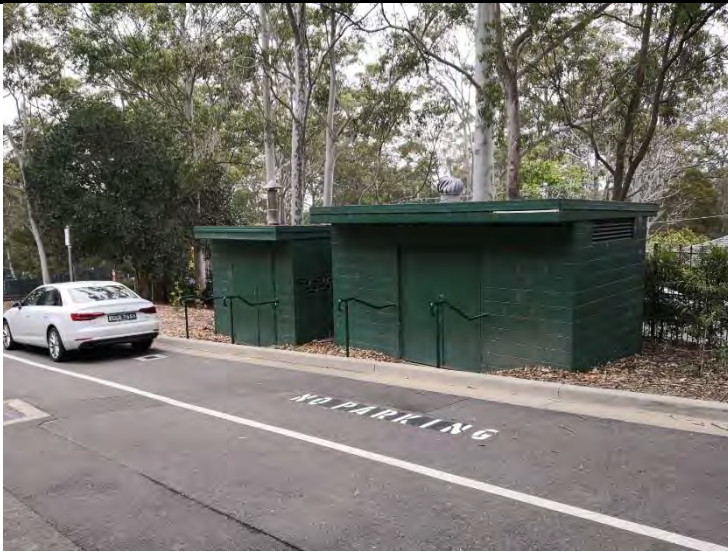
Photograph 3: Taken showing the storage sheds along the western boundary of the site. The storage sheds were locked at the time of inspection.

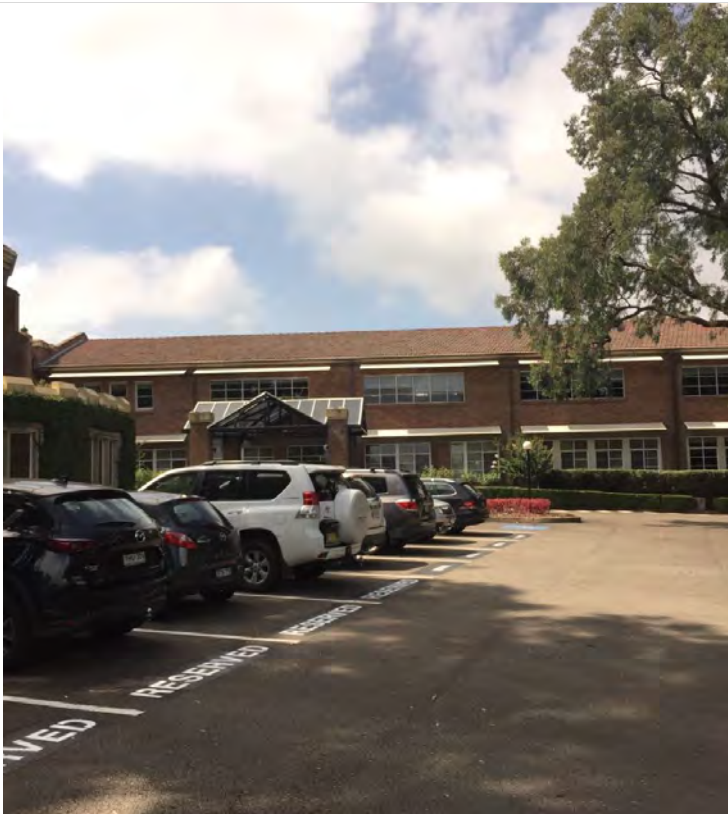
Photograph 4: Taken showing the administration and reception building in the north-east corner of the site.
