**REPORT TO
LORETO NORMANHURST SCHOOL**

**ON
REMEDiation ACTION PLAN**

**FOR
PROPOSED STAGE 1 WORKS AREA**

**AT
LORETO NORMANHURST GIRLS SCHOOL, 91-93
PENNANT HILLS ROAD, NORMANHURST, NSW**

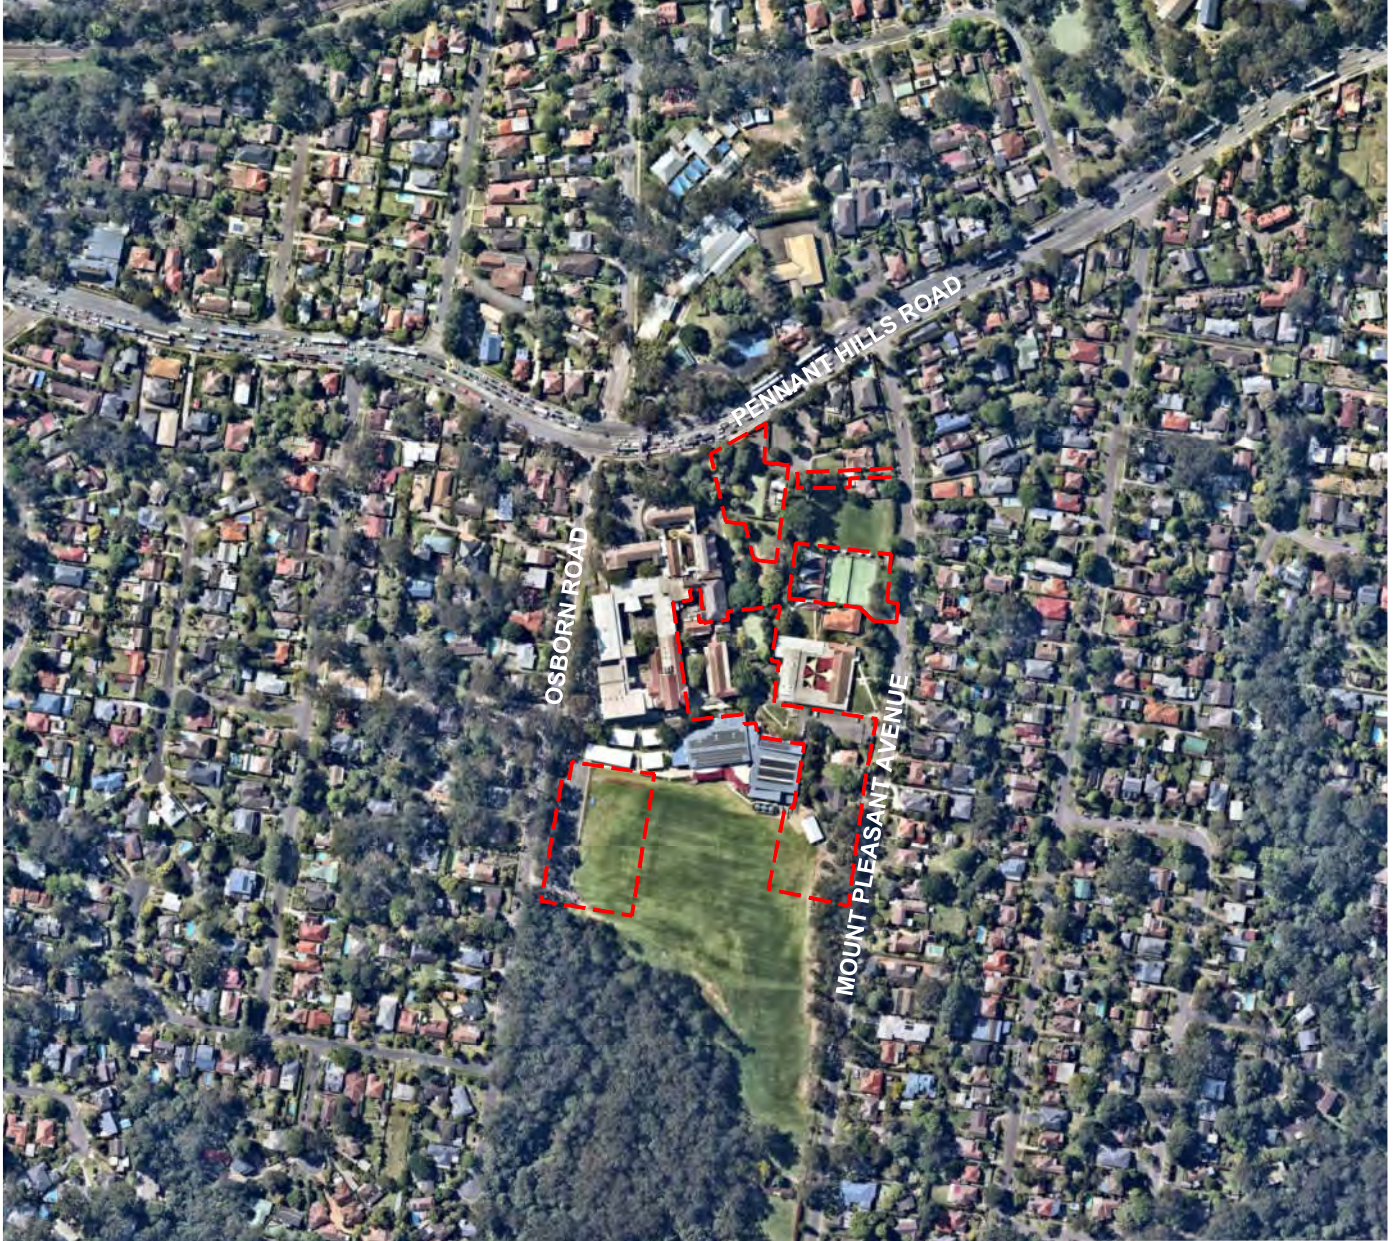
--- APPROXIMATE SITE BOUNDARIES

The development areas/stages and relevant building areas are shown on Figure 2.

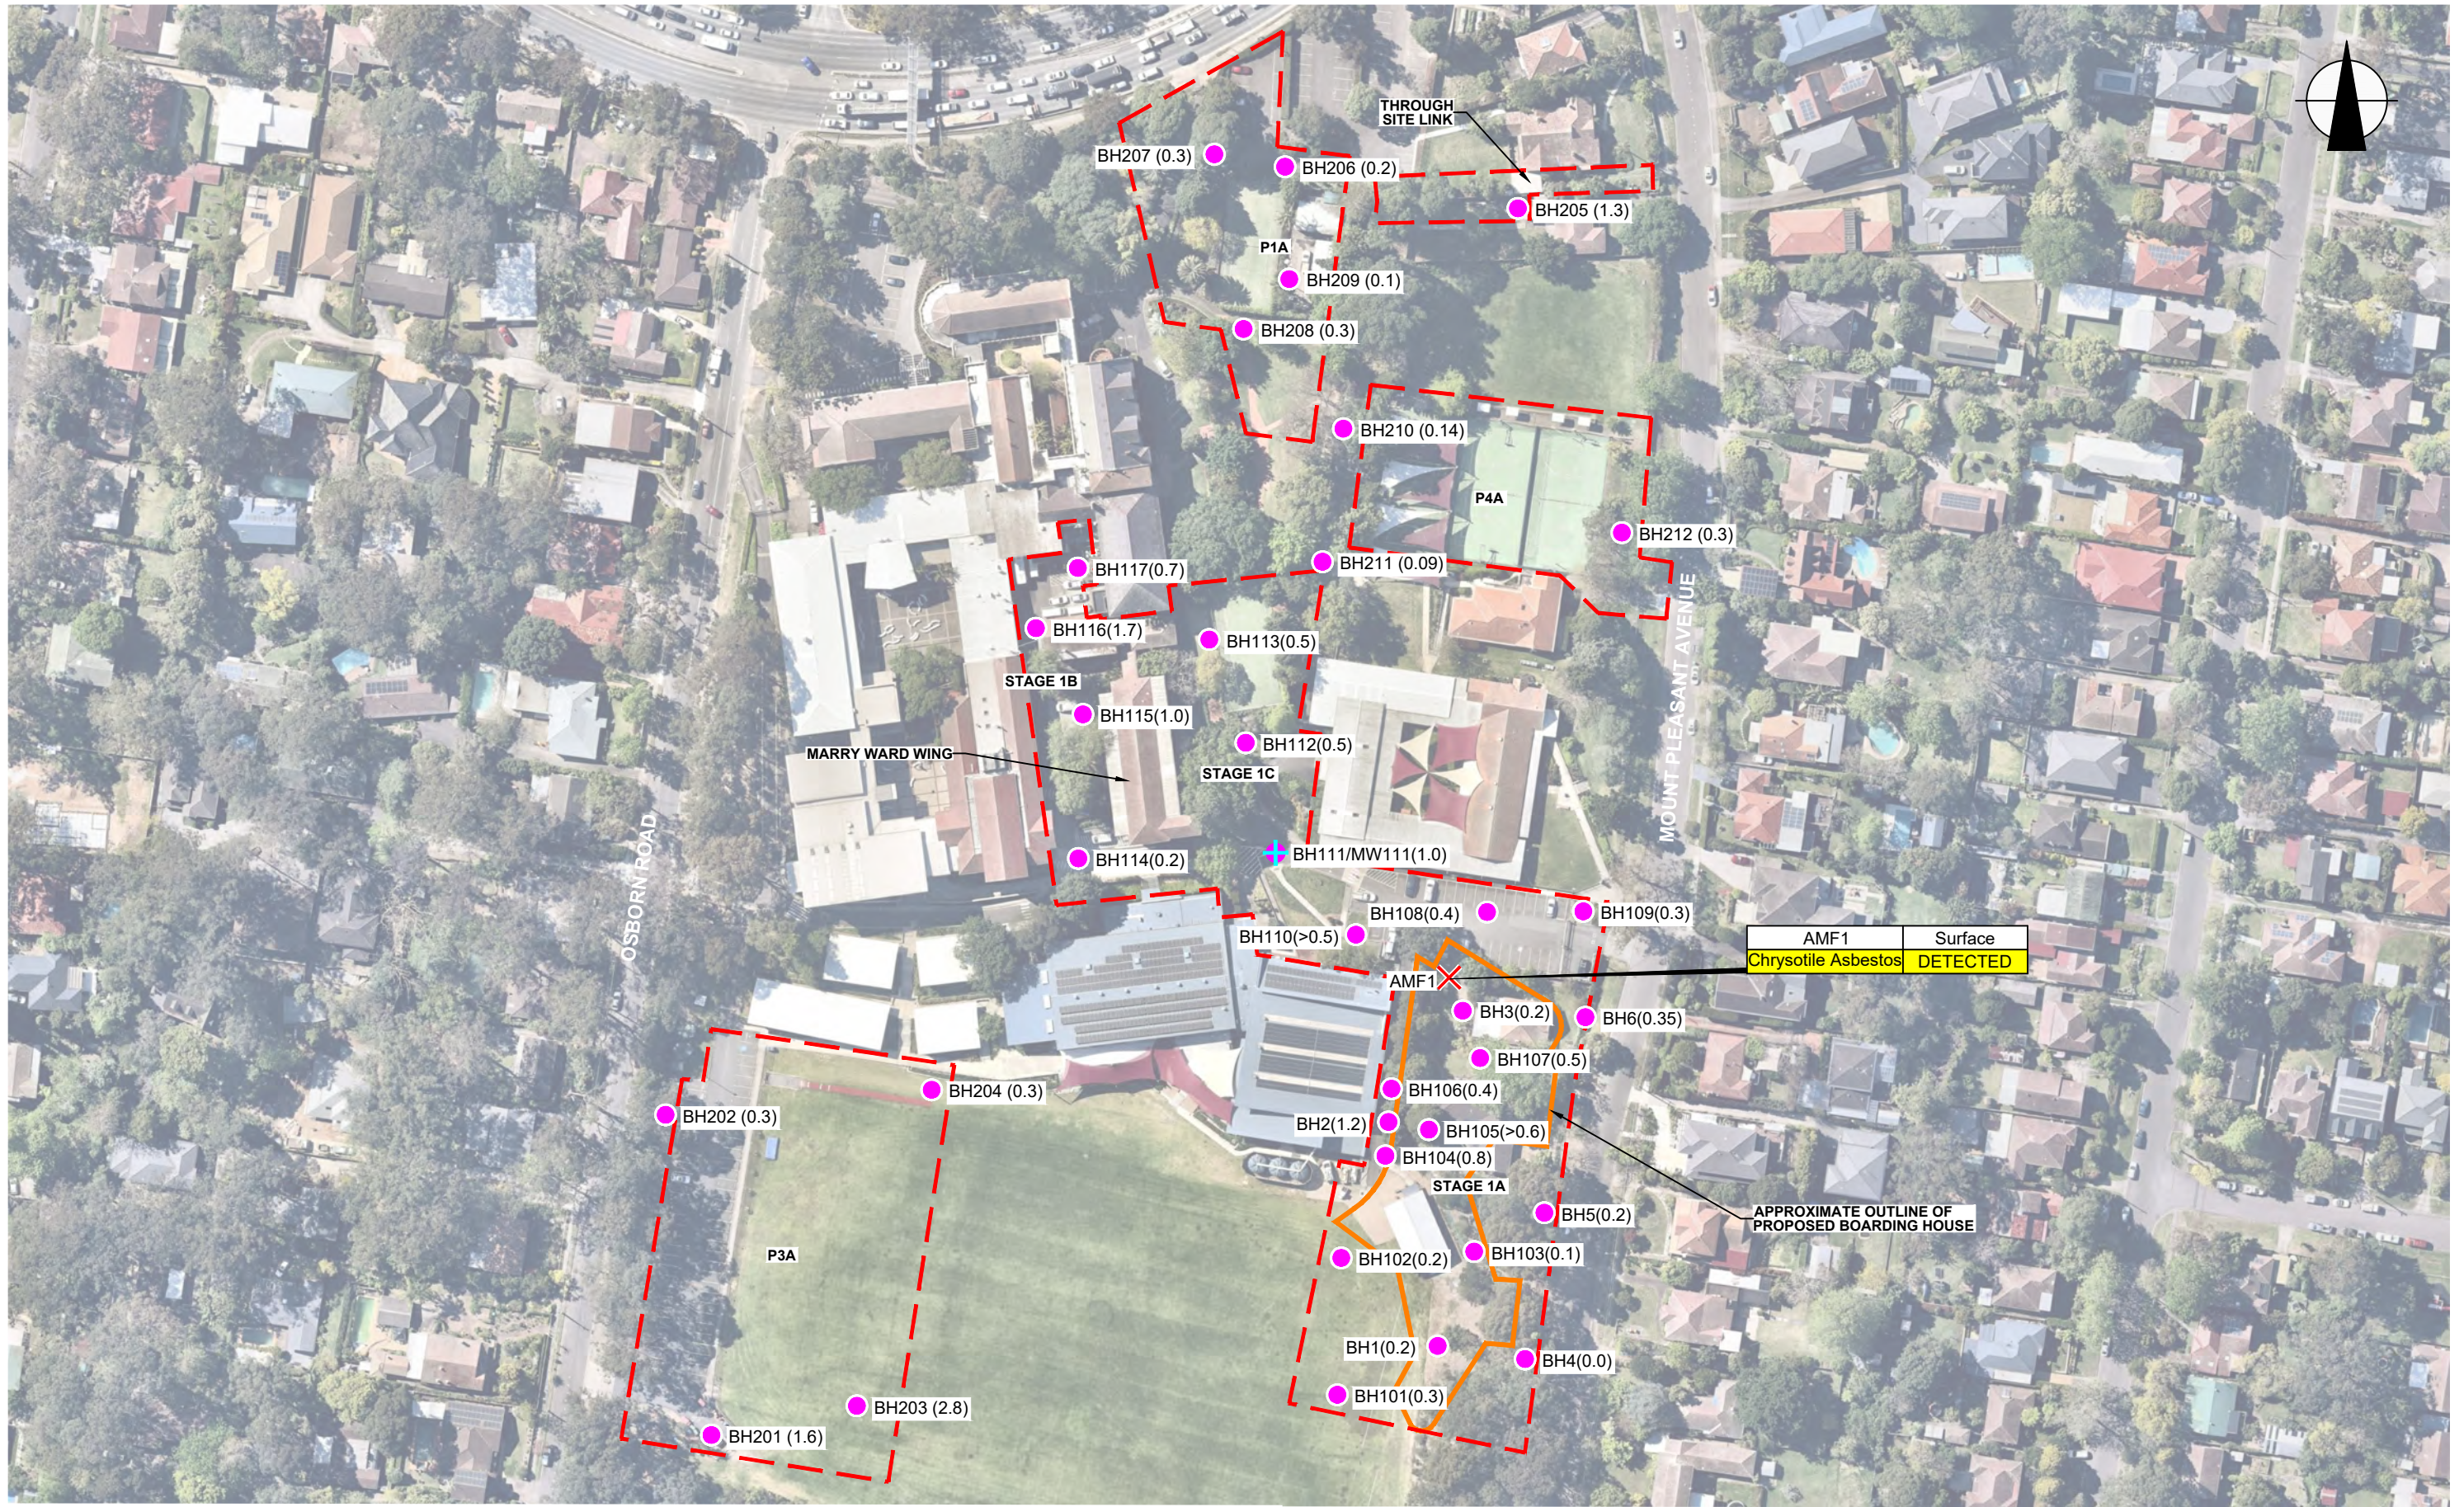
- APPROXIMATE SITE BOUNDARY
- BH(Fill Depth) BOREHOLE LOCATION, NUMBER AND DEPTH OF FILL (m)
- ⊕ BH/MW(Fill Depth) BOREHOLE AND GROUNDWATER MONITORING WELL LOCATION, NUMBER AND DEPTH OF FILL (m)

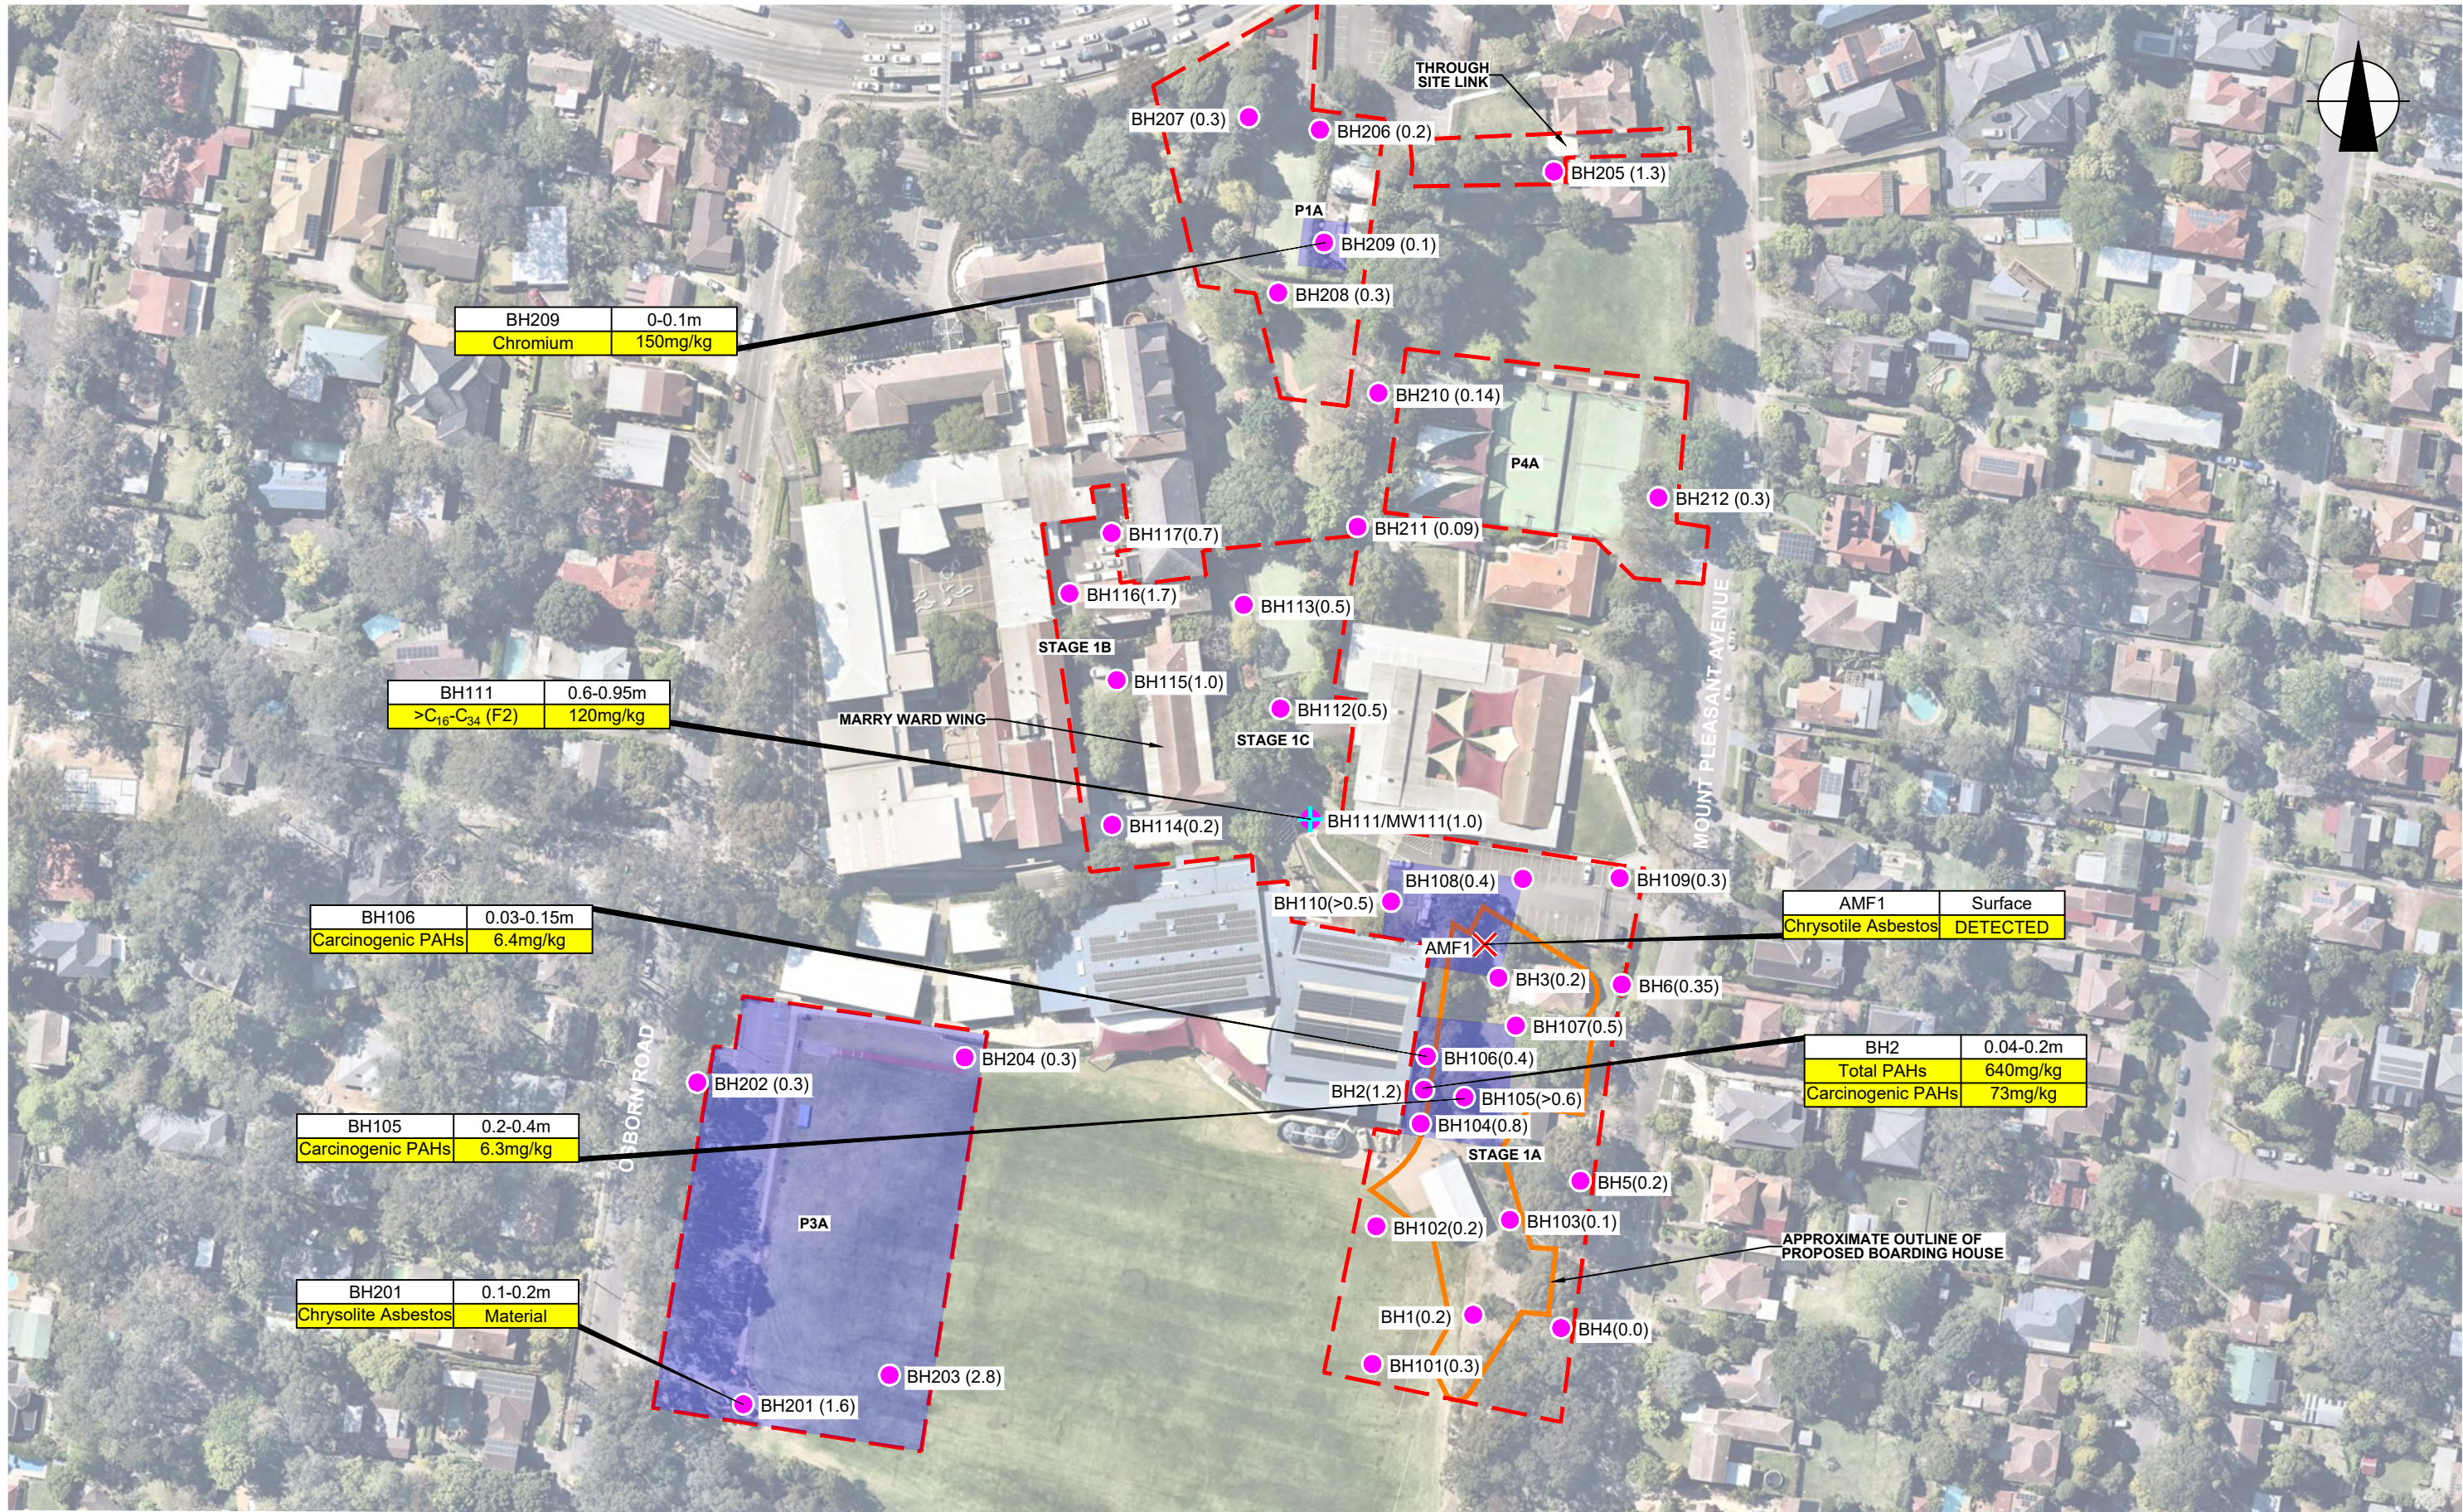
APPROXIMATE SITE BOUNDARY				
	BOREHOLE LOCATION, NUMBER AND DEPTH OF FILL (m)				
	BOREHOLE AND GROUNDWATER MONITORING WELL LOCATION, NUMBER AND DEPTH OF FILL (m)				
<table><tr><th>SAMPLE ID</th><th>DEPTH (metres)</th></tr><tr><td>CHEMICAL</td><td>CONCENTRATION</td></tr></table>	SAMPLE ID	DEPTH (metres)	CHEMICAL	CONCENTRATION	SOIL/SURFACE SAMPLE EXCEEDANCE ABOVE HUMAN HEALTH SAC
SAMPLE ID	DEPTH (metres)				
CHEMICAL	CONCENTRATION
