# WAGGA WAGGA BASE HOSPITAL

## BASELINE ARCHAEOLOGICAL ASSESSMENT

### FOR WEIR PHILLIPS

**December 2012**

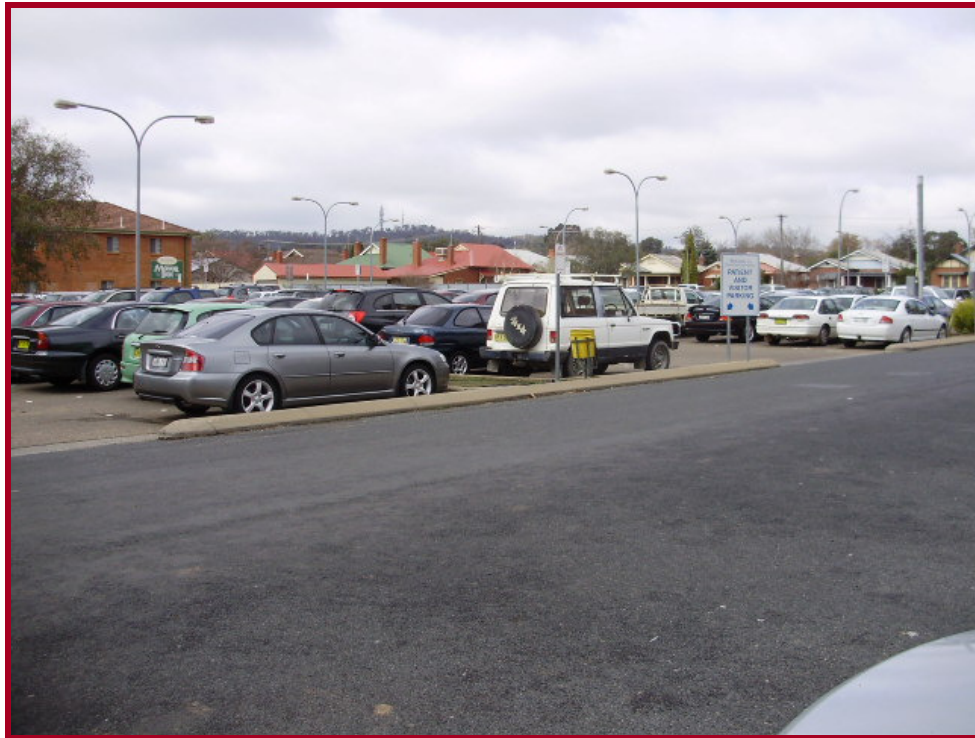
Figure 4. View facing south-east across the carpark, showing lack of original vegetation and carpark.

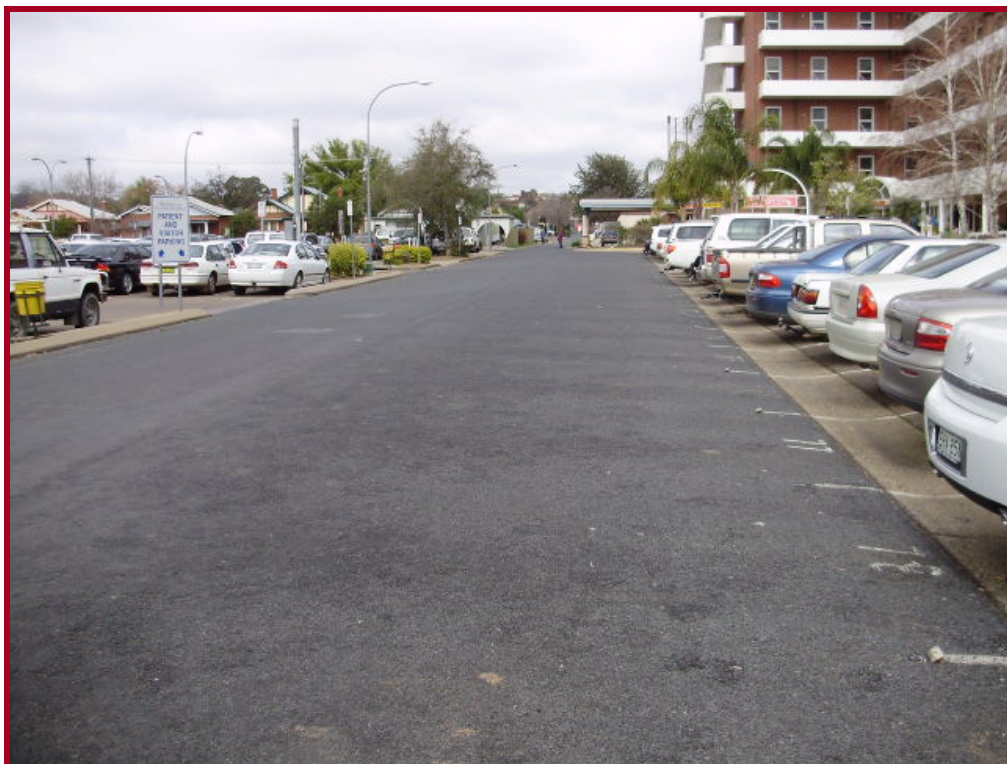
Figure 5: View to south with main hospital building at right.

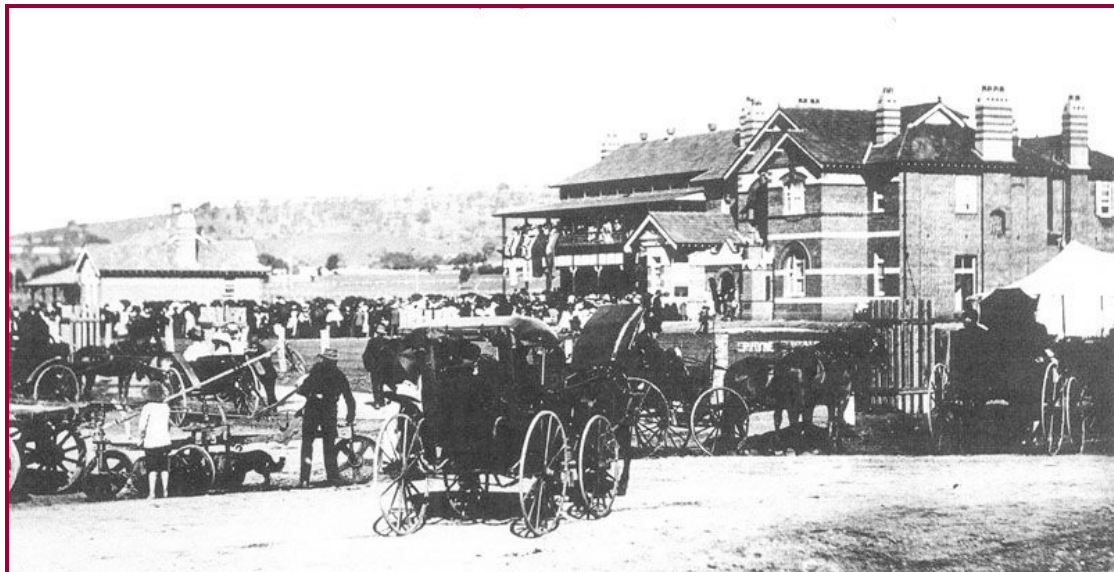
Figure 7: Official Opening. The building to the front of the Hospital is the Nurses Quarters (Morris, 1988).

By 1910, the site included the main hospital (the eastern wing of the current building), the original Nurses Quarters (separate building to the front and east of the main building), a mortuary and several outbuildings (**Figure 7**). The need for additional buildings was met in early 1916 with the construction of an additional brick building consisting of additional wards, day, duty and nurse's rooms. A western wing with a dedicated Children's Ward on the upper floor, was also completed by September 1922 (**Figure 8**).

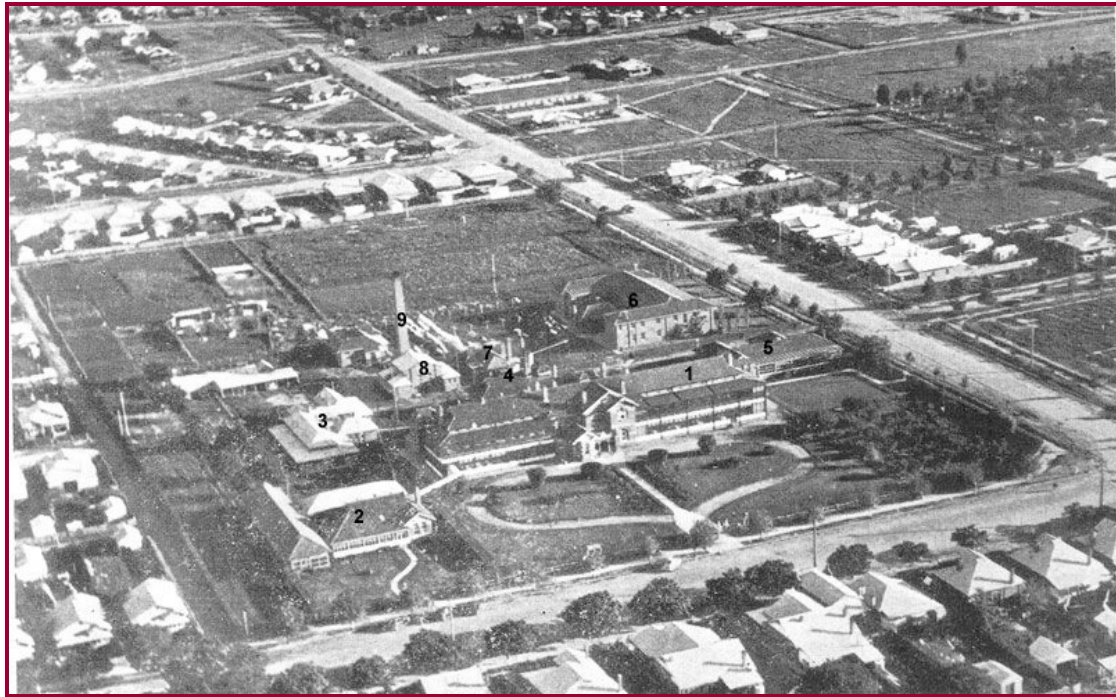
**Figure 9: Aerial photograph of Wagga Wagga Hospital, 1943.**

- 1. Main Building (now the Old Hospital Building)
- 2. Rawson House (private and intermediate wards)
- 3. Isolation Block
- 4. Kitchen and Staff Dining
- 5. Maternity Unit (later Robinson House)
- 6. Nurses Home (later Harvey House)
- 7. Laundry
- 8. Boiler House
- 9. Chimney Stack

By 1943 the hospital had grown into a complex of buildings, services, and landscapes including a kitchen garden to the south of the site (Figure 9).

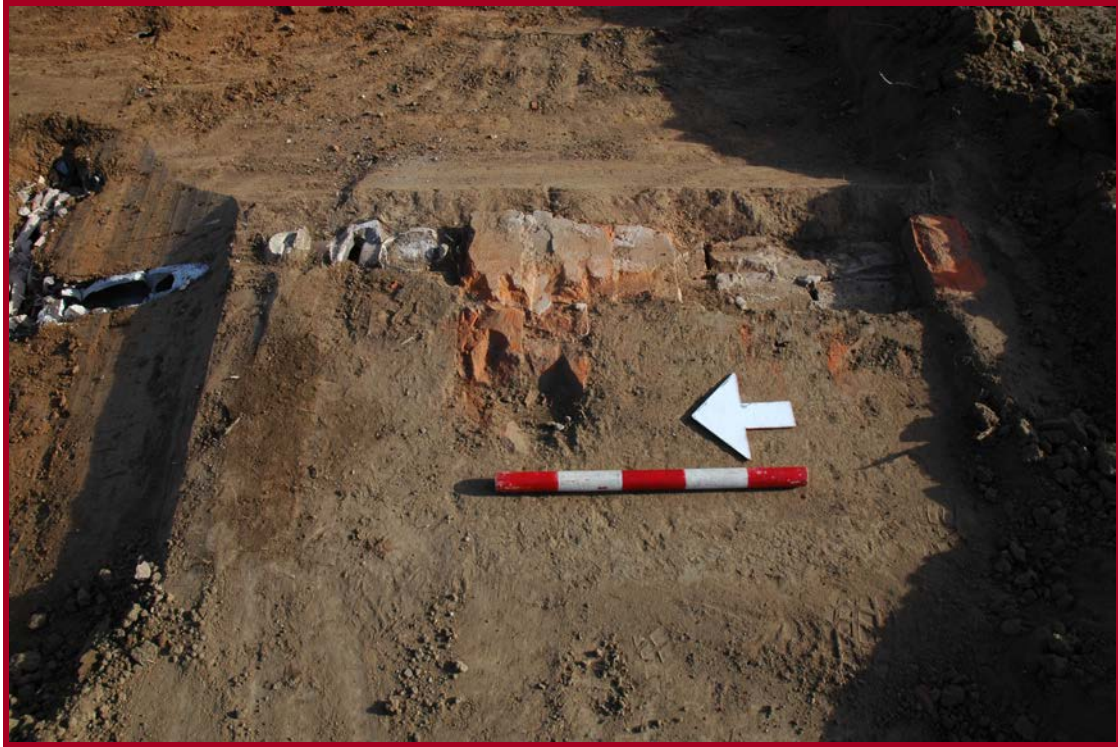
**Figure 12: Remnant footings of Rawson House recorded in-situ.**

The area of Rawson House, however, was identified as an area of some high potential and archaeological research significance. On this basis, in January 2012, archaeologists monitored machine clearance of the area of Rawson House and recorded remnant features associated with the former structure. This recording demonstrated the impact previous development of the site had had on subsurface features and deposits (see **Figure 12** and **Figure 13**). The archaeological recording showed that landscaping and later excavations had removed former surfaces, associated with early to mid-20<sup>th</sup> Century occupation.

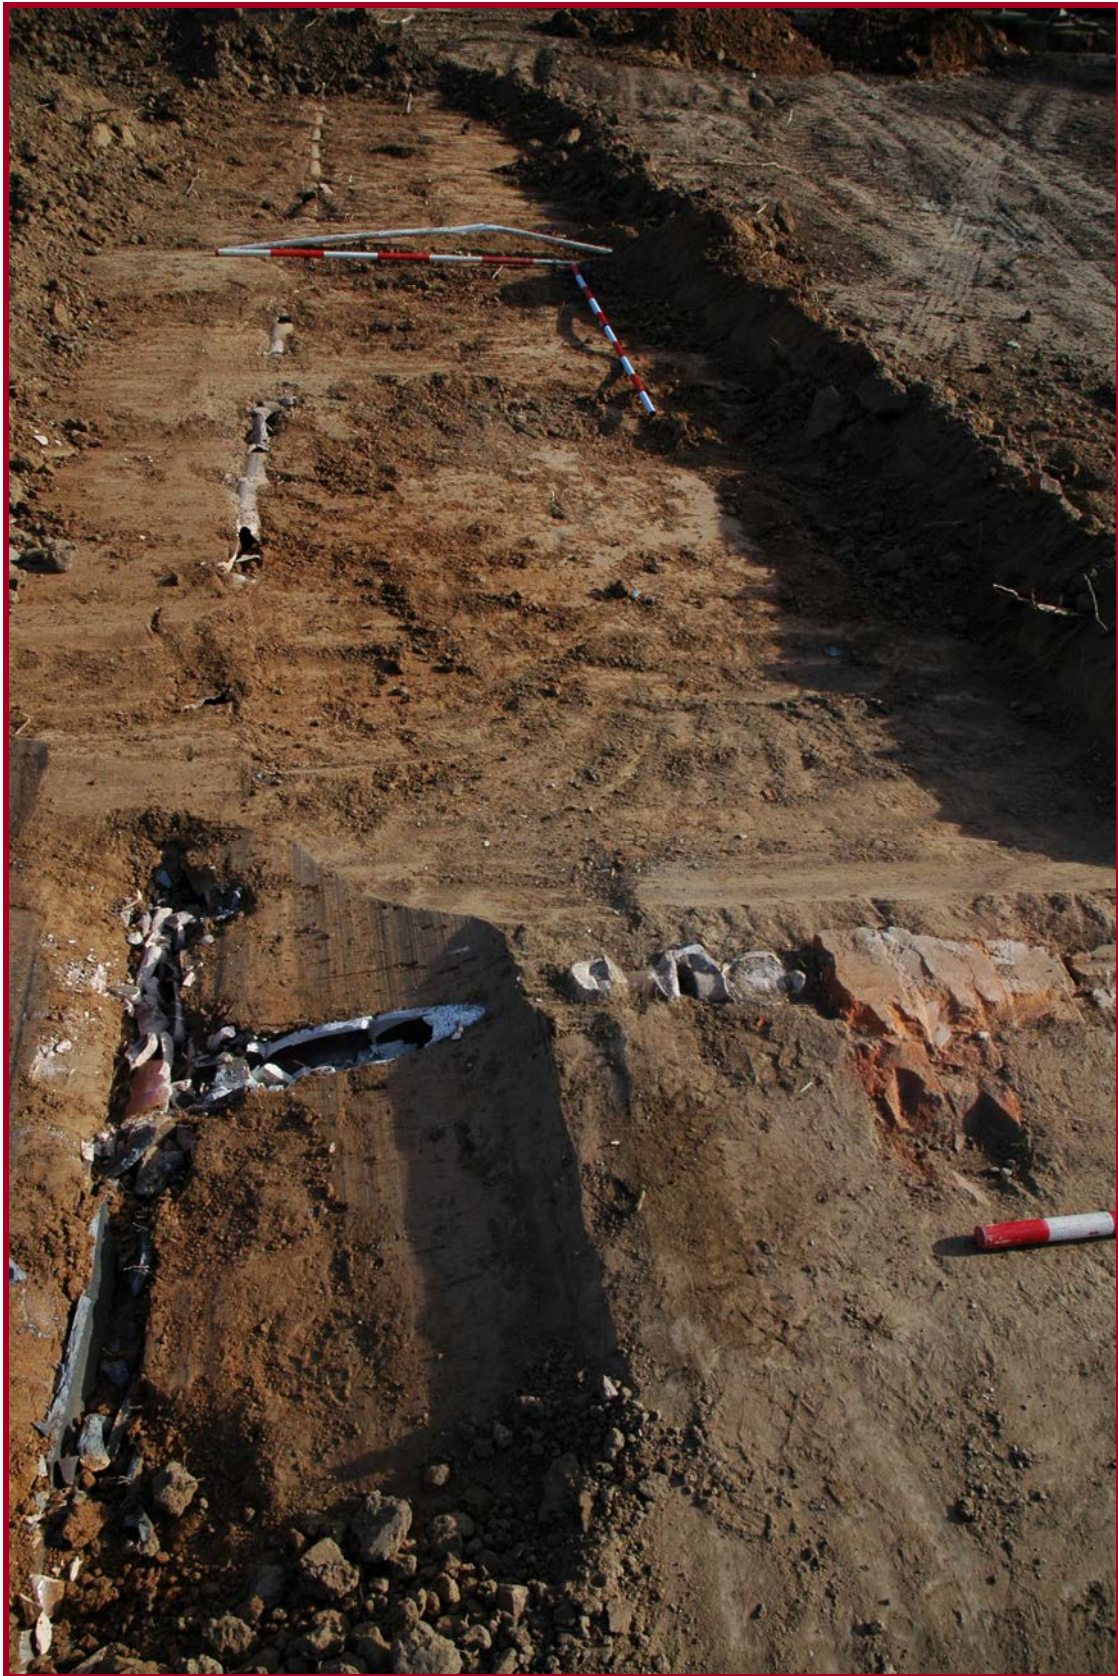
Figure 13: Fragmentary footings and drainage lines from Rawson House recorded in January 2012.
