Health Infrastructure NSW  
Wagga Wagga Rural Referral Hospital  
Redevelopment Project  
Remedial Action Plan

Stage 3  
Sturt Highway, Wagga Wagga, NSW

9 May 2018  
54397/114204 (Rev 3)  
JBS&G

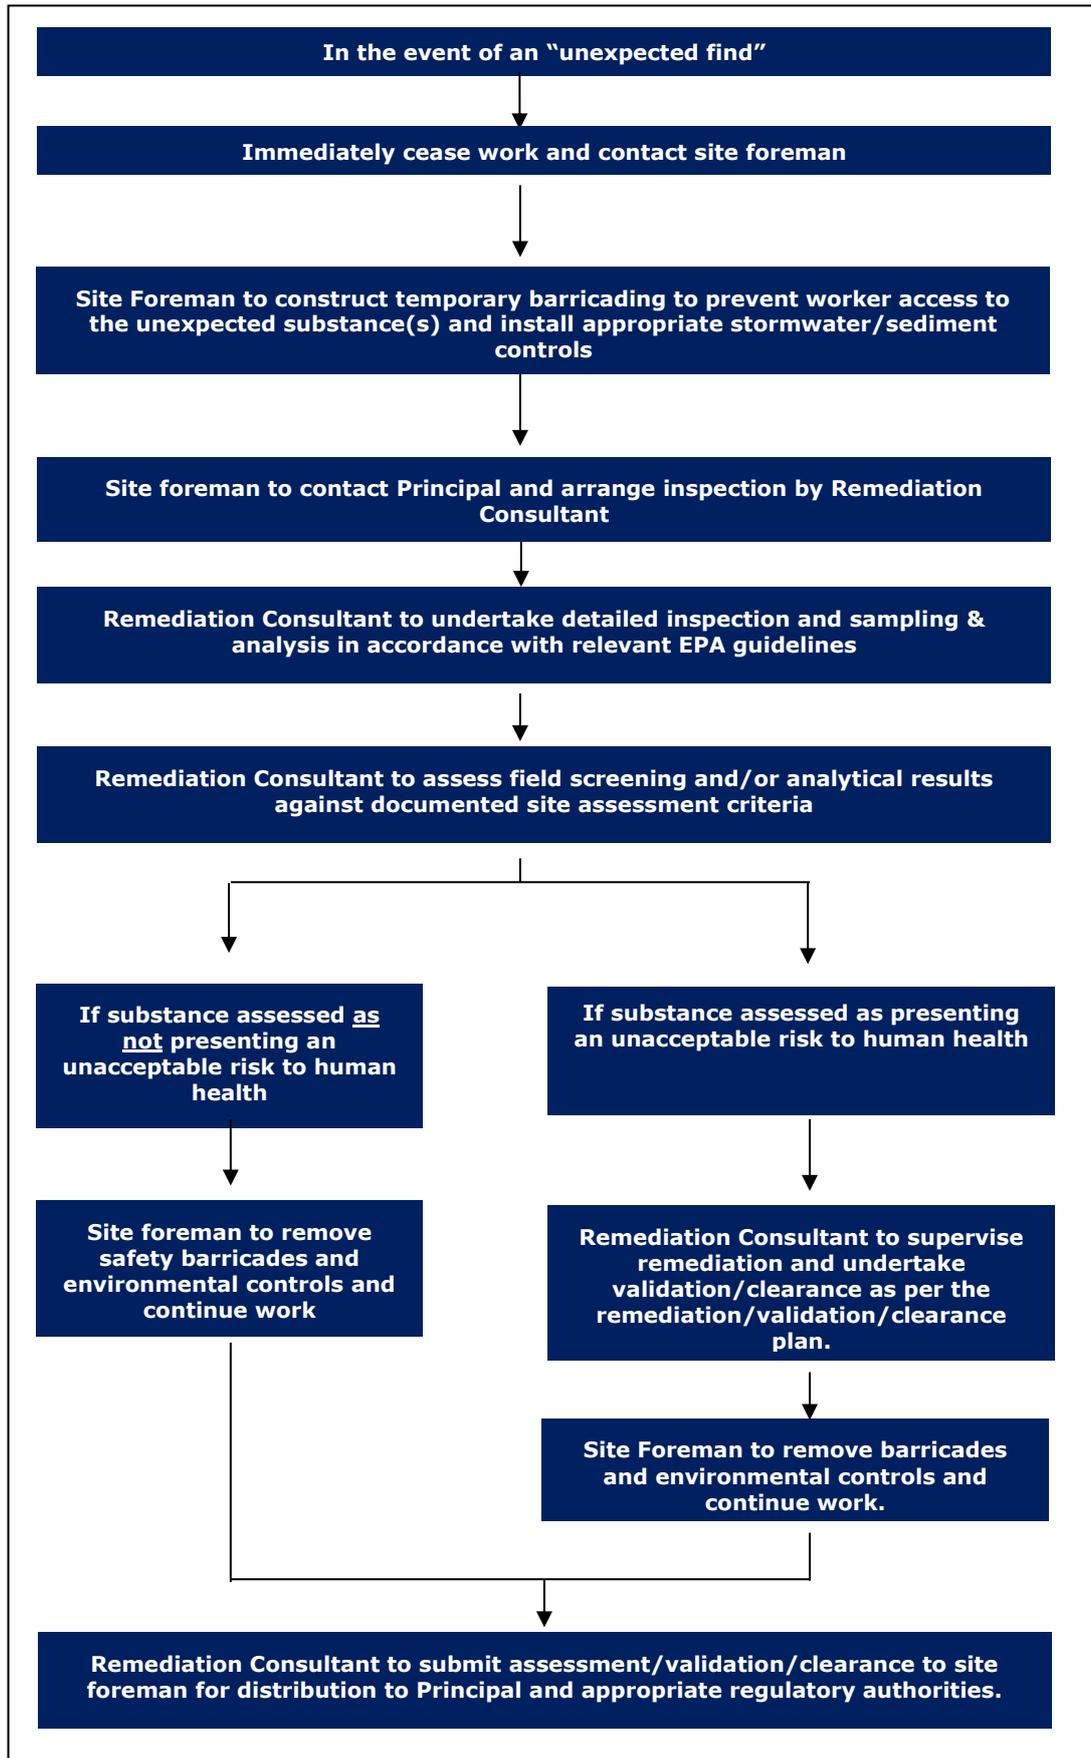
Flowchart 10.1 – Unexpected Finds Protocol

As a precautionary measure to ensure the protection of the workforce and surrounding community, should any of the abovementioned substances be identified (or any other unexpected potentially hazardous substance), the procedure summarised in **Flowchart 10.1** is to be followed.

An enlarged version of the unexpected finds protocol, suitable for use on-site, should be posted in the Site Office and referred to during the site specific induction by the Contractor.

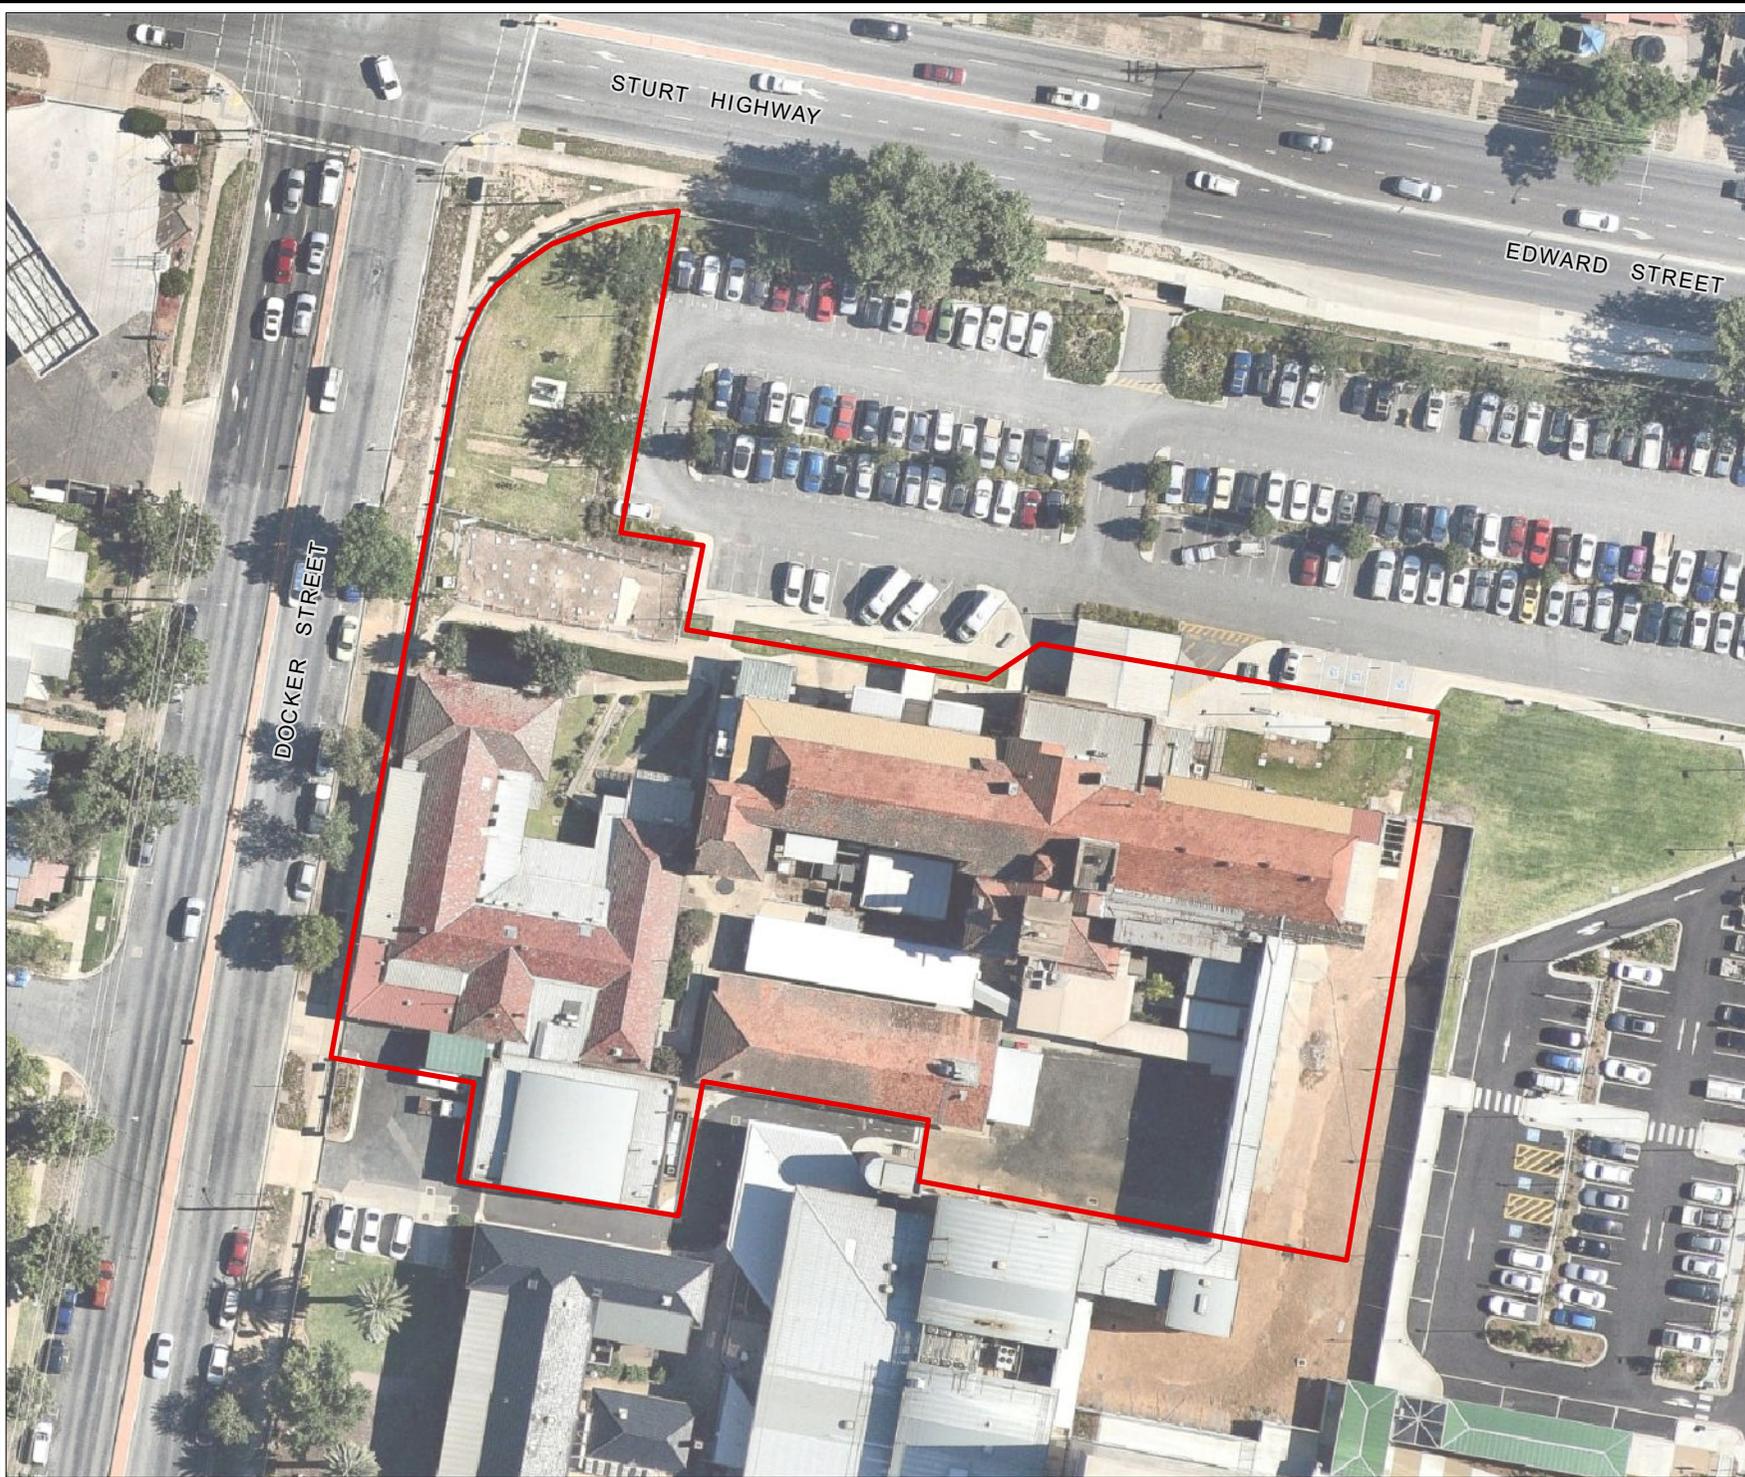
**FIGURE 2**

**SITE LAYOUT**

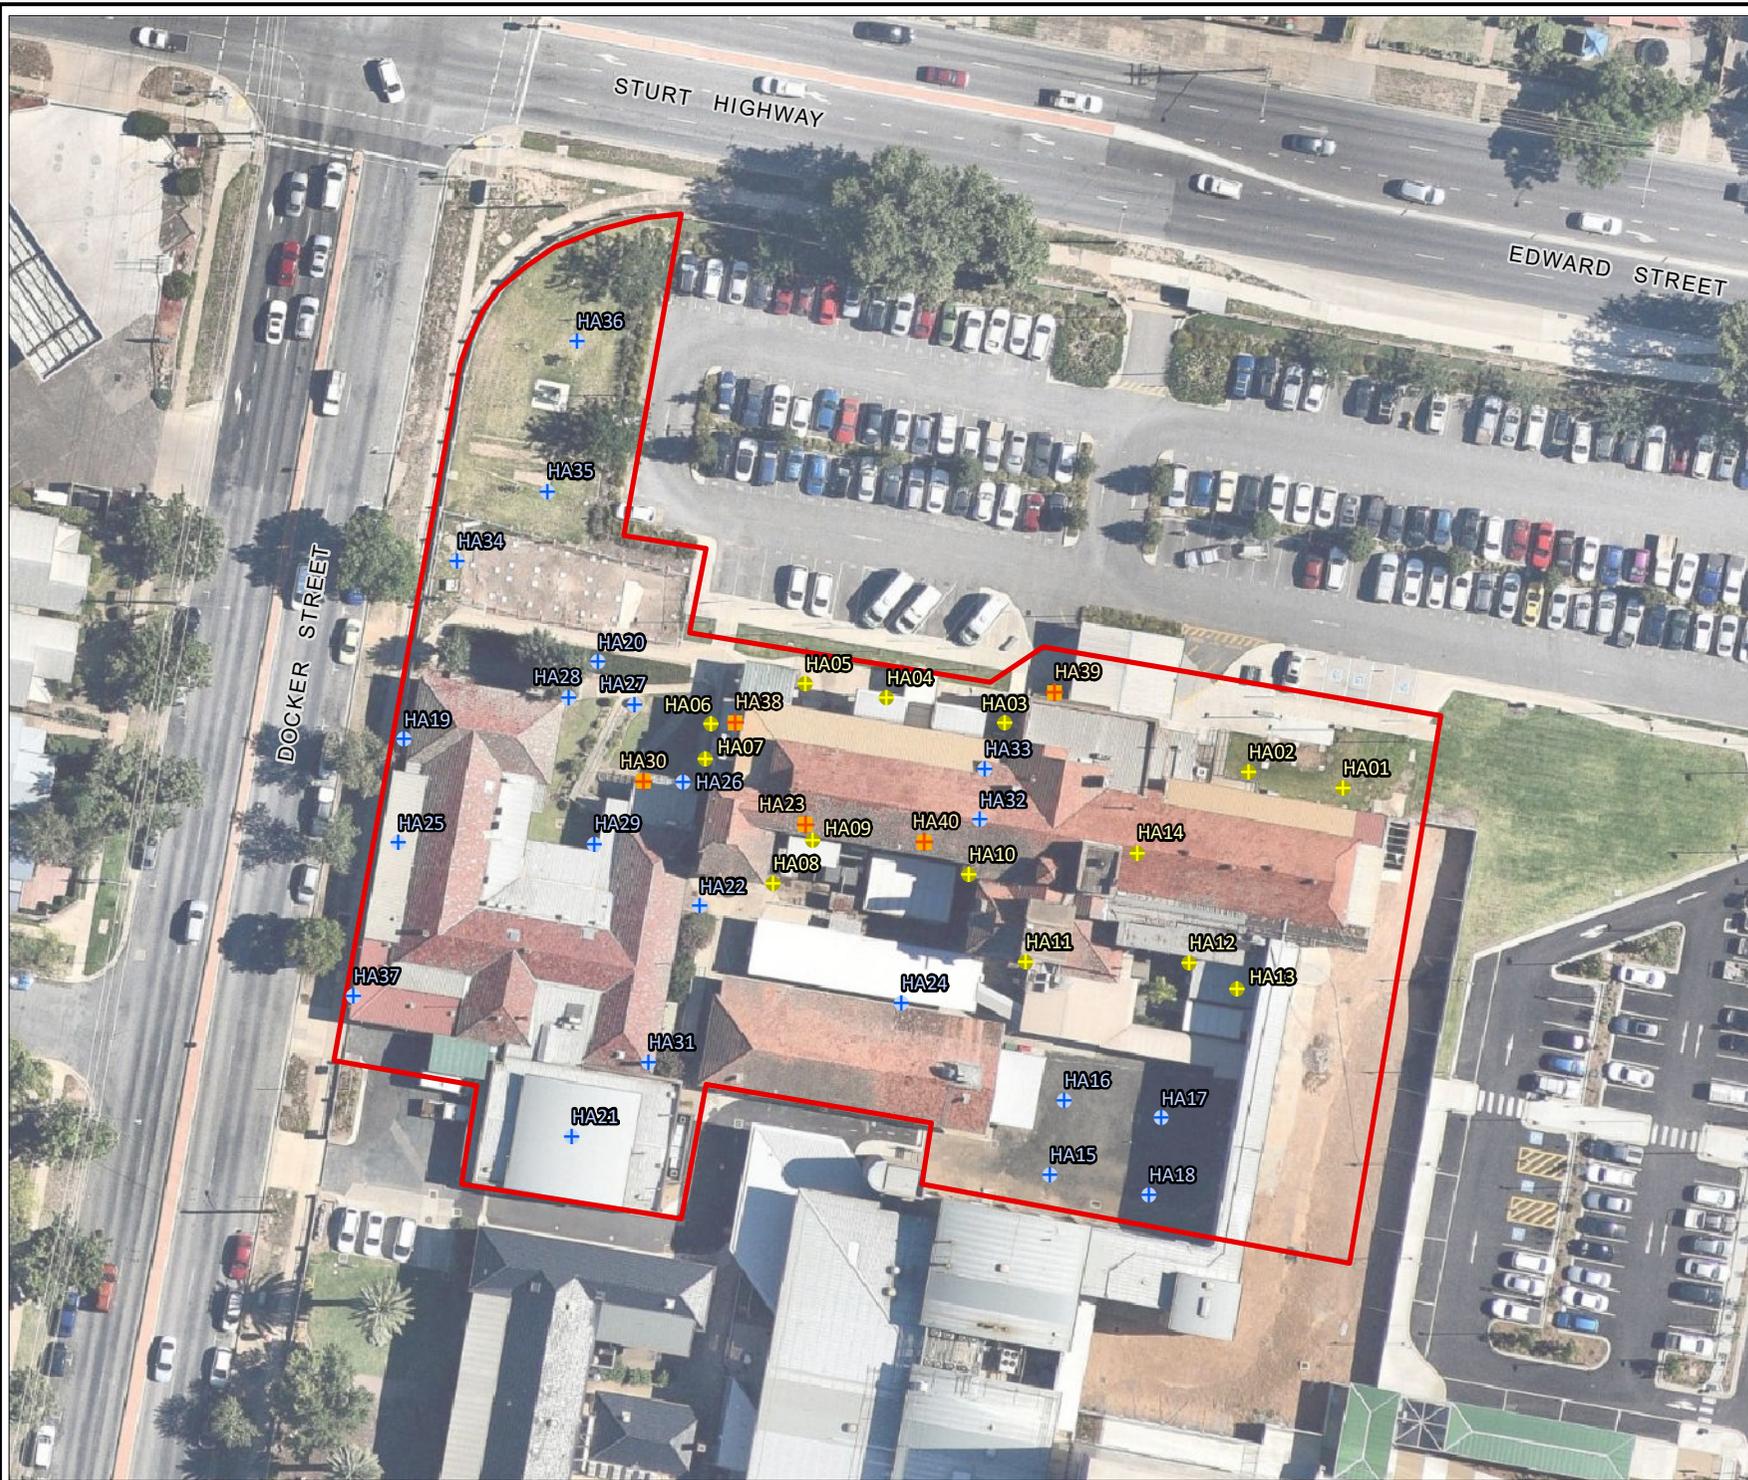
**FIGURE 3**

- Legend:**
- Approximate Stage 3 Boundary
  - + Hand Auger Sample Location (JBS&G 2017a)
  - + Hand Auger Sample Location (JBS&G 2017b)
  - + Access Hatches Sample Location (JBS&G 2017b)

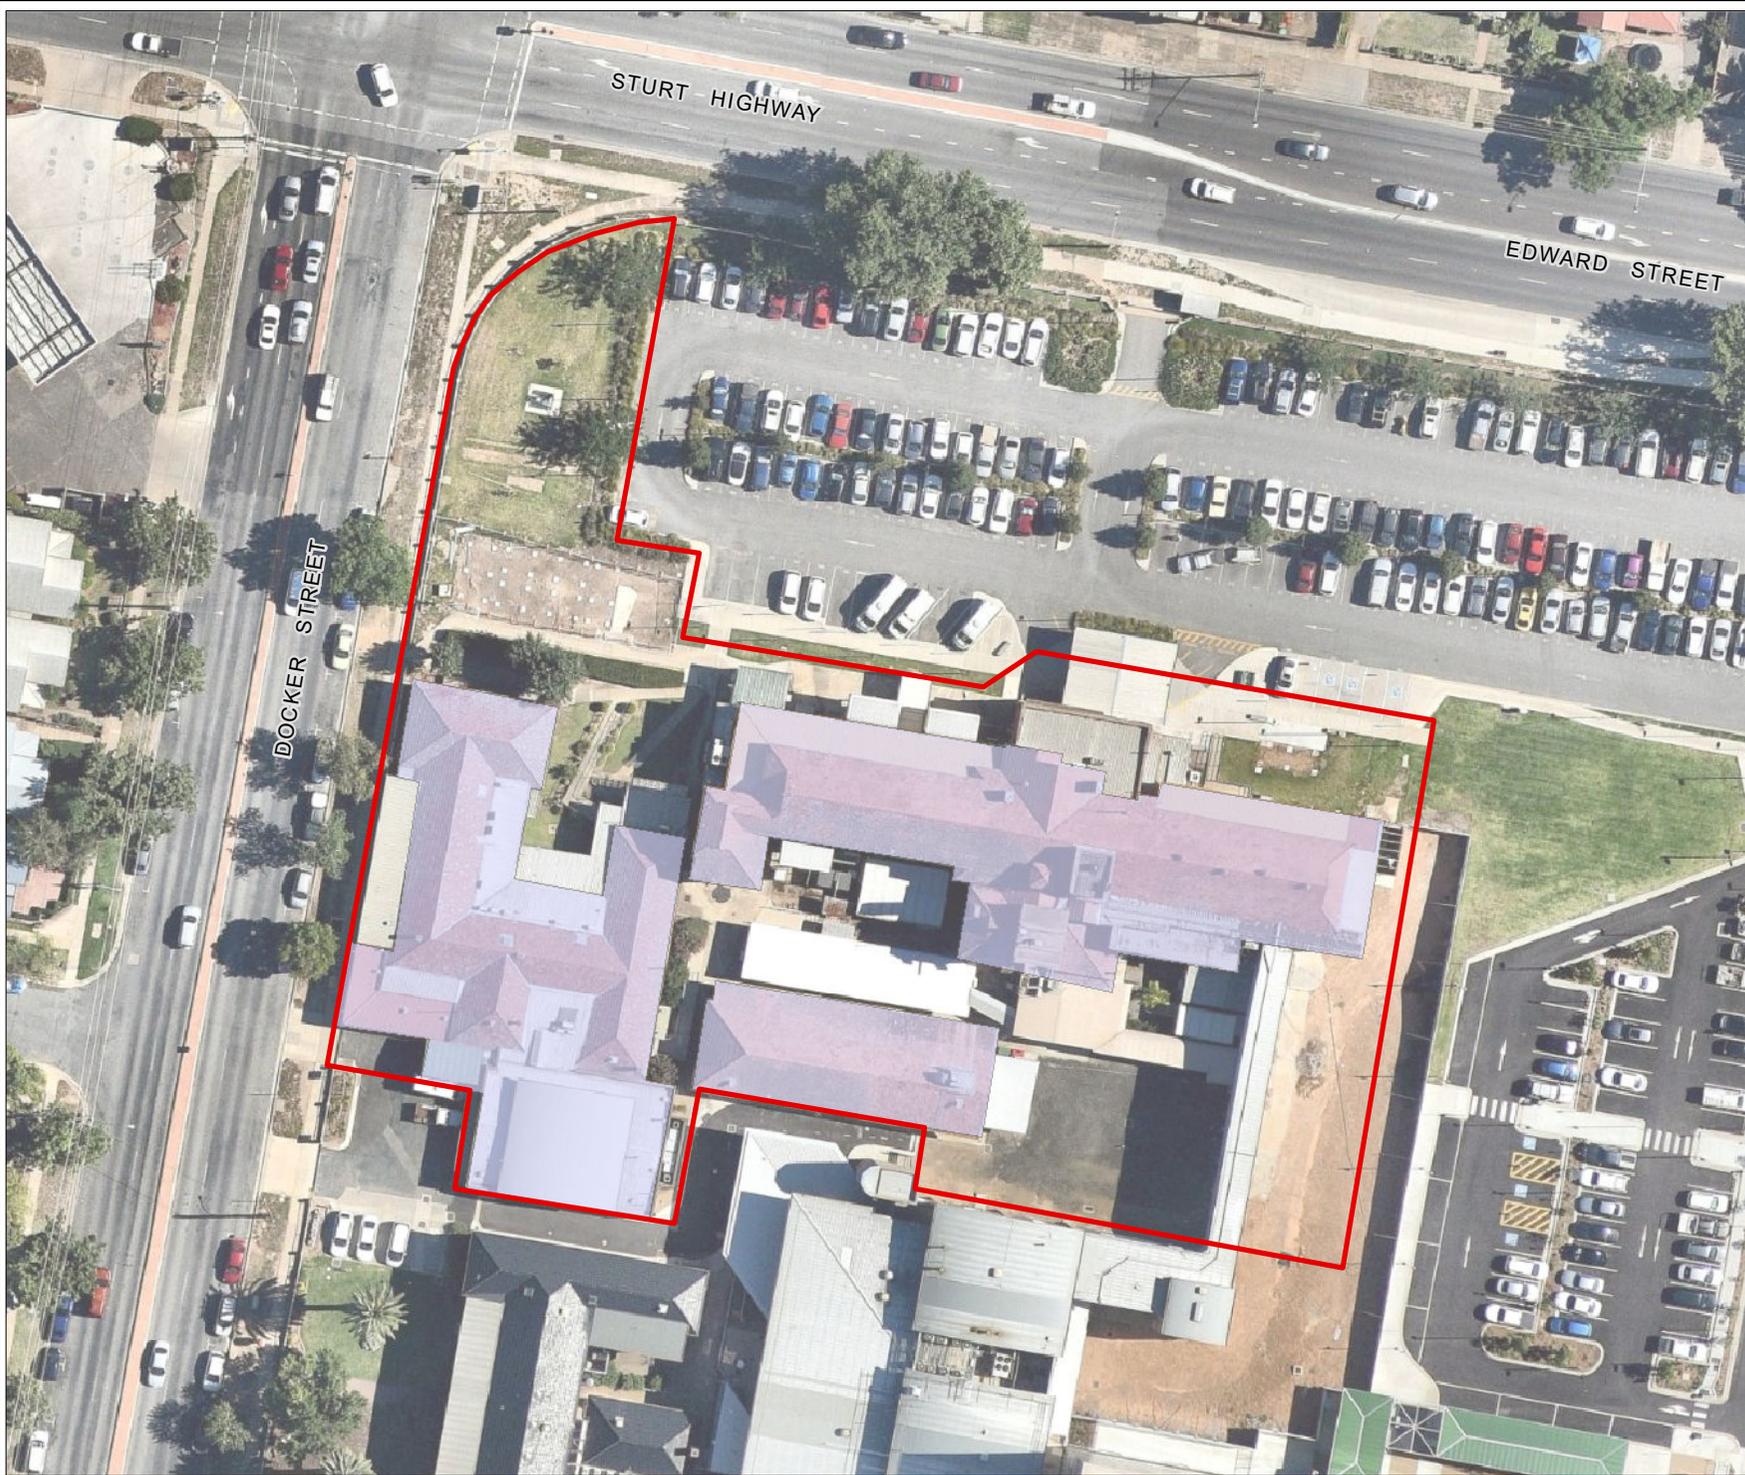
**FIGURE 4**

- Legend:**
- Approximate Stage 3 Boundary
  - Data Gap Assessment Area

**DATA GAP ASSESSMENT AREAS**

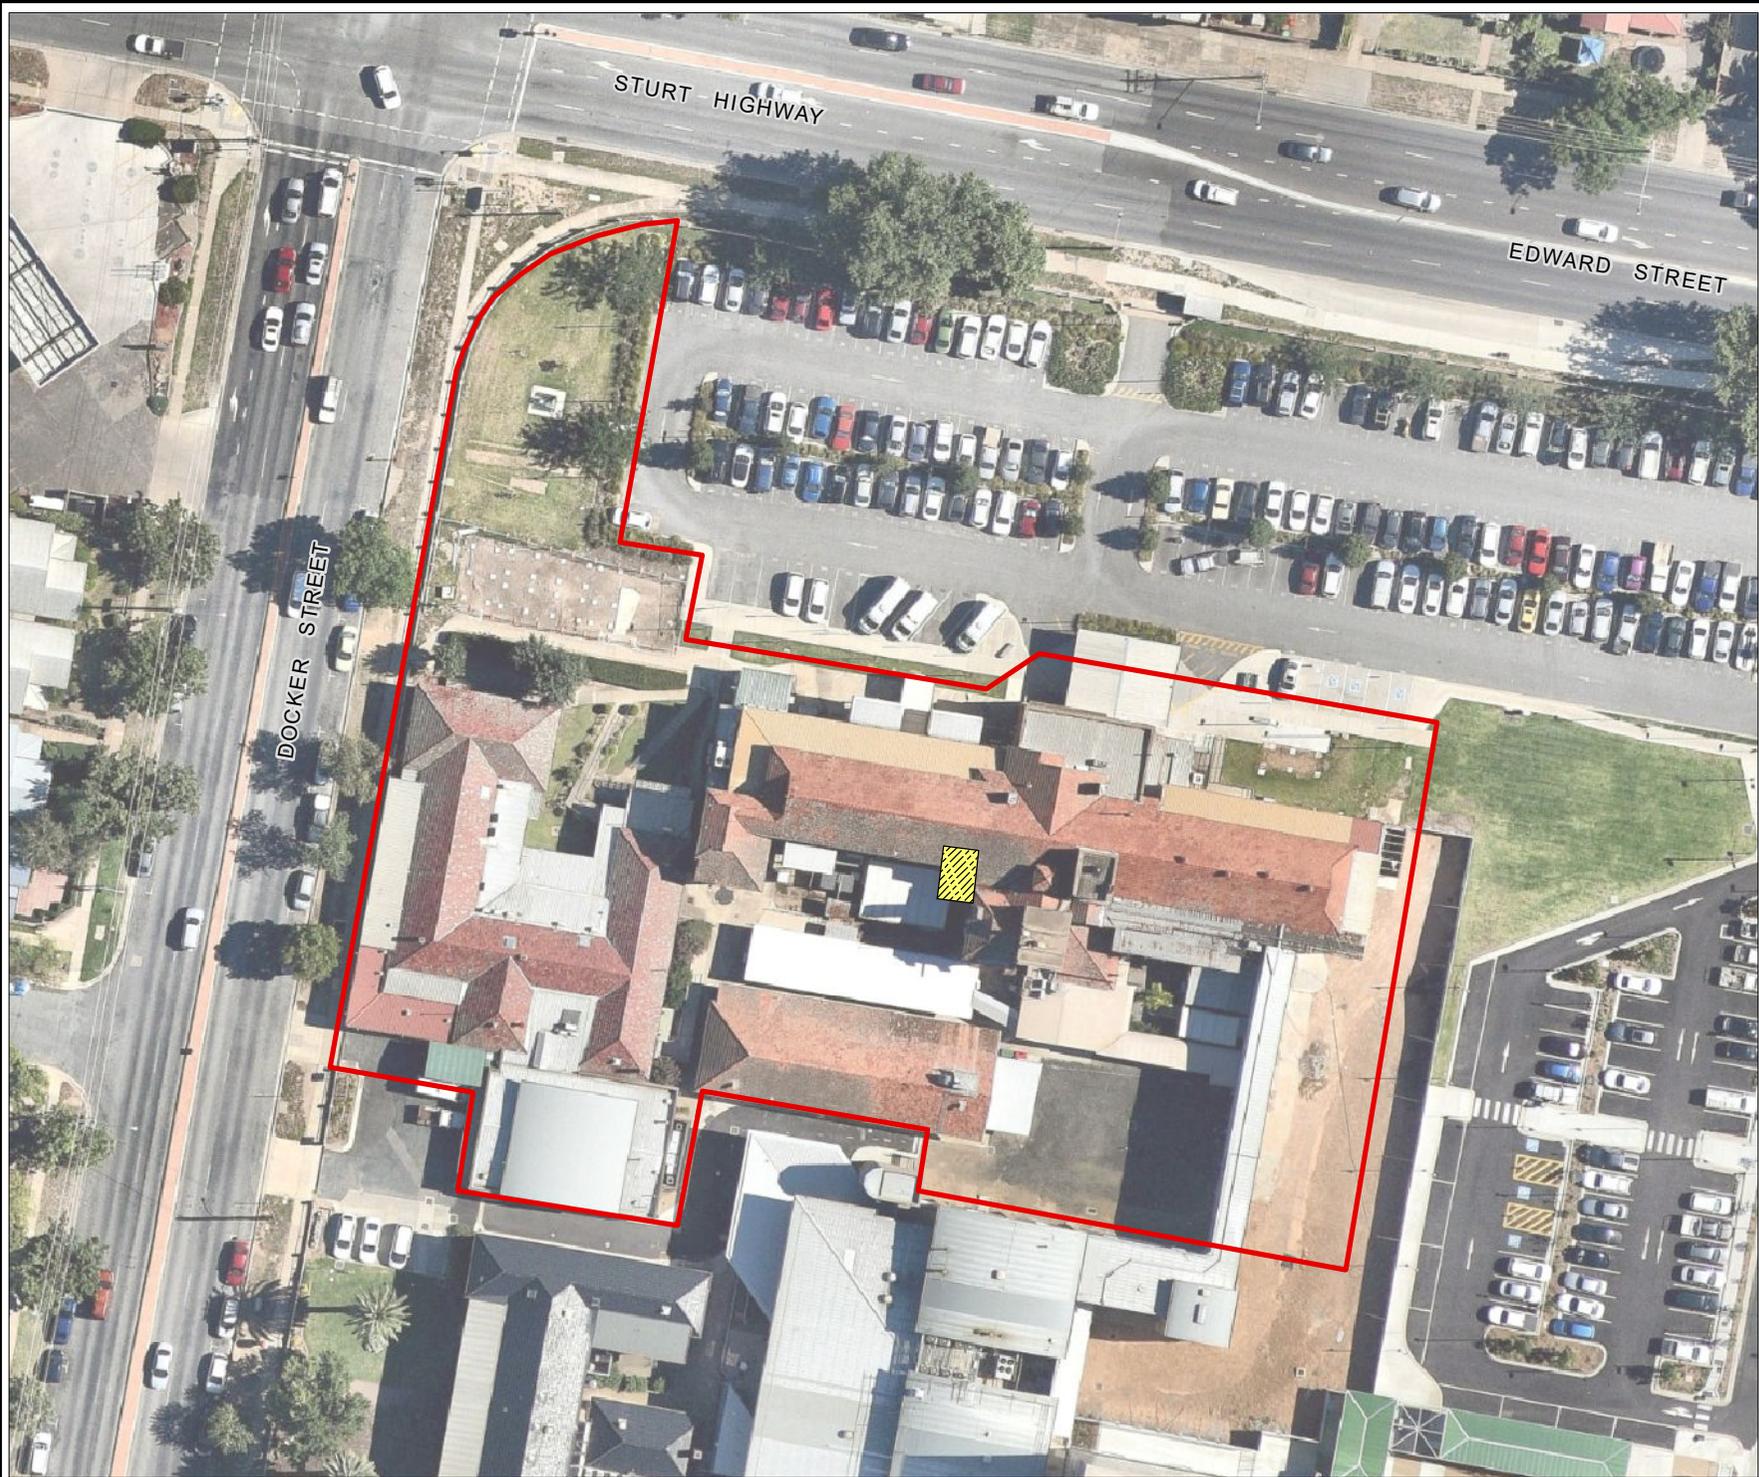
**FIGURE 5**

**LEAD & B(a)P REMEDIATION  
 AREA**

Lead and B(a)P concentrations have been identified above adopted HIL-B within fill materials at previous sampling location HA10 (JBS&G 2017a) to the southern face of the Old Hospital Building. A lateral extent of 25 m<sup>2</sup> surrounding location HA10 is recommended to be included within the remediation of this contamination and a vertical depth to the base of fill materials (anticipated to be approximately 0.5 m bgs).

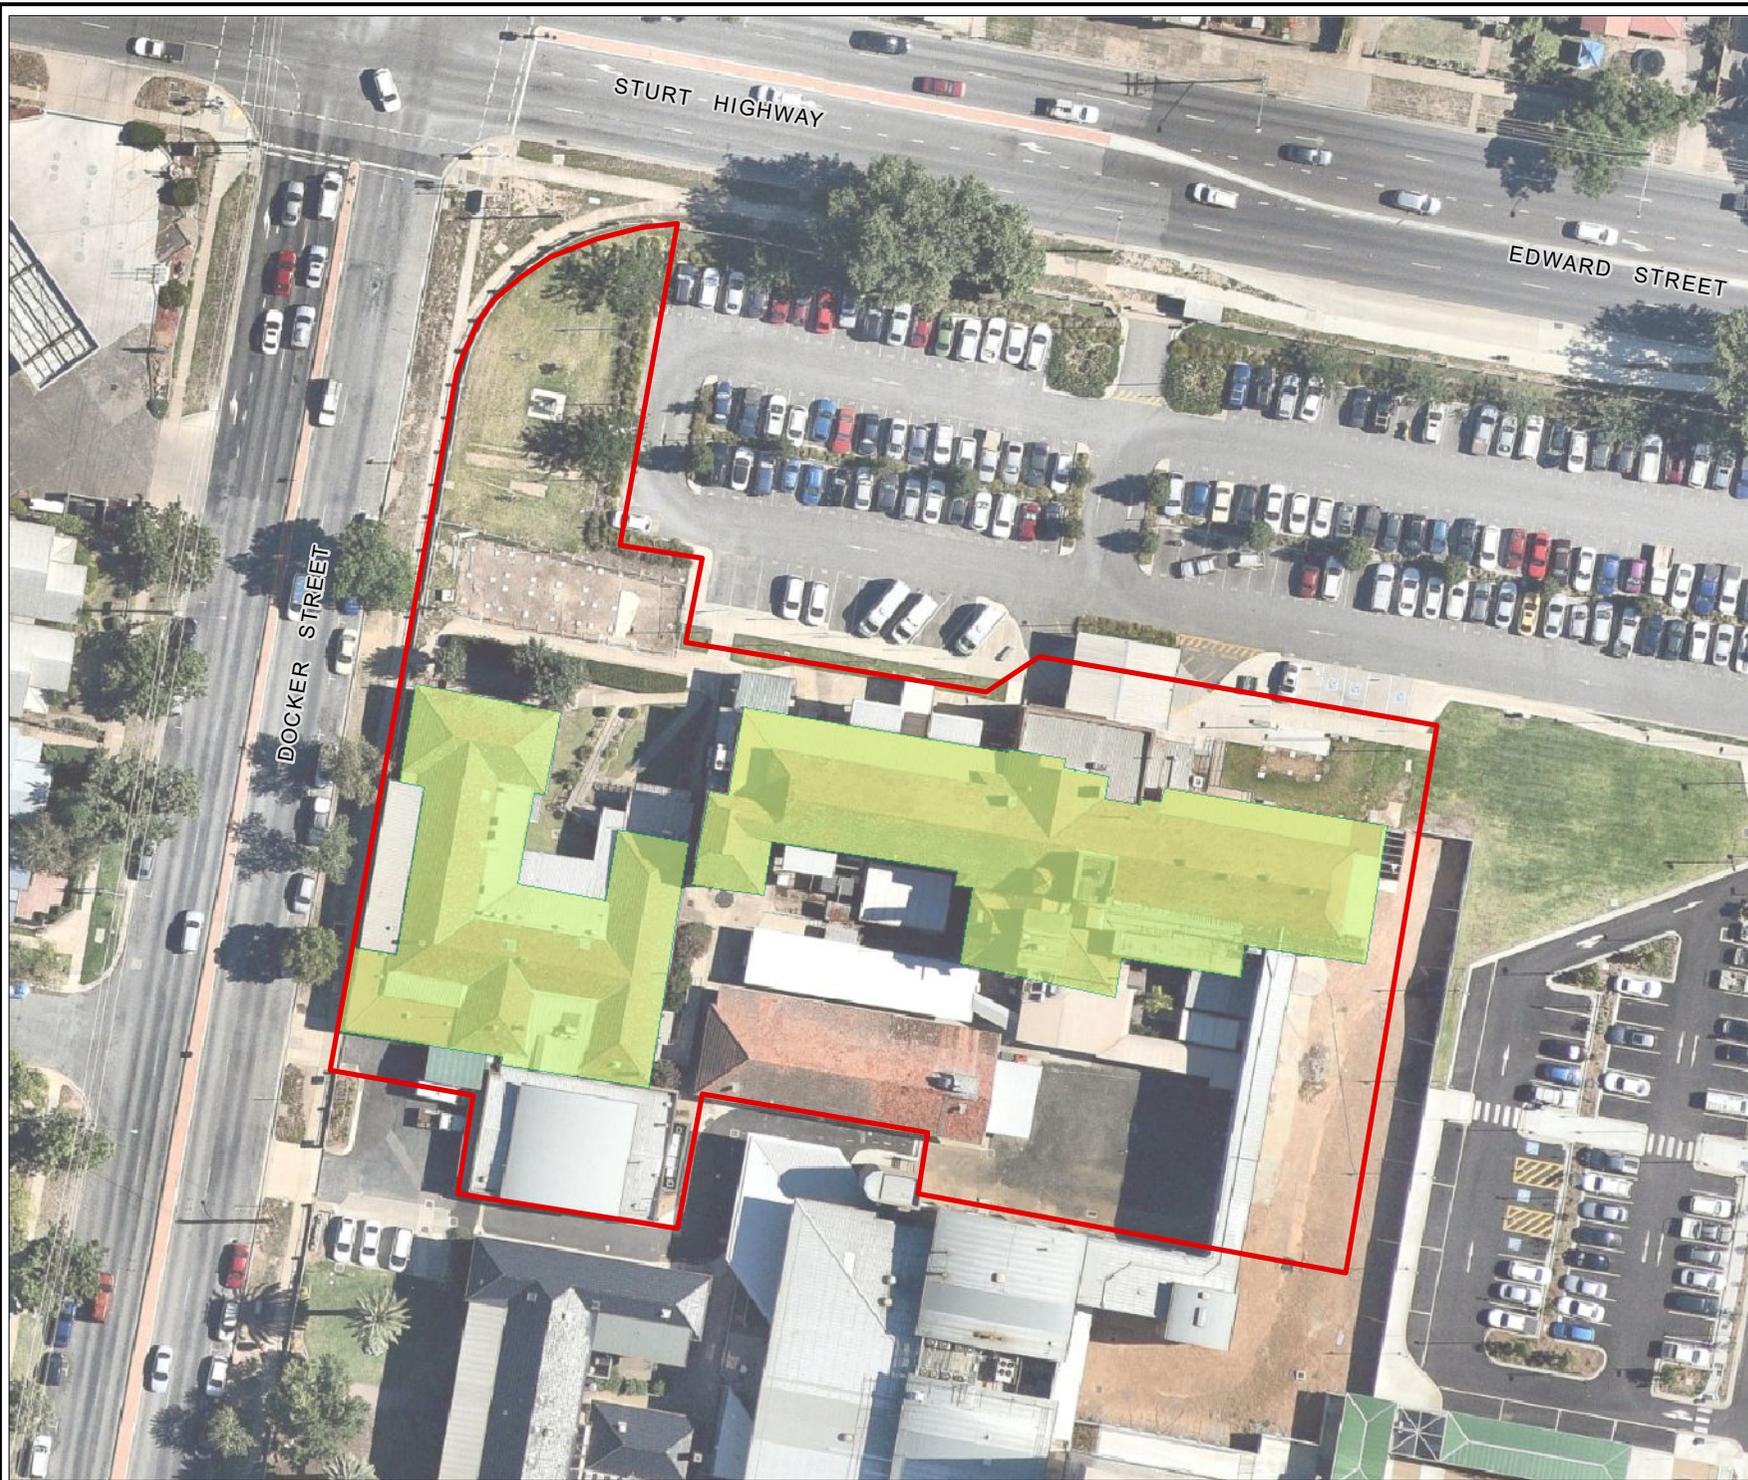
**Legend:**

- Approximate Stage 3 Boundary
- Friable Asbestos Remediation Area
