CONTAMINATED SOIL VALIDATION REPORT
STAGE 3 ENABLING WORKS
WAGGA WAGGA BASE HOSPITAL
260-280 Edward Street,
Wagga Wagga, NSW, 2650
Report No: 17910C02

CONTAMINATED SOIL VALIDATION REPORT, STAGE 3 ENABLING WORKS – WAGGA WAGGA BASE HOSPITAL

January 2019

Report No: 17910C02

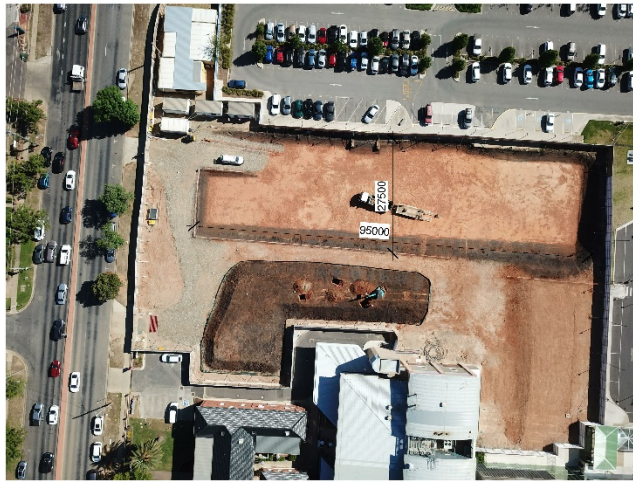
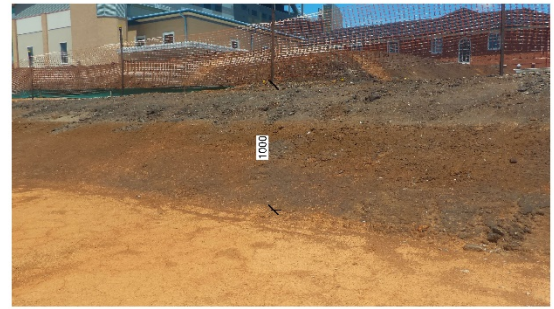
Figure 7: Completed site excavation – Showing profiles

Following remediation and validation for asbestos, lead and B(a)P, material was excavated for construction purposes across the site. Excavations began on the 1st of August 2018 and can be seen in the aerial photograph obtained from Google Earth dated the 2nd August 2018. A change in soil profile is evident with the stockpiles to the south west appearing darker and the excavation into red earth occurring. The completed excavation and soil profile is also provided in figures 7 and 8.
