# Johnstaff on Behalf of Health Infrastructure Concord Hospital Redevelopment Project – Phase 1

**Detailed Site Investigation**

## Concord Hospital Redevelopment Project - Phase 1

Project Reference: SYDGE253211-AF

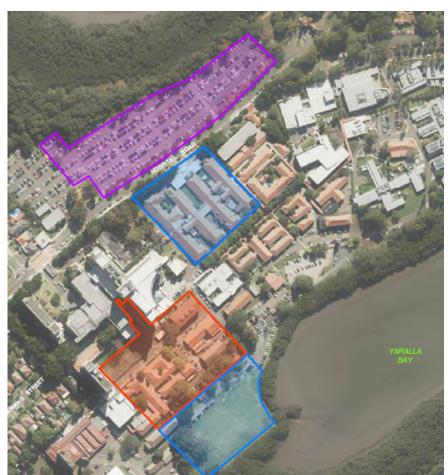
Plate 1- Concord Hospital Phasing Plan

- Phase 1 involves demolition of the existing structures and construction of a new multi storey
  building with one basement level, located in the red zone in Plate 1. The basement will comprise
  a loading dock constructed to RL4.0mAHD, and ground floor used as an atrium providing access
  to upper floors.
- Phase 2 covers two areas located in the blue zones in Plate 1. Details of these proposed developments are not yet confirmed.
- Phase 3 is a proposed multi storey carpark located between Hospital Road and Bray's Bay (purple zone in Plate 1). This area is currently an at-grade carpark.
