# **Phase I Preliminary Site Investigation**

Cudgegong Road Station Precinct South, Rouse Hill NSW

Cudgegong Road Station Precinct South, Corner of Schofields Road and Cudgegong Road, Rouse Hill NSW

**Report No:** STC-1023-13390 / PSI1 / v3f

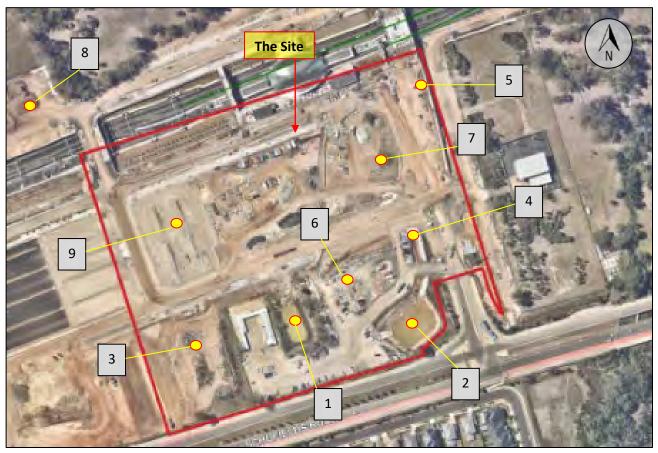
Figure 2. Aerial photograph of the Site with Site observation markers (image provided by Landcom).

- 1. Existing dam in use for Site water. Flow channel from the north. Healthy vegetation surrounding the dam. No odour or sheen;
- 2. Recently excavated dam. Excavated walls are virgin material. Water flow following site gradient with in channels from the north east / north west, and out channels south / south east. Hydrochloric Acid containers observed adjacent dam. Majority of the Sites surface water run off drains into the dam. No hydrocarbon sheen or odours. Water slightly cloudy;
- 3. Large stockpile of fill material observed west of the Site offices. Three (3) potential asbestos containing fibre cement fragments observed on the soil surface;
- 4. Site drainage channel, majority of surface water runoff will flow from the north / north west, into this channel and south into the excavated dam. No sheen or odour. Healthy vegetation present;

- 5. Large retaining wall present along Cudgegong road. Site raised towards the station approximately 5-8 m with fill material;
- 6. Lay down area. Large concrete pipes, construction material and storage containers. Un-lined concrete washout observed;
- 7. Imported fill materials (DGB) and landscaping materials such as topsoil stockpiled;
- 8. Large stockpile of soil material to the north west of Site, possibly used as fill material on Site; and
- 9. Site compound and carparks. Filled with compacted DGB approximately 1 m above Schofield's road.

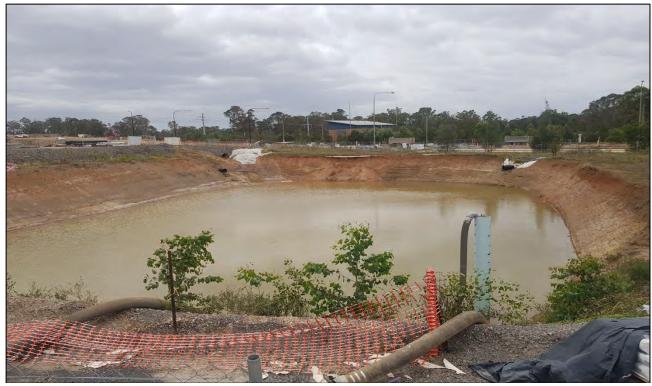
**Photograph 2.** Large excavated dam in the south eastern corner of Site, as observed on 16.01.2018.

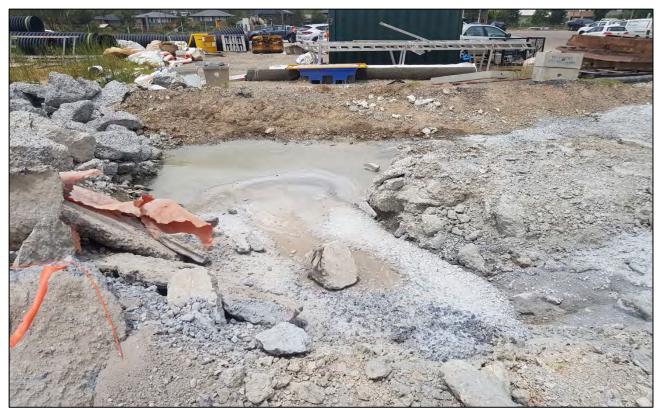
Carpark construction, hardstand, service roads and trenching for service installation are currently in progress throughout the western section of Site. An unlined concrete washout was observed in a laydown area to the east of the small existing dam.

**Photograph 3.** Un-lined concrete washout bay, as observed on 16.01.2018.

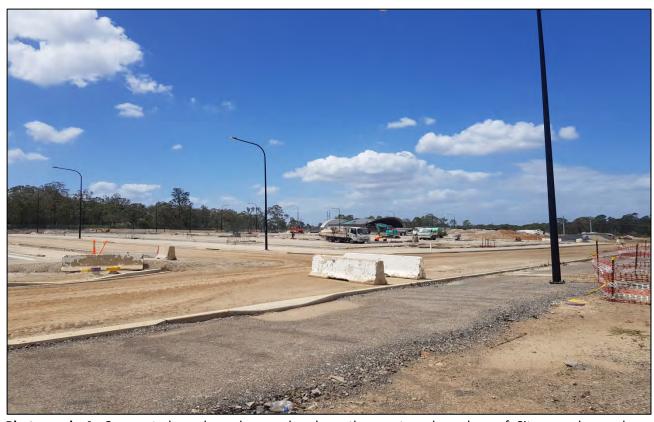
**Photograph 4.** Compacted roads and carparks along the western boundary of Site, as observed on 16.01.2018.

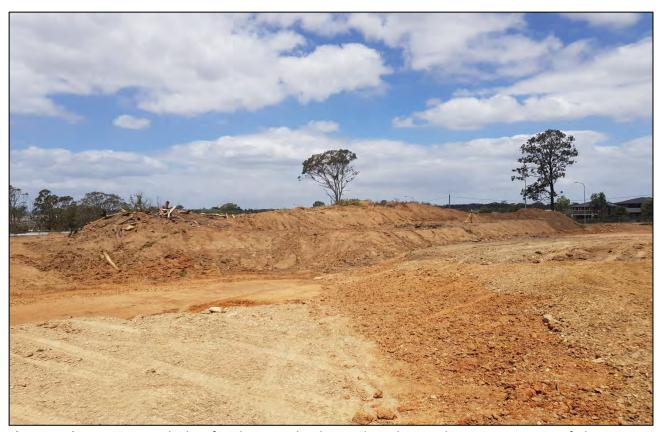
A large stockpile of soil, trace building debris and vegetation was observed in the south west corner of the Site. Three (3) potentially asbestos containing fibre cement fragments were observed on the soil surface of the western side of the stockpile, and asbestos is presumed to be present beneath the surface of the stockpile.

**Photograph 5.** Large stockpile of soil materials observed in the south western corner of the site, as observed on 16.01.2017.

- The fill materials both historically placed and as part of the current development of the Site in order to determine the vertical and lateral extent (if any) of potential contaminants of concern (i.e. Asbestos, Heavy Metals, PAHs, TRH, OCPs, OPPs, PCBs);
- ASS assessment to a maximum of one (1) metre beyond the proposed design depth as per the ASSMAC (1998);
- Salinity assessment (both soil and groundwater) of soil material to be collected and analysed prior
  to the construction phase. This will determine potential impacts of soil salinity on structures i.e.
  foundations and basements;
- The two (2) dam footprints including fill material for dam wall construction and sediments within;
   and
- The large soil stockpile within the south-western sector of the site.

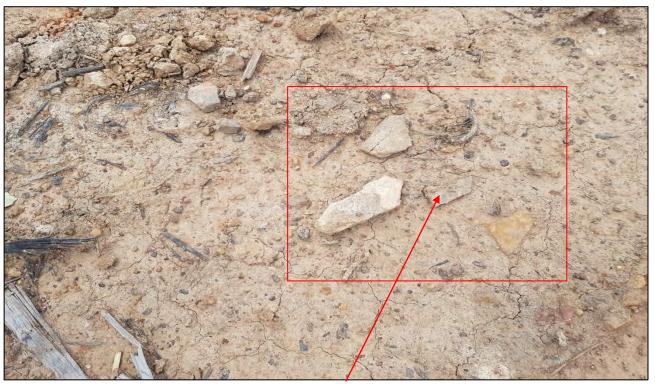
- o A large stockpile of soil stored in the south west corner of the Site was observed to be containing potential asbestos fibre cement fragments and requires assessment;

**Photograph 6.** Potential ACM fragment observed on the soil surface of the stockpile, as observed on 16.01.2017.

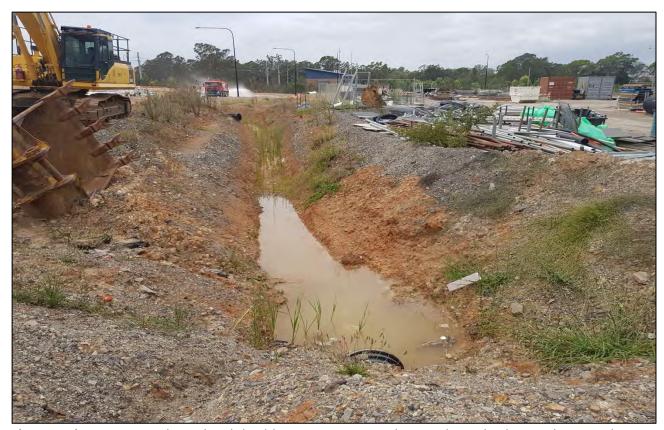
- The potential for contamination as a part of chemical vegetation control has been considered low based on the healthy condition of vegetation observed within drainage channels during the walkover.

**Photograph 7.** Drainage channel with healthy vegetation, no odour or sheen, leading to the main dam, as observed on 16.01.2017.

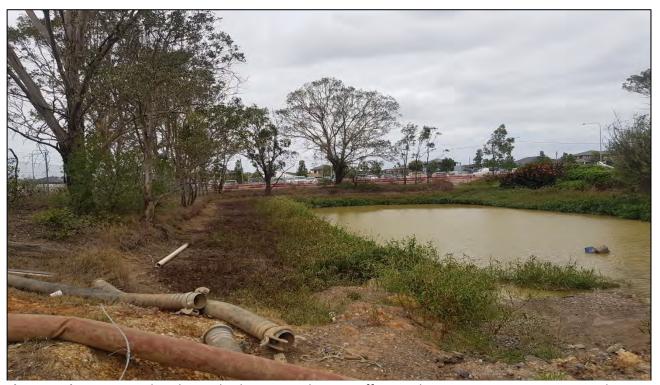
**Photograph 8.** Centre dam located adjacent to the Site office, with riparian vegetation surrounding, as observed on 16.01.2017.
