Report on  
Detailed Site Investigation

Randwick Campus Redevelopment  
Bound by High, Magill, Hospital and Botany Streets,  
Randwick

Prepared for  
LendLease Building Pty Limited

Project 72505.14  
September 2018

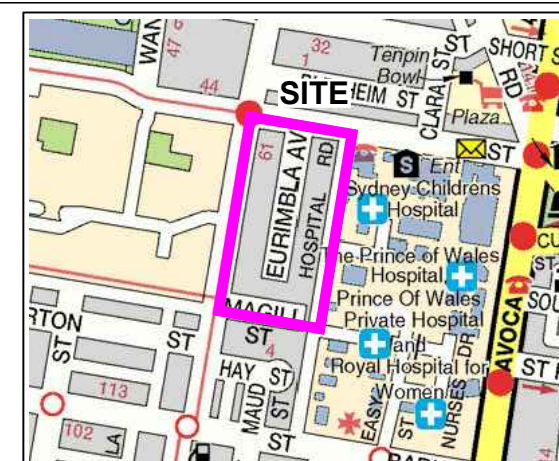
Locality Plan

NOTE:  
1: Base image from Nearmap.com  
(Dated 6.8.2017)  
2: Test locations were located using high resolution  
hand held GPS.
