Job No: 13968/1
Our Ref: 13968/1-AA
28 February 2017

re: **Proposed Marsden Park Industrial Stage 1.02B,
Richmond Road, Marsden Park
Contamination Clearance Report**

Marsden Park Industrial Stage 1.02B - Richmond Road, Marsden Park

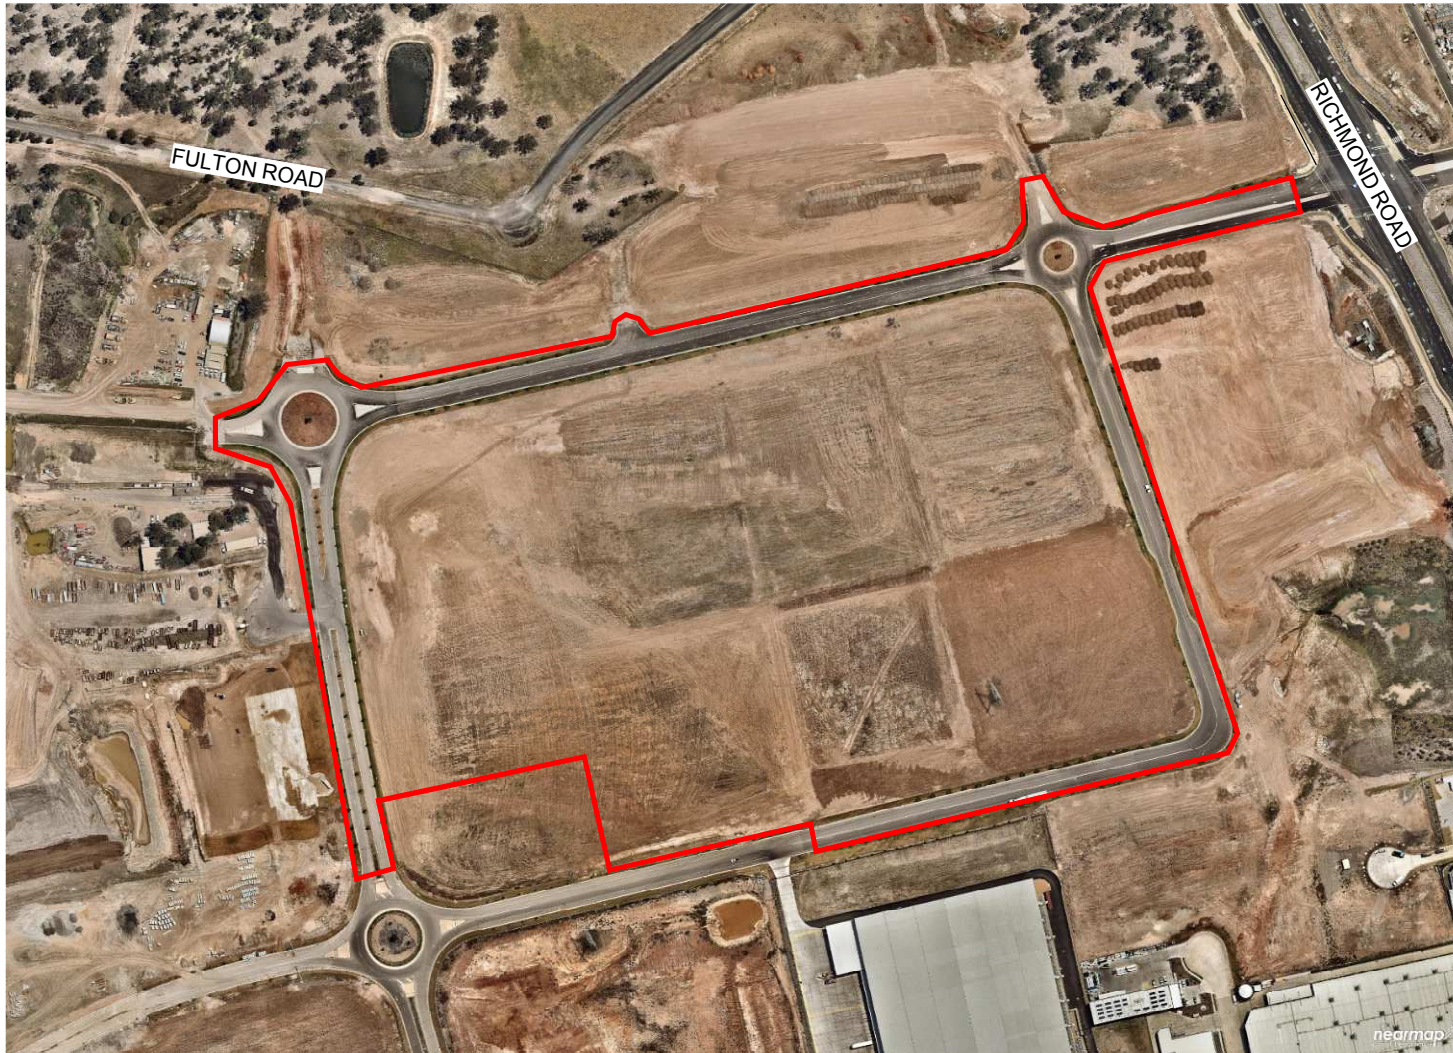
DRAWING NO: 13968/1-AA1

As requested, this letter report presents a post construction clearance based on the review of the contamination and validation reports related with Stage 1.02B - Sydney Business Park, located at Richmond Road, Marsden Park (hereafter known as the Site), as shown on the Drawing No 13968/1-AA1 (Attachment 1).

The subject (Marsden Park Industrial Stage 1.02B) is irregular shape and covers approximately, 202335m² as reported GT (Attachment 2a) and as shown Drawing No 13968/1-AA1. The site is bound by Richmond Road to the east and Access Road to the South.

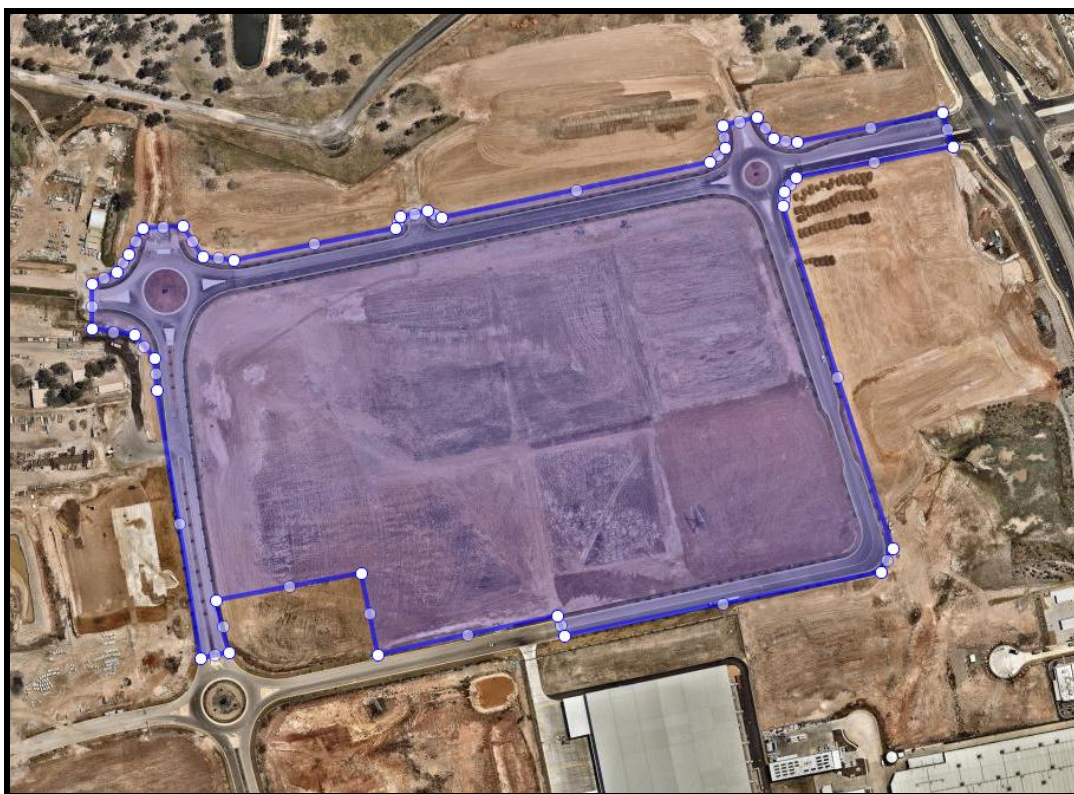
The site is Irregular in shape and covers approximately 202,335m². It is bound by Richmond Road to the East and Access Road 5A to the South.

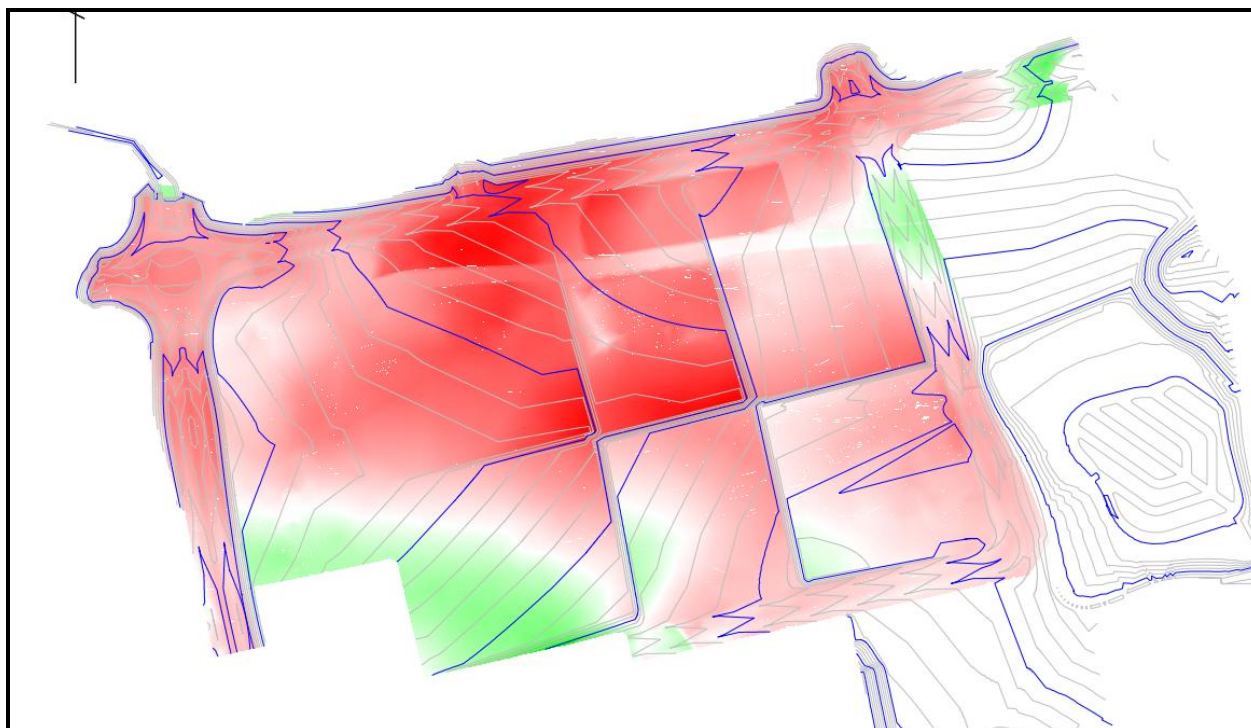
The total volume of bulk fill placement for this stage 1.02B was estimated to be approximately 299,000m³. These quantities were supplied by Mulgoa Quarries. The depth of fill averaged at 0.96m with a maximum fill depth of 4.10m. The average depth of cut was 1.34m with a maximum cut of 4.38m.

The figure below outlines the extent of fill highlighted in red.

Refer to survey plans provided to Mulgoa Quarries showing the stripped levels and finished levels.

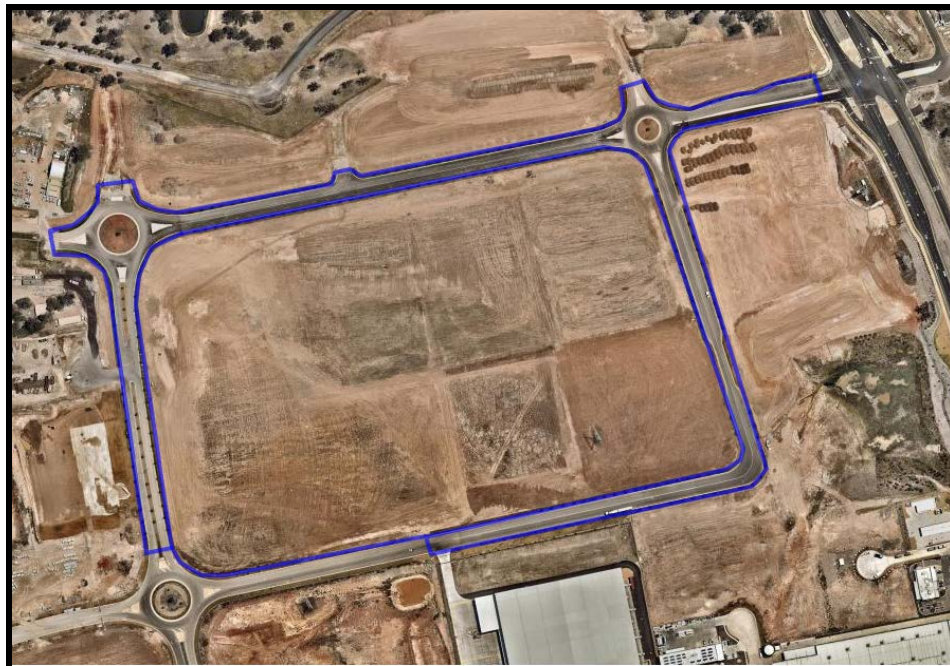
At the request of Mulgoa Quarries Pty Ltd, Ground Technologies (GT) has undertaken testing during the period 14th October 2016 to 16th January 2017 on the Geotechnical and Flexible Pavement works operations carried out at the above-mentioned project. It should be noted that fill placement was not continuous during this period. Refer to plan below;

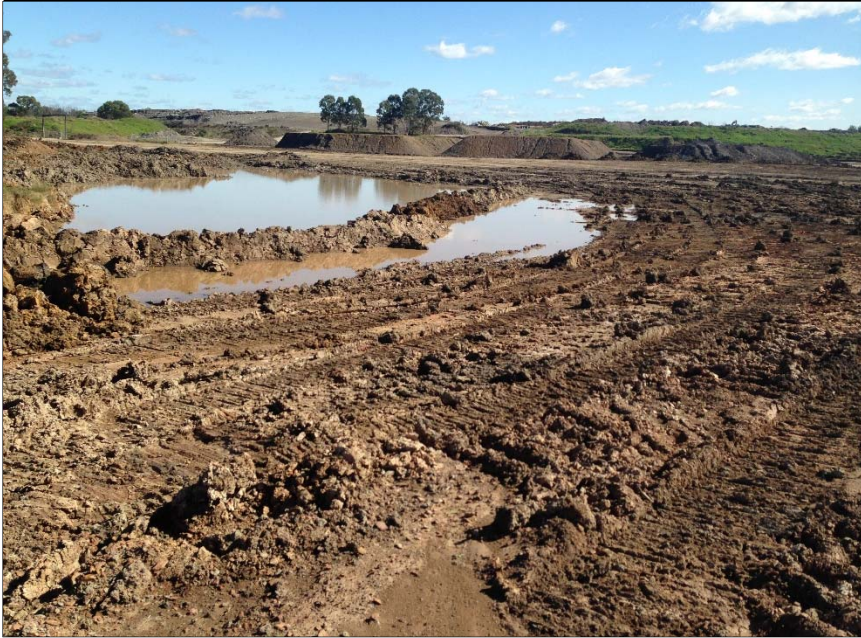
Photograph 1 - Lot 121, facing north-west

Lot 121 was located in the western portion of Stage 1.02 of the SBP. The surface of the lot comprised natural brown clay soil with a number of soil stockpiles of clay and topsoil located within the western portion of the lot. Ponded surface water was observed in the central portion of the lot as shown in **Photograph 1**. No staining or odours were observed in or around the water. There were no observations of asbestos containing materials, odours or staining of the ground surface at the lot.

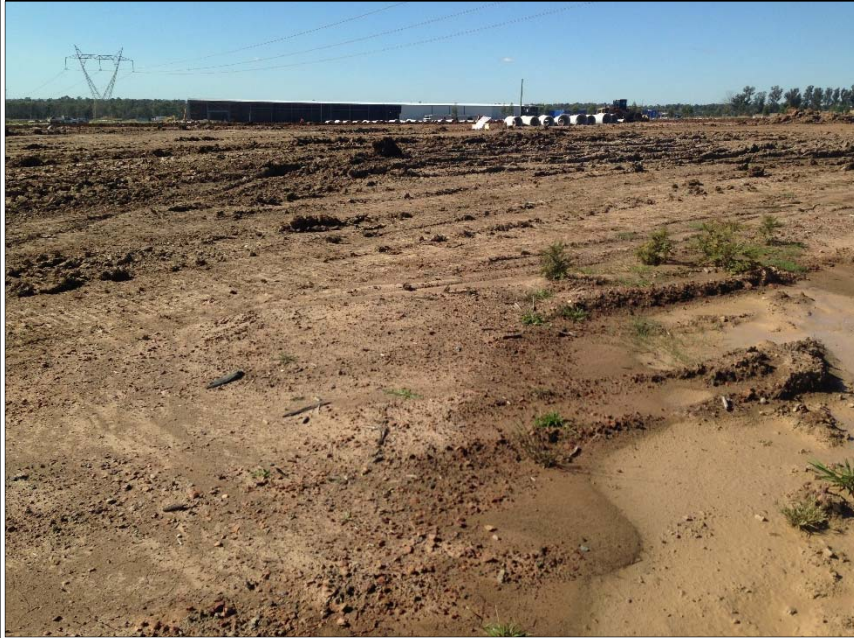
Photograph 2 - Lot 122, facing south-east

Lot 122 was located in the western portion of Stage 1.02 of the SBP and north of Lot 121 as shown in **Photograph 2**. The ground surface of the lot was predominantly natural clay soil. A number of clay stockpiles were observed within the western portion of the lot as shown in **Photograph 3**. A number of concrete drainage infrastructure were stored on the lot at the time of the site inspection, the pipes are shown in **Photograph 4**. There were no observations of asbestos containing materials, odours or staining at the ground surface of the lot.

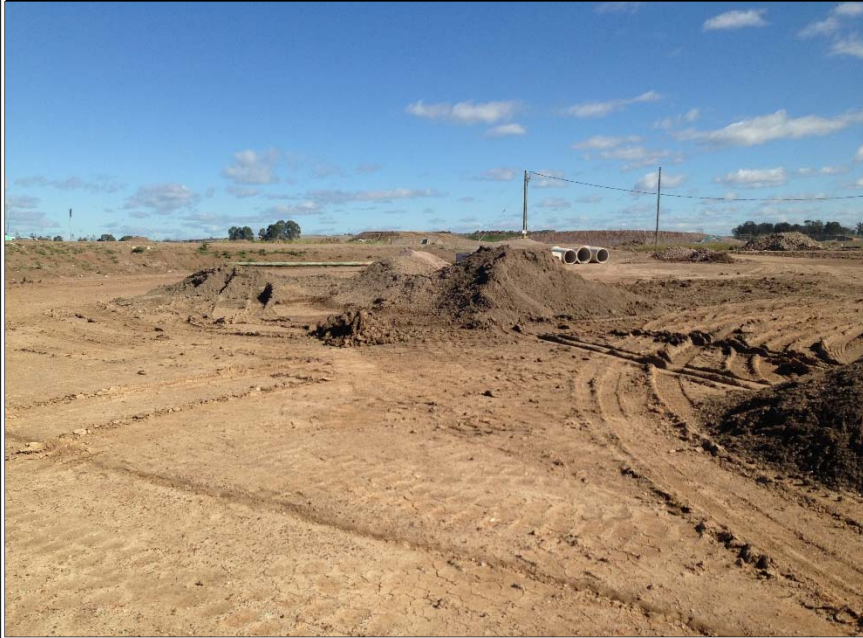
Photograph 5 - Stockpiles within lot 123, facing North

Lot 123 comprised vacant land with a surface covering of natural brown clay and sandstone gravel fill. Sand, mulch and topsoil stockpiles were located at various locations within the lot as shown in **Photographs 5, 6 and 7**. A soil embankment was located in the south-western corner of the lot. There were no observations of asbestos containing materials, odours or staining at the lot.

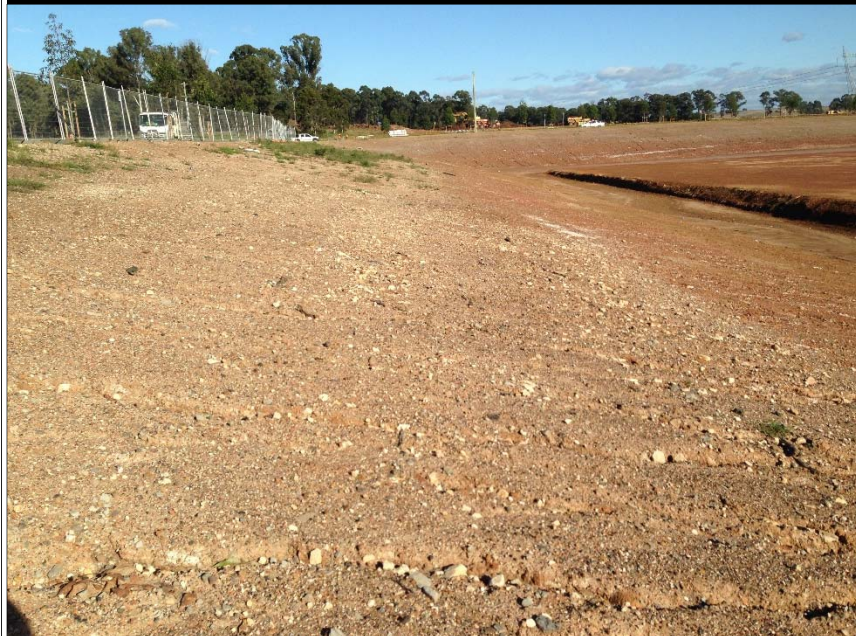
Photograph 8 - Lot 124, facing west

Lot 124 comprised of a rectangular lot which had previously undergone earth works. The ground surface of the lot comprised clay with sandstone gravel as shown in **Photograph 8**. The southern and western boundaries contained worked embankments from the road down to the level portion of the site and the centre of the site comprised a slightly raised, flat area as shown in **Photographs 9 and 10**. A retention pond was located in the north-eastern portion of the lot (**Photograph 11**) and a small (< 1m³) stockpile of asphalt and gravel was observed in the western portion of the site. Accumulated silt was observed on the eastern and southern boundaries of the lot. There were no observations of asbestos containing materials, odours or staining at the ground surface of the lot.

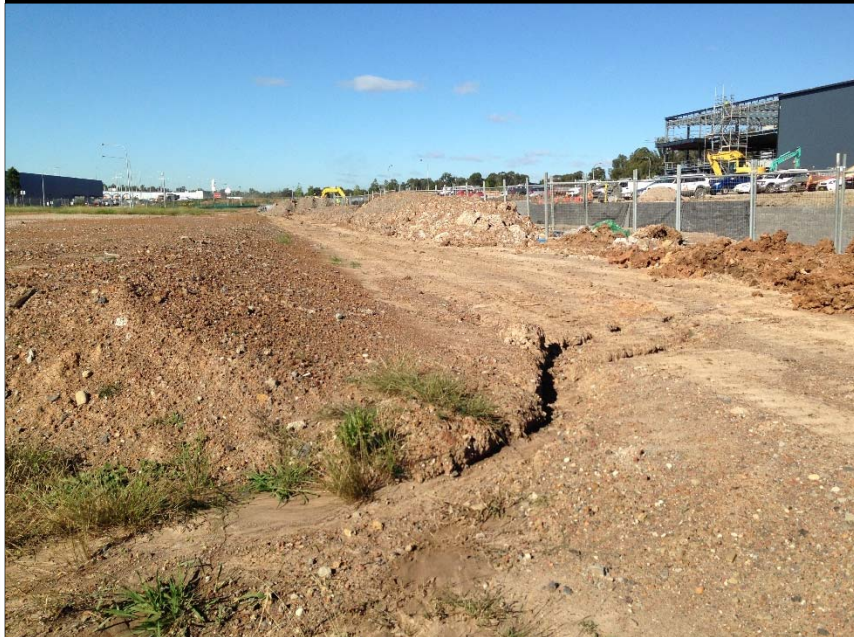
Photograph 12 - Lot 126, facing south

Lot 126 comprised a vacant lot in the eastern portion of Stage 1.02 of the SBD. The ground surface of Lot 126 comprised of clay with igneous and sandstone gravel fill as shown in **Photograph 12**. A retaining wall was located on the western boundary of the lot, and a number of stockpiles were observed at various locations throughout the lot. The stockpiles contained clay and gravel. There were no observations of asbestos containing materials, odours or staining at the ground surface of the lot.
