**Remediation Action Plan (RAP)  
Proposed New Amity College Campus  
Lot 1 DP 525996 No 85 Byron Road and  
Lot 2 DP 525996 No 63 Ingleburn Road  
Leppington NSW**

**Ref: JC18322B-r1(rev2)**

**May 2019**

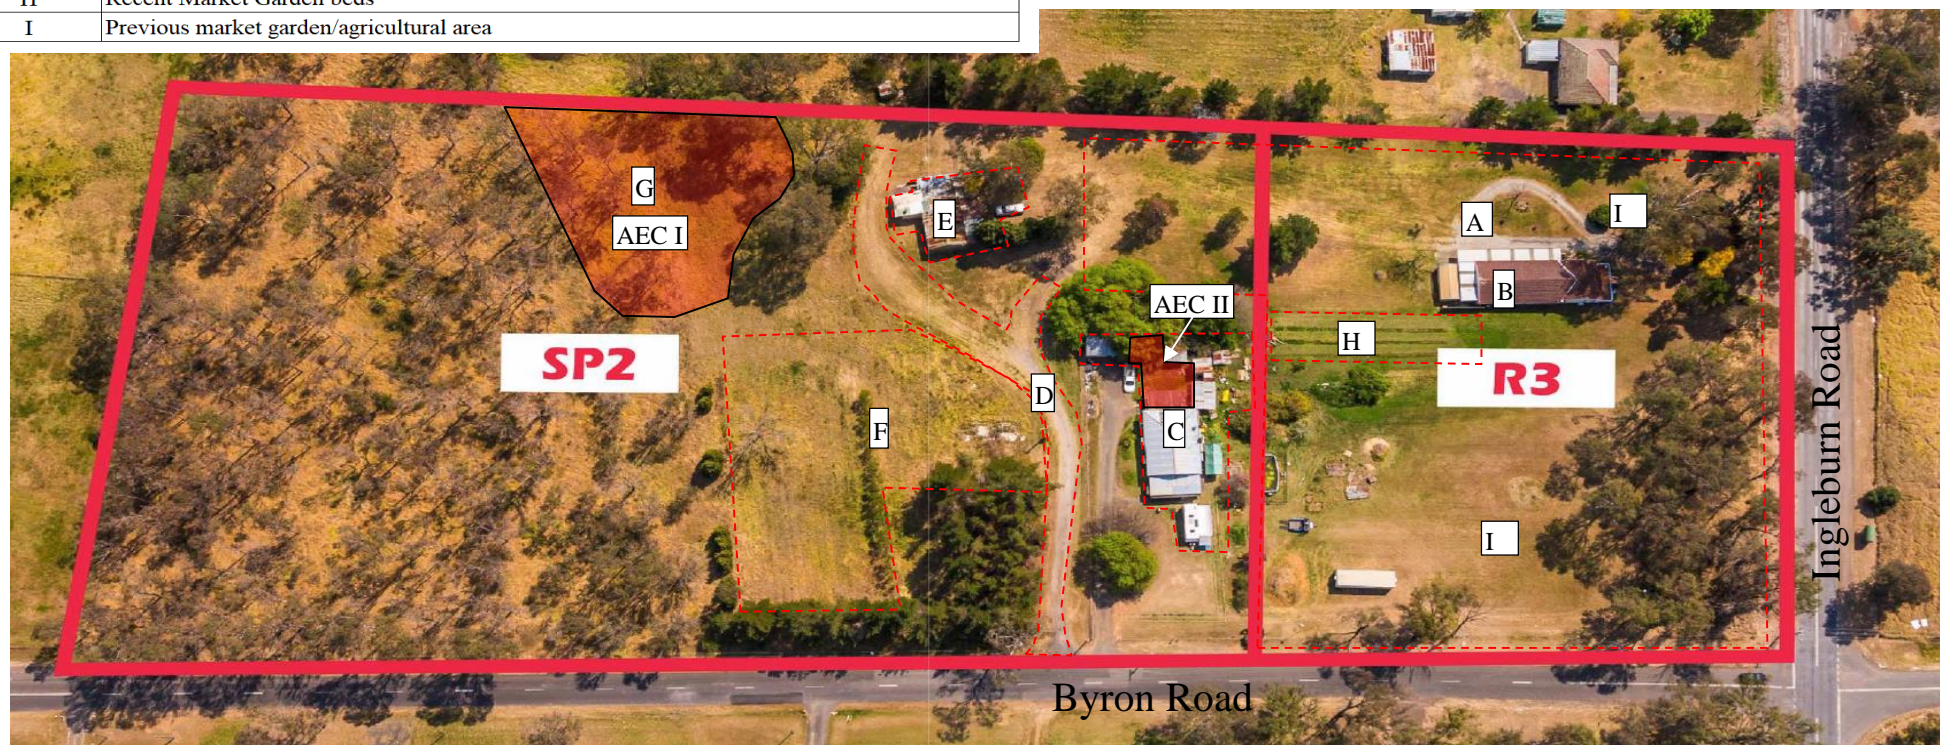
Site Feature	Description
A	Driveway constructed of crushed rock.
B	Single-storey brick, weatherboard and tile dwelling with a metal garage to the rear.
C	Single-storey fibro/metal dwelling with a number of small metal, timber and fibro sheds to the west. Sheds used for storage of miscellaneous items. Some minor hydrocarbon staining visible on surface
D	Driveway constructed of crushed rock, sandstone and traces of building debris (eg bricks and asphalt lumps)
E	Metal, timber and fibro shed with building extensions.
F	Area of previous numerous small buildings and sheds. Previous market garden area (1950s)
G	Backfilled depression with rubbish fill consisting of concrete boulders, bricks, glass and asbestos fragments
H	Recent Market Garden beds
I	Previous market garden/agricultural area

Note: The extent AEC I and II are only approximate and should be confirmed during site remediation

- AEC I : The buried rubbish/asbestos and Zinc contaminated fill (Area 4 – Site Feature G) to require remediation and this area is referred to as Area of Environmental Concern 1 (AEC I)
- AEC II : The areas of hydrocarbon stained soil encountered between the dwelling and sheds (Area 1 - Site Feature C)

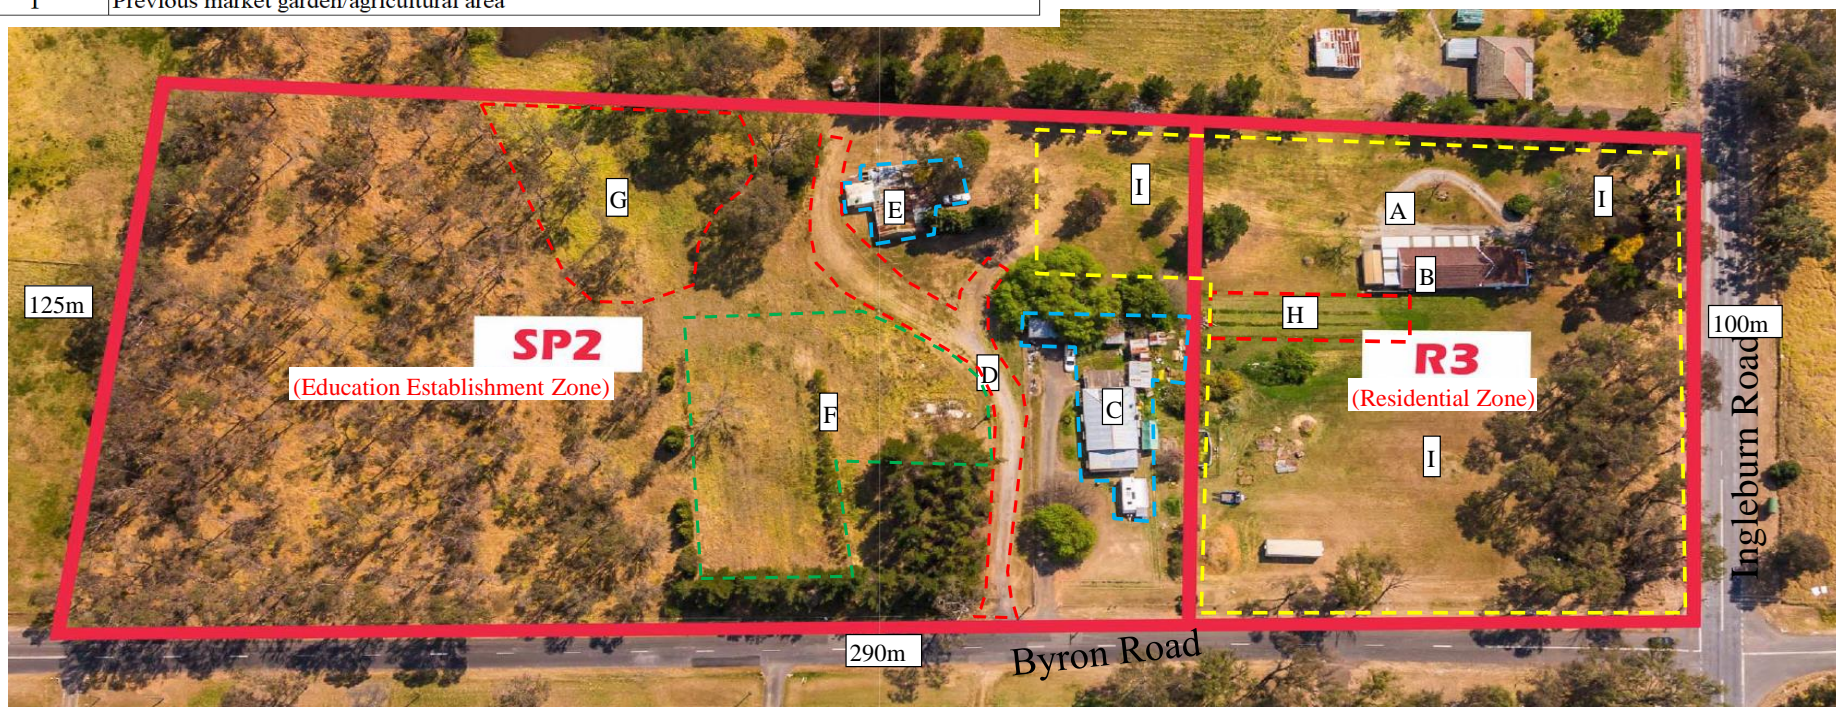
Drawn By: AT	Date: 6/6/18	<b>Gran Associates Pty Ltd</b> <b>85 Byron Road and 63 Ingleburn Road Leppington</b> <b>Site Zoning and Features Plan</b>	
Checked By: SL	Date: 6/6/18		
Revision By:	Date:		
Scale: Not to Scale		A3	Project No: JC18322A Drawing No: 2

Site Feature	Description
A	Driveway constructed of crushed rock.
B	Single-storey brick, weatherboard and tile dwelling with a metal garage to the rear.
C	Single-storey fibro/metal dwelling with a number of small metal, timber and fibro sheds to the west. Sheds used for storage of miscellaneous items. Some minor hydrocarbon staining visible on surface
D	Driveway constructed of crushed rock, sandstone and traces of building debris (eg bricks and asphalt lumps)
E	Metal, timber and fibro shed with building extensions.
F	Area of previous numerous small buildings and sheds. Previous market garden area (1950s)
G	Backfilled depression with rubbish fill consisting of concrete boulders, bricks, glass and asbestos fragments
H	Recent Market Garden beds
I	Previous market garden/agricultural area

Note: The extent site features are only indicative

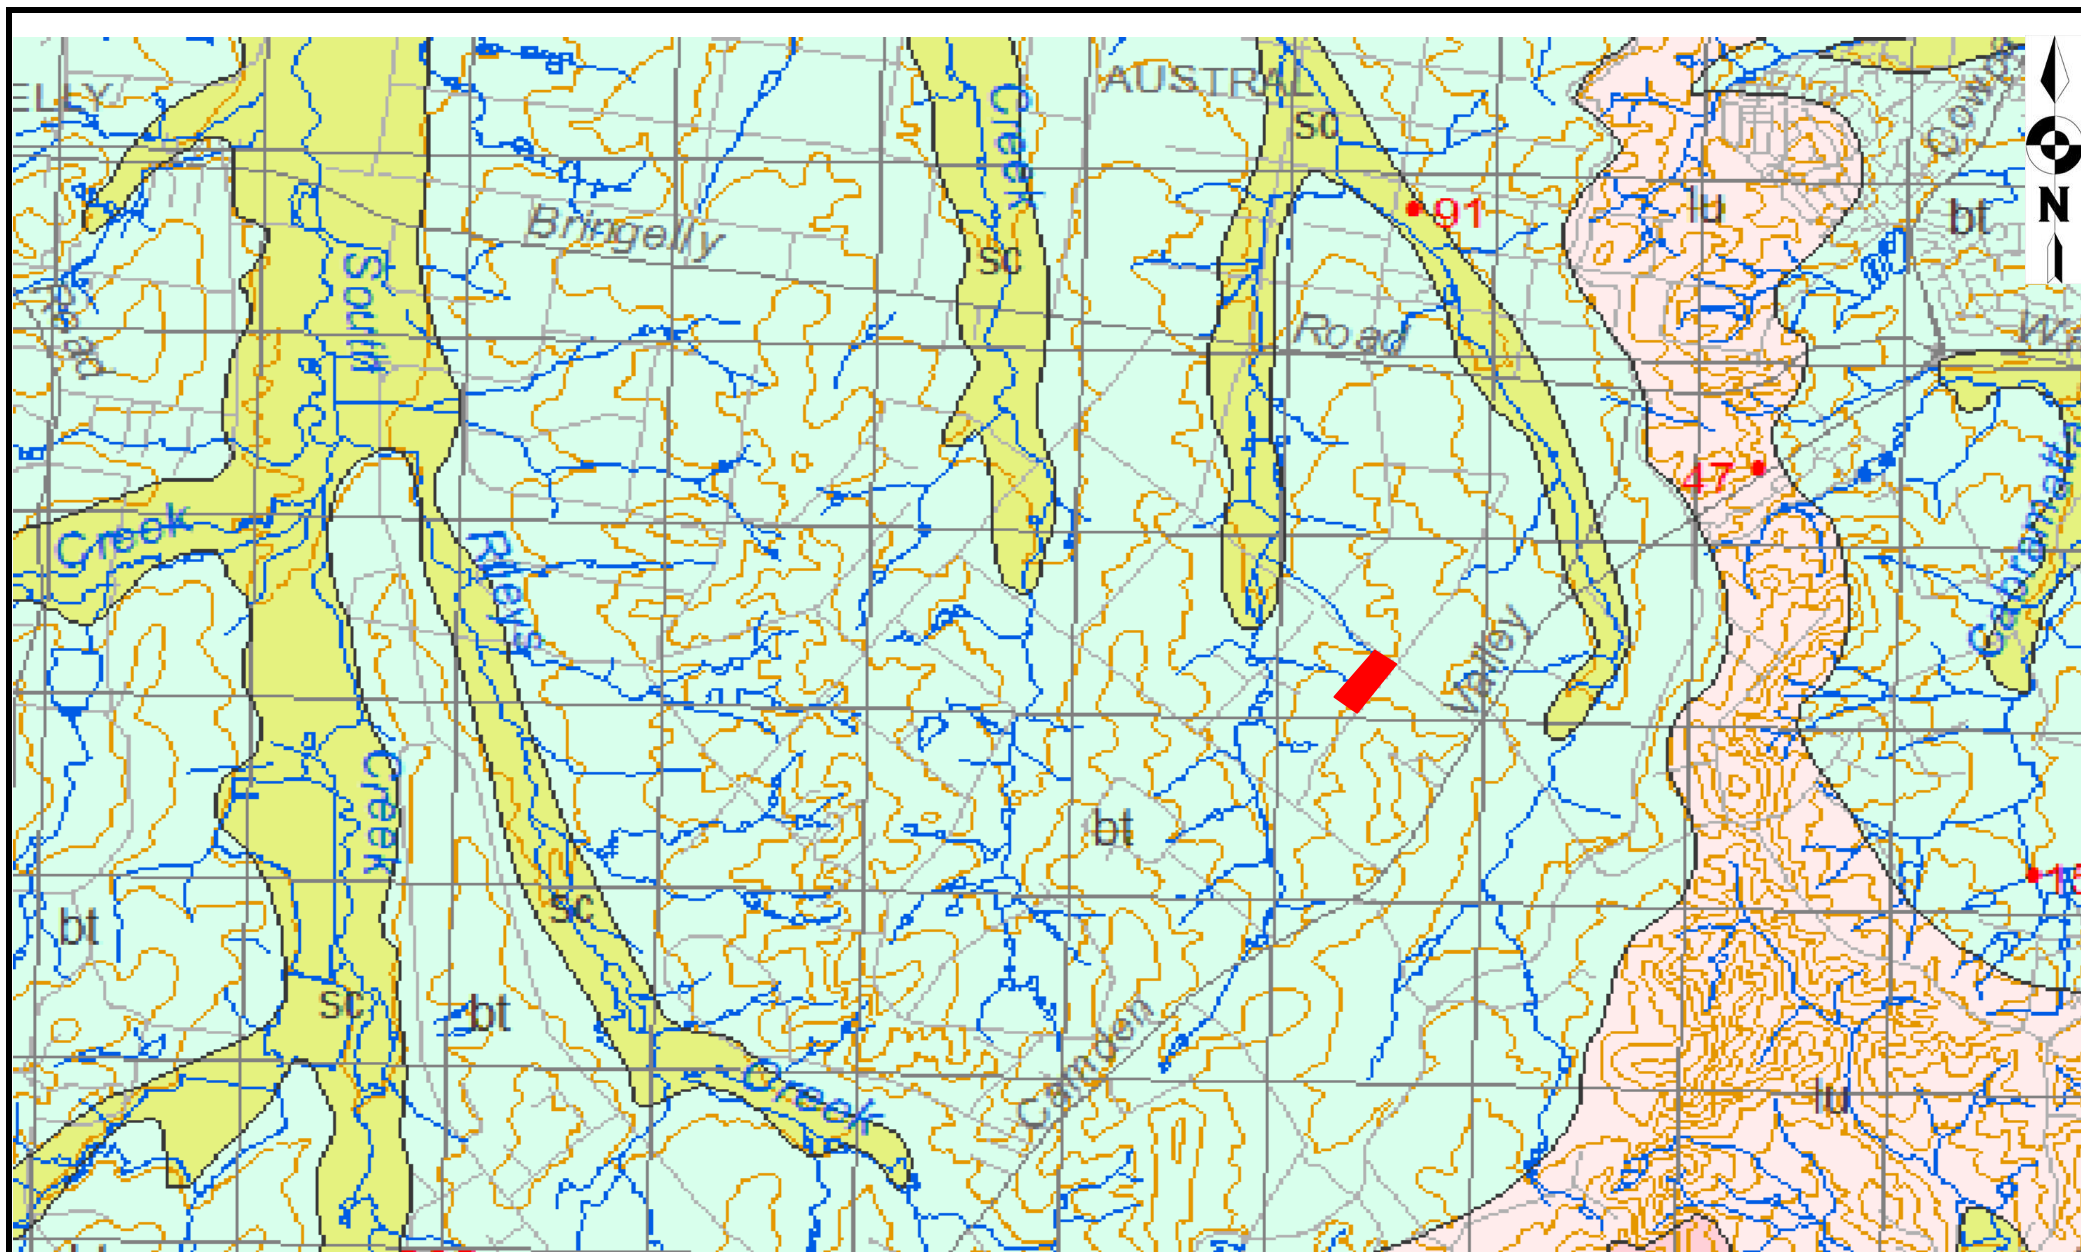
<b>Gran Associates Pty Ltd</b> <b>85 Byron Road and 63 Ingleburn Road Leppington</b> <b>Soil Landscape Group Map</b>	
Project No: JC18322A	Drawing No: 4

- Subject Site
- bt Blacktown Landscape Group
- sc South Creek Landscape Group
- lu Luddenham Landscape Group

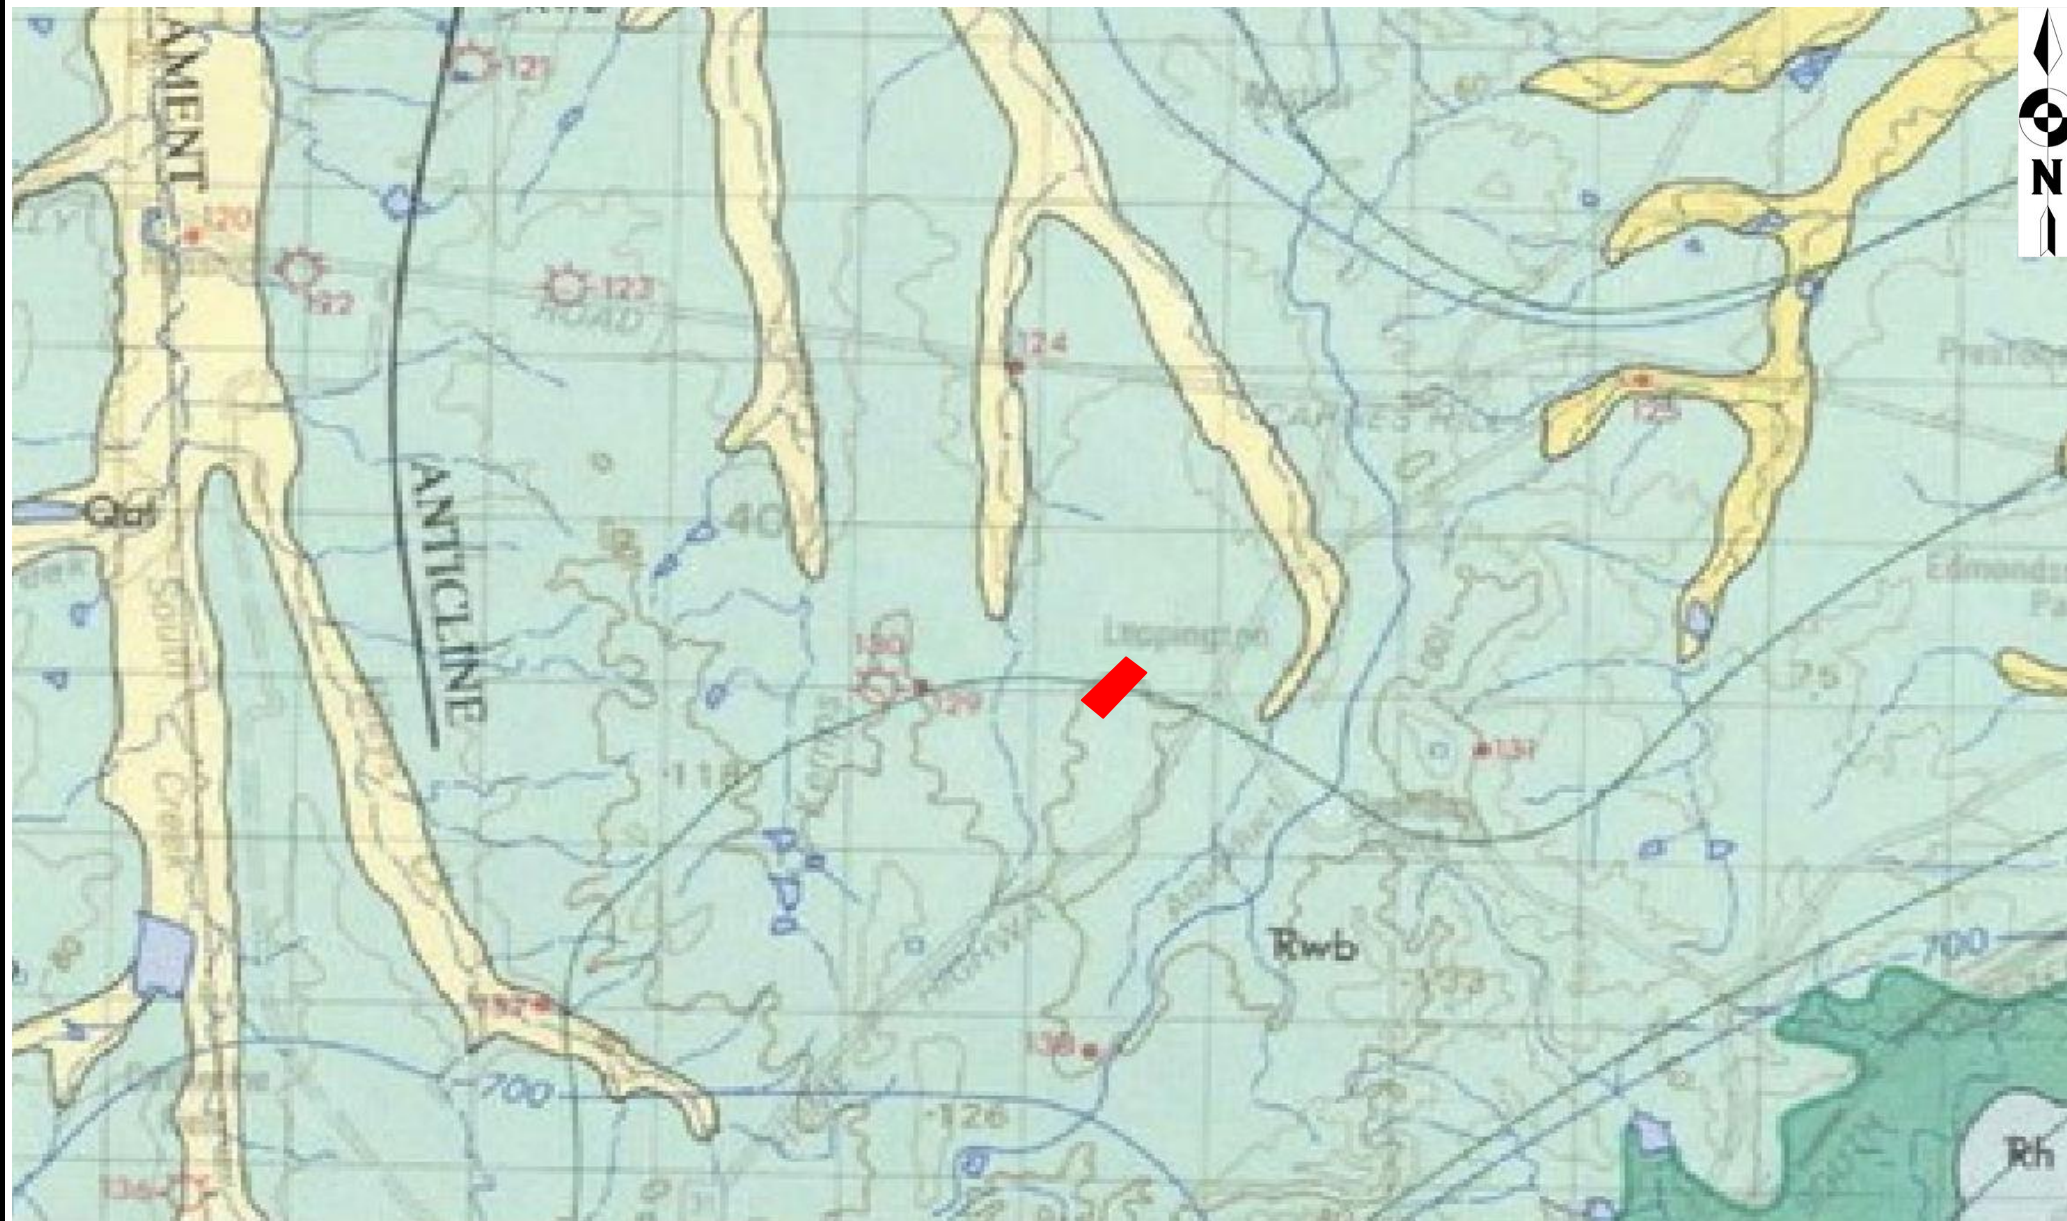
**Drawing No: 5**

- Subject Site
- Bringelly Shale (Rwb)
- Fluvial Deposit (Qal)
