**Salinity Management Plan
Proposed New Amity College Campus
Lot 1 DP 525996 No 85 Byron Road and
Lot 2 DP 525996 No 63 Ingleburn Road
Leppington, NSW**

Ref: JC18322C-r1(rev)

May 2019

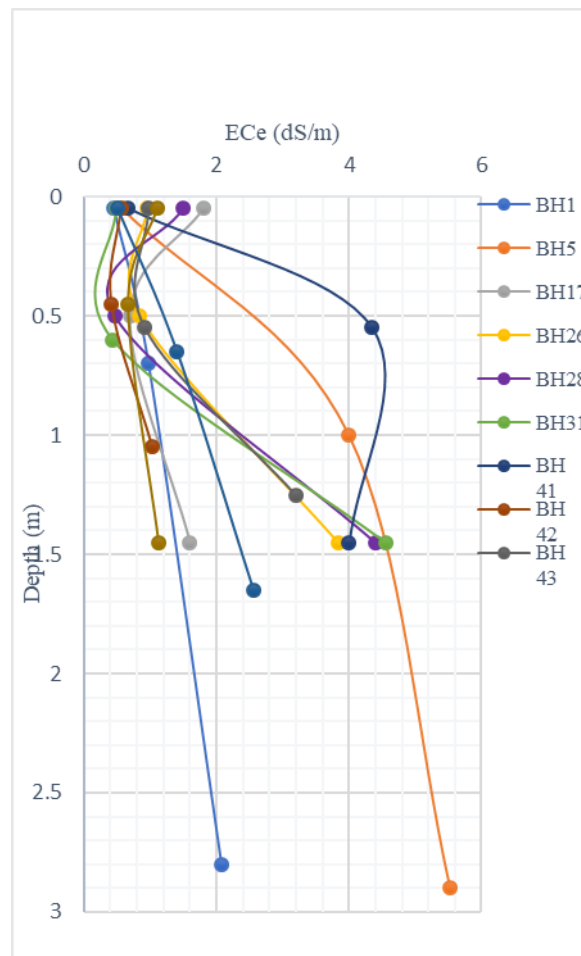
Figure 1: Salt Profile Shapes from Boreholes

- ‘Normal’ Salt Profiles – The salinity levels in this profile increase with depth and there is no rising groundwater effect to bring the salts to the surface. This profile is common over the entire site.
- ‘Recharge’ Salt Profiles – The salinity levels in this profile are low and fairly constant with depth. This salt profile does not appear to have occurred on any part of the site.
- Discharge’ Salt Profiles – The salinity levels in this profile reduce with depth and generally occurs when subsurface flows rises up due to the topography and vegetation uptake and salt is being brought up to the surface. This salt profile does not appear to have occurred on any part of the site with the exception of BH 41.

The following Figure 1 shows typical salt profile shapes with depths for the site;

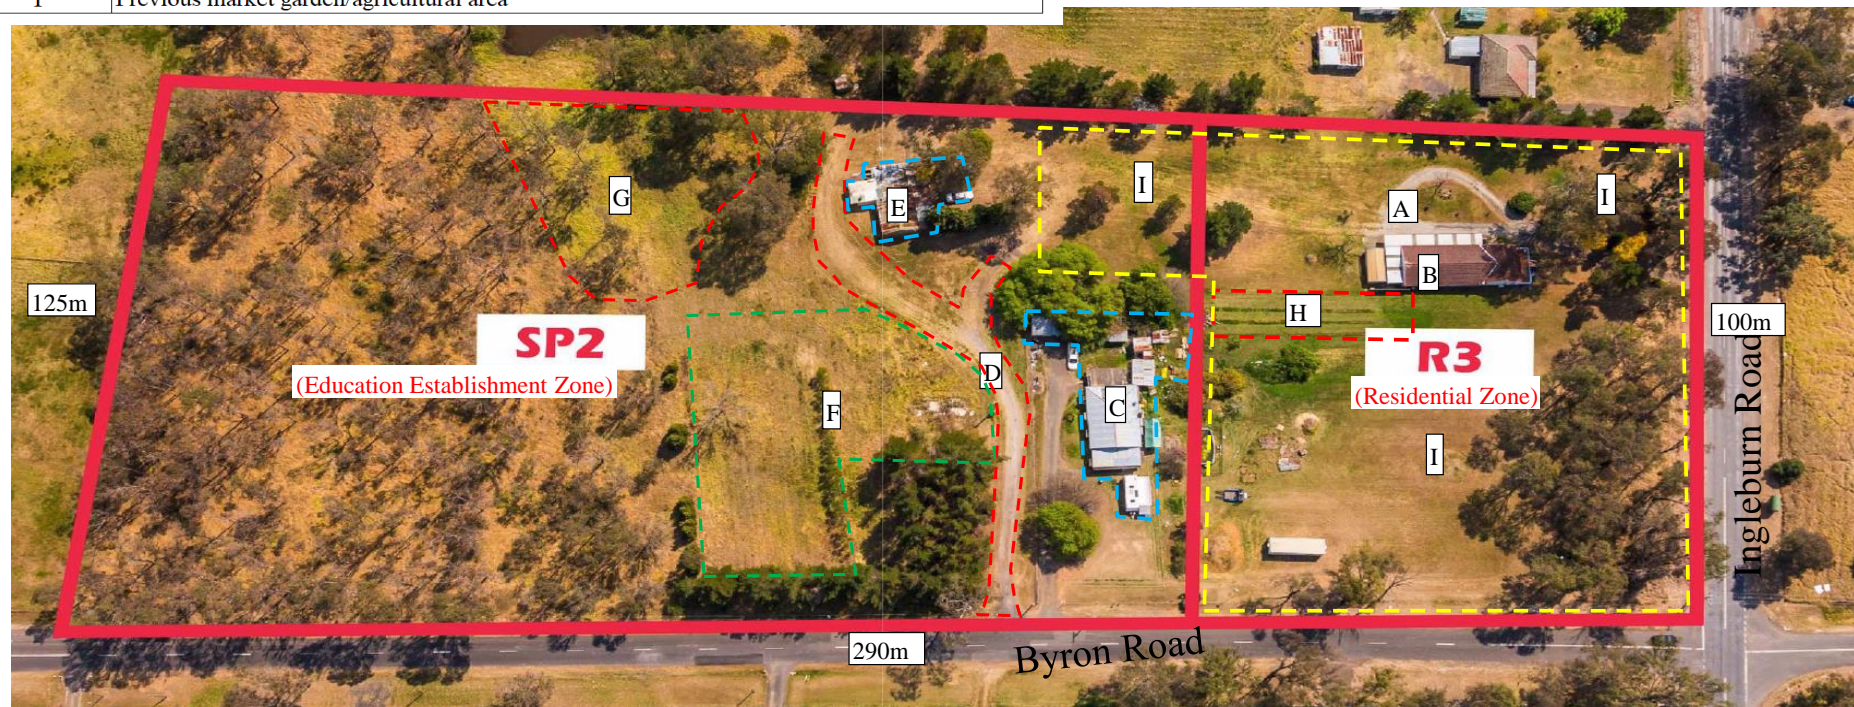
Drawn By: AT	Date: 6/6/18	Gran Associates Pty Ltd 85 Byron Road and 63 Ingleburn Road Leppington Site Zoning and Features Plan	
Checked By: SL	Date: 6/6/18		
Revision By:	Date:		
Scale: Not to Scale		A3	Project No: JC18322A Drawing No: 2

Site Feature	Description
A	Driveway constructed of crushed rock.
B	Single-storey brick, weatherboard and tile dwelling with a metal garage to the rear.
C	Single-storey fibro/metal dwelling with a number of small metal, timber and fibro sheds to the west. Sheds used for storage of miscellaneous items. Some minor hydrocarbon staining visible on surface
D	Driveway constructed of crushed rock, sandstone and traces of building debris (eg bricks and asphalt lumps)
E	Metal, timber and fibro shed with building extensions.
F	Area of previous numerous small buildings and sheds. Previous market garden area (1950s)
G	Backfilled depression with rubbish fill consisting of concrete boulders, bricks, glass and asbestos fragments
H	Recent Market Garden beds
I	Previous market garden/agricultural area

Note: The extent site features are only indicative

At the time of the site investigation, the site was mainly used for residential with the southern rear portion of the site consisting of medium dense trees. Refer to attached Drawing No 2 for site features. The following is a summary of site features noted;

Site Feature	Description
A	Driveway constructed of crushed rock.
B	Single-storey brick, weatherboard and tile dwelling with a metal garage to the rear.
C	Single-storey fibro/metal dwelling with a number of small metal, timber and fibro sheds to the west. Sheds used for storage of miscellaneous items. Some minor hydrocarbon staining visible on surface
D	Driveway constructed of crushed rock, sandstone and traces of building debris (eg bricks and asphalt lumps)
E	Metal, timber and fibro shed with building extensions.
F	Area of previous numerous small buildings and sheds. Previous market garden area (1950s)
G	Backfilled depression with rubbish fill consisting of concrete boulders, bricks, glass and asbestos fragments
H	Recent Market Garden beds
I	Previous market garden/agricultural area

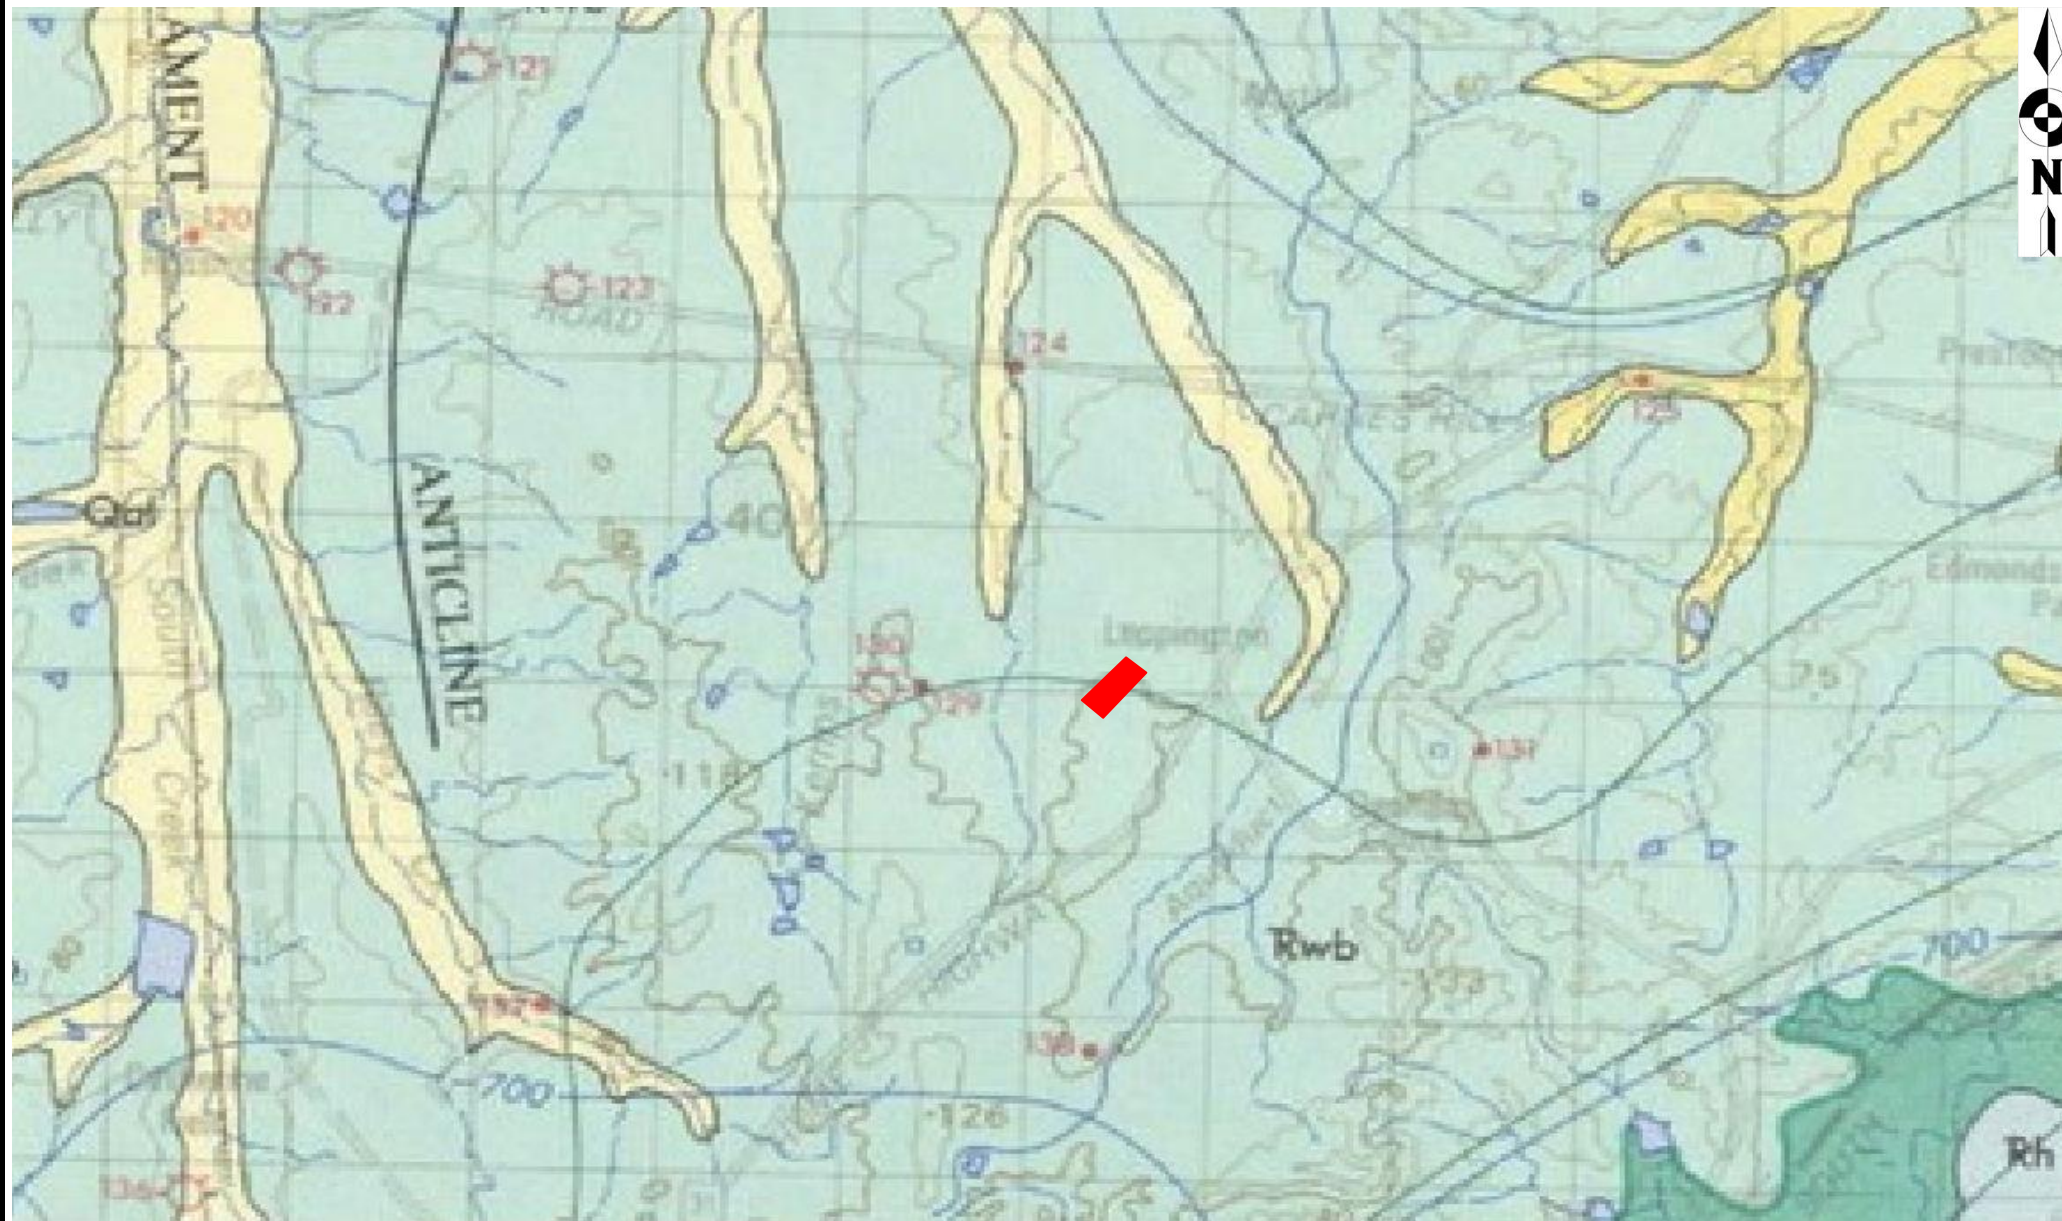
Drawing No: 4

- Subject Site
- Bringelly Shale (Rwb)
- Fluvial Deposit (Qal)
