Amity College - Proposed New Primary and Secondary School Campus 85 Byron Rd & 63 Ingleburn Rd, Leppington Structural Report

19-07 / 9 July 2019 / Revision A

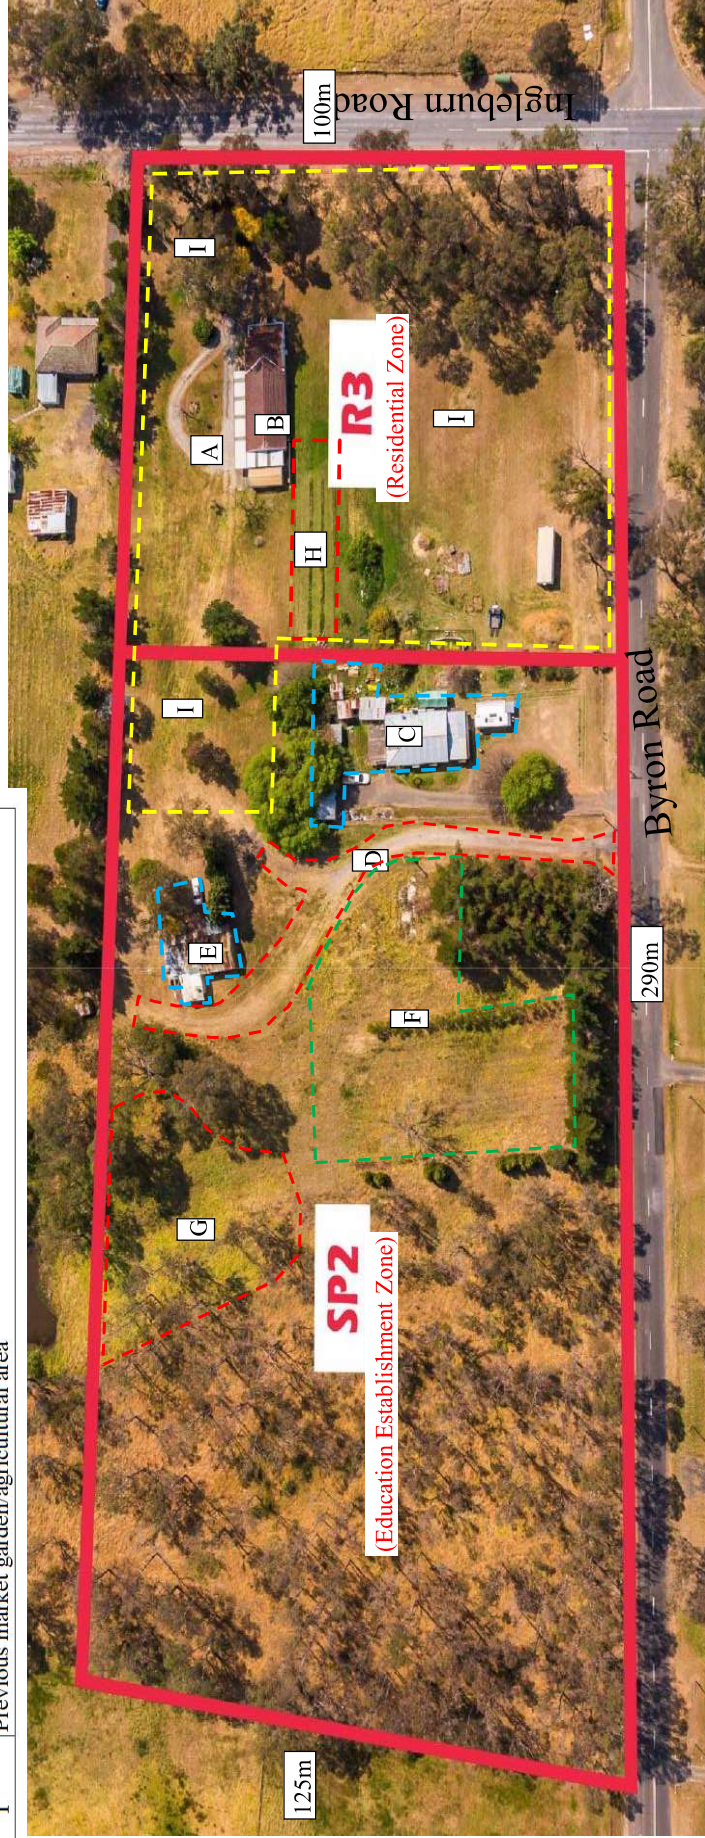
Legend A Site Feature			Gran Associates Pty Ltd	
	Unit 5, 39-41 Fourth Avenue, Blacktown NSW 2148, Australia		85 Byron Road and 63 Ingleburn Road Leppington	
	Tel: (02) 96798733 Fax: (02) 96798744		Site Zoning and Features Plan	
Scale: Not to Scale		A3	Project No: JC18322A	Drawing No: 2

Site Feature	Description
A	Driveway constructed of crushed rock.
B	Single-storey brick, weatherboard and tile dwelling with a metal garage to the rear.
C	Single-storey fibro/metal dwelling with a number of small metal, timber and fibro sheds to the west. Sheds used for storage of miscellaneous items. Some minor hydrocarbon staining visible on surface
D	Driveway constructed of crushed rock, sandstone and traces of building debris (eg bricks and asphalt lumps)
E	Metal, timber and fibro shed with building extensions.
F	Area of previous numerous small buildings and sheds. Previous market garden area (1950s)
G	Backfilled depression with rubbish fill consisting of concrete boulders, bricks, glass and asbestos fragments
H	Recent Market Garden beds
I	Previous market garden/agricultural area

Note: The extent site features are only indicative

At the time of the site investigation, the site was mainly used for residential with the southern rear portion of the site consisting of medium dense trees. Refer to attached Drawing No 2 for site features. The following is a summary of site features noted;

Site Feature	Description
A	Driveway constructed of crushed rock.
B	Single-storey brick, weatherboard and tile dwelling with a metal garage to the rear.
C	Single-storey fibro/metal dwelling with a number of small metal, timber and fibro sheds to the west. Sheds used for storage of miscellaneous items. Some minor hydrocarbon staining visible on surface
D	Driveway constructed of crushed rock, sandstone and traces of building debris (eg bricks and asphalt lumps)
E	Metal, timber and fibro shed with building extensions.
F	Area of previous numerous small buildings and sheds. Previous market garden area (1950s)
G	Backfilled depression with rubbish fill consisting of concrete boulders, bricks, glass and asbestos fragments
H	Recent Market Garden beds
I	Previous market garden/agricultural area

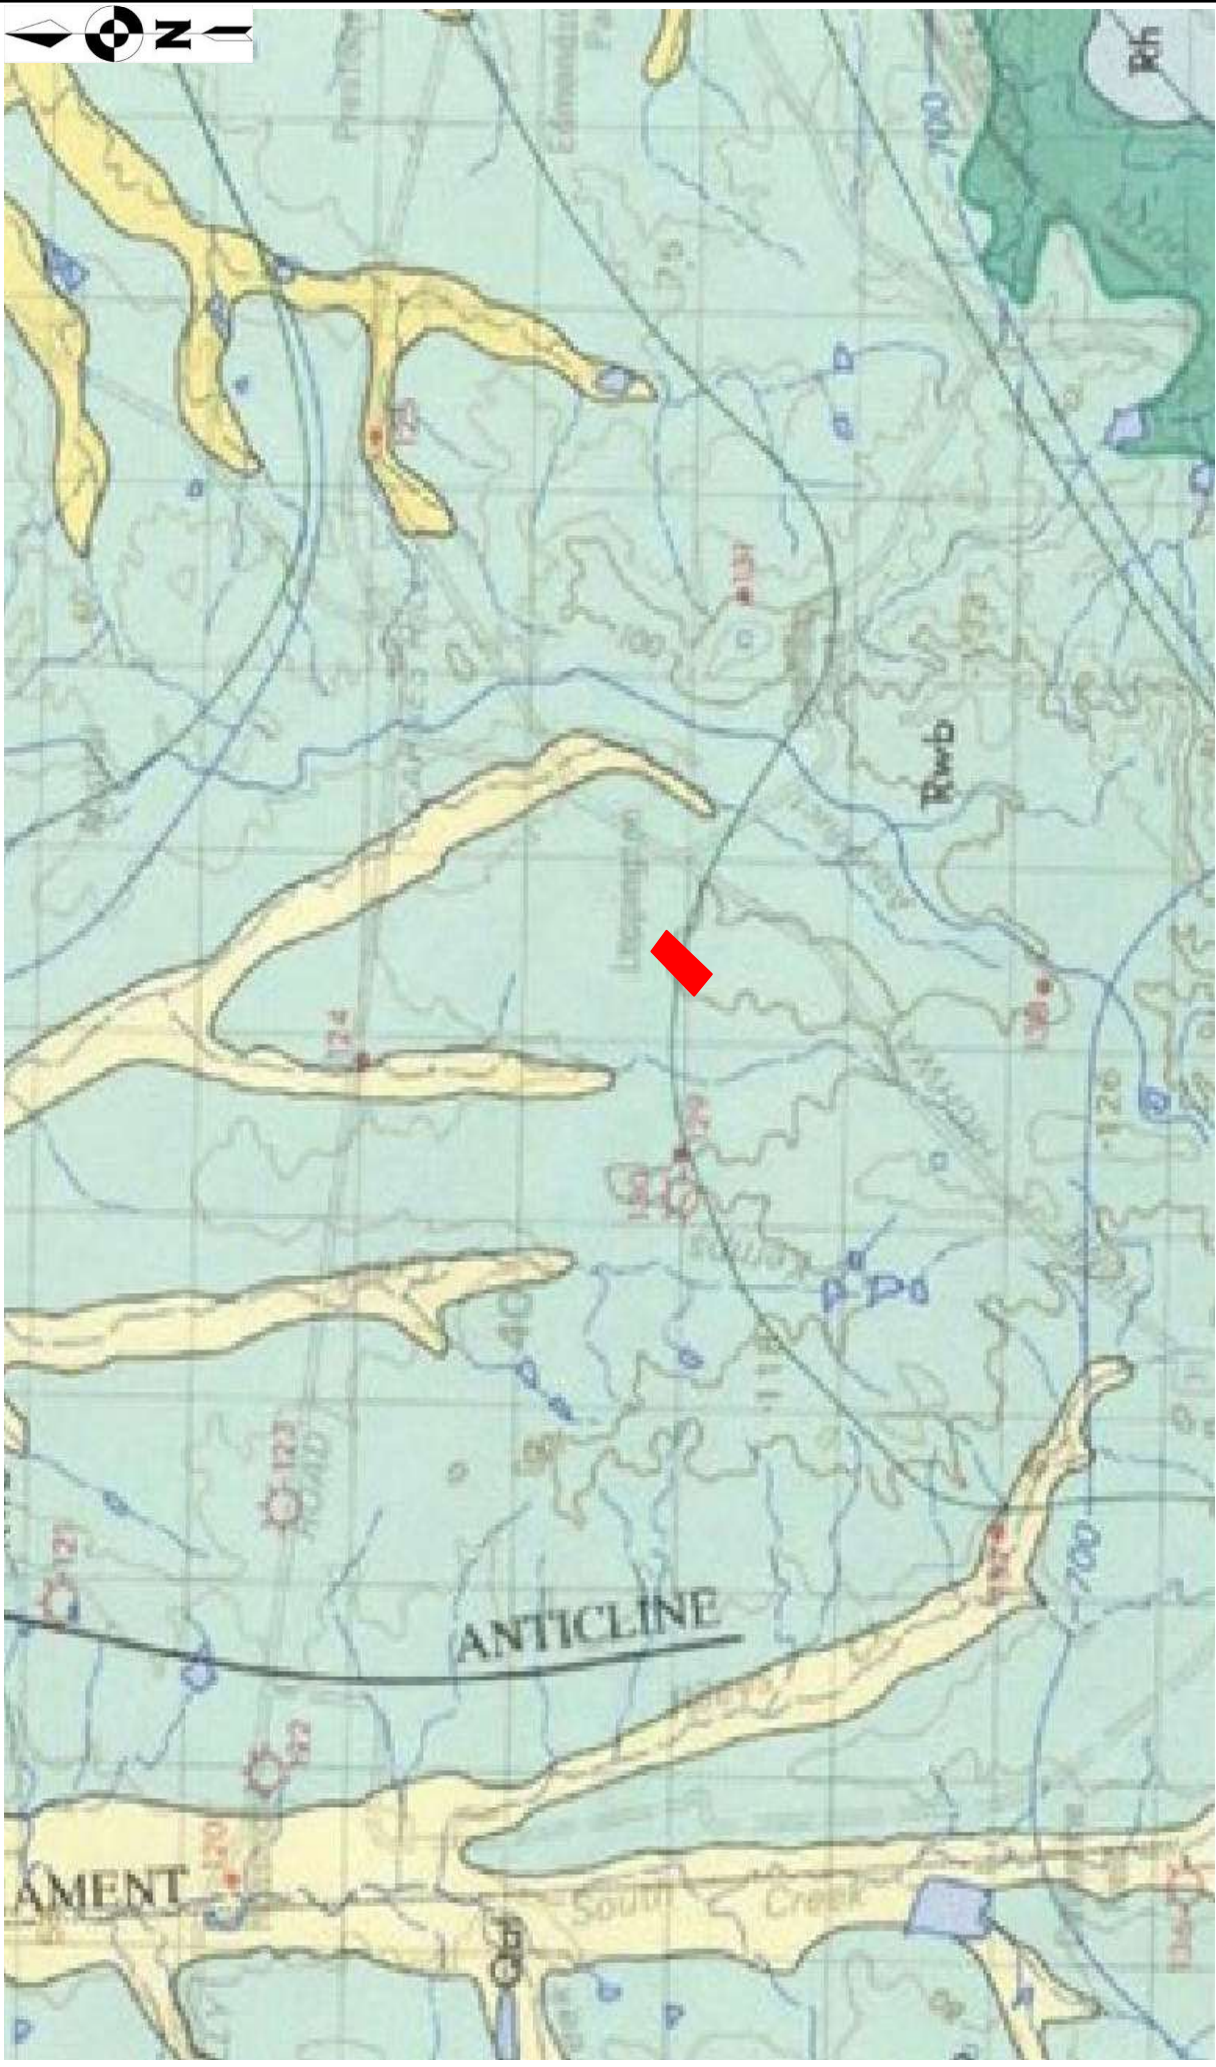
Gran Associates Pty Ltd	
85 Byron Road and 63 Ingleburn Road Leppington	
Geological Unit Map	
Project No: JC18322A	Drawing No: 5

Subject Site
Briggelly Shale (Rwb)
Fluvial Deposit (Qal)

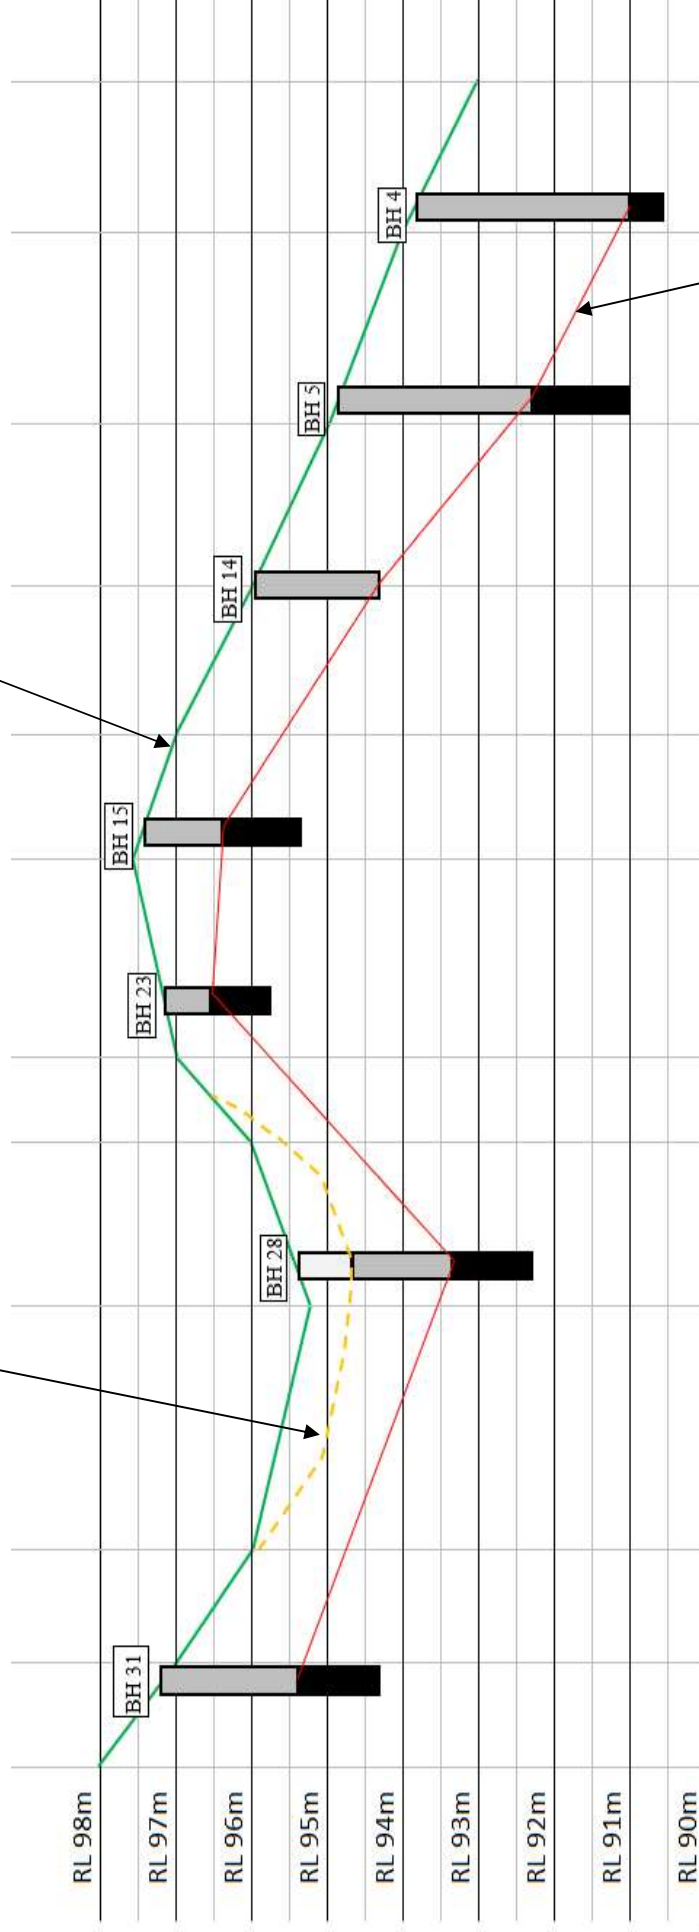
Gran Associates Pty Ltd	
85 Byron Road and 63 Ingleburn Road Leppington	
Soil/Rock Profile Transect - Section A-A	
Project No: JC18322A	Drawing No: 10

Ground Level

Bedrock Level
