Report on  
Preliminary Geotechnical Investigation

Campbelltown Hospital Stage 2 Redevelopment  
Therry Road, Campbelltown

Prepared for  
Health Infrastructure

Project 34275.08-2  
July 2018

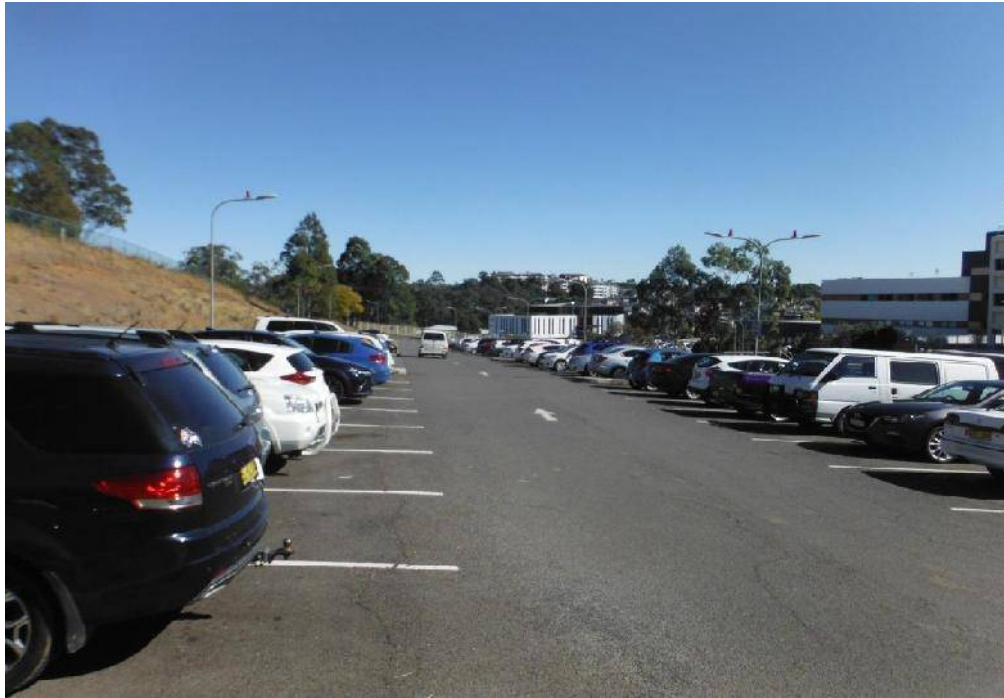
Photo 1 - Looking west across southern-most terrace of car park (southern edge of proposed CSB)

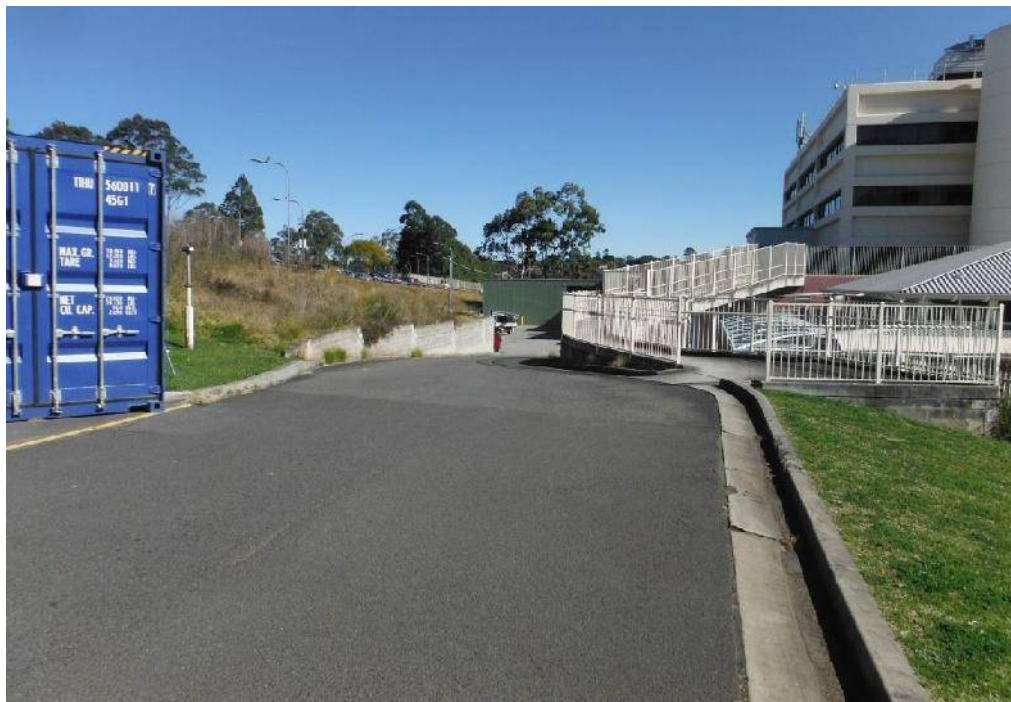
Photo 2 - Looking east across loading dock (northern edge of proposed CSB)

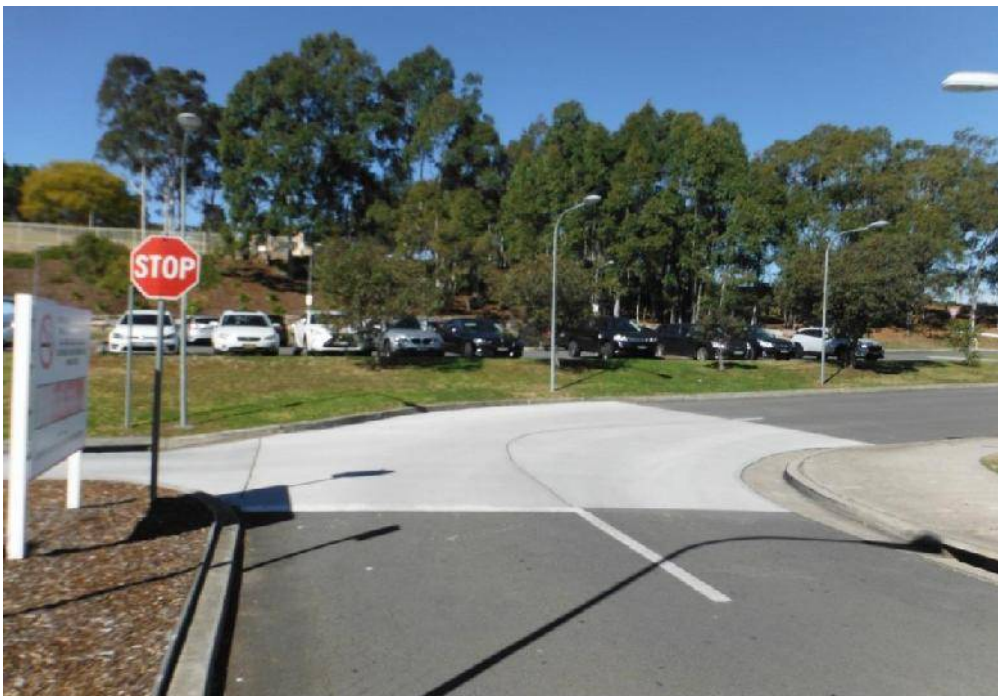
Photo 4 - Looking south across western edge of the proposed CSB site

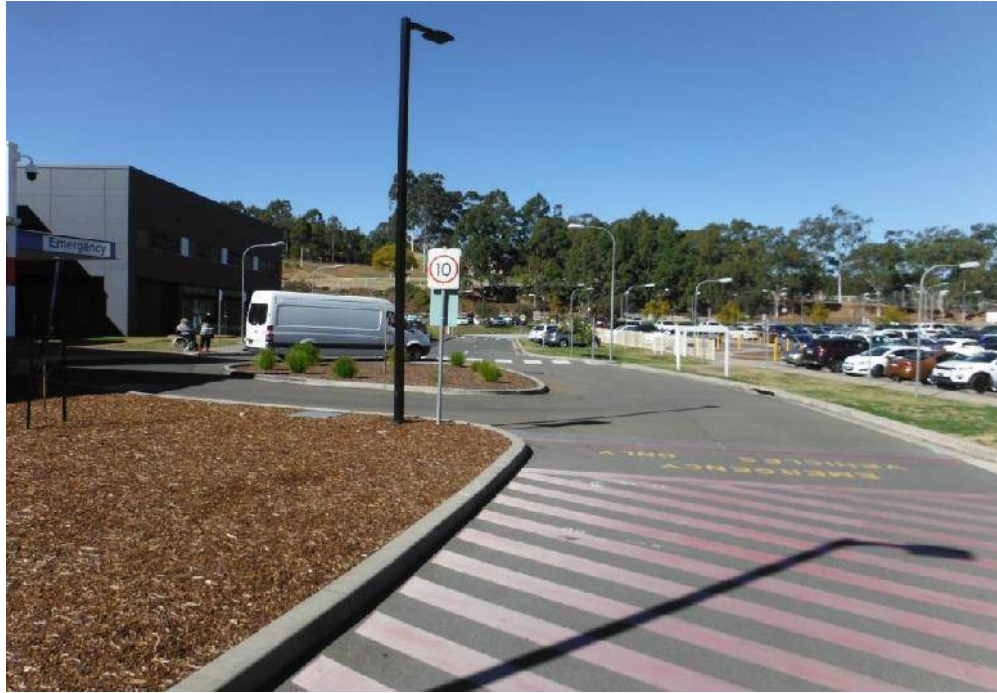
Photo 5 - Looking south-east across proposed link structure site (northern end)

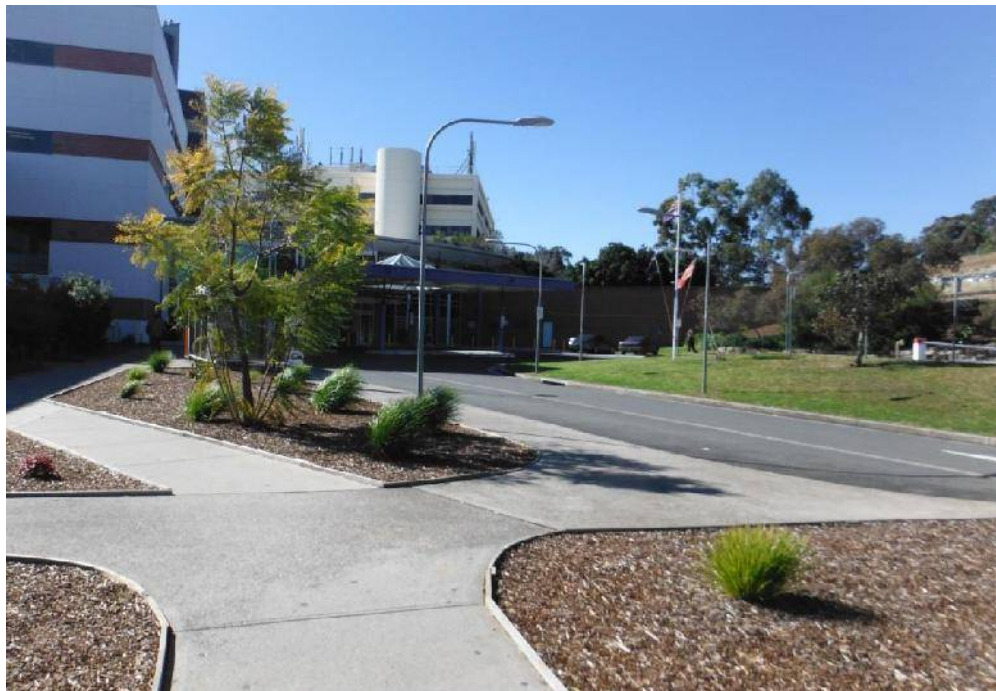
Photo 6 - Looking south-east across proposed link structure site (southern end)

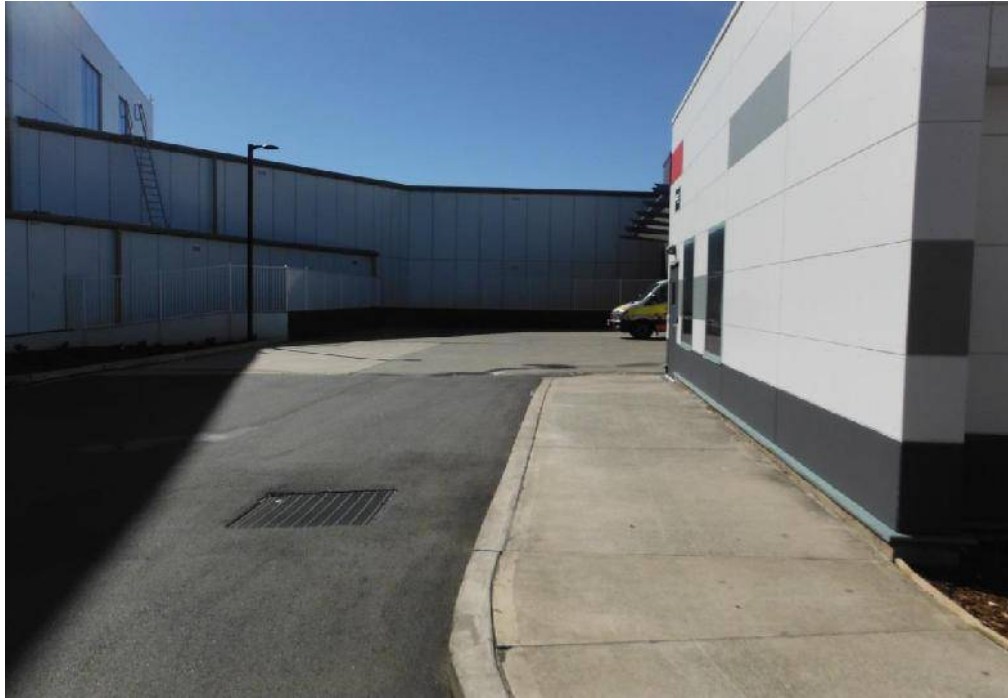
Photo 7 - Looking north-east across proposed link building site (between Buildings A and D)

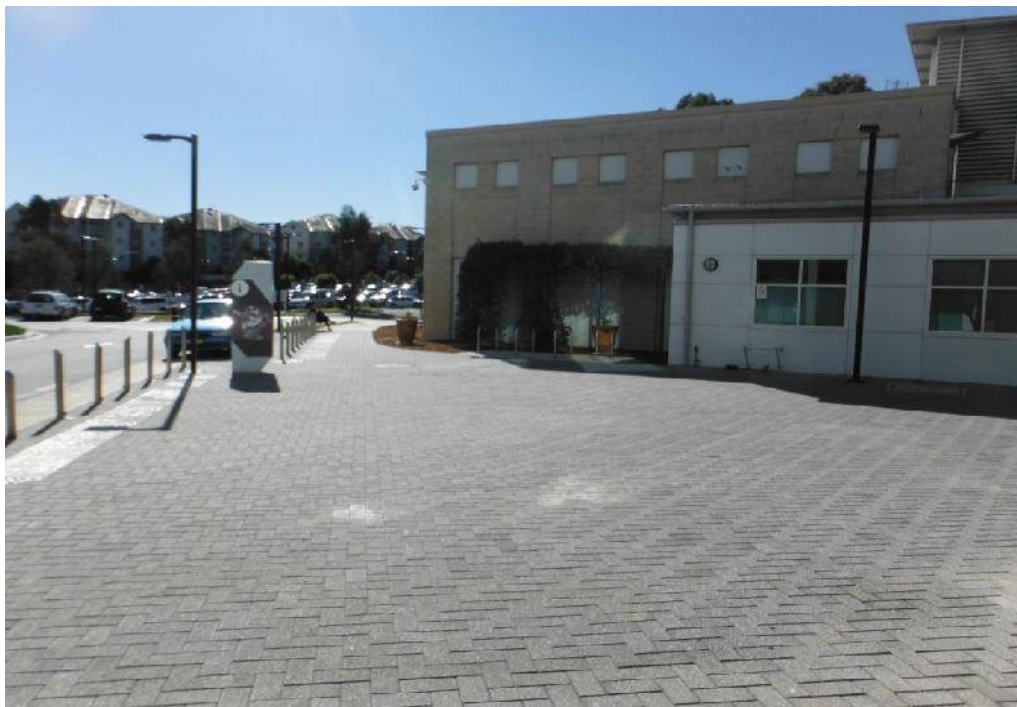
Photo 8 - Looking east at existing CTC (western side)
