Report on
Detailed Site Investigation

Stage 2 Proposed Redevelopment
Campbelltown Hospital, Campbelltown, NSW

Prepared for
Health Infrastructure NSW

Project 34275.09
August 2018

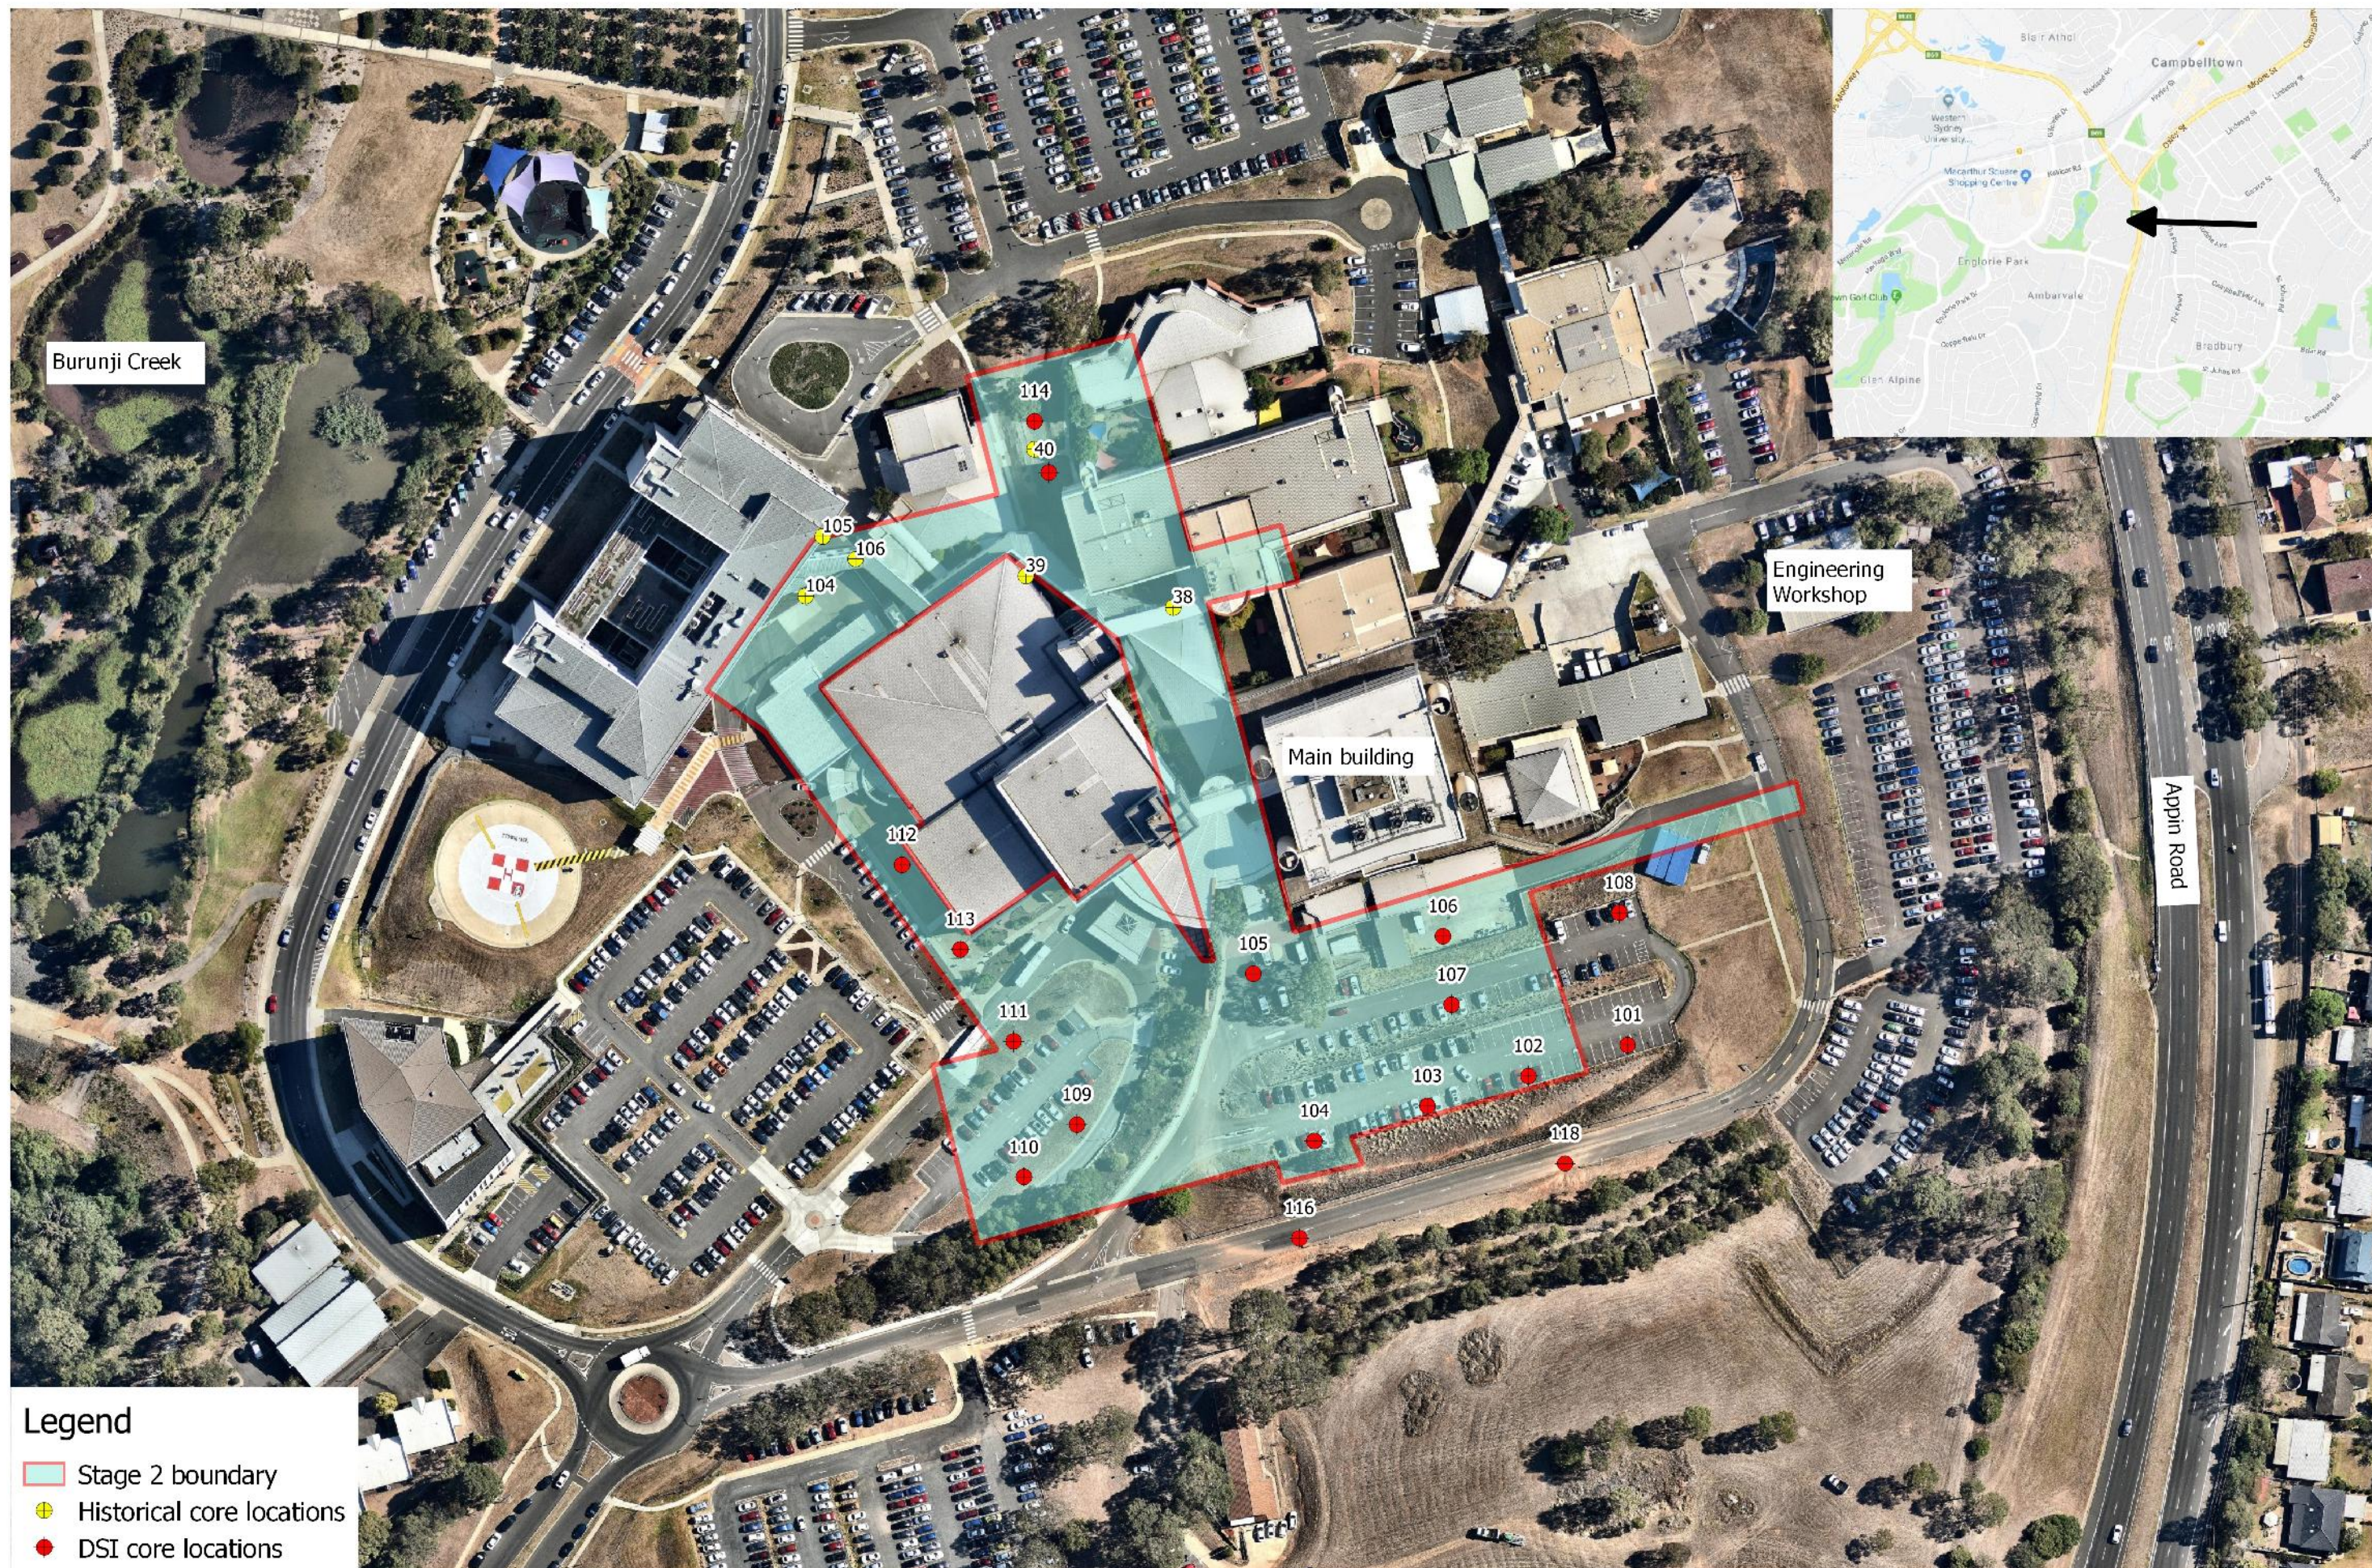
<p>Douglas Partners Geotechnics Environment Groundwater</p>	CLIENT: Health Infrastructure NSW		TITLE: Site Layout and Core Locations Stage 2 Proposed Redevelopment Campbelltown Hospital, Campbelltown, NSW	 	PROJECT No: 34275.09
	OFFICE: Macarthur	DRAWN BY: EMG			DRAWING No: 1
	SCALE: 1:24,936	DATE: 9 Apr 2018			REVISION: A

The log sheets are included in Appendix C and should be read in conjunction with the accompanying standard notes defining classification methods and descriptive terms. The strata observed at the site is broadly summarised as follows:
