4.0 Aboriginal Archaeology

6.0 Potential Historical Archaeological Resources

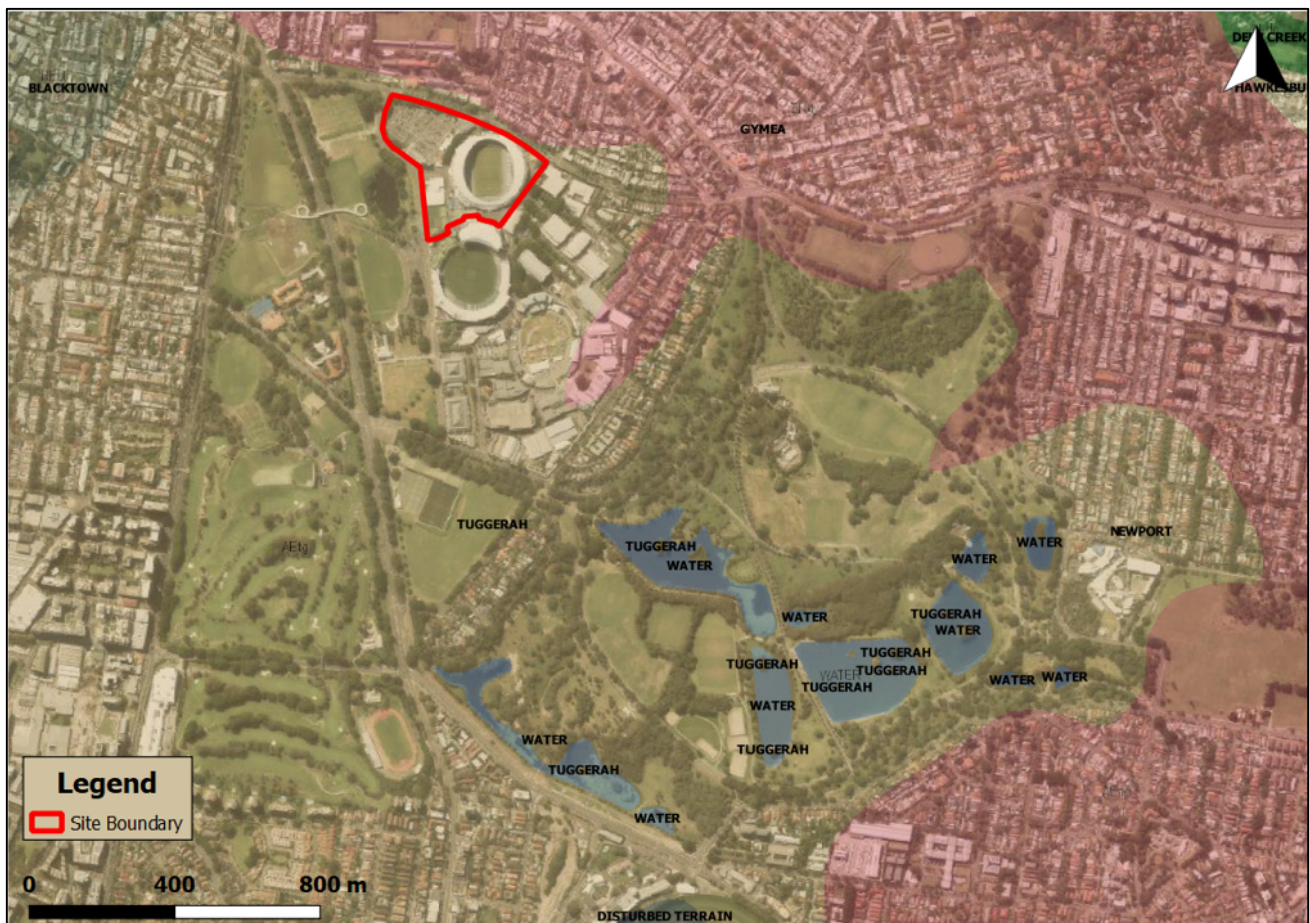
FIGURE 36: SOIL LANDSCAPES ACROSS SUBJECT SITE AND SURROUNDS. (SOURCE: GOOGLE EARTH PRO WITH CURIO ADDITIONS 2018)

The subject site is located on the Tuggerah Soil Landscape (Figure 37), underlain by Quaternary marine sands, deposited by marine and Aeolian actions during the Holocene. The landscape of Tuggerah soils is characterized by gently undulating to rolling coastal dunefields, and extends from the northern edge of Moore Park, east to the coast, west to Surry Hills, and south to Botany Bay. Tuggerah soils are a major ecological unit of Sydney, forming what is often referred to as the Botany Sands or Botany Lowlands, located across the Botany Aquifer. Tuggerah soils tend to be relatively deep (>200cm) and generally consist of fine to medium grained quartz sand.³⁴ The northeast corner of Moore Park originally contained exposed Hawkesbury Sandstone formations, however these have since been removed by modern development and landscaping.

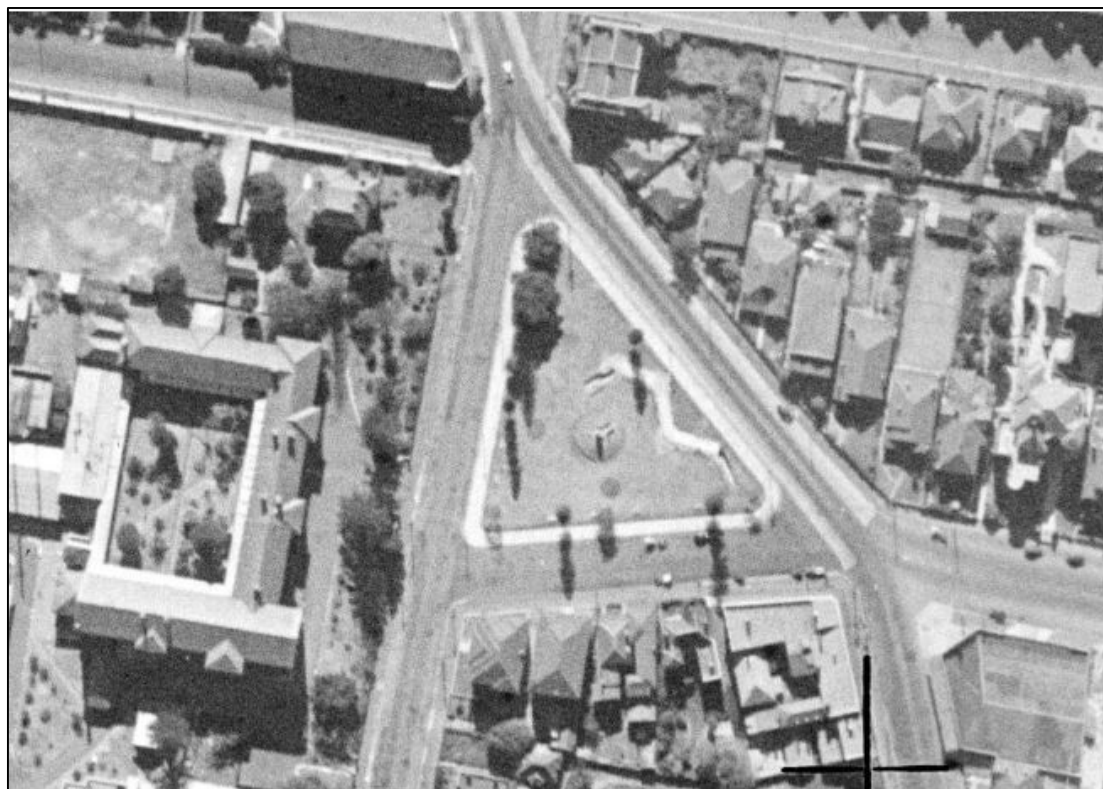
FIGURE 41: A ZIG-ZAG ANTI-AIRCRAFT TRENCH IN HIGH CROSS PARK, RANDWICK. 1943 (SOURCE:ABC NEWS, 12.10.2017).

During the construction works for the CBD and South East Light Rail at High Cross Park in Randwick, evidence of the zig-zag anti-aircraft trenches were exposed and archaeologically recorded during the excavation program⁵⁹, as shown in Figures 42 and Figures 43 below.

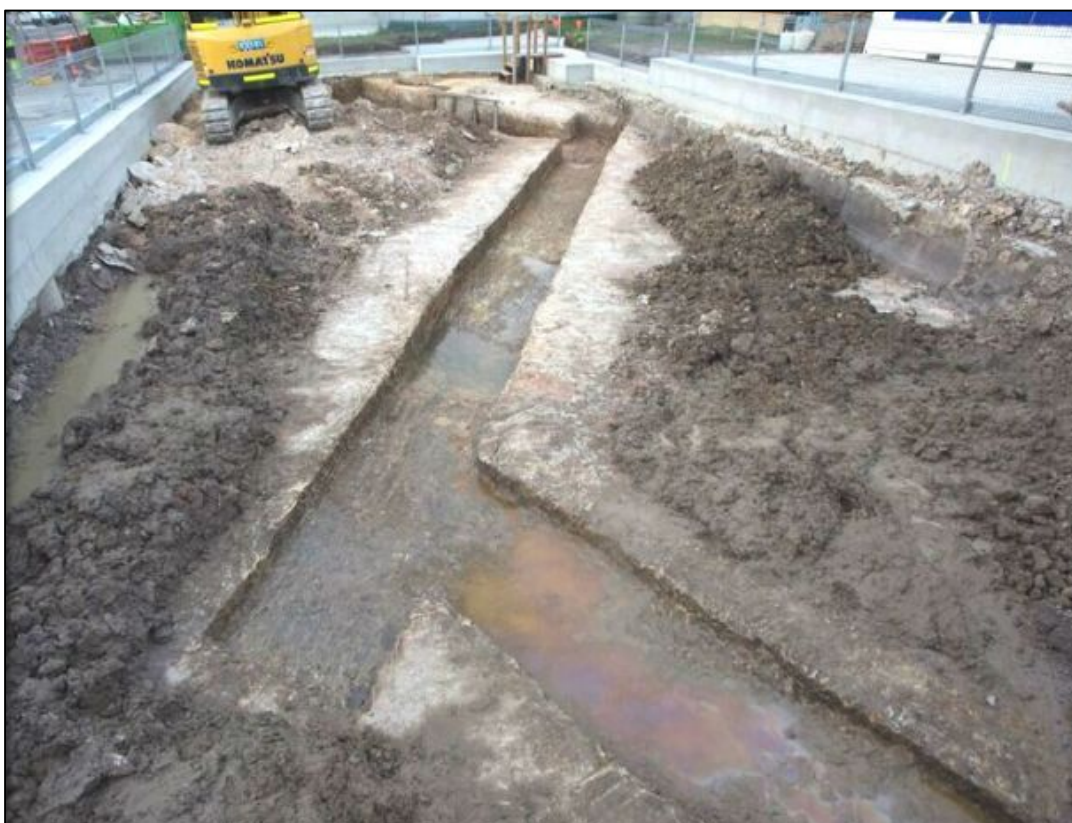
FIGURE 42: ARCHAEOLOGICAL EVIDENCE OF THE ZIG-ZAG ANTI-AIRCRAFT TRENCH UNCOVERED DURING LIGHT RAIL WORKS IN RANDWICK
(SOURCE: ABC NEWS. 12.10.2017)

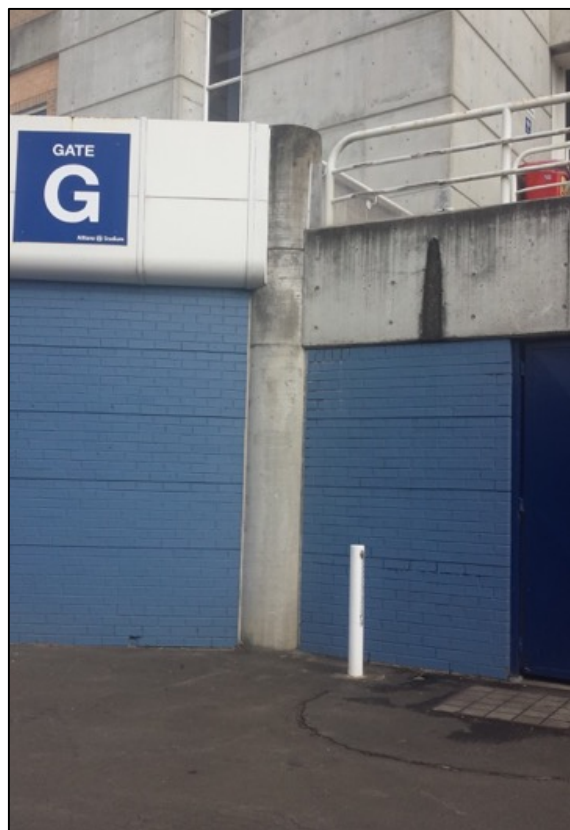
FIGURE 46: LOCATION OF SHAFT 9, ALONG EASTERN SIDE OF STADIUM BOUNDARY (SOURCE: CLIENT)

The GPR survey was undertaken roughly along the believed path of Busby's Bore within the study area, with no conclusive results. During the survey, Shafts 9 and 10 pit lids were opened, and the depth of each shaft measured. Shaft 9 measured 4.4m to bedrock, and 6.2m to the bottom of the shaft, while Shaft 10 was measured as 2.2m to bedrock, and c.3.5m to the bottom of the shaft. However, the report also noted that it was possible that an additional cover was located over the shaft, and therefore measured depths may not be representative of the true depth of Busby's Bore in this location.

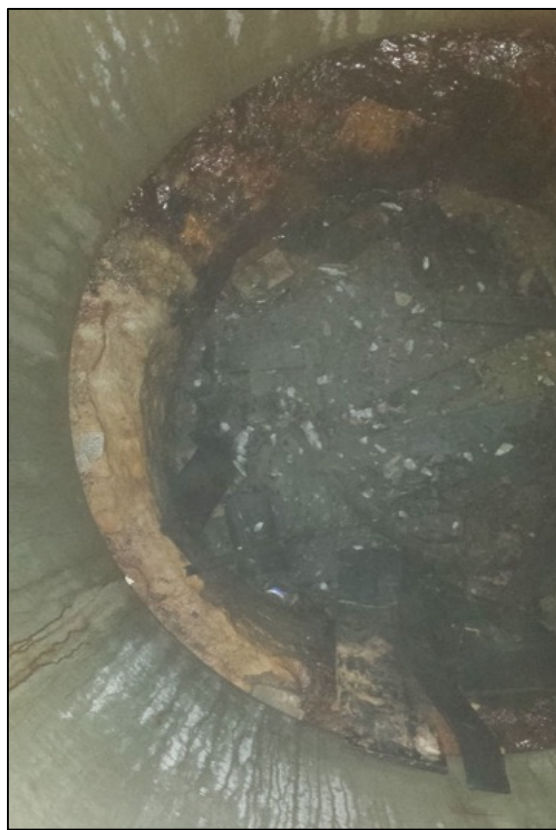
FIGURE 47: SHAFT 9 (SOURCE: CLIENT)

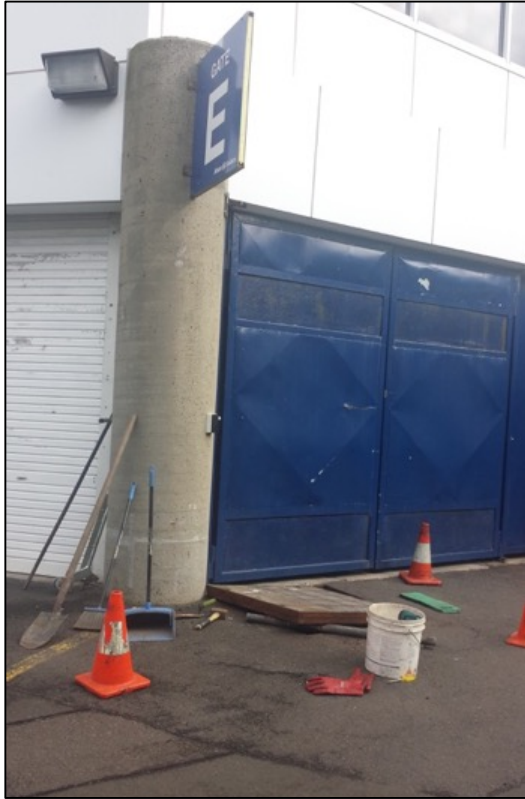
FIGURE 48: LOCATION OF SHAFT 10, ALONG NORTHEASTERN SIDE OF STADIUM (SOURCE: CLIENT)

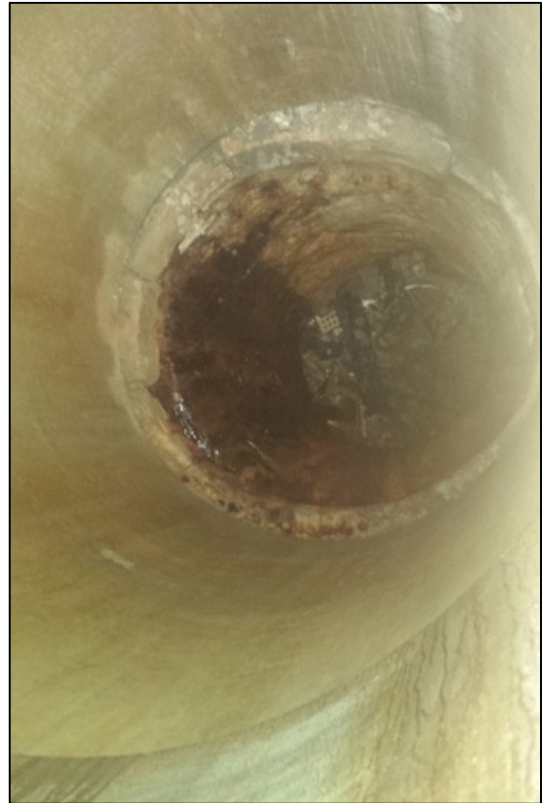
FIGURE 49: SHAFT 10 (SOURCE: CLIENT)

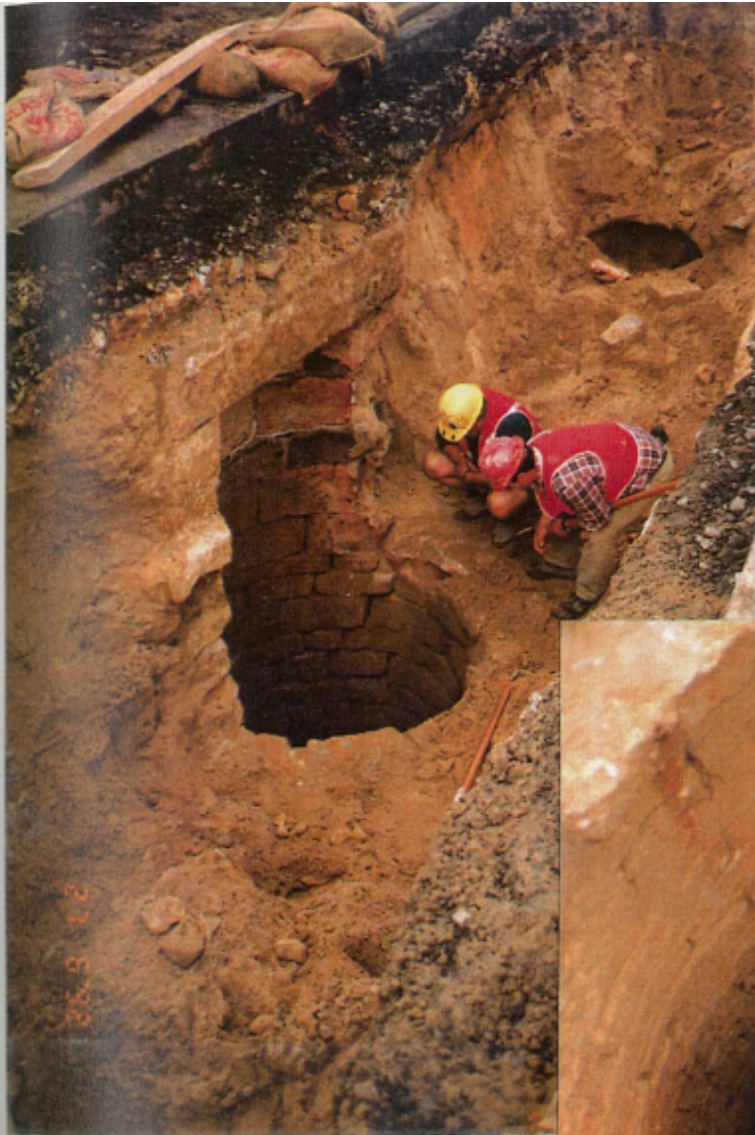
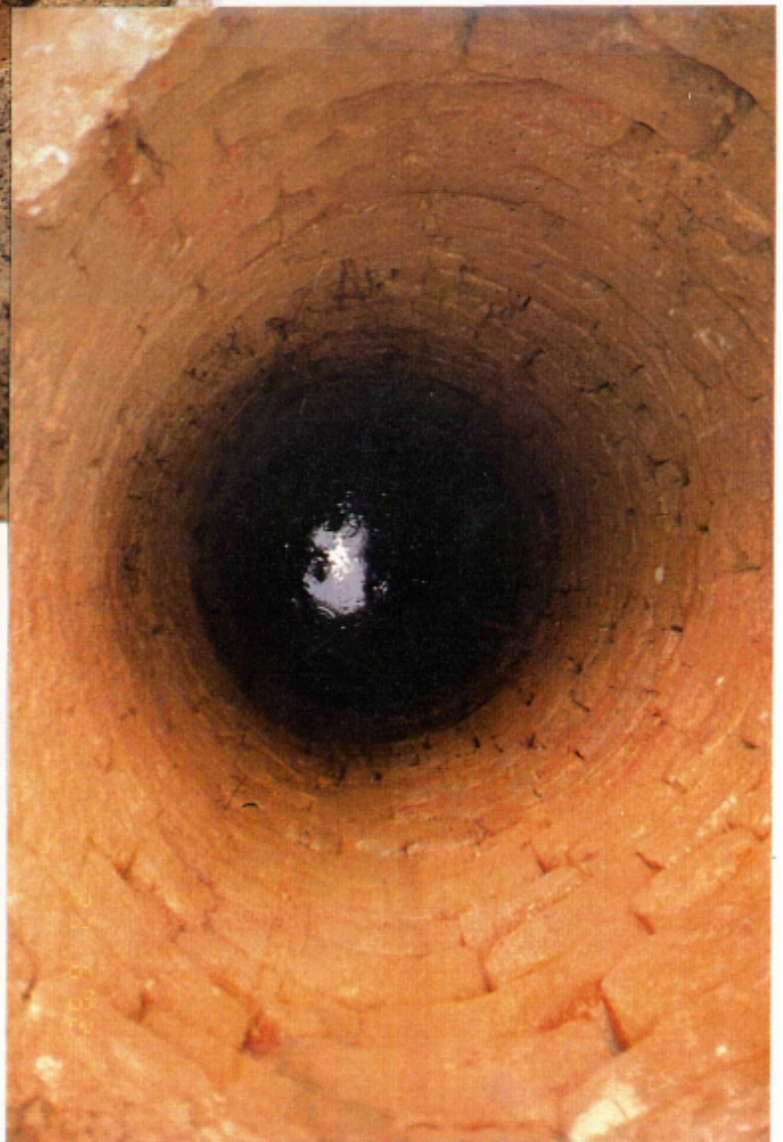
FIGURE 50: SHAFT 12, 1992 (SOURCE: PHOTO 5 AND 6, AWT 1993)

Photo 5: Shaft No.12,
Moore Park Rd.
June 1992.

Photo 6: Shaft No.12,
full-block
construction

An excavation permit (requiring archaeological monitoring) was issued in 1992 for the renewal of a rising main between Moore Park and Oatley Road, that was located in the vicinity of three Busby's Bore shafts.⁶⁵ These works located Shaft 12 (Figure 51) approximately 5m to the east of its presumed location (as per original Water Board records/survey plans), within the road easement of Moore Park Road. Shaft 12 appeared to be lined with sandstone blocks to its full depth of c.10.8m below the road surface. It was found that the original path of the rising main (1899) had been laid across the southern half of the shaft. While this work appeared to have been undertaken with care, it resulted in the removal of the two top courses of stone on the southern side of the shaft, as well as a channel cut in the lower three or four courses to allow laying of the rising main. Presentation of mortar in the top stone courses on the northern side of the shaft also suggested that the whole top of the shaft had been disturbed in 1899, but the stone from the northern side had been rebuilt with original materials. The

archaeological recommendation was made that the new 1992 replacement main could be laid over the top of the shaft again, as the 1899 work had already disturbed the whole top of the shaft. A 25mm steel plate was placed over the shaft below the new main.
