Tamworth Solar Farm

Response to Request for
Information 29/4/20

Prepared for: Tamworth Solar Farm Pty Ltd
May 2020

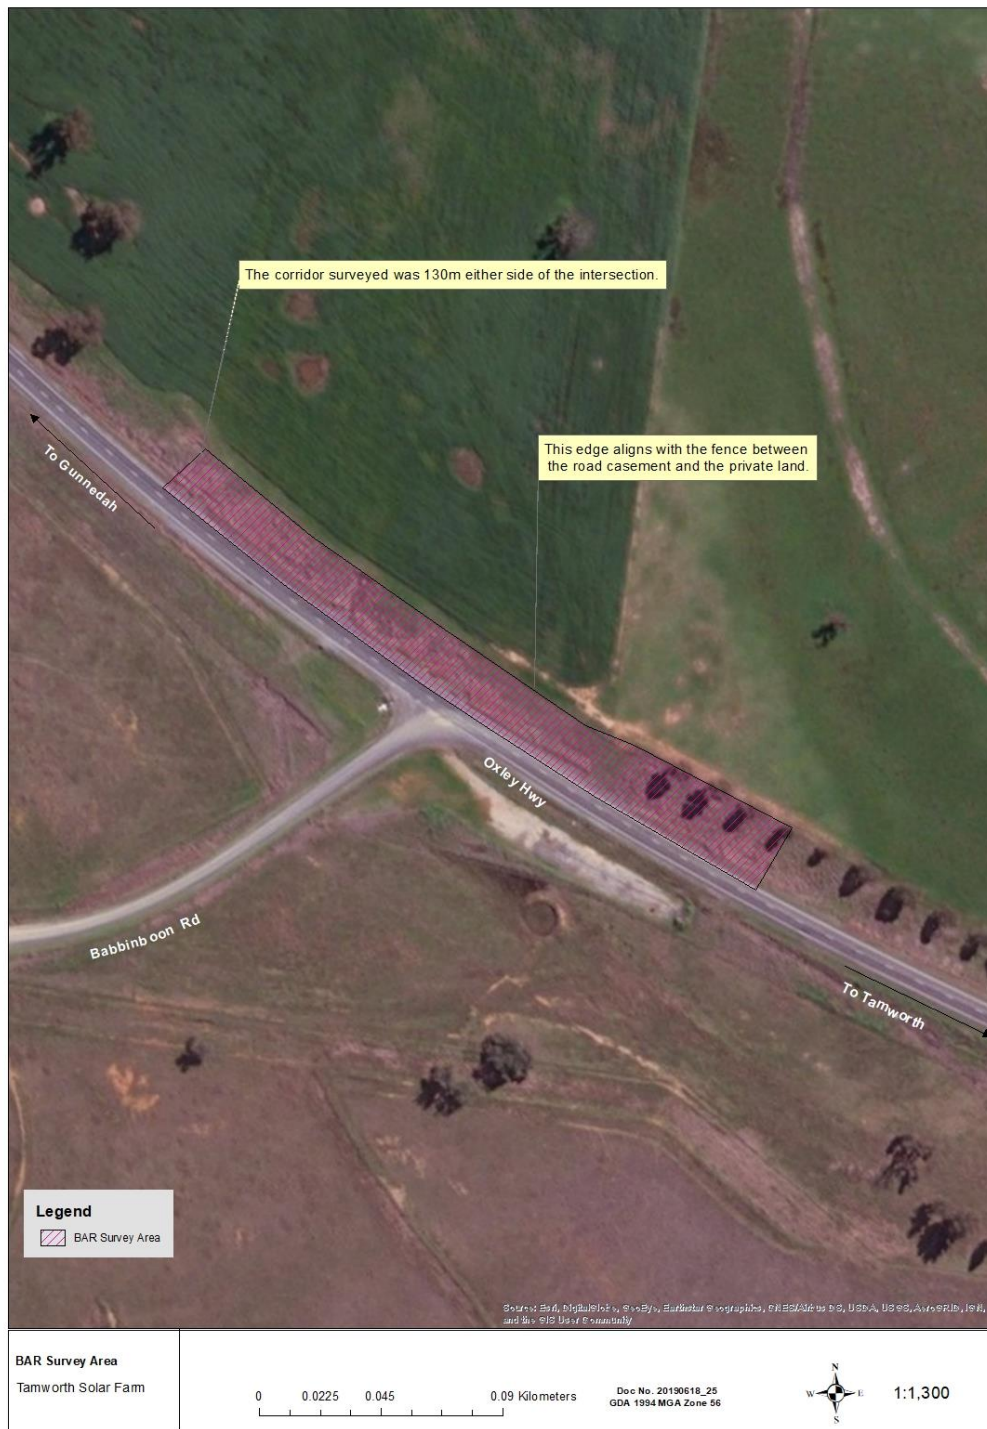
Figure 1. Survey area for the Basic Auxiliary Right treatment and adjacent bus stop.

The BAR and adjacent bus stop lay outside the area that was originally surveyed. Consequently, the area was surveyed for biodiversity and Aboriginal cultural heritage on the 18th May 2020. The results of these surveys are provided in Appendices D and E. The survey area is shown in Figure 1. In relation to biodiversity, no threatened flora or fauna species were detected and ecological values for the site were considered to be low. The area was dominated by exotic species.

With respect to Aboriginal cultural heritage, one Aboriginal site was identified (consisting of 3 artefacts). This was an extension of Open Camp Site 7 which was recorded in the Aboriginal cultural heritage assessment: Tamworth Solar Farm 2019 (AREA 2019). This site can be managed with actions provided in Section 9 of the Aboriginal cultural heritage assessment: Tamworth Solar Farm 2019 (AREA 2019).

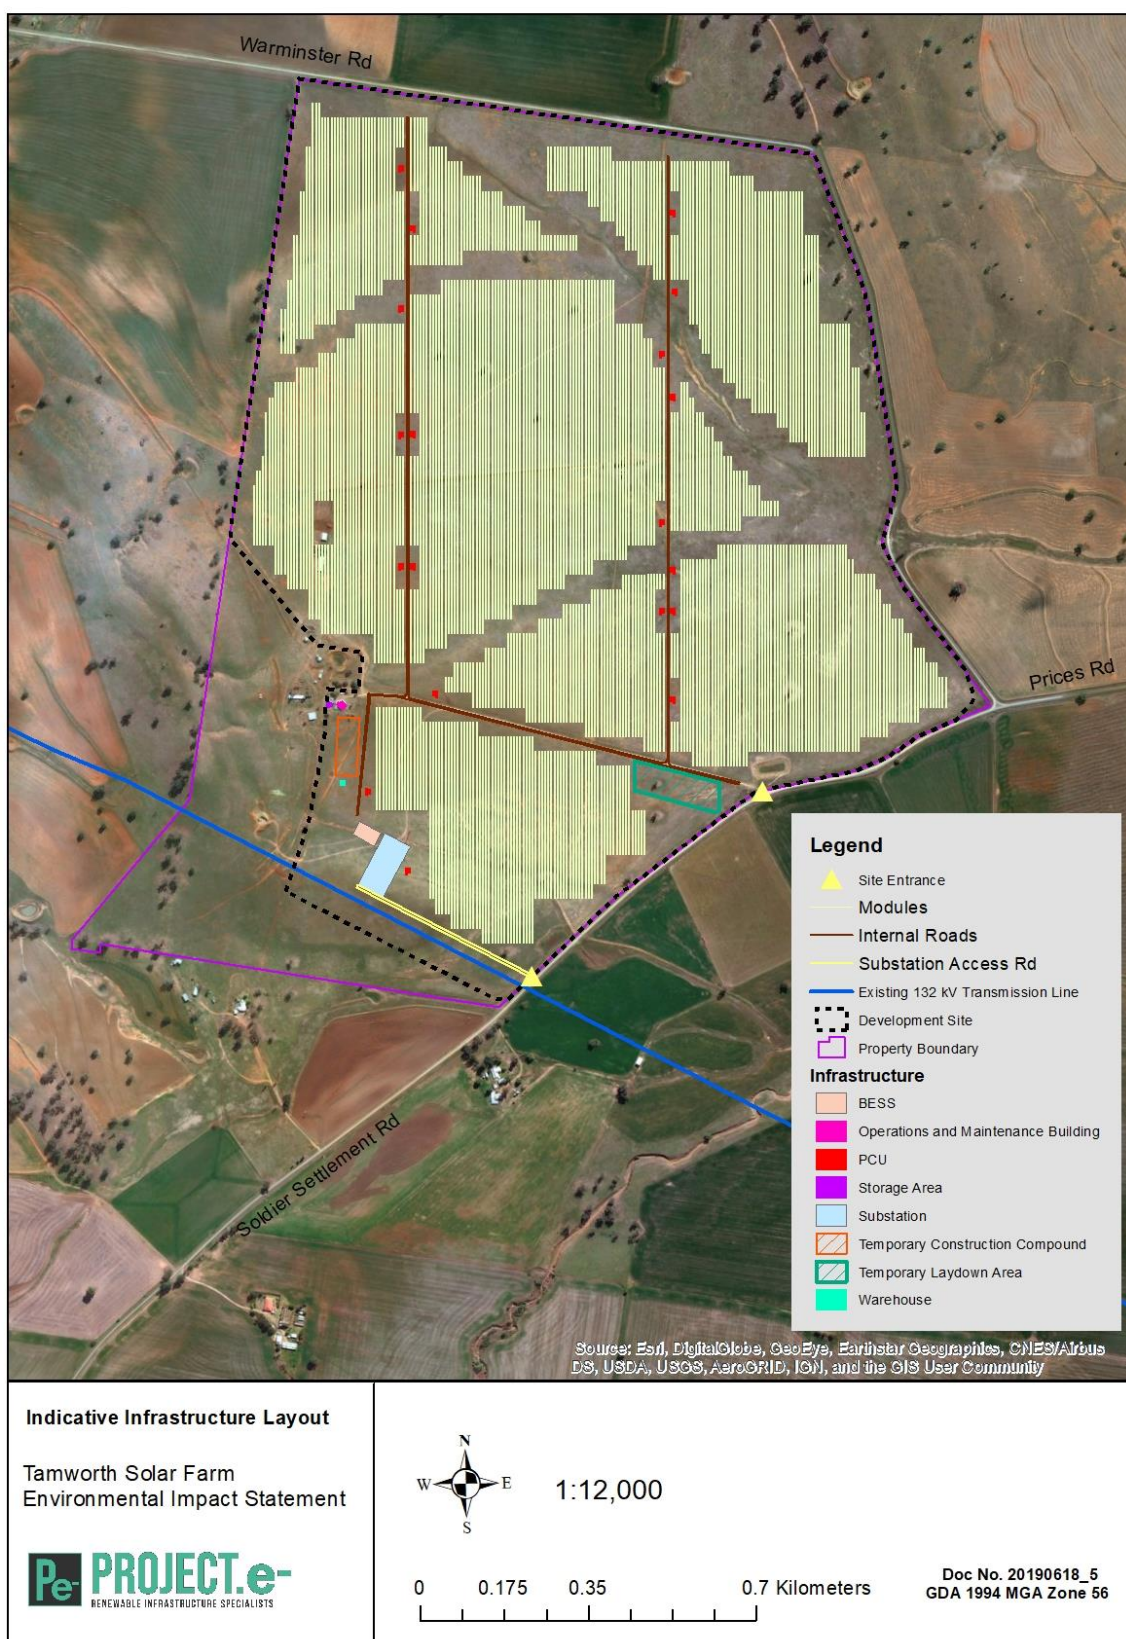
Figure 2. Site entrance points.

There are two site access points as shown in Figure 2. The most northern access point is the main access point to the site. The southern access point is to the substation and will be used infrequently.

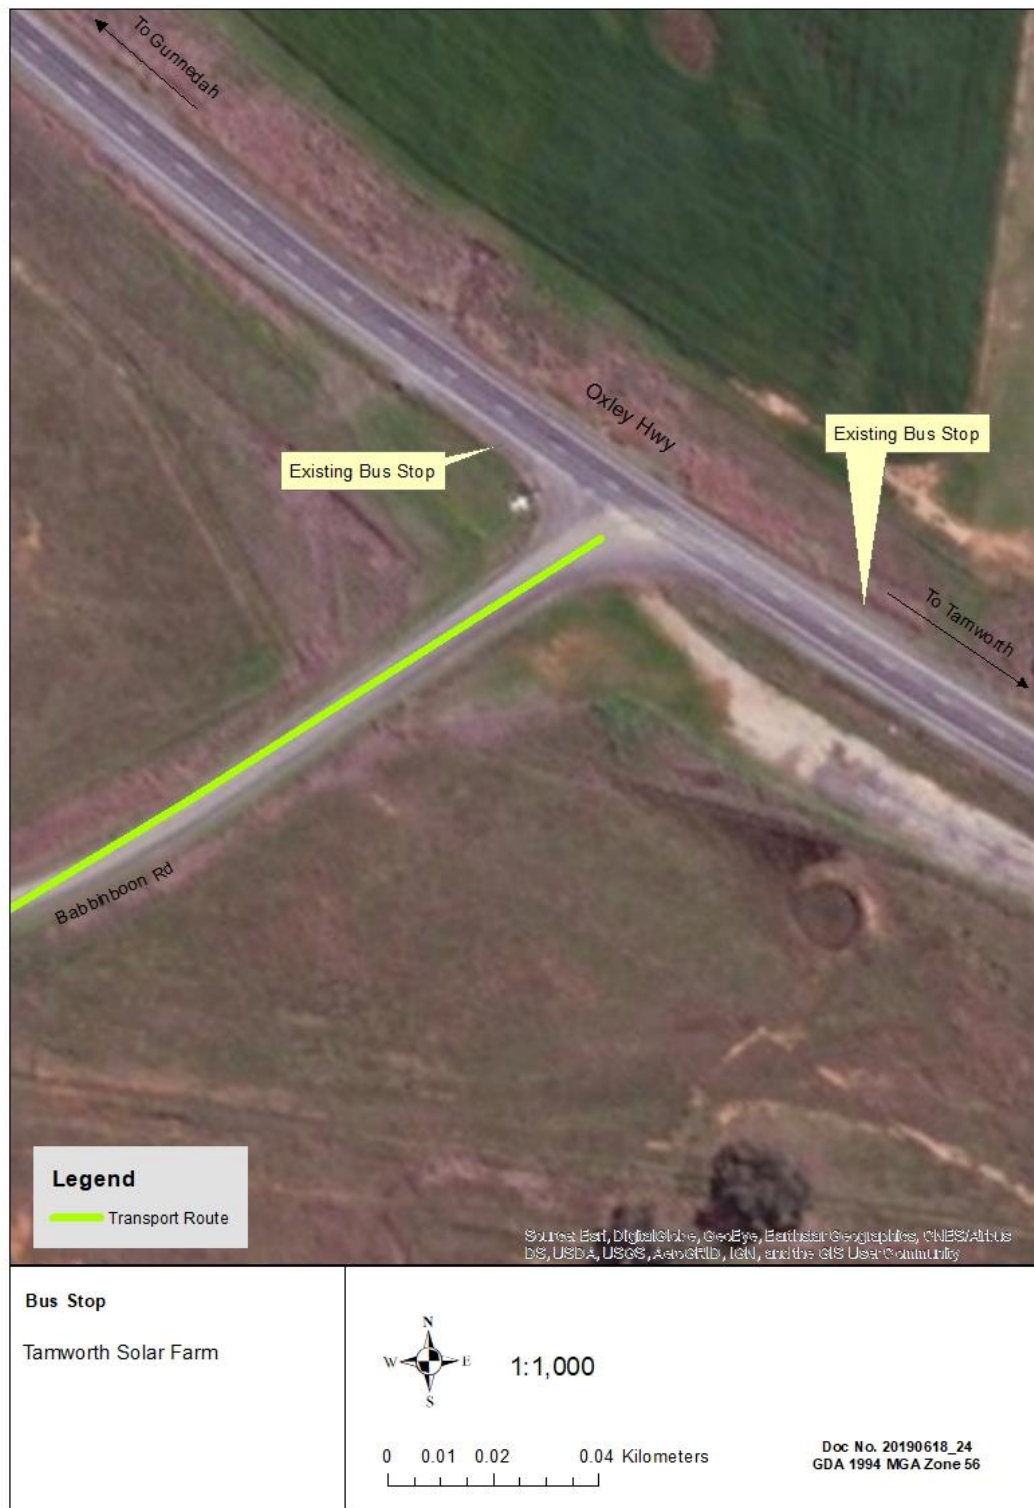
Figure 3. Existing bus stops at the intersection of Babbaboob Rd and Warminster Rd.

Each of these companies were contacted and asked if they had any school bus routes between the Oxley Highway and the site. All confirmed that they do not. Macphersons Coaches do operate along the Oxley Hwy. Macphersons stated that their bus stop for buses travelling towards Gunnedah was just past the intersection of Babbins Rd as shown in Figure 3. For buses travelling to Tamworth, it is just east of the intersection.

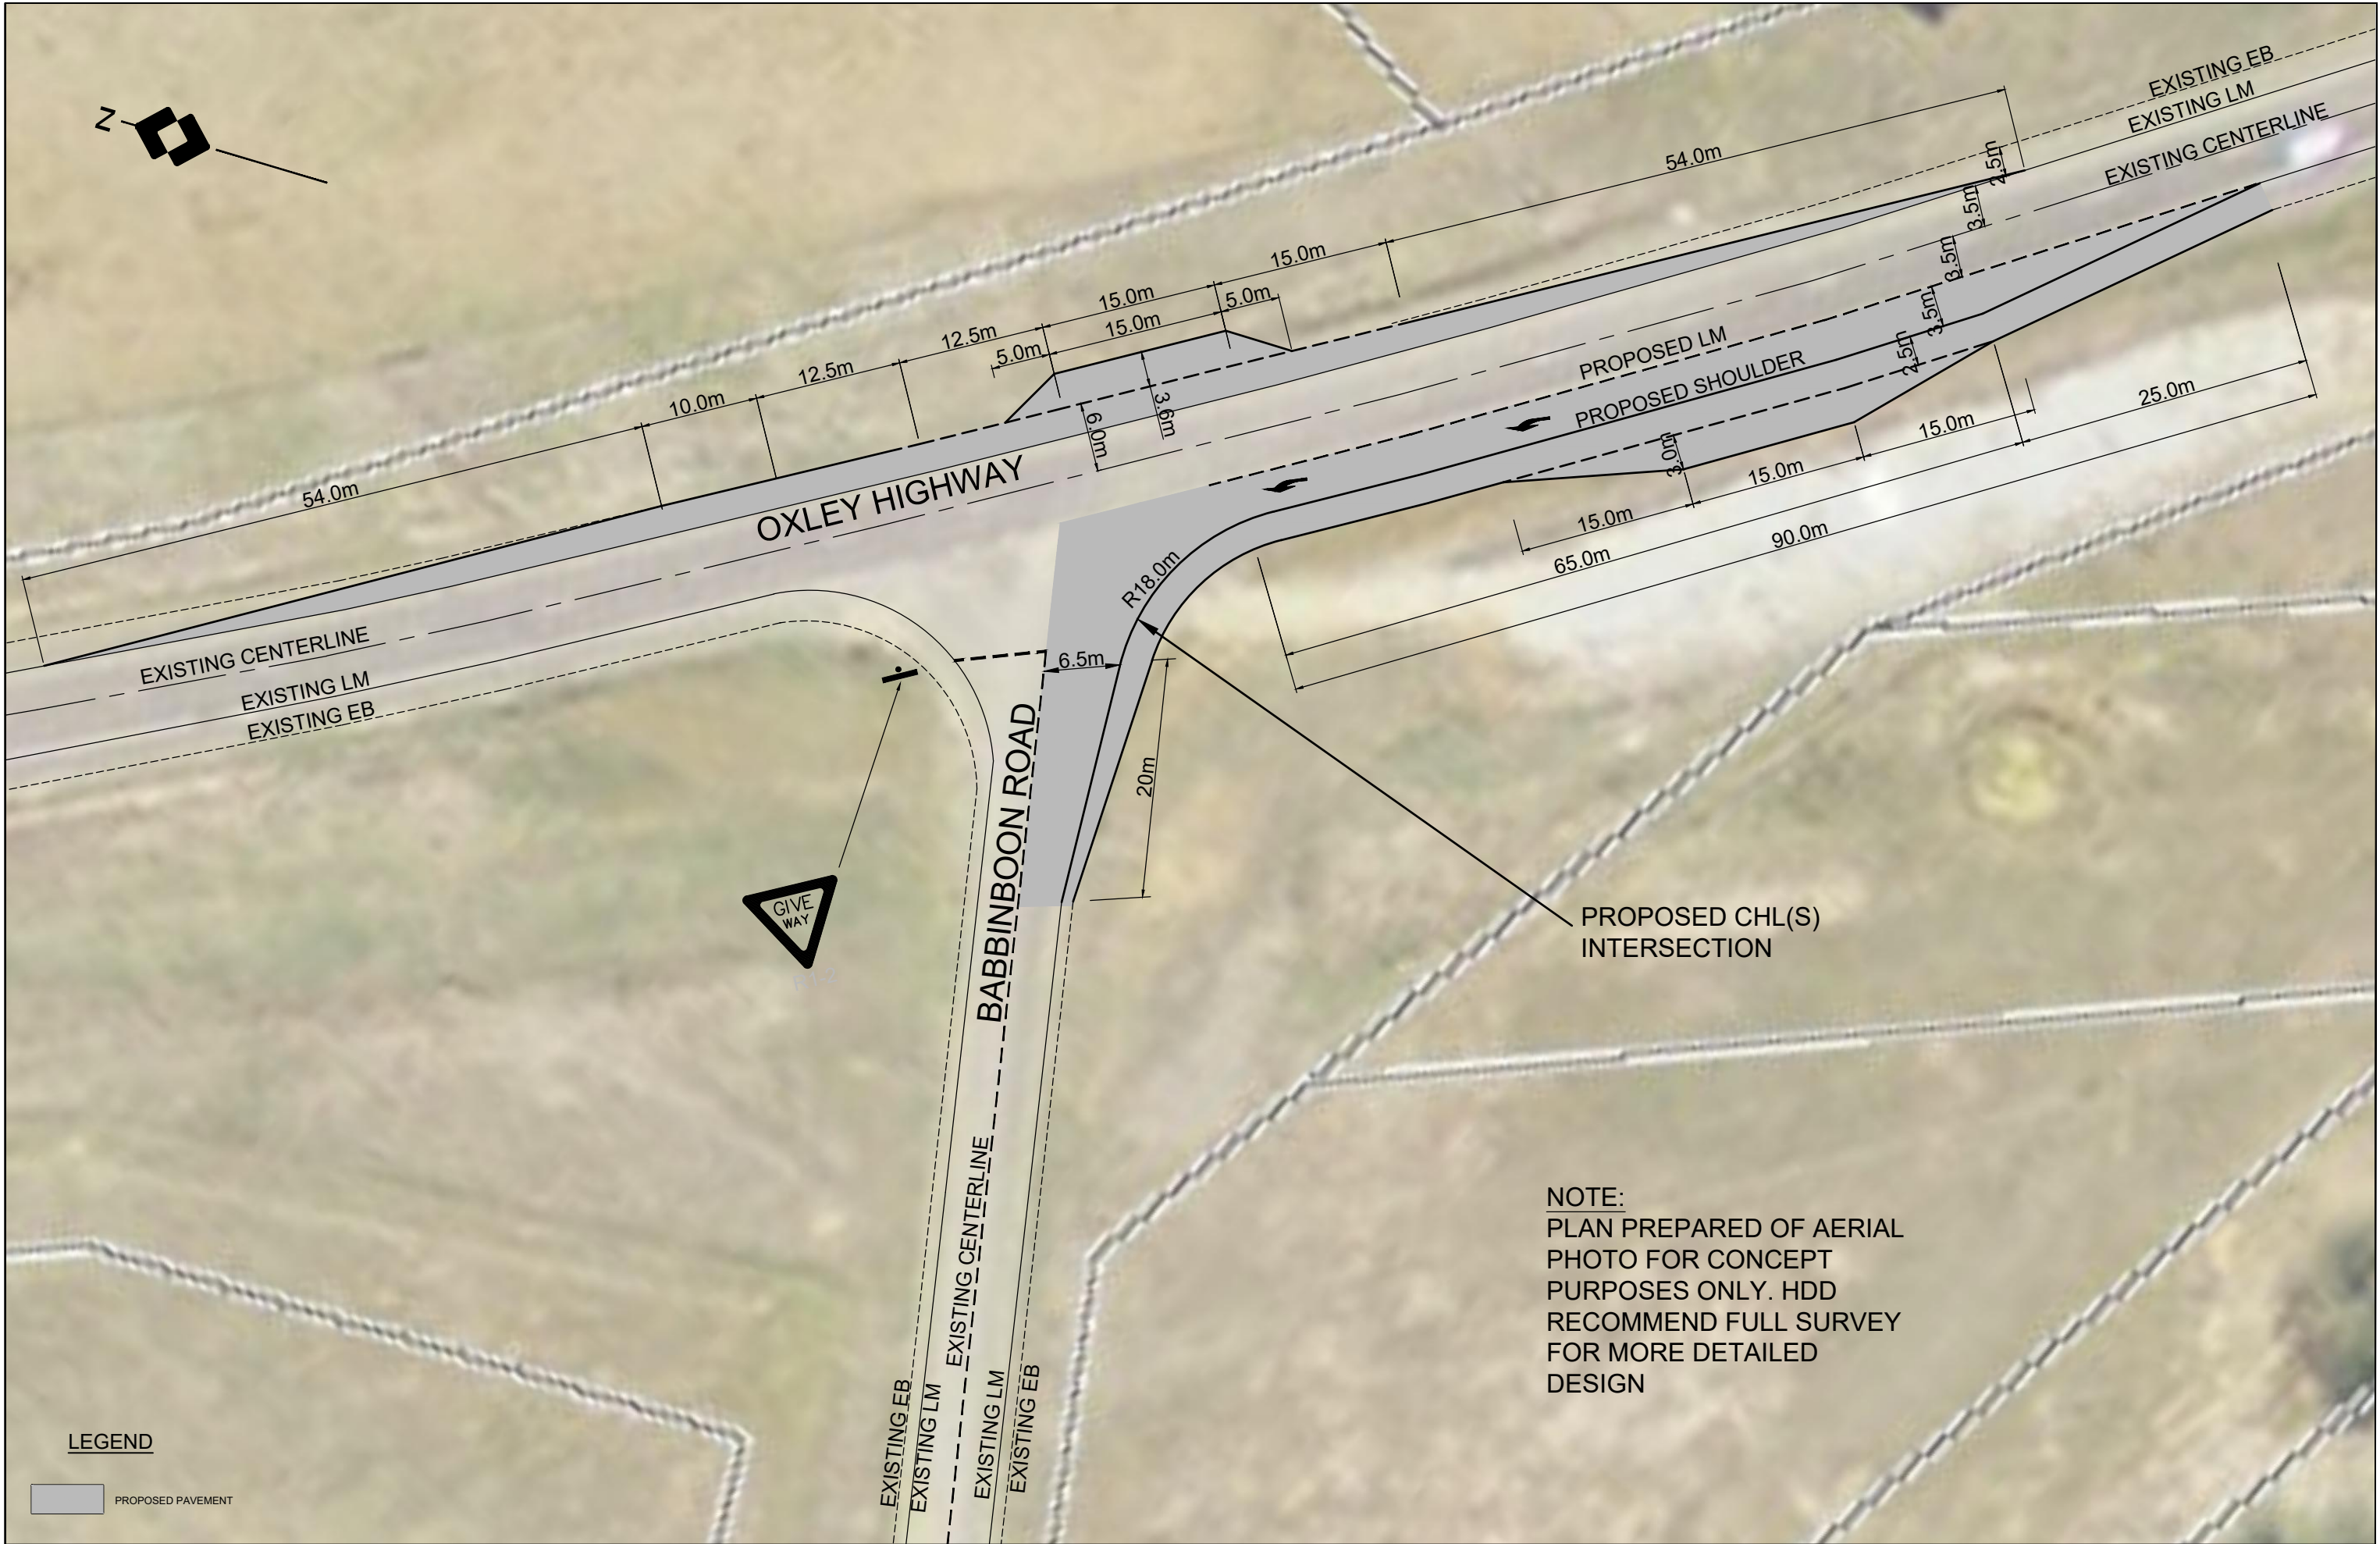
TITLE: PROPOSED CHL(S)
OXLEY HIGHWAY
OVERALL PLAN
CLIENT: SECA SOLUTIONS

The intersection of the Oxley Highway and Babbinboon Road is being upgraded to include a deceleration lane for vehicles turning left into Babbinboon Rd. Based on the discussions with TfNSW and on their request, a Basic Auxiliary Right (BAR) treatment is being provided at the intersection. Furthermore, two new bus stops will be provided that will give a much greater level of safety than the existing bus stops. A concept plan for the upgrade and a swept path diagram for the largest vehicle is included as Appendix A. Further information on why a higher level of treatment is not required is provided in the Technical Design Note in Appendix F along with information on sight lines for the bus stops.

To provide better bus stop locations at the intersections, Tamworth solar farm will construct sealed bus stops as shown in Appendix A. These locations have been discussed with Macphersons Coaches and they think the sites are suitable. An email from Macphersons is provided in Appendix C. The request they made to have the bus stop on the northern side of the highway widened to 3.6m has been included in the concept design in Appendix A.

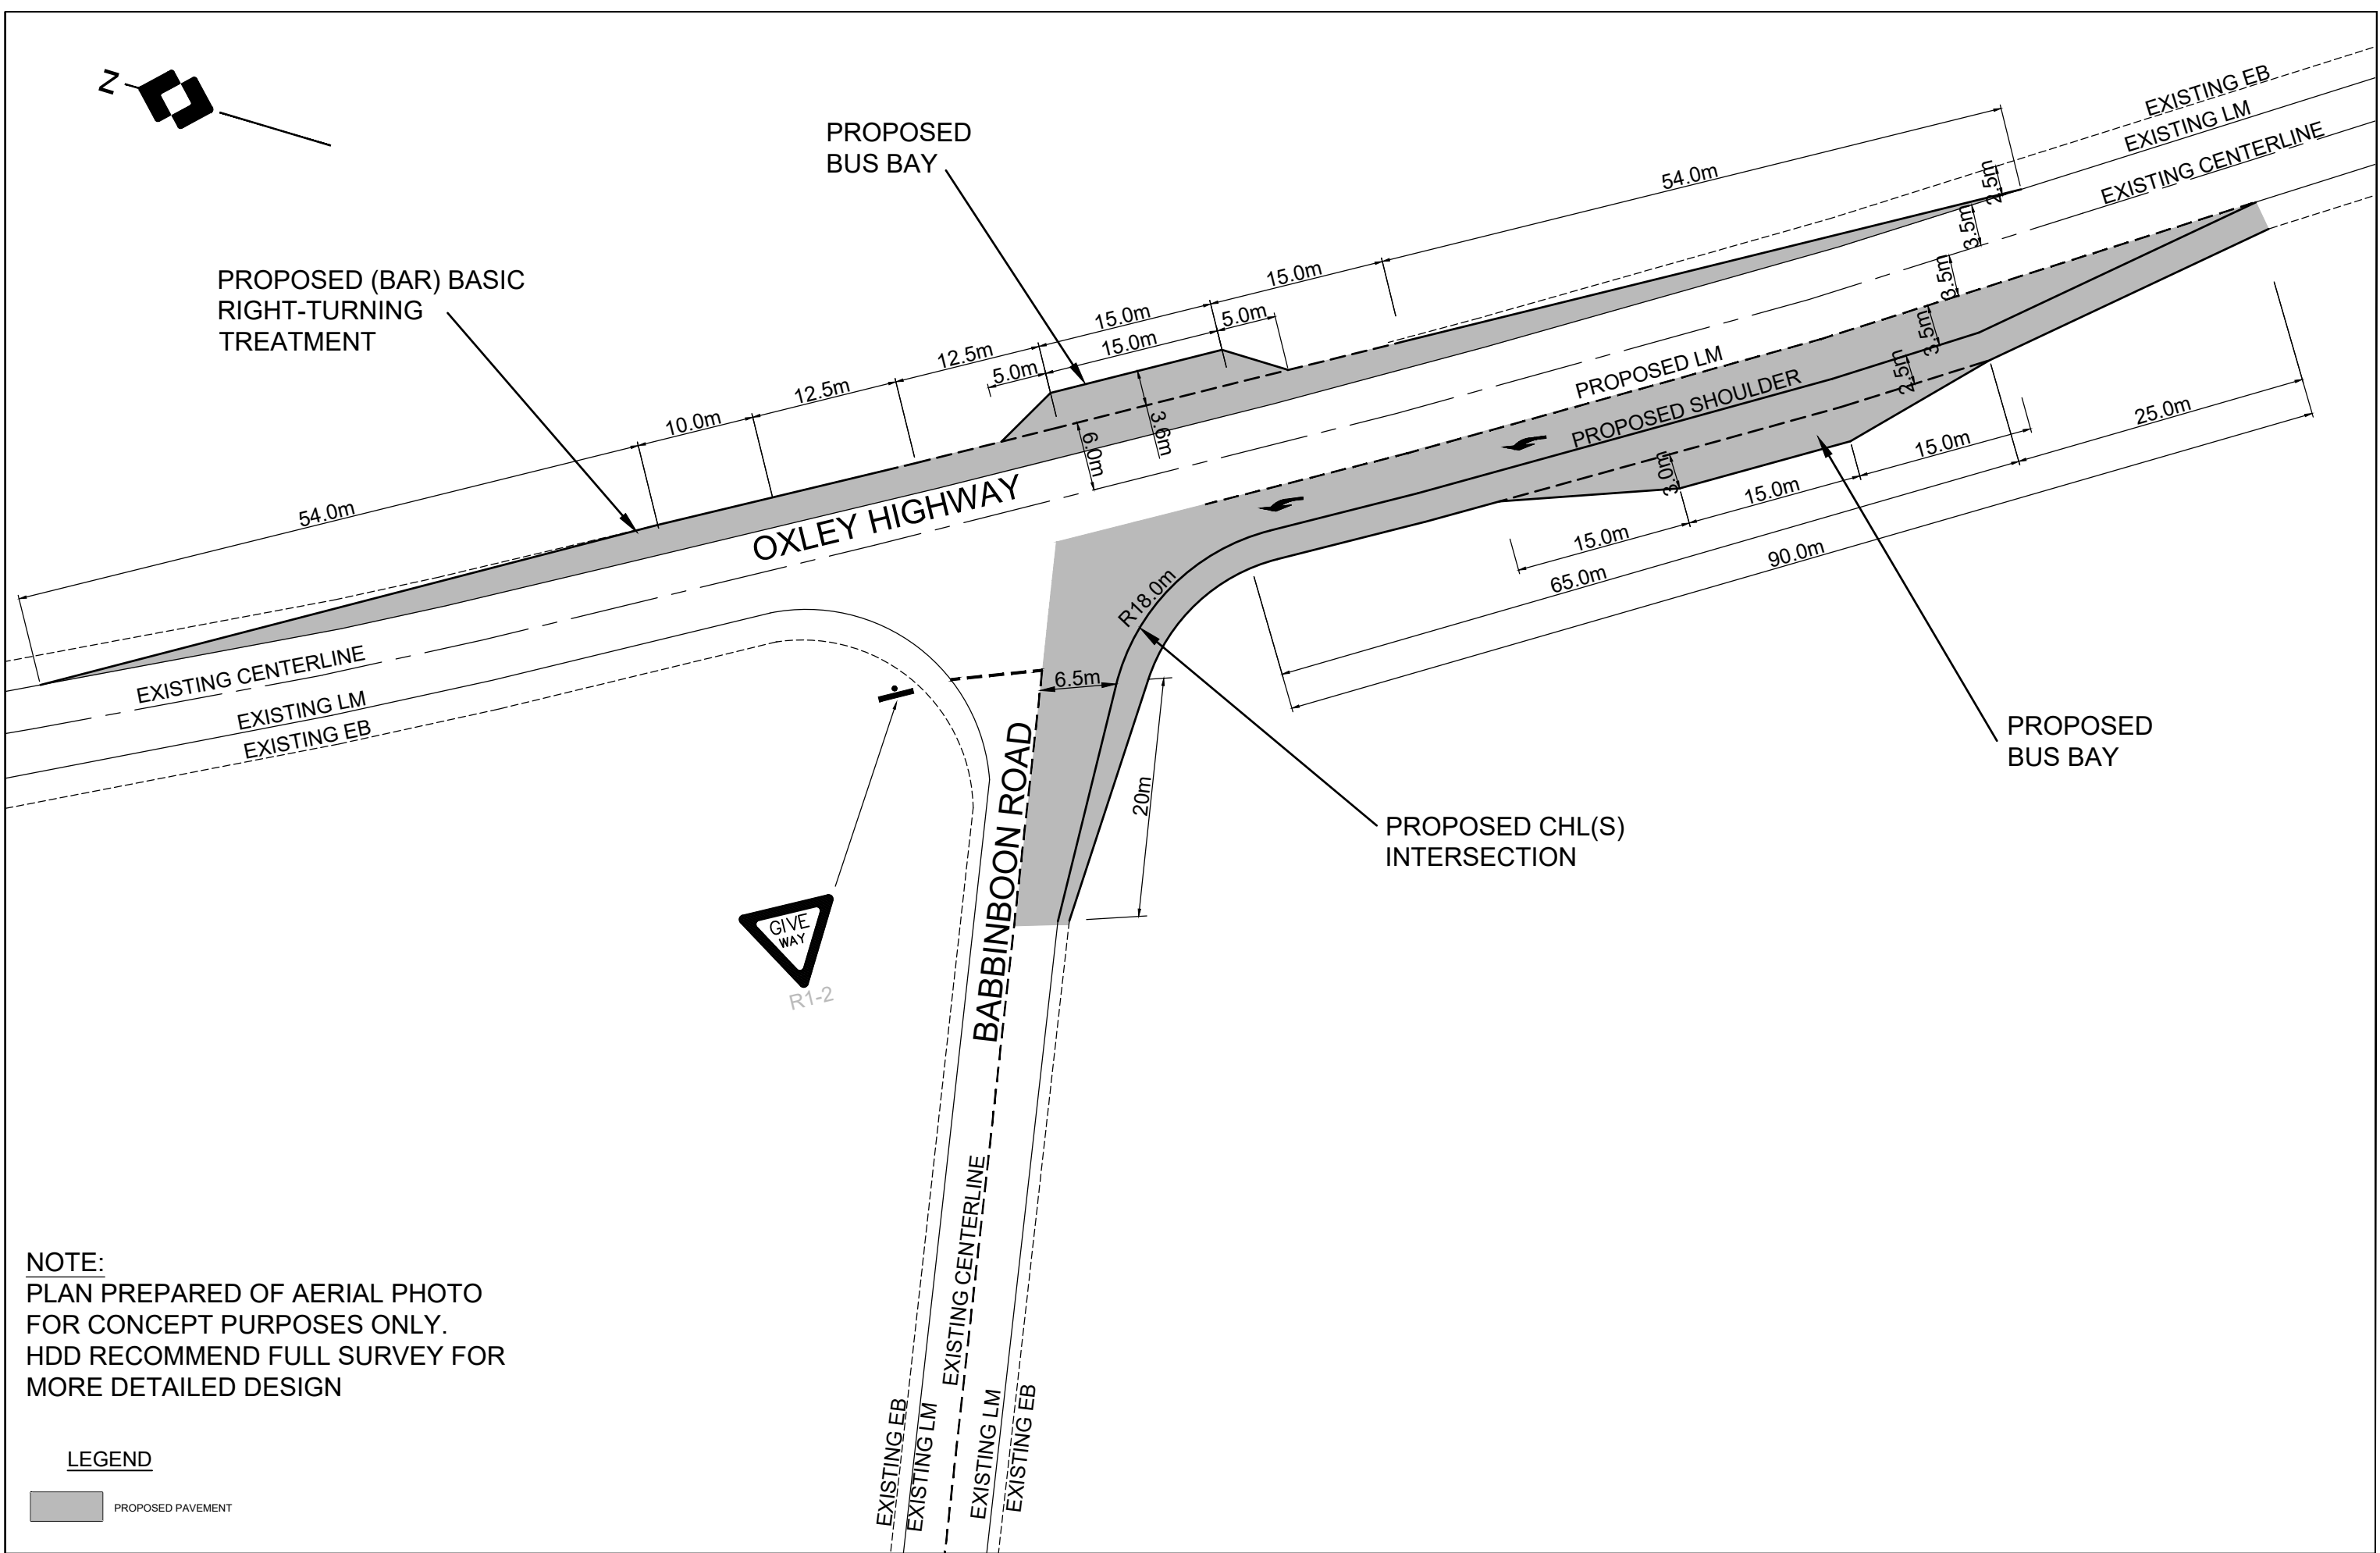
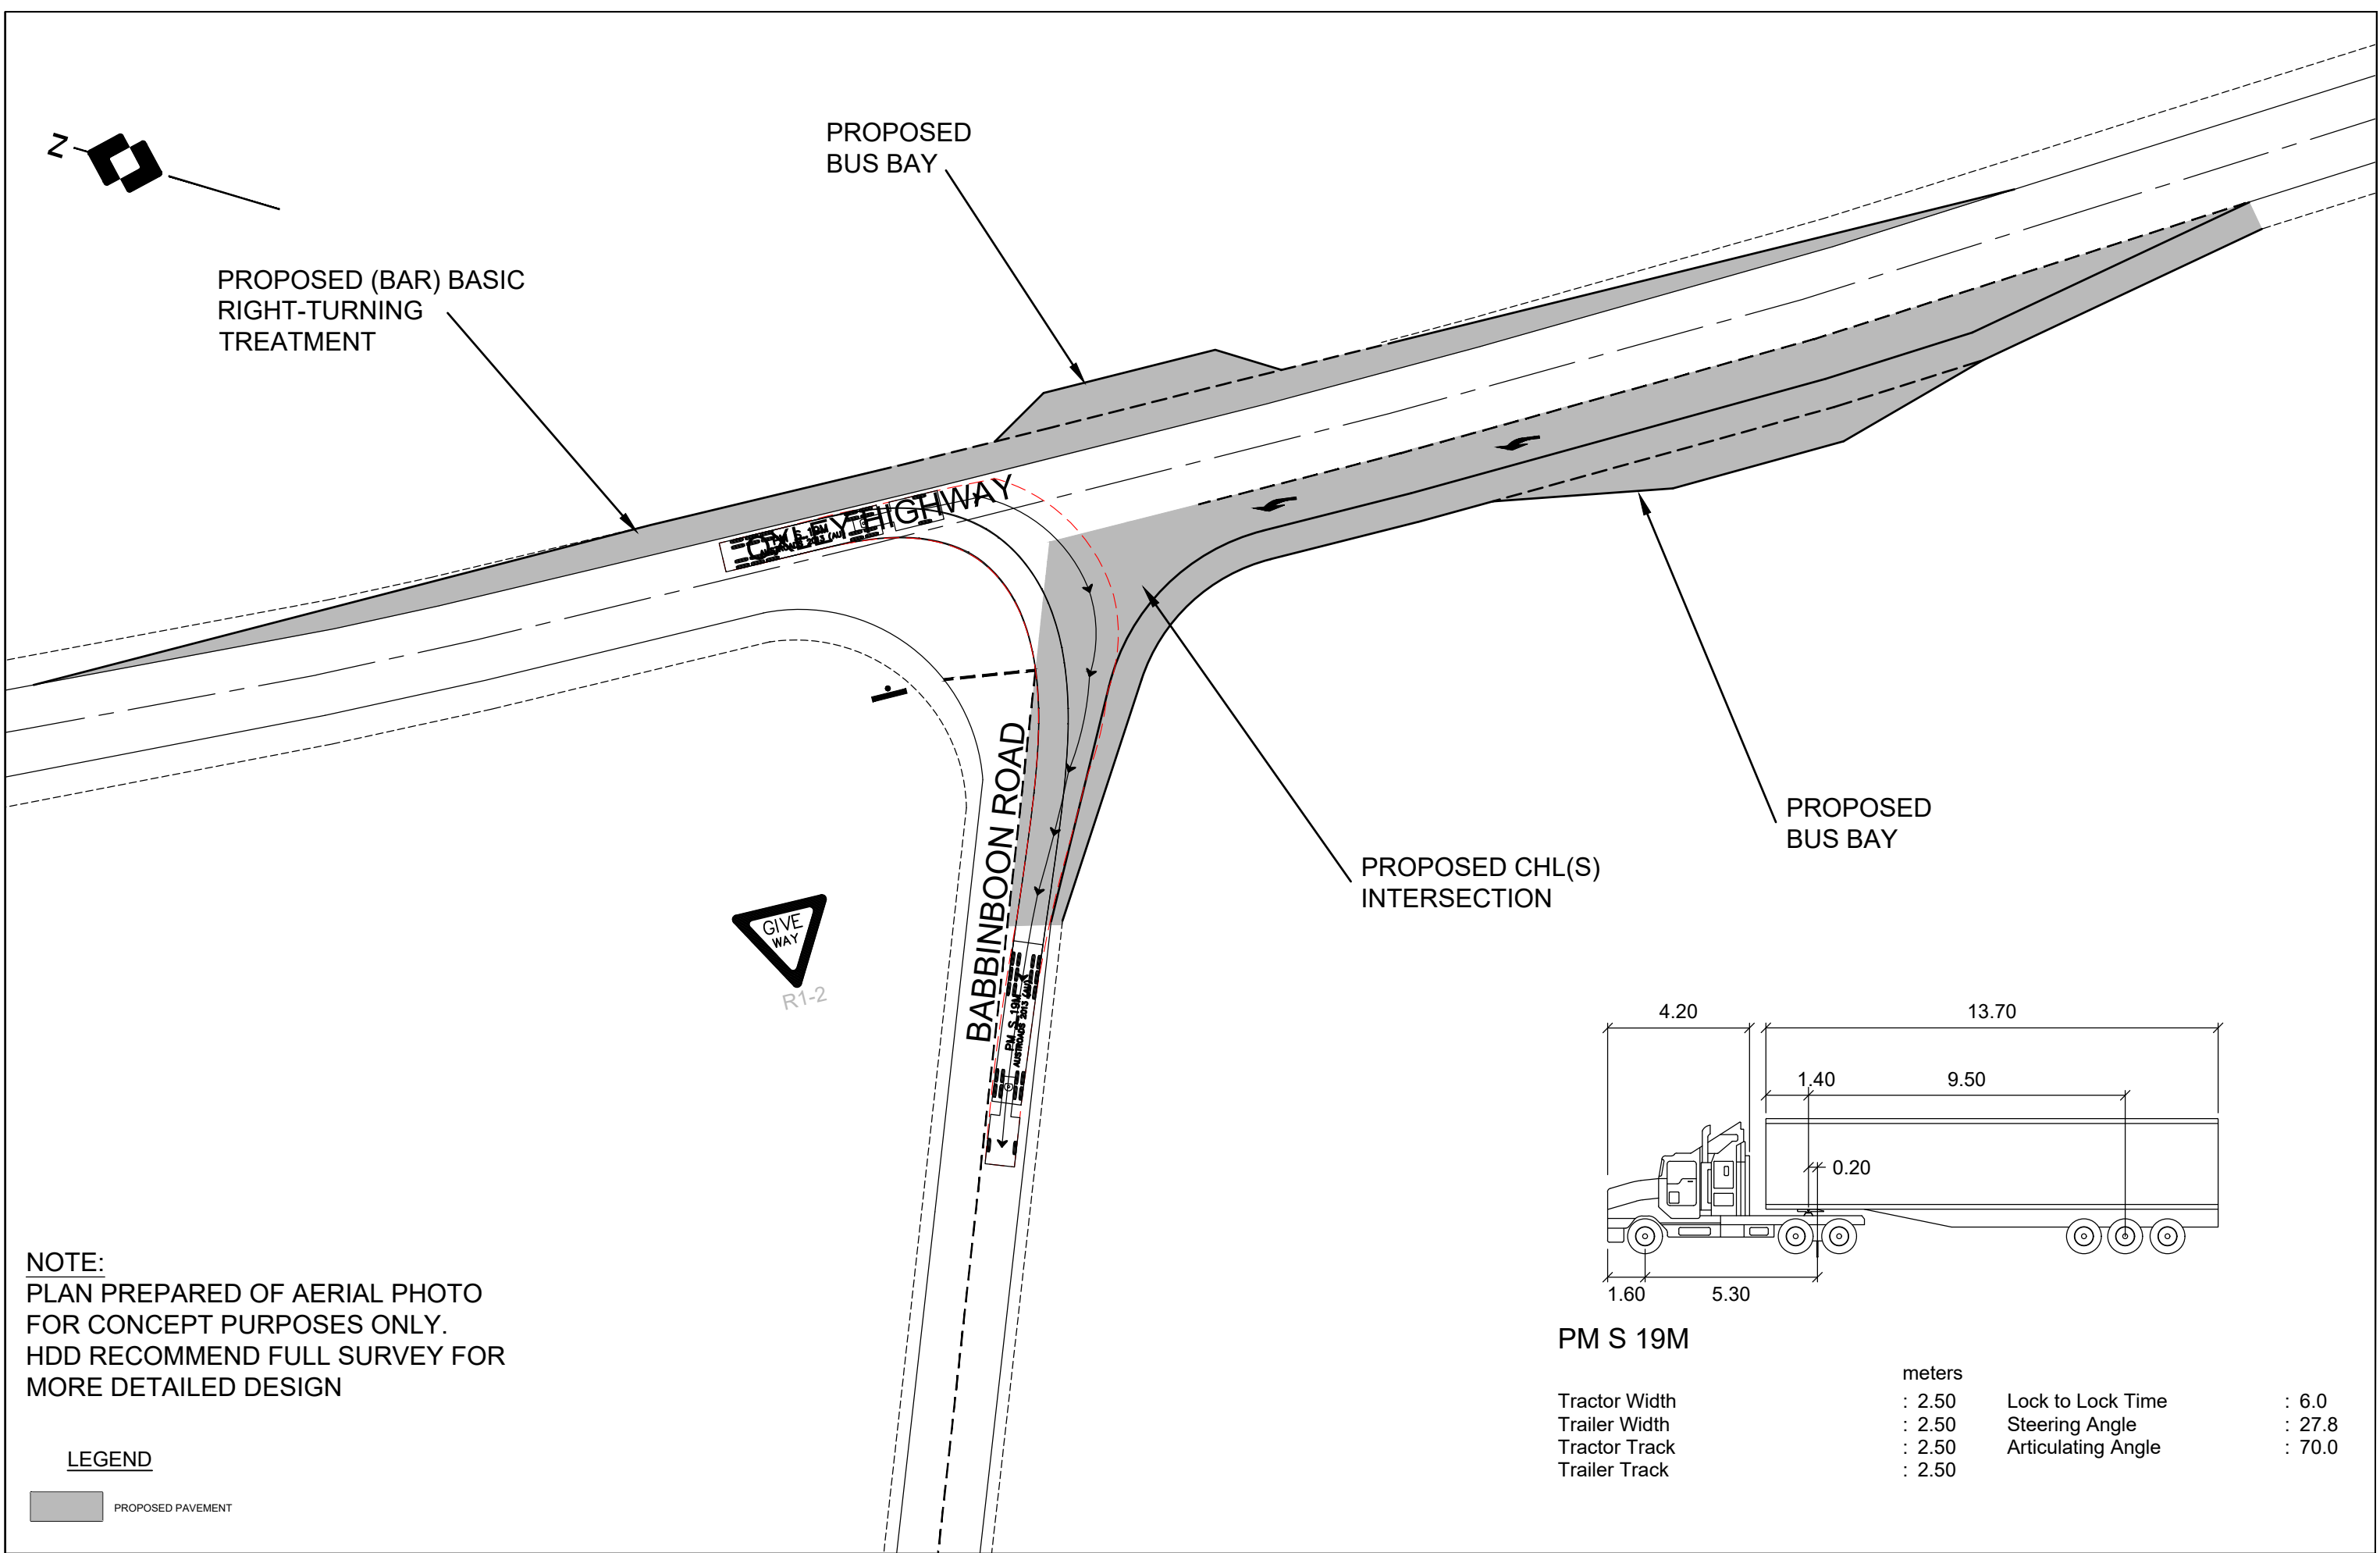
TITLE: PROPOSED CHL(S)
OXLEY HIGHWAY
INTERSECTION PLAN
CLIENT: SECA SOLUTIONS

PROPOSED (BAR) BASIC
RIGHT-TURNING
TREATMENT

PROPOSED
BUS BAY

PROPOSED CHL(S)
INTERSECTION

The location of this upgrade is shown in Appendix A. The bus stop on the southern side of the Oxley Highway, adjacent to the deceleration lane is completely within the “Development Site” that was surveyed as part of the EIS. The Development Site at the deceleration lane is entirely within the road easement. There are no additional land parcels impacted.

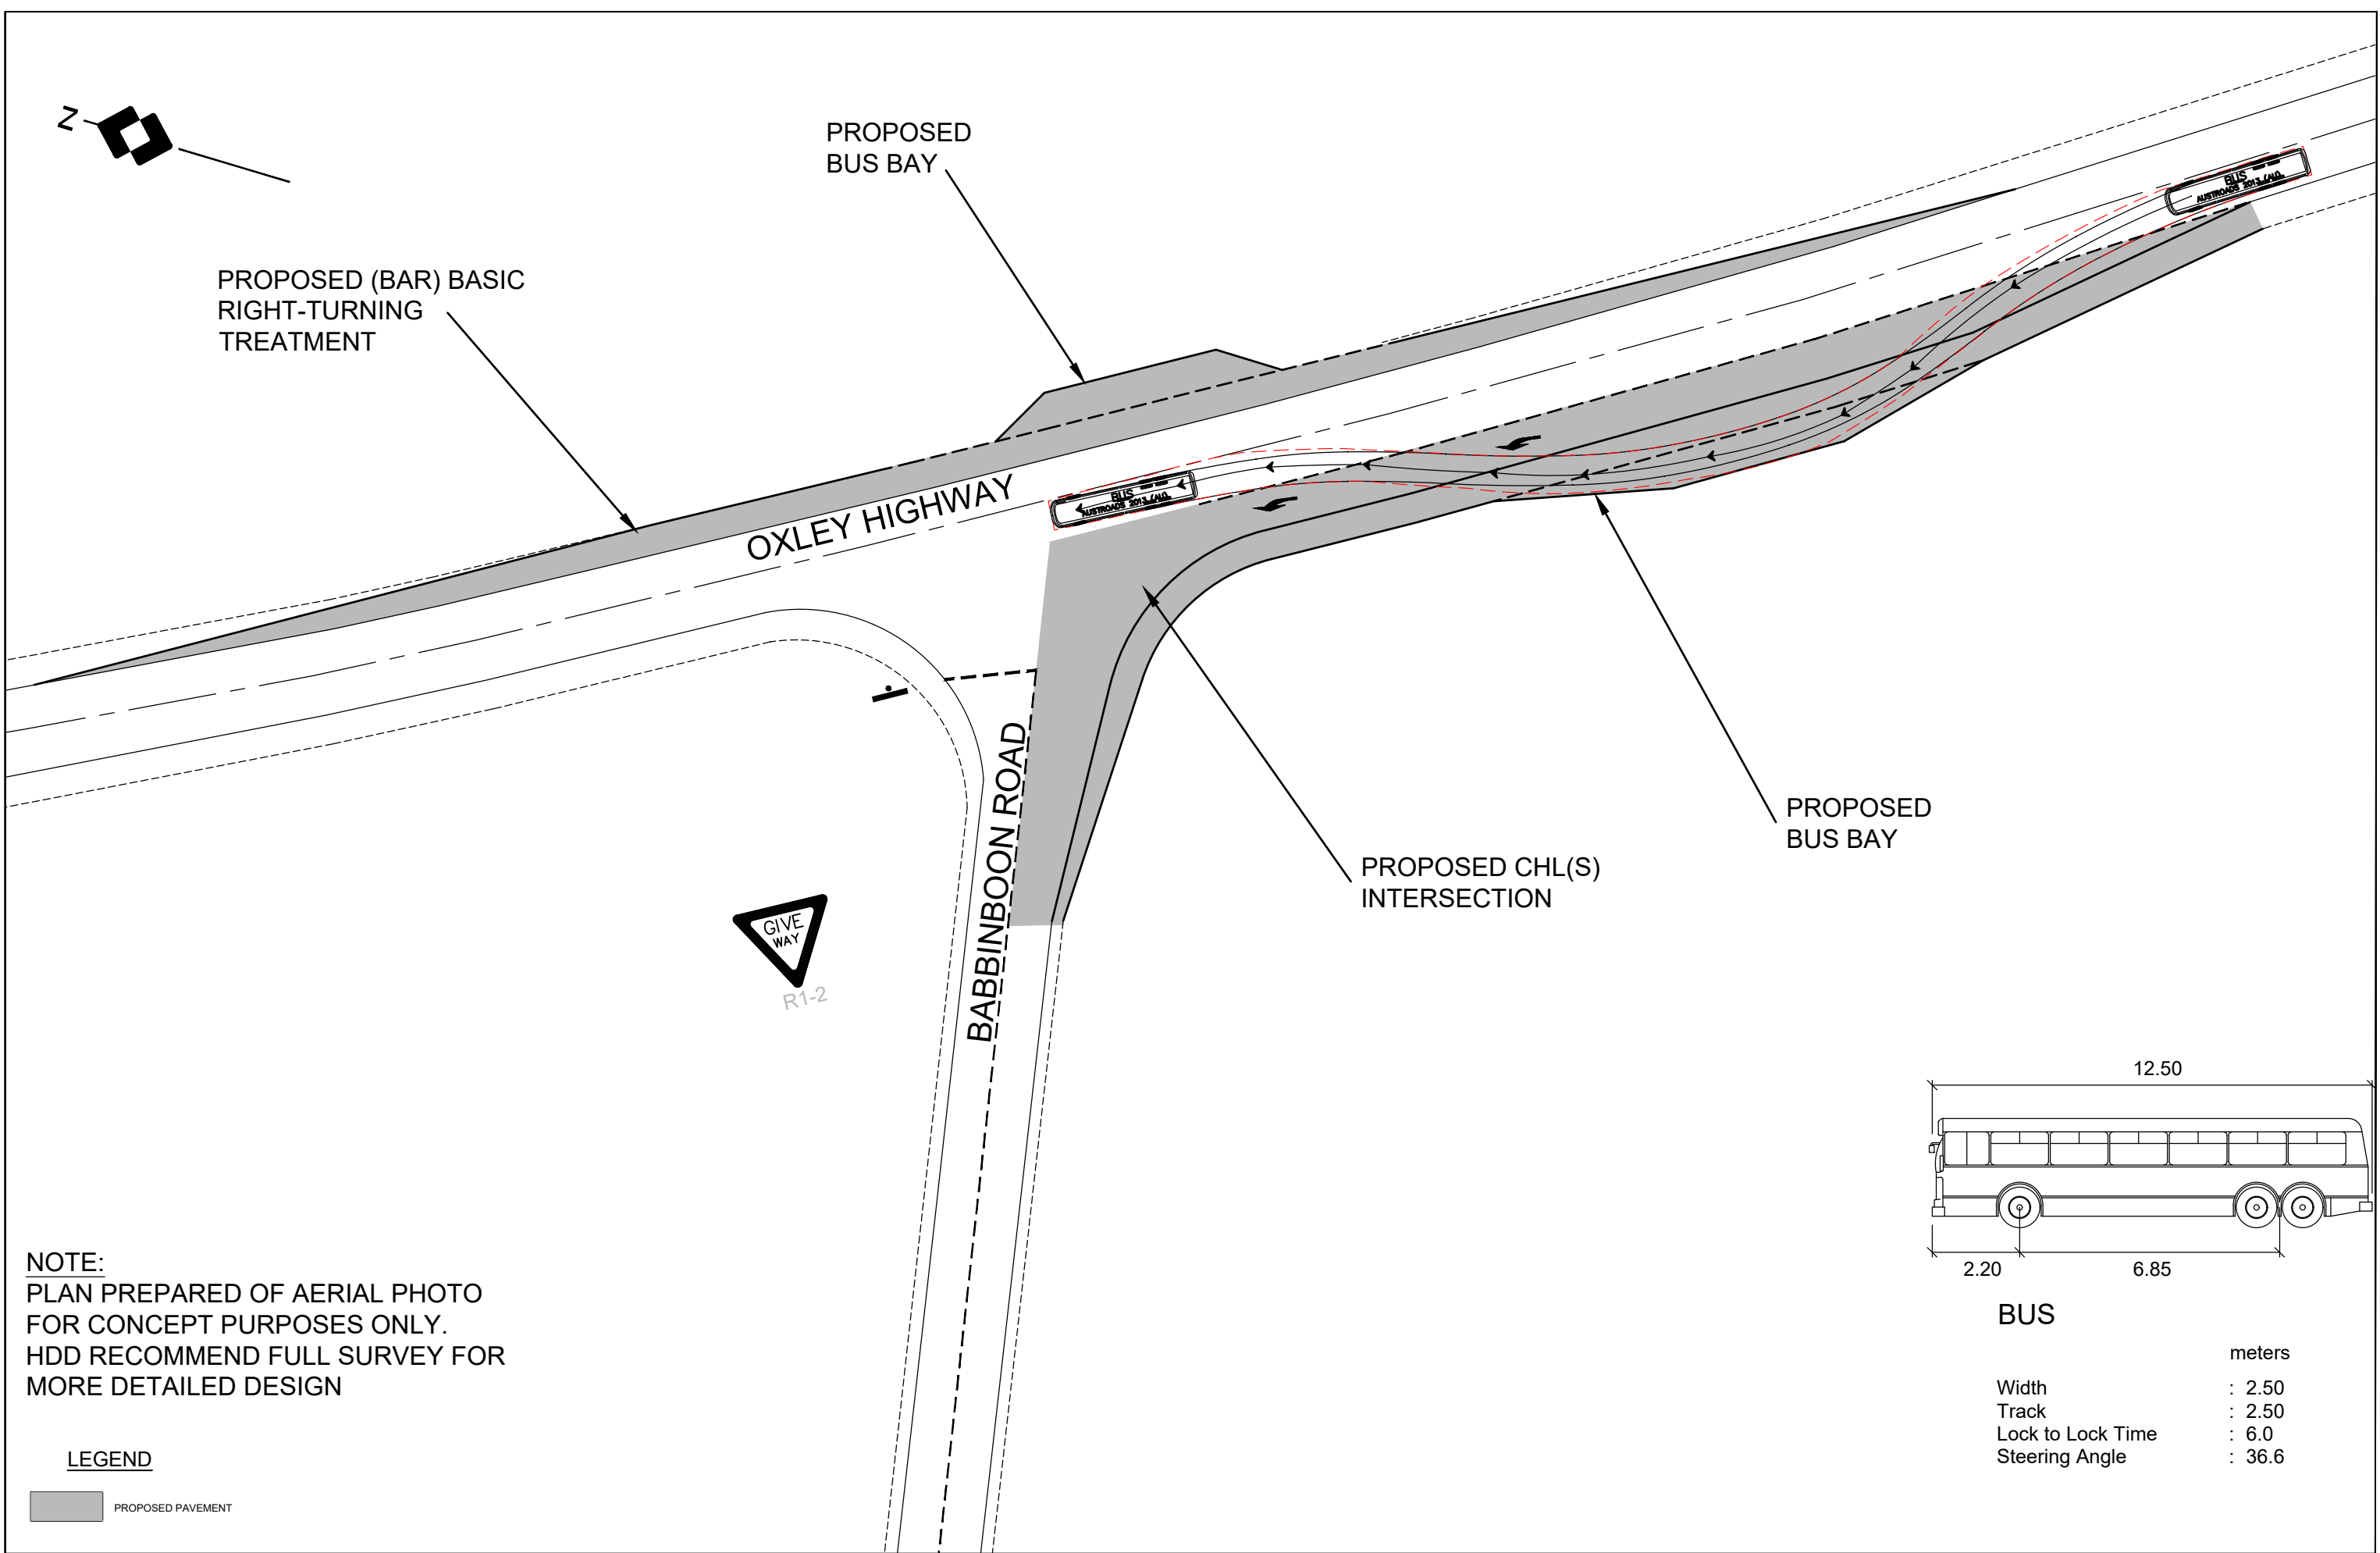
BUS

Width : 2.50

Track : 2.50

Lock to Lock Time : 6.0

Steering Angle : 36.6
