Tamworth Solar Farm

Response to Request for
Information 29/4/20

Prepared for: Tamworth Solar Farm Pty Ltd
May 2020

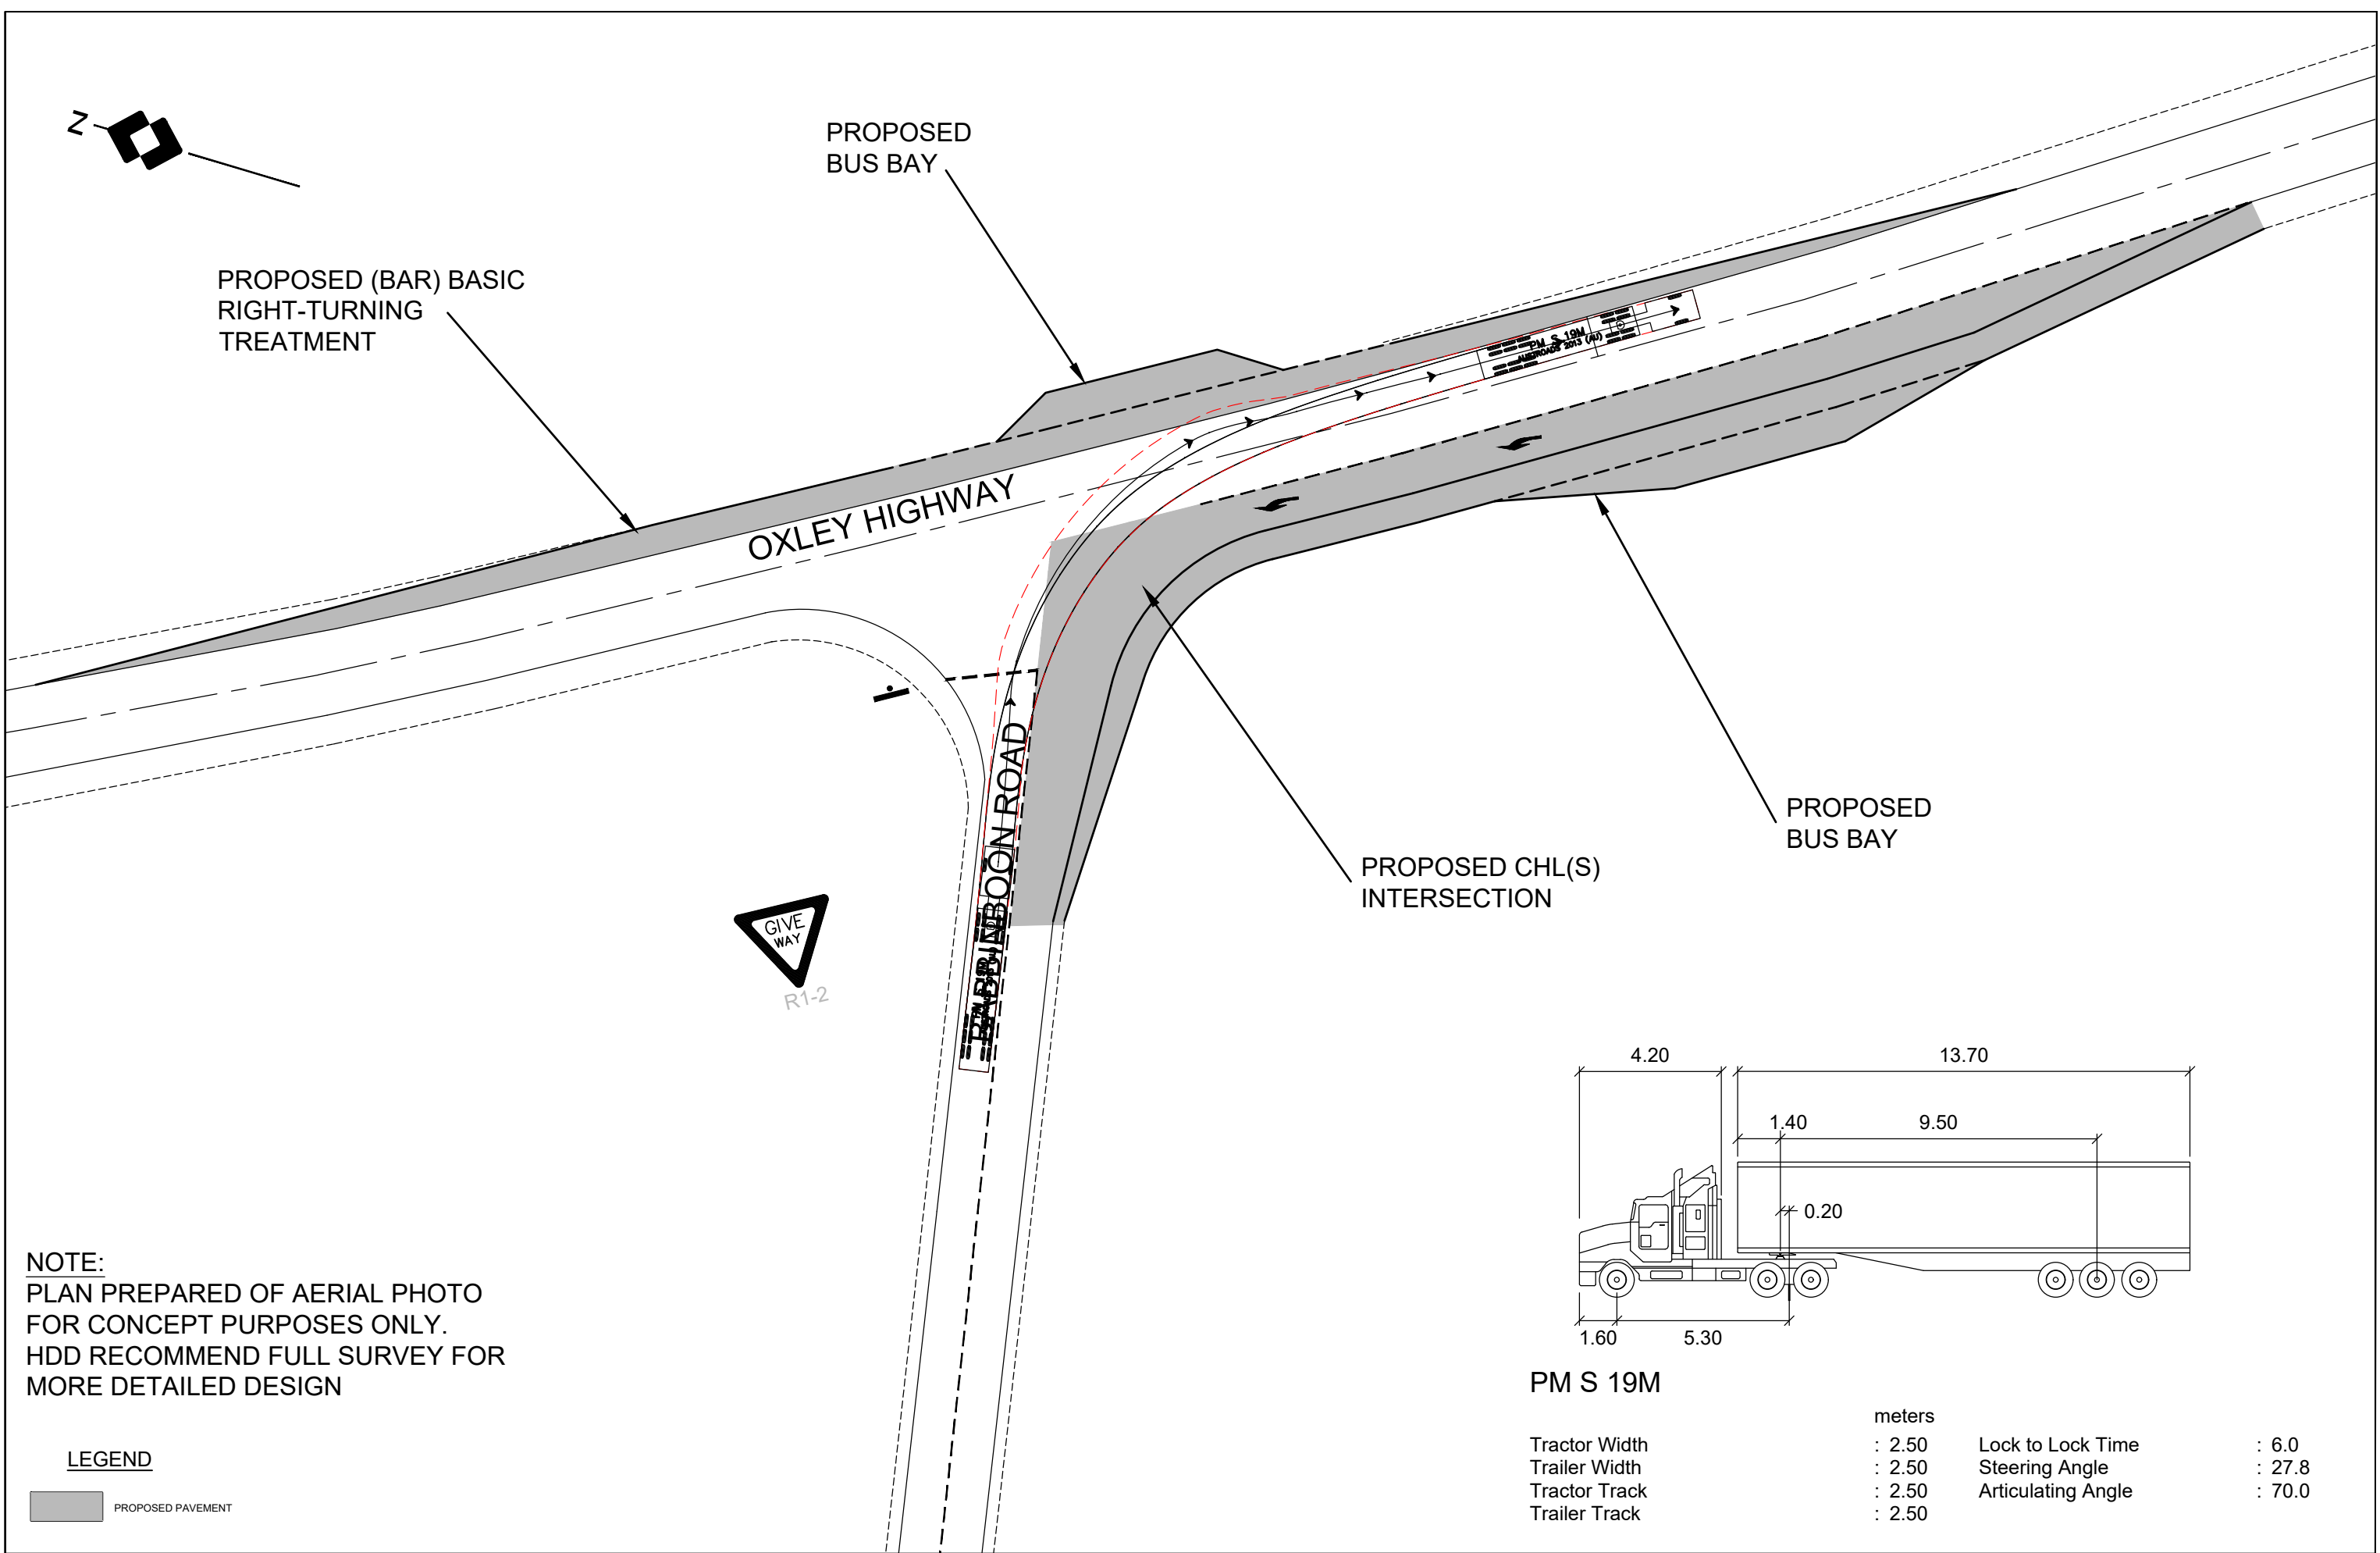
PM S 19M

Tractor Width	: 2.50	Lock to Lock Time	: 6.0
		Trailer Width	: 2.50	Steering Angle	: 27.8
		Tractor Track	: 2.50	Articulating Angle	: 70.0
		Trailer Track	: 2.50

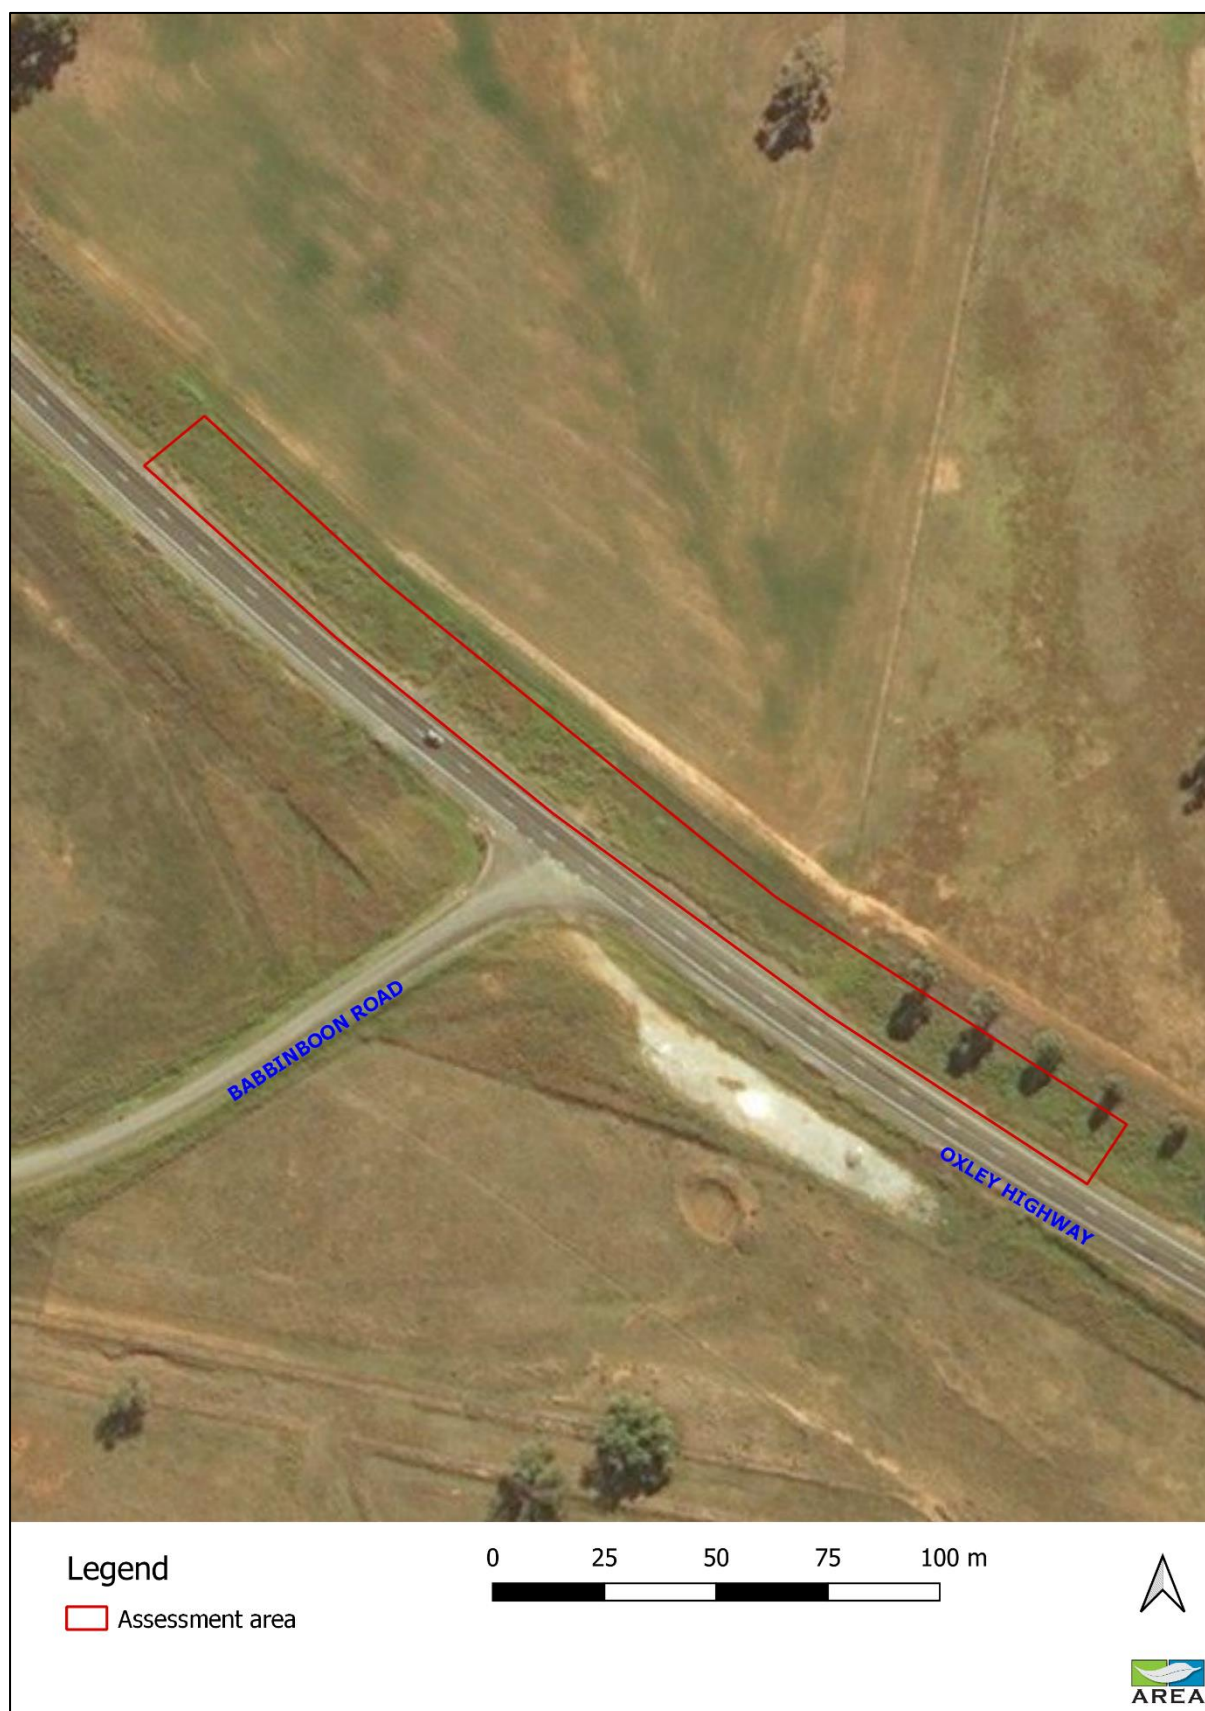
Figure 1-2: Additional assessment area for the Tamworth bound lane Basic Auxiliary Right treatment (Study Area 1) (Base image source: Bing Satellite).

Study Area 1 was devoid of trees and shrubs or woody debris and was dominated by exotic grass species, particularly Johnson grass and Feathertop Rhodes grass. Some native grasses and forbs were identified but they represented a very small proportion of total vegetation at the site. A summary is:

- A proposed new Deceleration Lane Development Area along the Tamworth bound lane of the Oxley Highway at Babbinboon Road intersection (additional 0.42 hectares) (Figure 1-2)
- The portion of the substation access track between the solar farm boundary and Soldier Settlement Rd (an area of 0.03 hectares) (Figure 1-3).

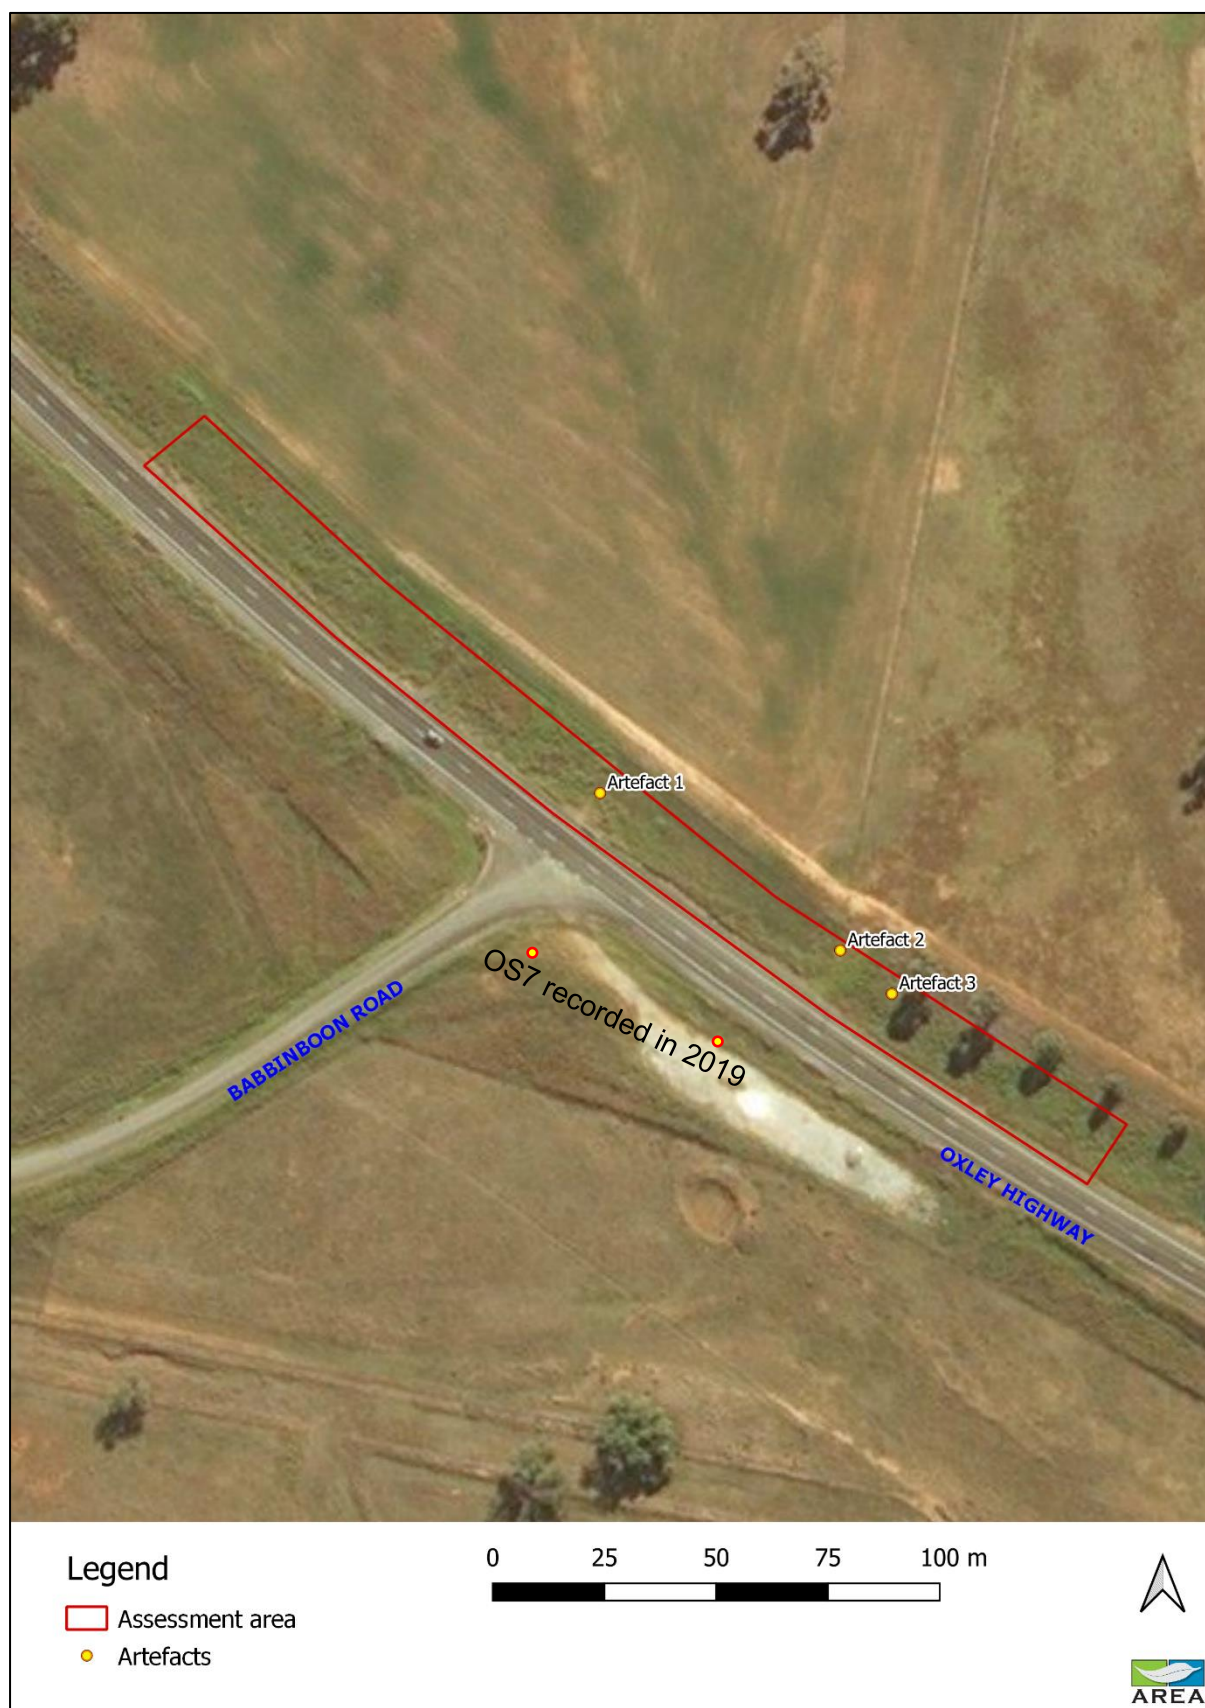
Figure 1-4: Extension to Open Camp Site 7 for the Tamworth bound lane Basic Auxiliary Right treatment (Study Area 2) (Base image source: Bing Satellite).

Three Aboriginal objects were recorded on an area not built on fill toward the agricultural fence line (Figure 1-4). One stone artefact has characteristic attributes while two were possible artefacts. Unfortunately, the photos taken of these objects were all out of focus and are not useful for the purpose of this report. The following attributes were noted:

- Object 1 is a basalt broken flake, 42x26x4mm, 20 per cent cortex possessing a bulb, eralier scar, broken narrow platform with evidence of bipolar flaking.
- Object 2 is quartzite and possibly a broken flake 16x9x9mm, no cortex. A possible negative flake scar was noted. This is in proximity to other more definitive Aboriginal objects both sides of the highway.
- Object 3 is quartzite and possibly a broken flake 23x22x6mm, no cortex, a bulb and possible flake scar. This is in proximity to other more definitive Aboriginal objects both sides of the highway.

AREAs (2019) comments pertaining to Open Camp Site 7 are directly relevant to these artefacts insomuch as this additional information supports what was observed on the other side of the highway within 40 metres and there is an argument it is an extension to Open Camp Site 7 as opposed to a standalone Aboriginal site.

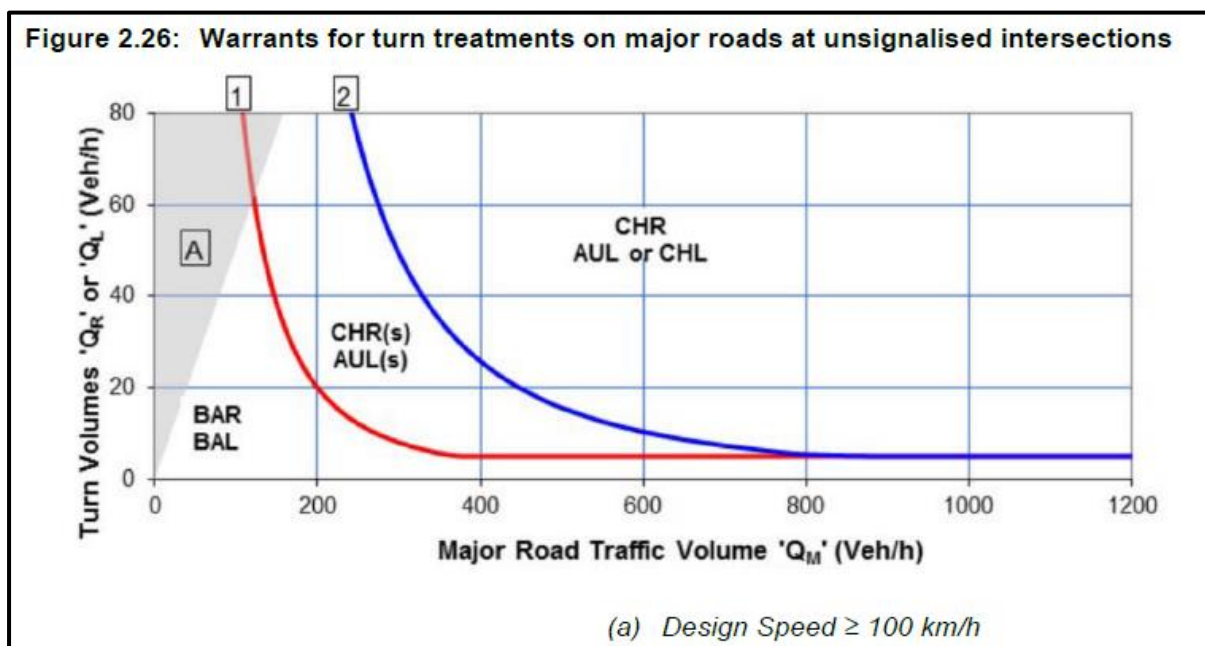
Based on the construction traffic demands and associated increase in heavy vehicle demands, this intersection will need to be upgraded to allow for a left turn deceleration lane. Based upon the warrants provided by Austroads Guidelines Part 6: Traffic Management for Intersections, Interchanges and Crossings (reproduced below) a short Auxiliary Left turn lane is proposed (AUL(S)).

Daily flows on the Oxley Highway are 3265, so based on peak flow of 10% gives 326 2-way. Assume 60% peak westbound gives 196 vehicles for Q_M and left turn movement of 70 vehicles in the AM peak (Q_L).

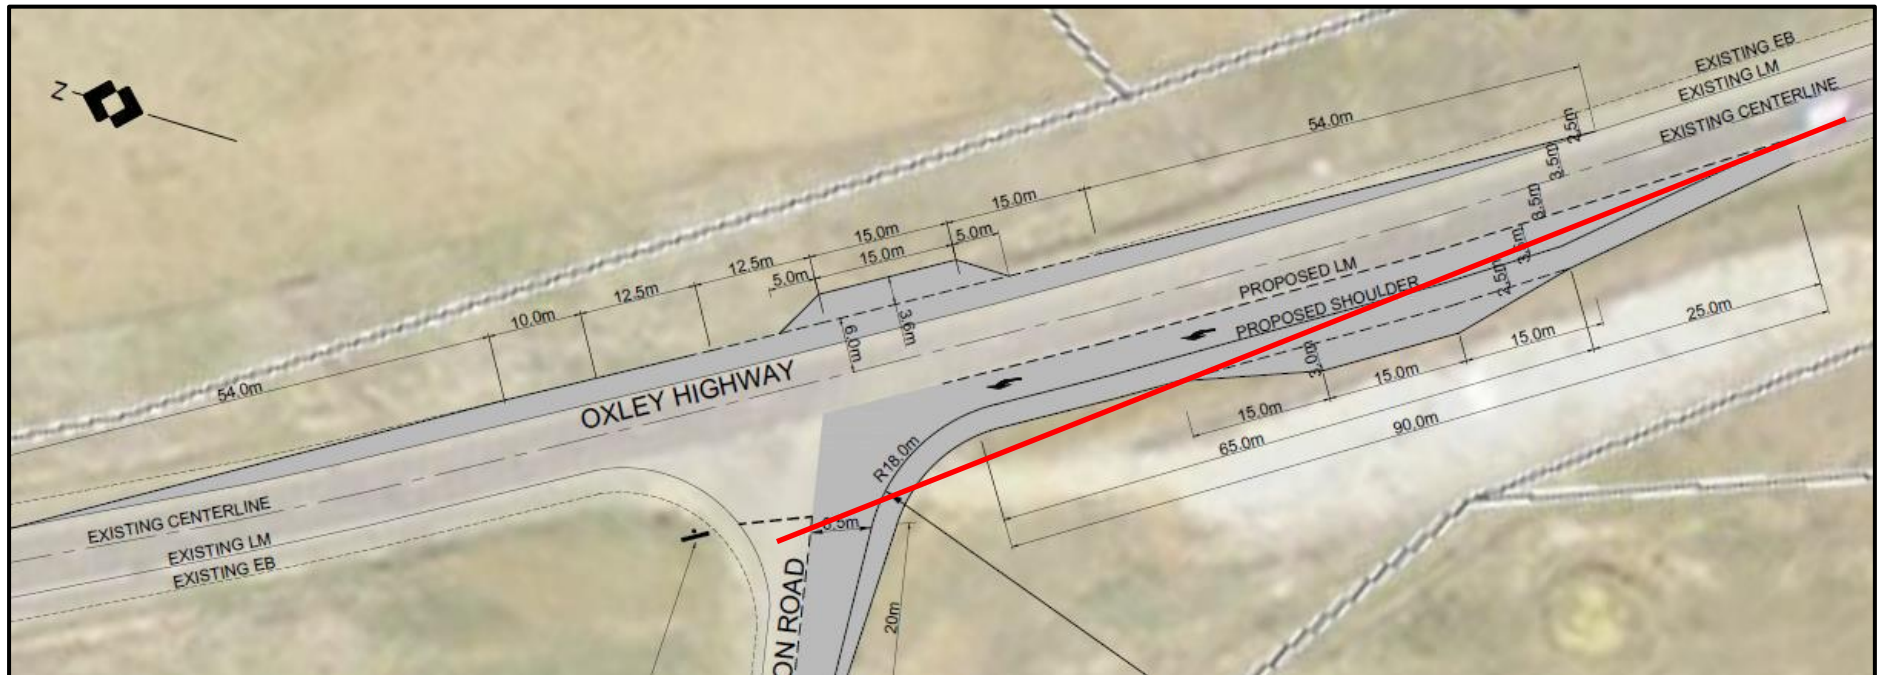
Figure 1 – Sight line (red line) showing the sight line for a driver exiting Babbins Road is not impacted upon by a bus in the proposed hard stand area

An assessment has been completed for the impact of the proposed bus standing area to the south of the intersection of Babbins Road and the Oxley Highway to ensure that the bus standing area does not impact upon the sight lines for a driver exiting Babbins Road. The Figure 1 and 2 show that the design will not impact upon this sight line, with the curvature of the road providing a benefit for the sight line. The bus standing zone is located behind the 3.5 metres wide deceleration lane and the 2.5 metres wide sealed shoulder and hence 6 metres away from the northbound travel lane on the Oxley Highway. It is noted that the current intersection layout and bus stand area is located adjacent to the running lane northbound on the Oxley Highway and as such could impact upon the sight line.
