Demolition Plan

Location: Ridgecrop Drive, Castle Hill NSW

Demolition Structure Description: Single Story Buildings, Basket Ball Court and Refurbishment of 2 Buildings

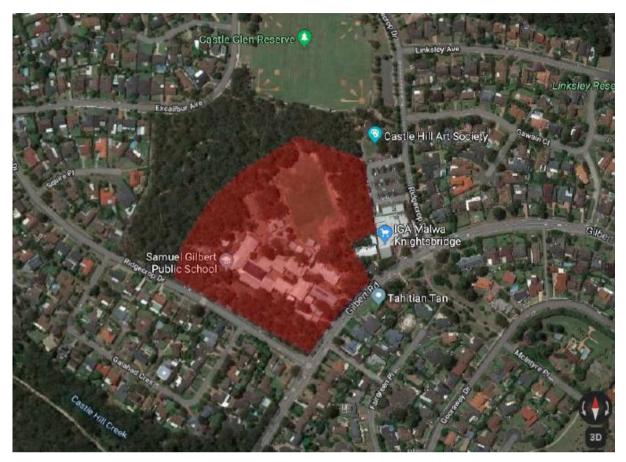
Figure 1. Locality Plan

The proposed development is located in the suburb of Castle Hill on Ridgecrop Drive as shown in **Figure 1**.

The site is bounded by Ridgecrop Drive on the south-western boundary, Gilbert Road on the south-eastern boundary and high-density vegetation land on the northern boundary.

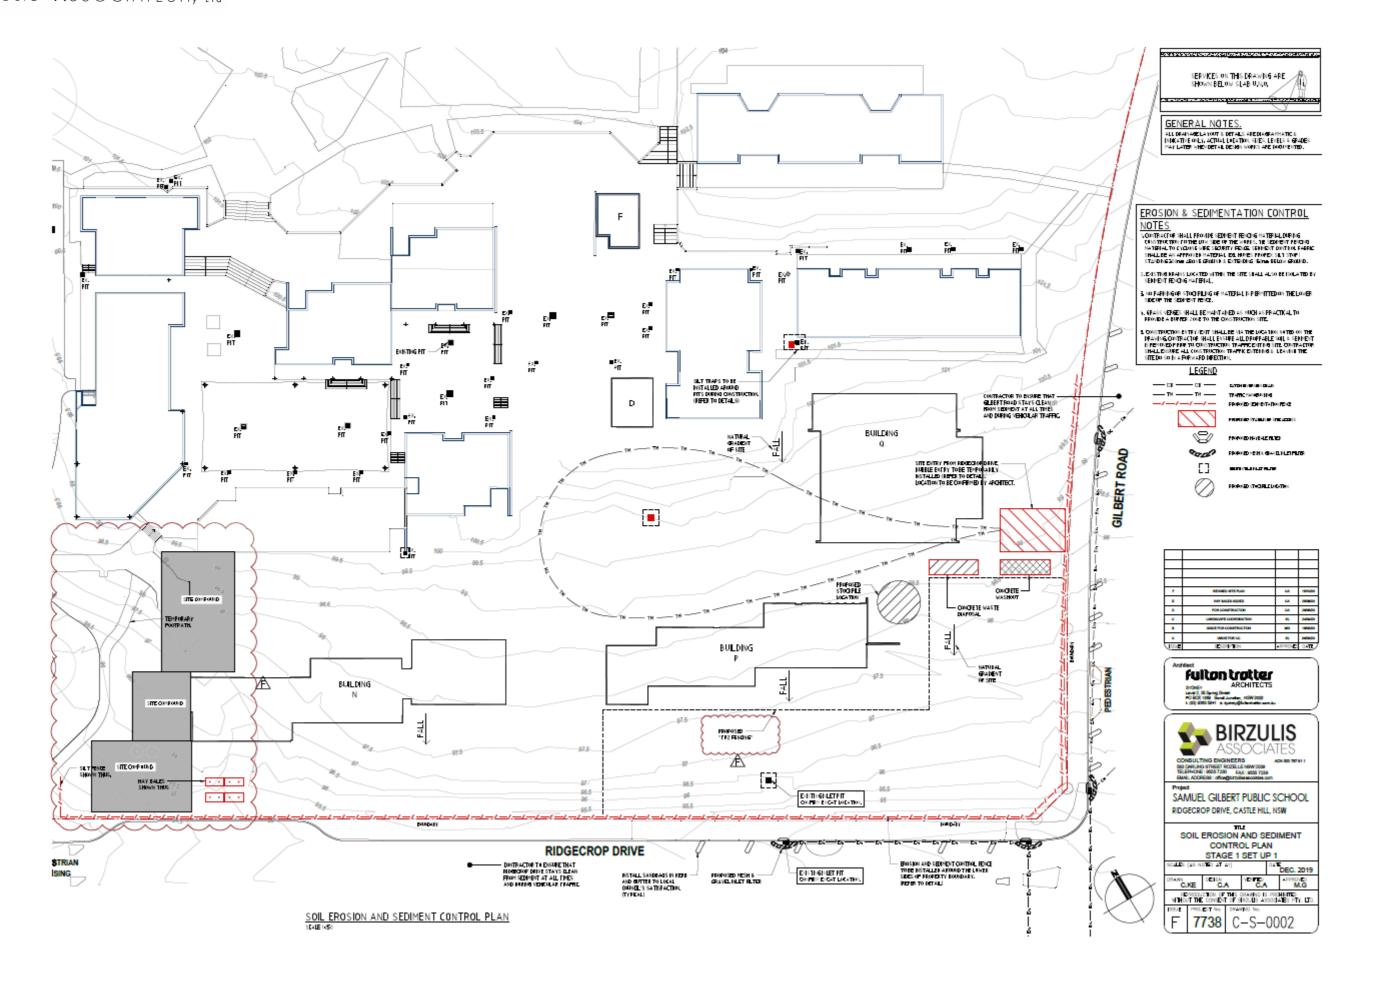
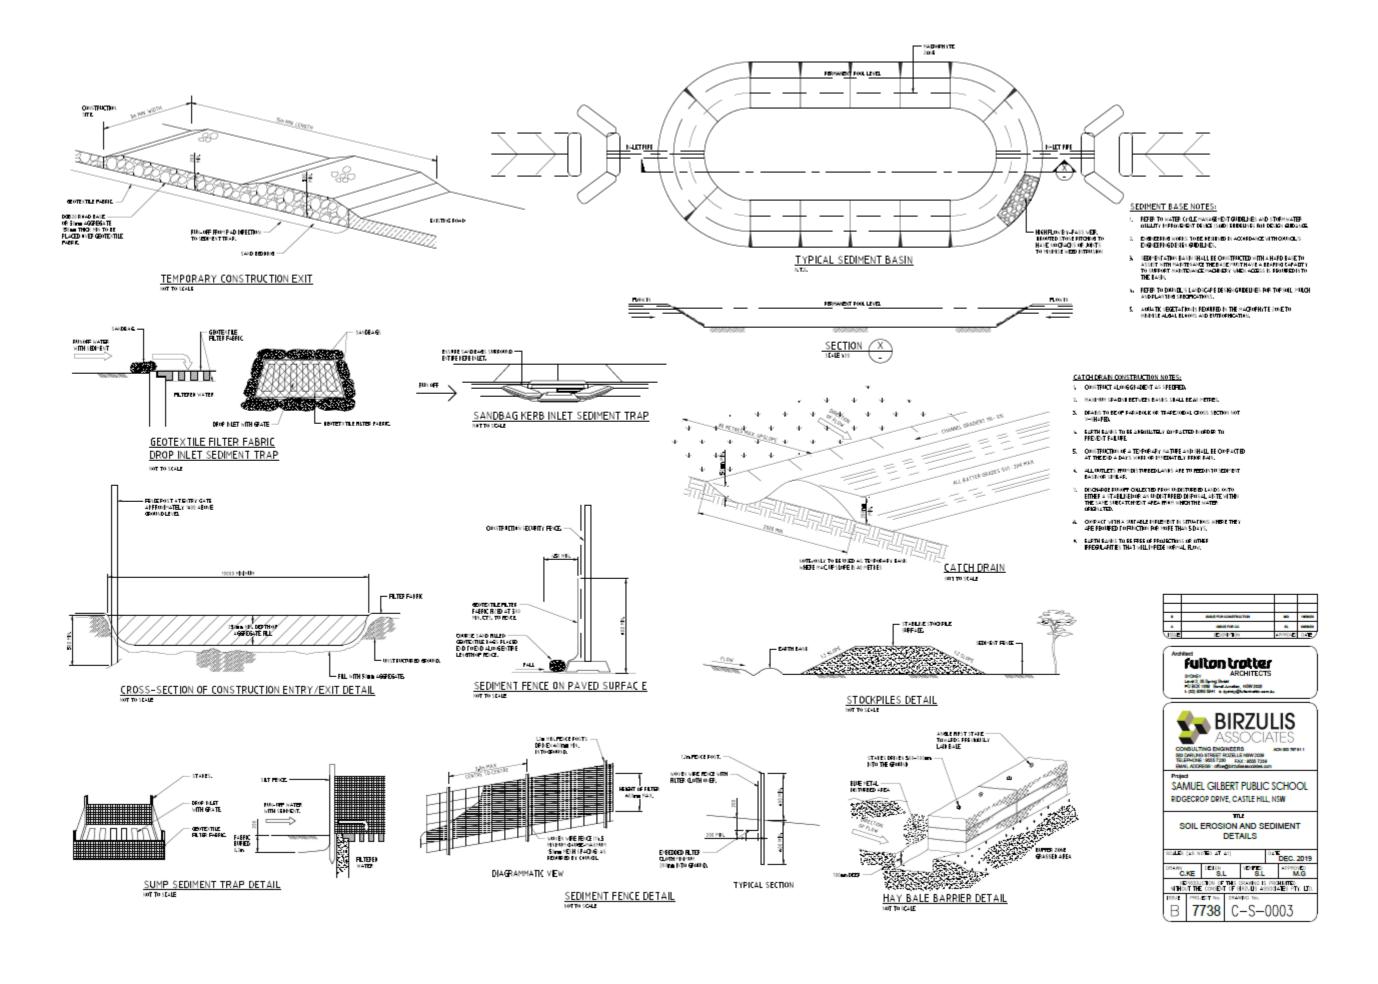
APPENDIX A EROSION & SEDIMENT CONTROL PLAN & DETAILS

The above is achieved using the correct implementation of the Erosion and Sediment Control Plan shown on the engineering drawings and any other recommendations in this report.

To achieve the requirements of not concentrating water flows which can lead to transportation of sediment off site it is recommended the swales on the stormwater design drawings be constructed as soon as practicable to divert upstream water around the site.

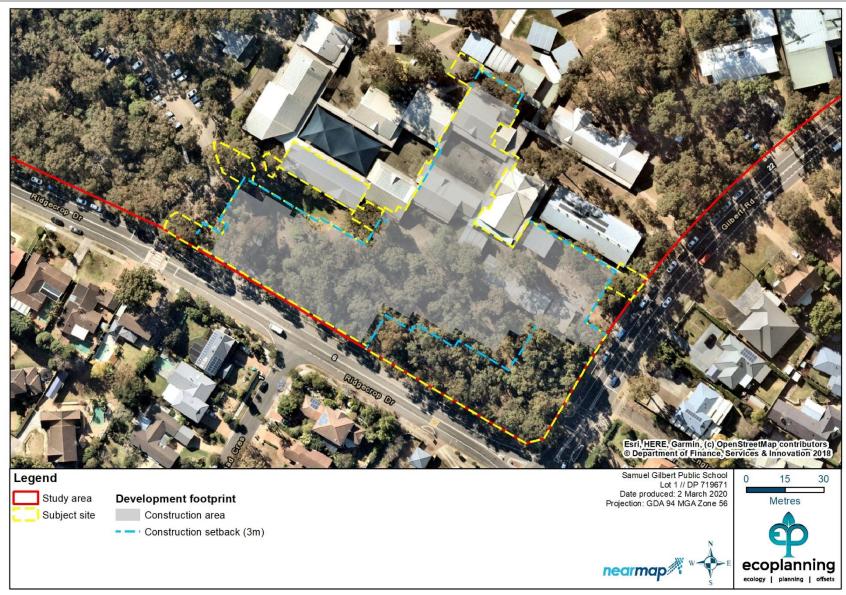
Figure 1.3: Development footprint, including construction setback.

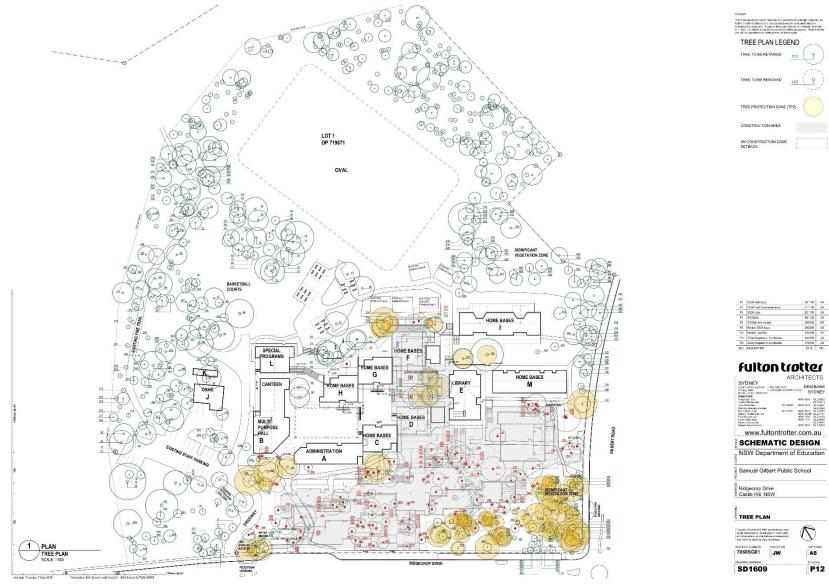
Figure 1.4: Tree removal and retention plan (issued by client 11/02/2020).

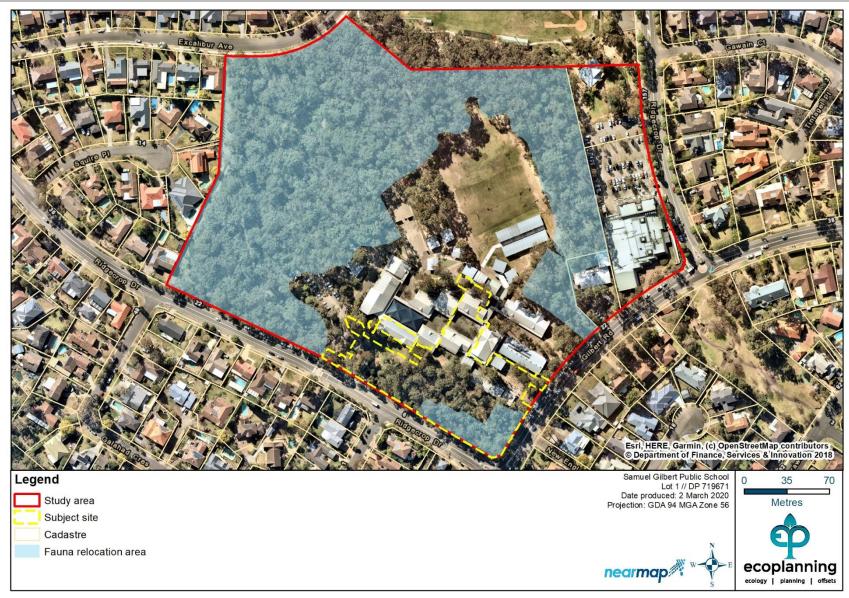
Figure 3.1: Fauna relocation area within school property.

- Relocation of any fauna must be undertaken under the guidance of a suitably qualified ecologist or wildlife carer and taken to an agreed location. It is advised that fauna be relocated to native vegetation retained within the school property (Figure 3.1),

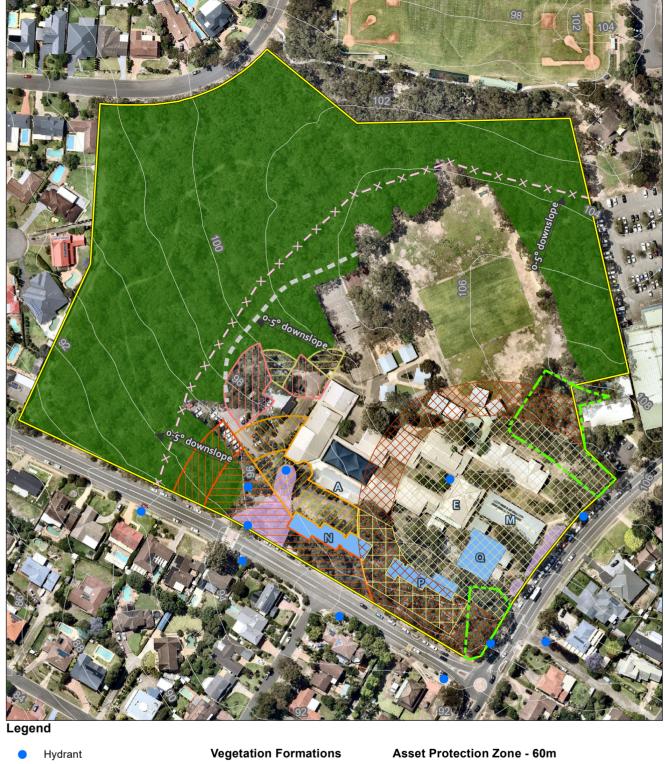
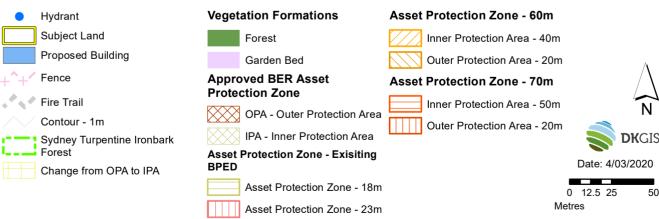
Figure 2: Bushfire Hazard Analysis and Asset Protection Zone

- The school benefits from two road frontages with hydrants as well as additional hydrants located throughout the school property (refer to Figure 2 for hydrant locations).

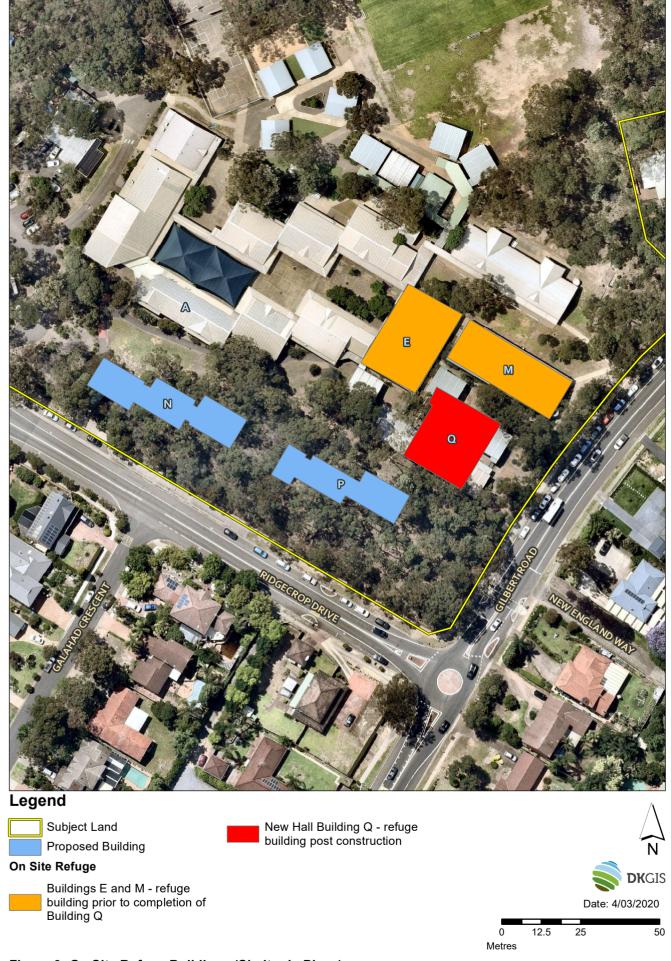
Figure 3: On Site Refuge Buildings (Shelter in Place)

The location of both refuge scenarios is identified on Figure 3. The New Hall (Building Q) will offer the best level of protection as it will be located furthest from the hazard, have direct access onto Gilbert Road and will have the ability to accommodate the entire School community. Prior to the construction of the New Hall being completed, Buildings E and M will be able to accommodate the School community across the two buildings with a level of hazard separation similar to the New Hall. Building M is also compliant with BAL-12.5. The existing hall (Building B) is located on the hazard side of the school and therefore does not offer a safe level of refuge.

- 1. Chief Warden to advise School community, including contractors, of the decision to shelter on site.
- 2. Chief Warden to activate fire siren.
- 3. Upon being alerted by fire siren, Area Wardens are to visit each classroom/building within their area advising all people to move to the on site shelter (refer to Figure 3 for location of refuge building).

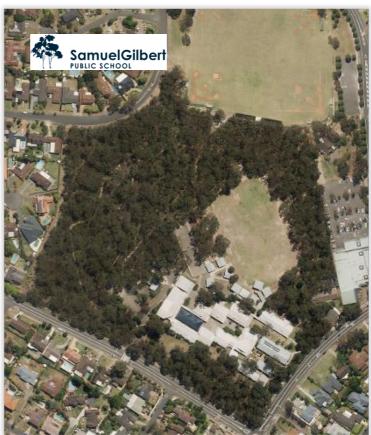
Image 2: Aerial view of school Inset School symbol with tall trees

The site comprises an extensive area of land rising from south to the north. The site is bounded by streets to the south and south-east. Remnant bushland is present to the west and north, between residential areas to the west, and a public oval to the north. Also, a preschool and shopping centre to the north-east (See Image 2).

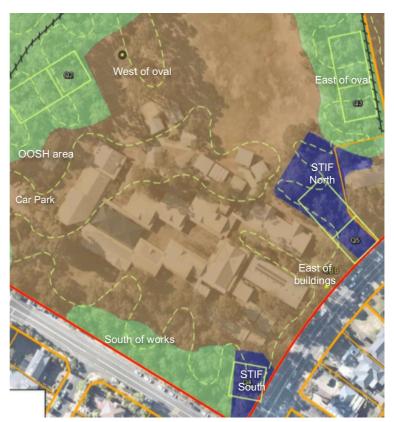
Image 3: Aerial view of school & vegetation groups discussed in report from Travers s report

The building designs have been planned to avoid works in the ecologically important (Sydney Turpentine-Ironbark Forest (STIF) areas (see blue areas on Image 3),

Tree near the oval and those east beyond are outside the area of works with the exception of those west of the STIF area. These may be impacted upon by the temporary relocation of demountables.

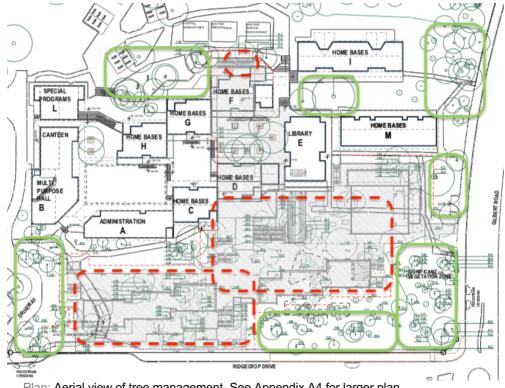
Trees beyond three metres of works will require that careful management of most of their Tree Protection Zone (i.e.10 x trunk diameter) must be undertaken.

Plan: Aerial view of tree management. See Appendix A4 for larger plan

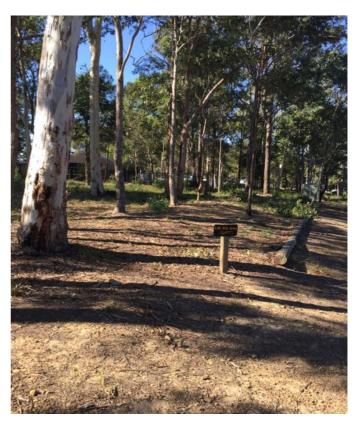
There is fill and rubble in this area and this has built up around the trunks of

Image 5: Lilli Pilli Grove – STIF north Fill under trees causing decline

trees. If this area is to survive in the longer term, this fill and rubble should be removed to clear the tree trunks.

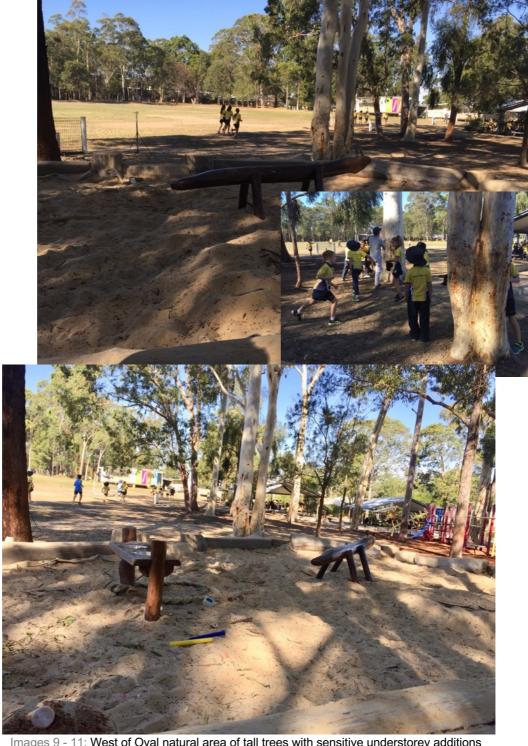
Images 9 - 11: West of Oval natural area of tall trees with sensitive understorey additions

Trees in this area are very tall and heathy, with the under area modified to provide active play. The soil in this area was not compacted and not as dry as was the area around oval. The trees in this area are an exemplary example of the possibilities for interaction between children and trees (see Images 9-11 below).

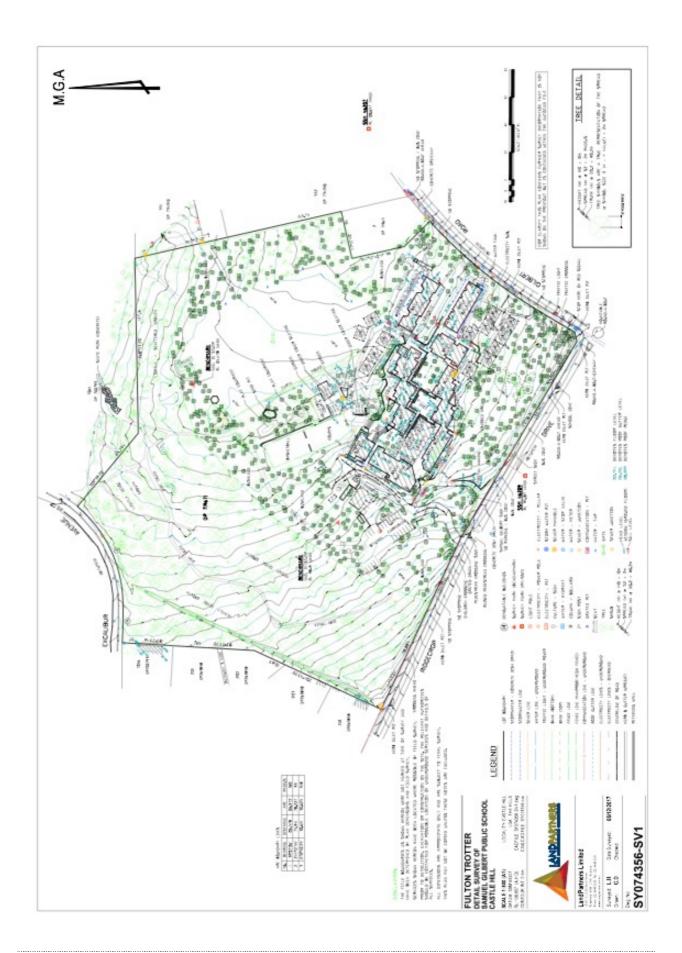
Tree Plan by Fulton Trotter Architects, Project No:7068SG01, Dwg No: SD1609/Rev P1, Dated 18/10/18
*see larger format plan and latest modifications sent separately

Tree Numbers added to Site survey by LandPartners Limited, Drawing No. SY074362-SV1, Dated 06/12/2017
*see larger format plan and latest modifications sent separately
