Meadowbank Education and Employment Precinct Schools Project Supplementary Geotechnical Investigation

Prepared by Alliance Geotechnical

11 October 2019

Report Number: 9280-GR-1-1 Rev 1
Report Type: Supplementary Geotechnical Investigation Report
Project Name: Meadowbank Education and Employment Precinct Schools Project
Site Location: 2 Rhodes Street Meadowbank, NSW 2114

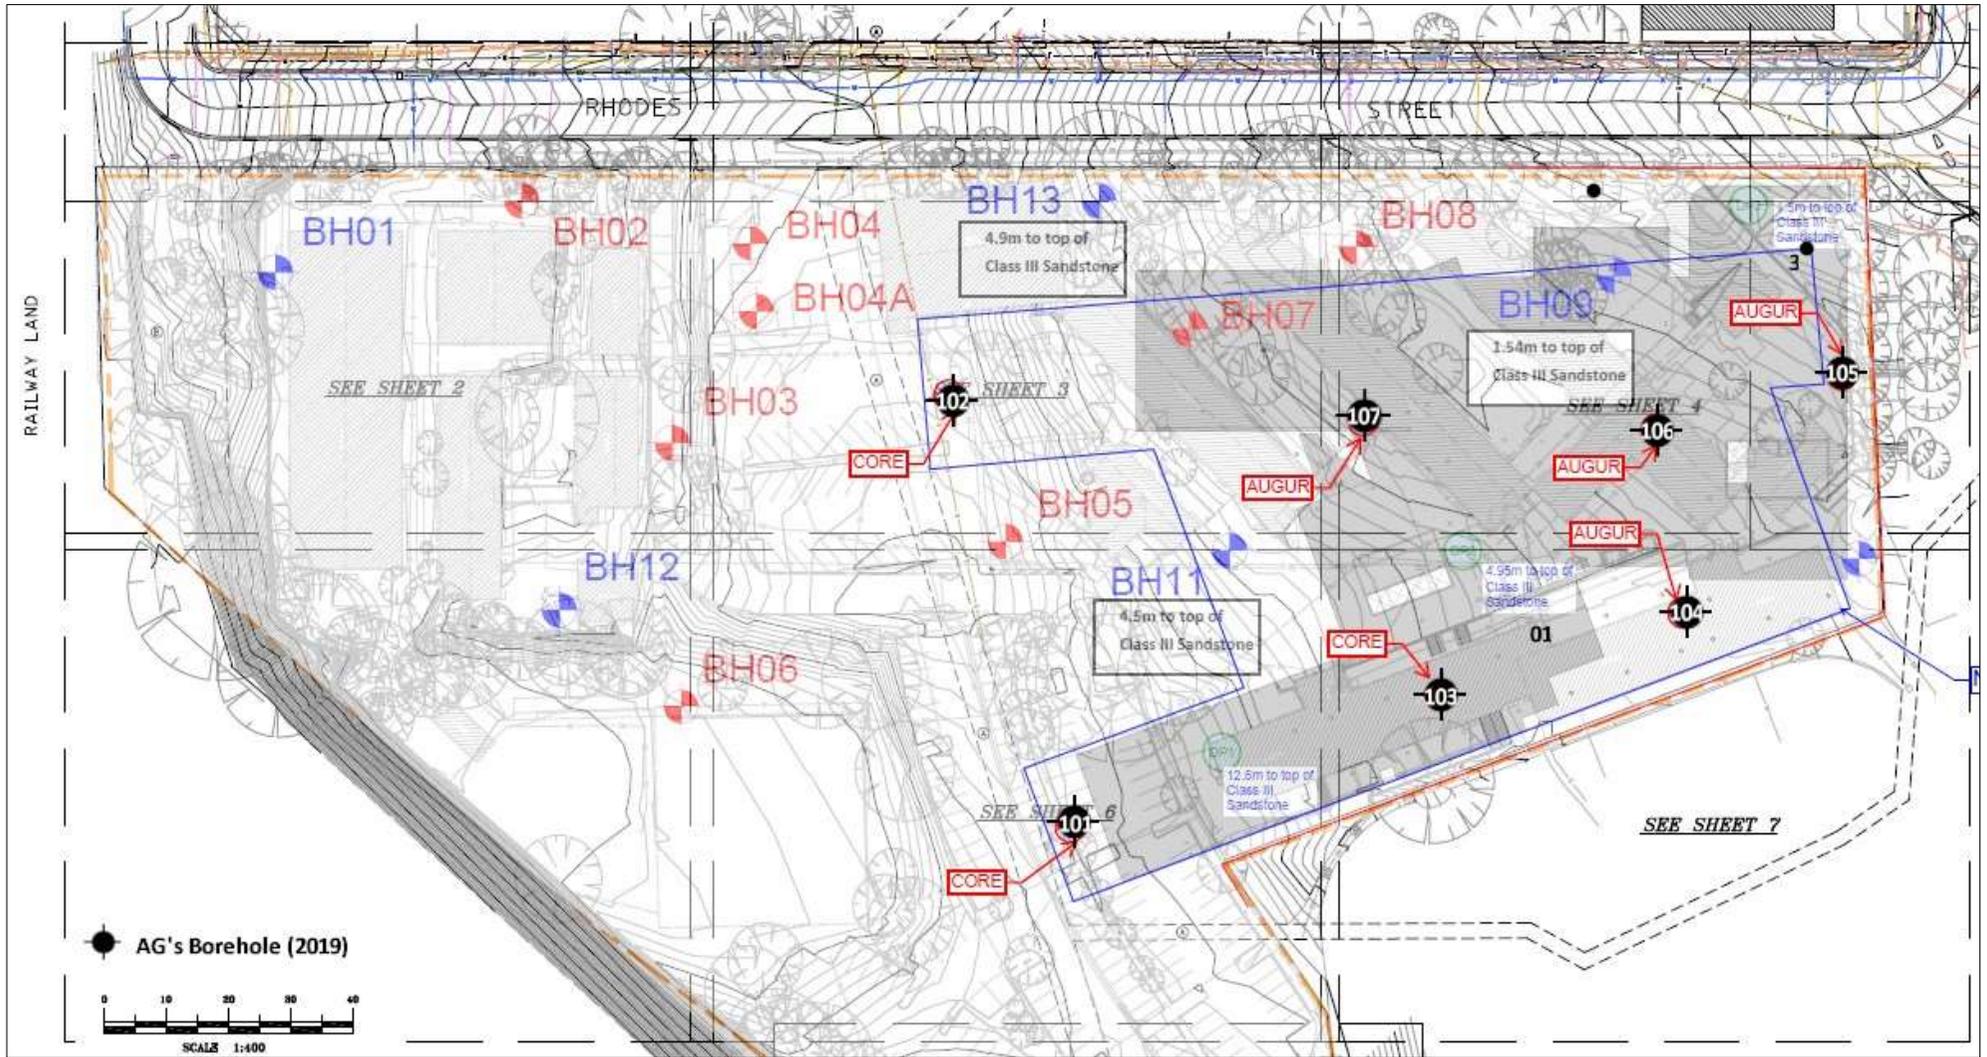
The approximate locations of the boreholes are shown on the Borehole Location Plan (Drawing 9280-GR-1-A) presented in Attachment 2.

The investigation comprised the drilling of three cored boreholes (BH101 to BH103) and four augured boreholes (BH104 to BH107) to a maximum depth of 21m at the locations indicated by the client. Borehole BH101 was terminated at a depth of 1.7m due to refusal on a buried concrete structure and BH101a was

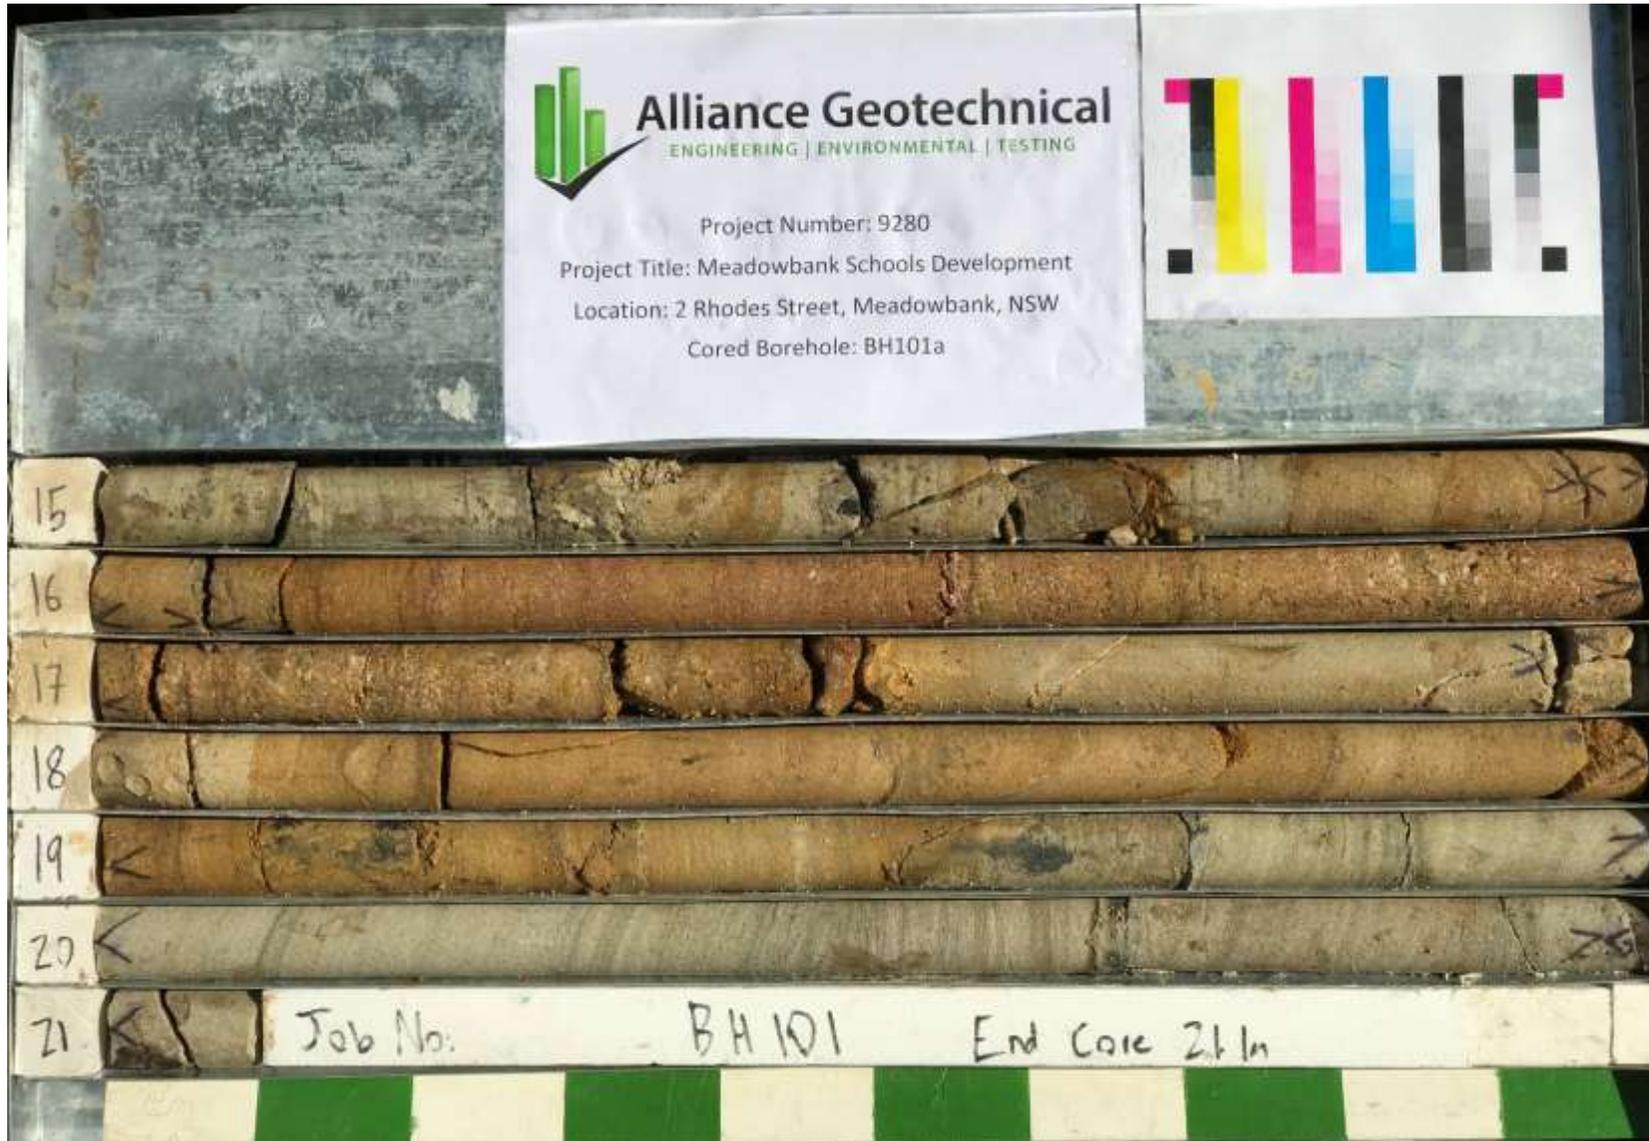
Core Box Photo BH101a – 15m to 21.1m

19.68, 19.69, Clay SM, 20mm thickness
																19.84, JT, 0-5°, Undulating, Rough, Clean
							20						1.46	1.58		
								0.29	0.52			20.90, 20.92, JT, 15°, Planar, Rough, Clean

1.66	1.75			21.03, 21.05, JT, 15°, Planar, Rough, Clean				
			21					1.38	1.46			End BH 101a				
			22		BH 101a terminated at 21.1m											
			23													
			24

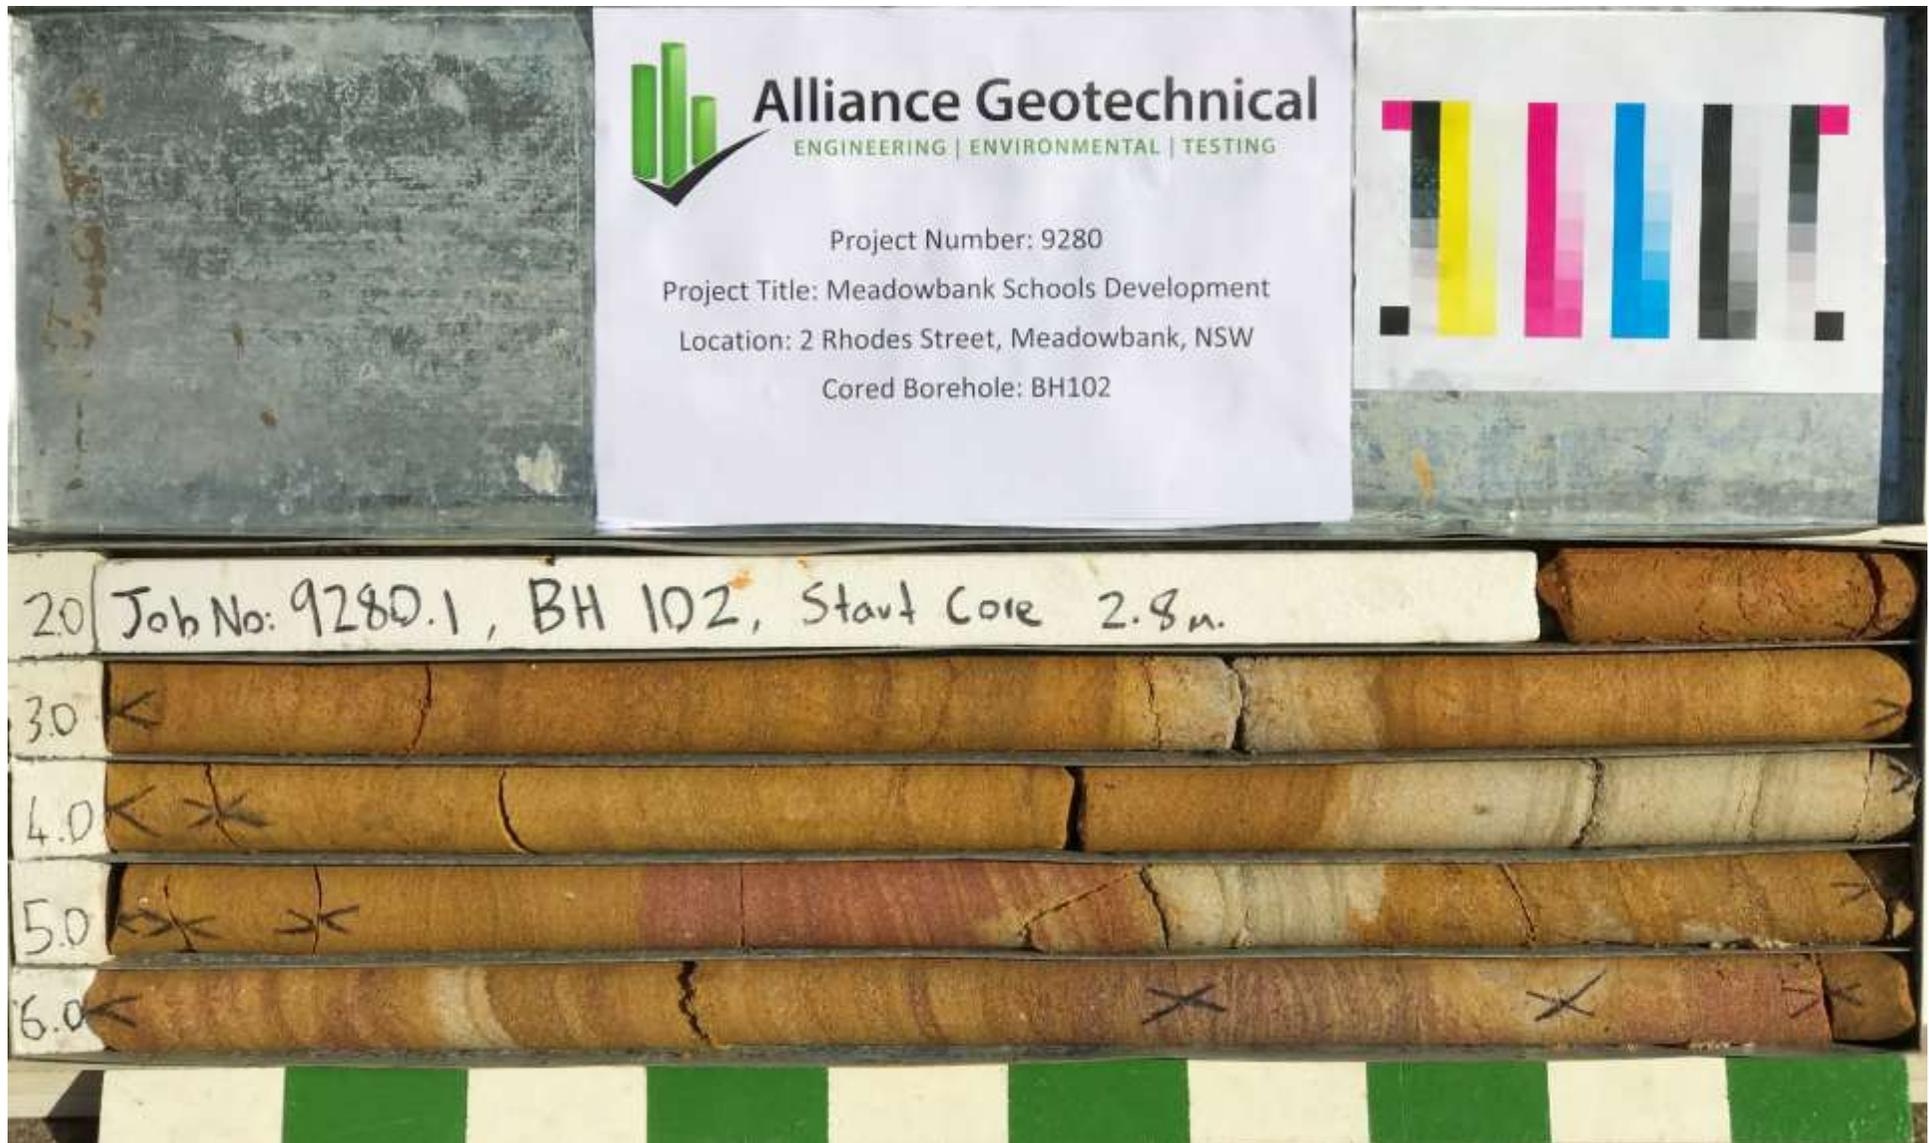
Core Box Photo BH102 – 2.8m to 7m

Method	Water	RL (m)	Depth (m)	Graphic Log	Material Description	Weathering	Estimated Strength			I _{s(50)} MPa	D- diam- etral A- axial	RQD %	Defect Spacing mm	Additional Data
							EL -0.03	VL -0.1	L -0.3					
NMLC			7	SANDSTONE, fine to medium grained, light orange-brown and light grey. <i>(continued)</i>	MW				D A 0.76 0.82	95			
	Full Return		8		BH 102 terminated at 7m									End BH 102
			9											
			10											
			11											
			12											
			13

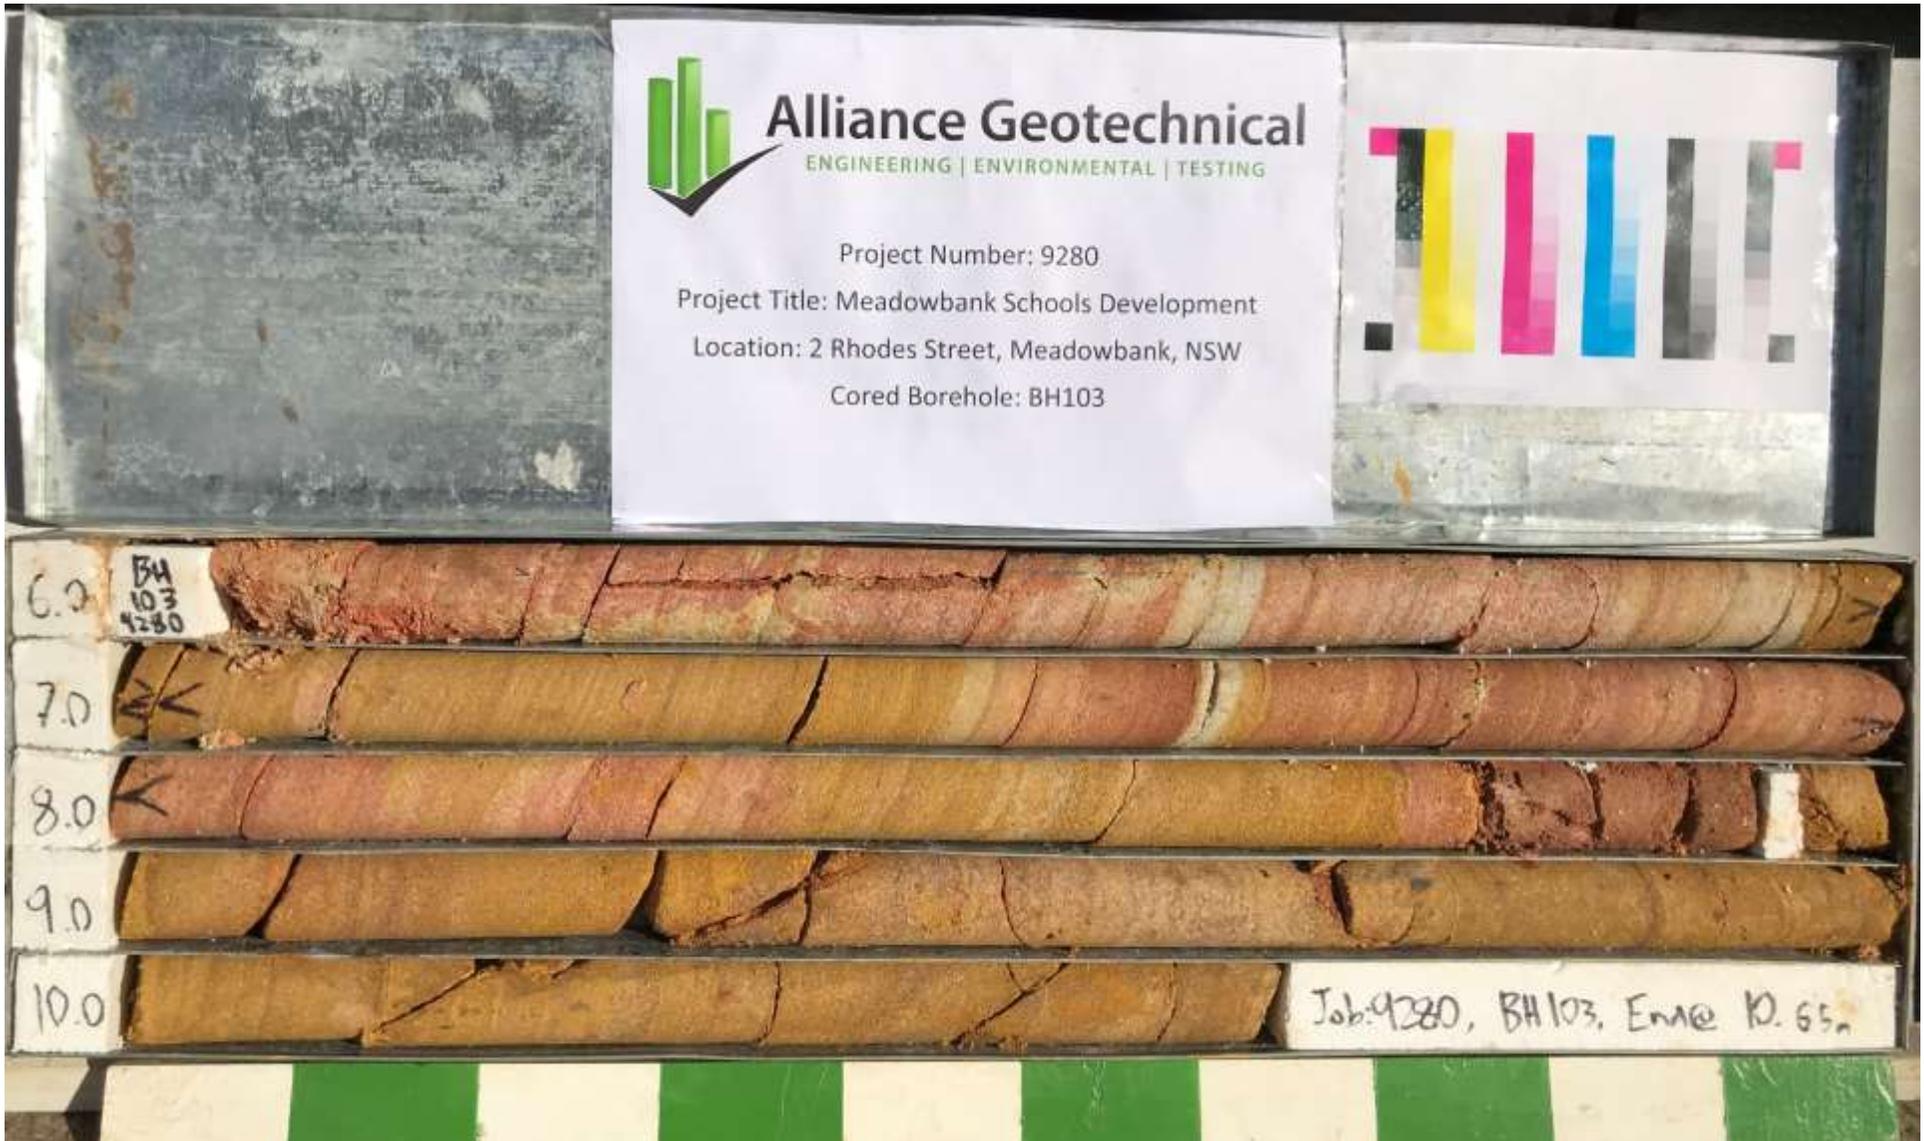
Core Box Photo BH103 – 6.05m to 10.65m

10.59, BP, 15°, Planar, Rough, Clean							
				BH 103 terminated at 10.65m	End BH 103						
			11								
			12								
			13

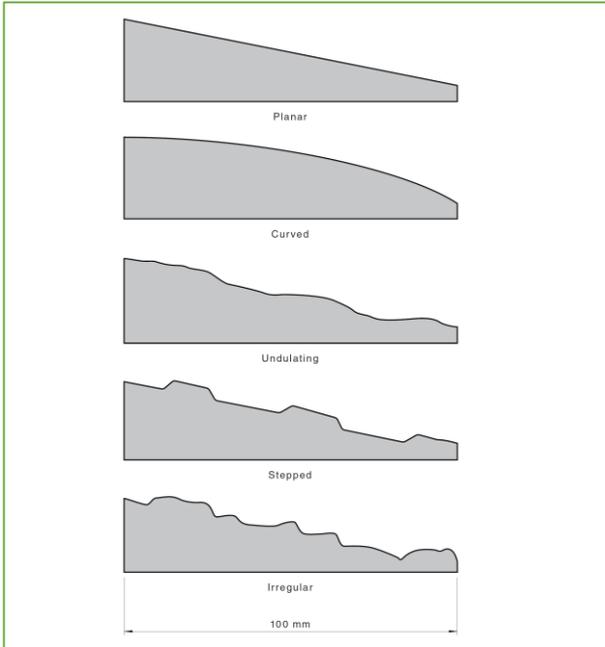
Surface Shape – At the medium scale of observation, description of the roughness of the surface shall be enhanced by description of the shape of the defect surface using the following terms, as illustrated below:

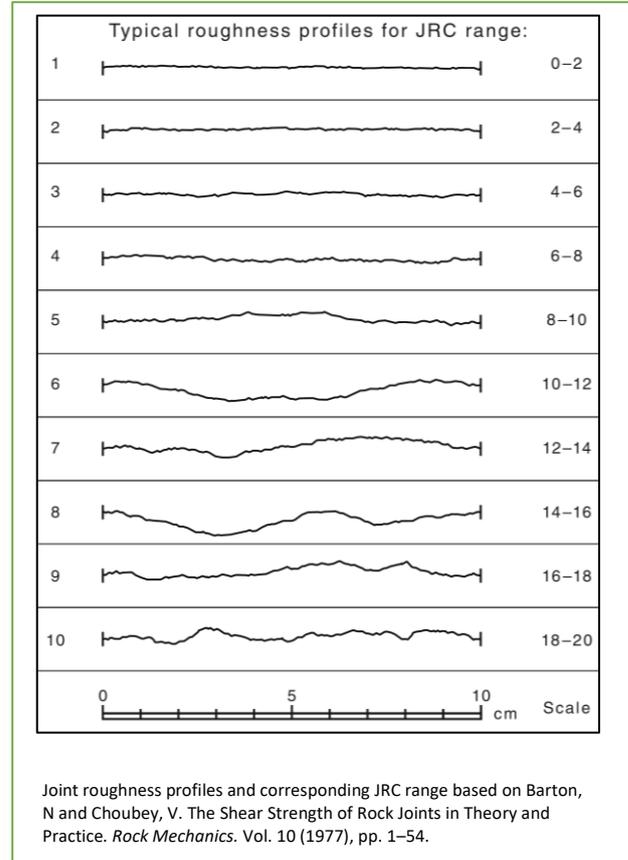
Where applicable Joint Roughness Range (JRC) is provided as follows:
