# **Meadowbank Education and Employment Precinct Schools Project Supplementary Asbestos Assessment**

**SSD 18\_9343**

**Prepared by Alliance Geotechnical  
For School Infrastructure NSW  
11 October 2019**

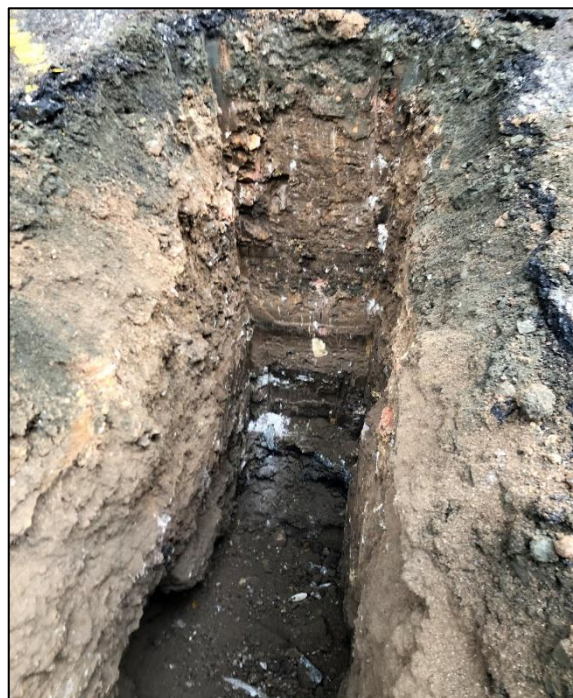
**Image 7.1.1 View of sampling point TP07E**

Samples were collected at each sampling point and placed in laboratory supplied 500ml zip-lock asbestos sample bags (where required). The jars and bags were labelled with the project number, sample identifier and date the samples were collected on.

Each sampling point was backfilled and track rolled at the completion of the sampling task.

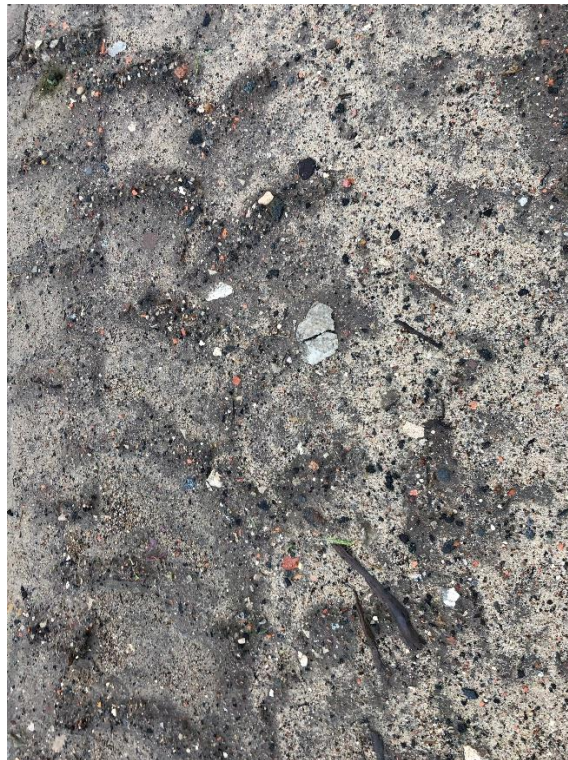
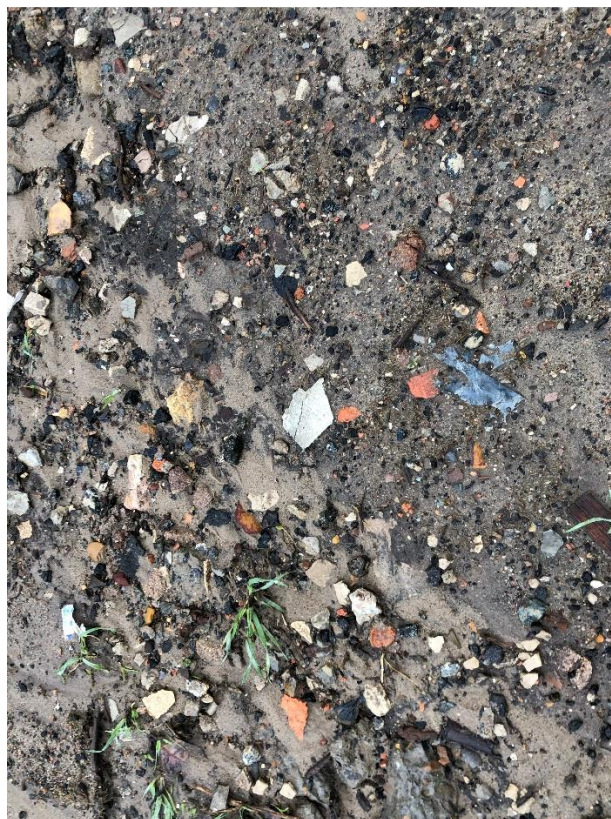
**Image7.3.1 View of potential ACMs onsite**

On 18 September 2019, visual evidence of potential asbestos containing materials (ACM) was observed on the surface of the site. The potential ACM was observed by AG as being scattered widespread across the recently exposed surface soils located beneath previous hardstand areas (refer to **Figure 7**).

The mobilisation to site on 18 September 2019, was carried out after and during significant rainfall events across Sydney. AG hypothesizes that the rainfall events caused substantial erosion of the loose topsoil across these portions of the site and exposed subsurface demolition waste containing potential ACM. The evidence was in the form fibre cement sheet fragments. Two samples of these fragments (FCS-01 and FCS-02) were collected and submitted for analysis at a NATA accredited laboratory.

Visual evidence of potential asbestos containing materials (ACM) was observed at several sampling points, including both on the surface and within the fill soil profile (TP04B, TP07A, TP30B, TP30C, TP40C and TP42). The evidence was in the form fibrous cement sheeting fragments. Samples of these fragments were collected when observed and submitted for analysis at a NATA accredited laboratory.

- The RAP be updated to include the recently identified contamination risks onsite and outline the appropriate remedial measures to adequately remove the contamination pathway and associated human health exposure risks. It is recommended that any update to the RAP be undertaken by an appropriately experienced environmental consultant.

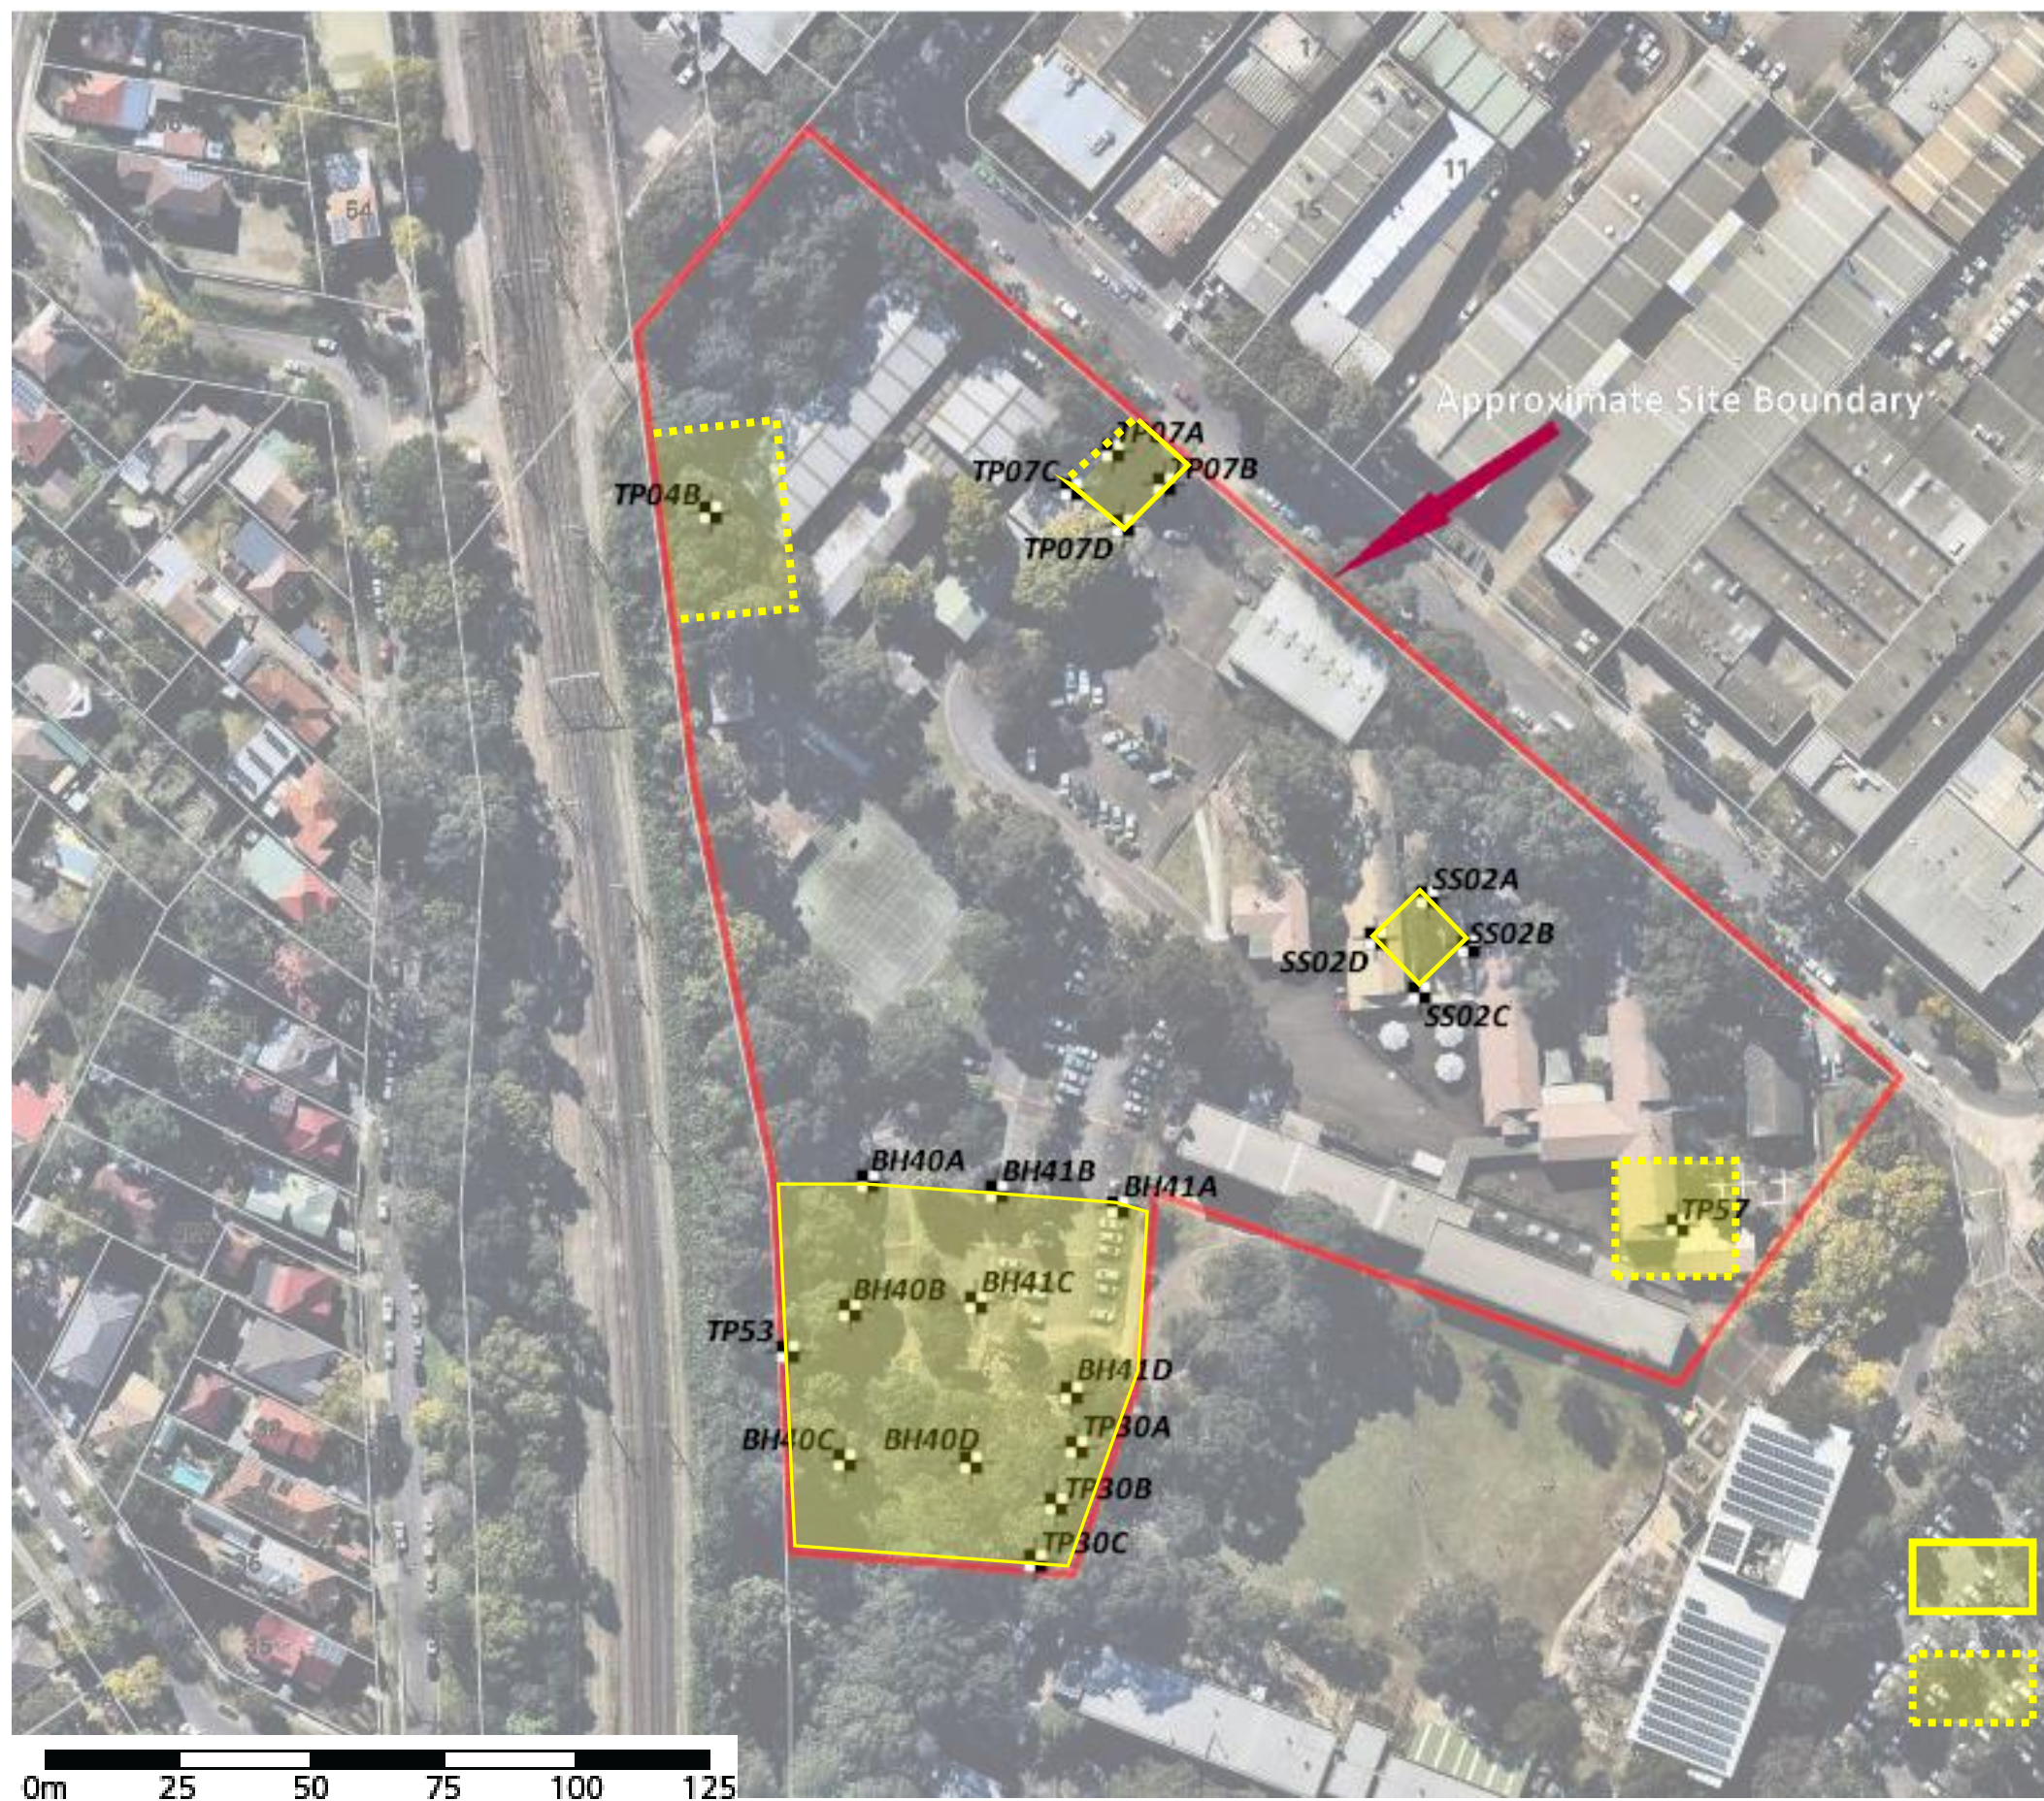
Unknown Extent of Asbestos Contamination.
